CONDITION SURVEY

**1-4 Church Close,
Sproughton,
Suffolk,
IP8 3BD**

**Church Close
Properties Ltd**

Ref: 23002-CS rev 1

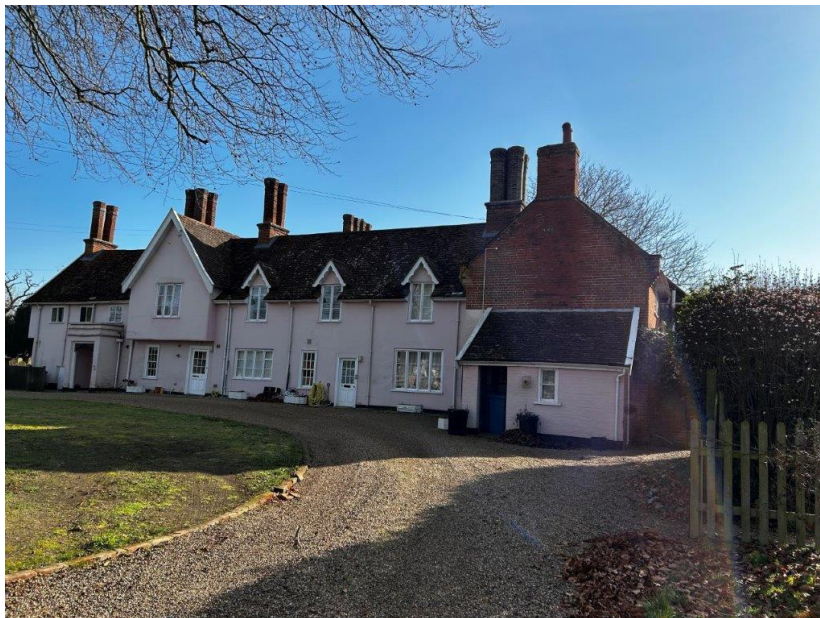
At the left of the elevation there is a large section of failing render and paintwork. This appears to be as a result of rising damp and also of the failing rainwater pipe serving the main roof.

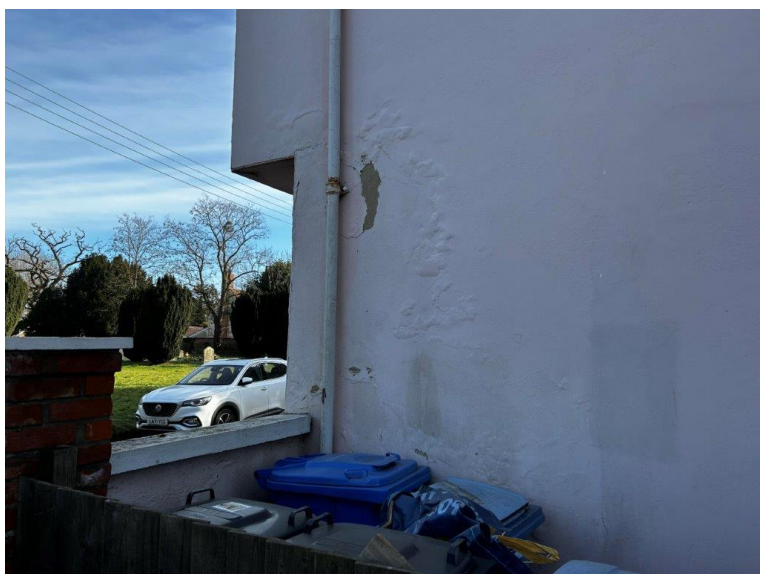
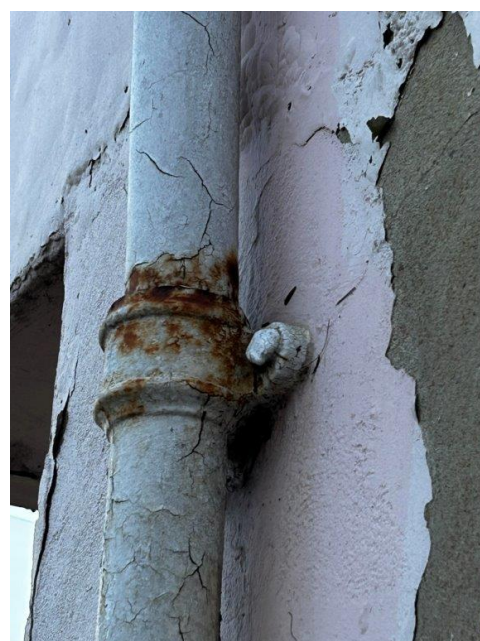
The damage is apparent at the level of a rusted collar joint in the cast iron rainwater pipe.

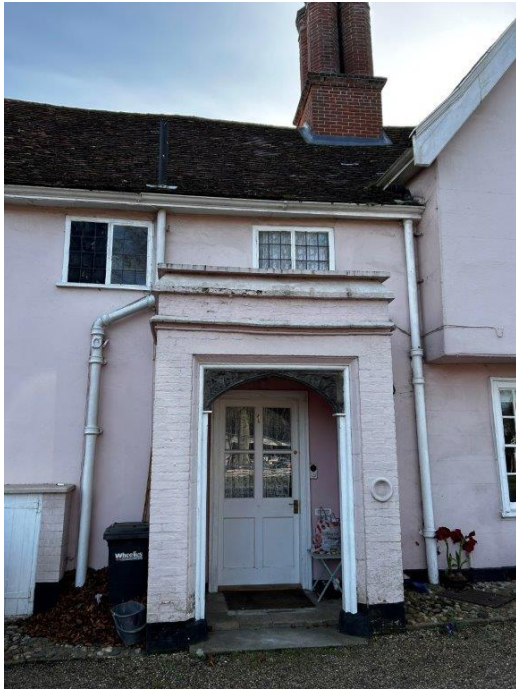
The rainwater hopper and downpipe to the RH side are listing and fixings appear to have failed.

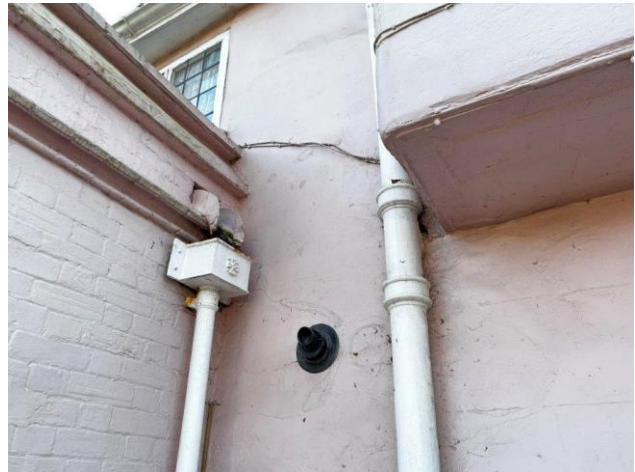
The timber panelling above the entrance shows signs of rot although the features are still visible.

Evidence of rising damp is present on both sides of the porch.

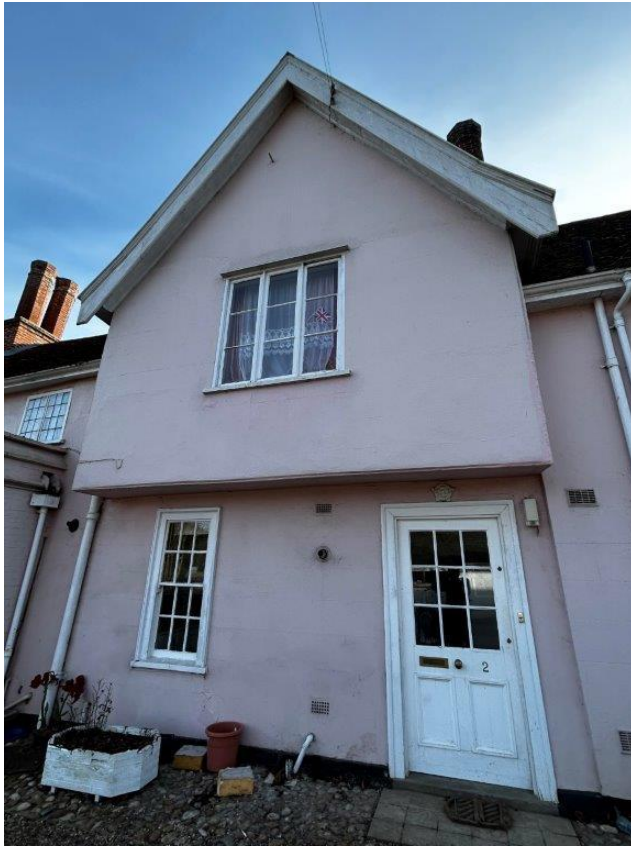
A large gable at first floor level cantilevers over the ground floor with panelling to the soffit. The panelling to the soffit has an uneven surface and exposed joints as a result of historic movement and settling.

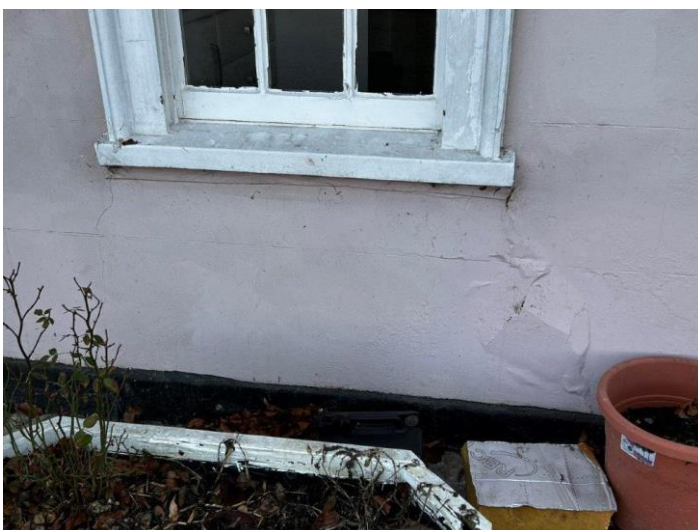
A small section of render has also blown at the LH end of the first floor window cill.

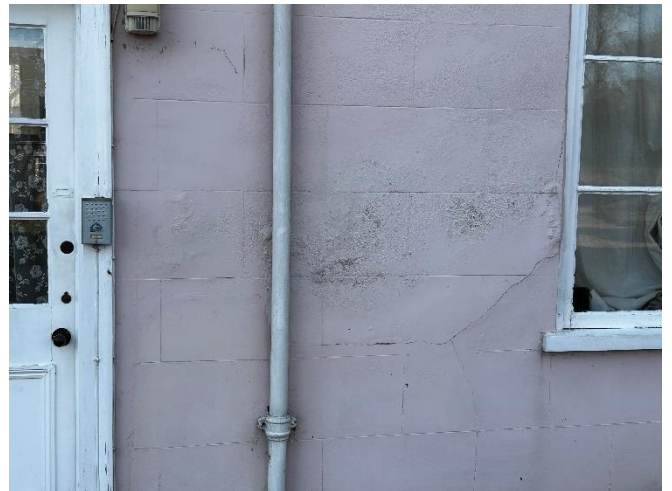
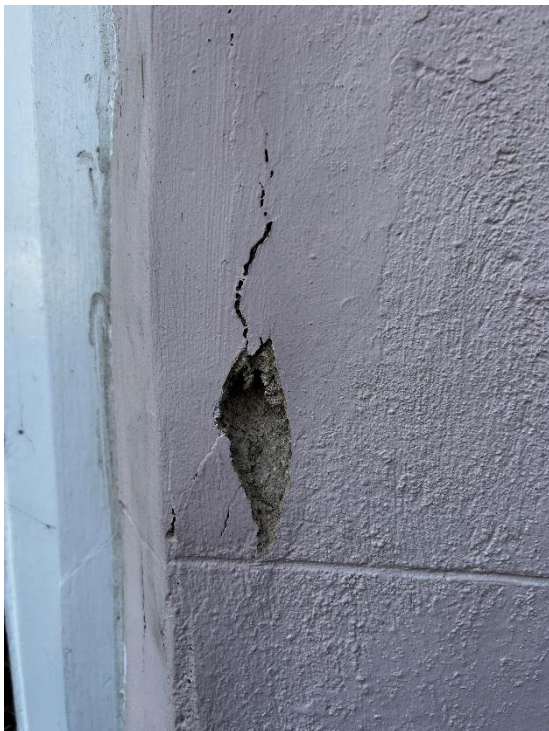
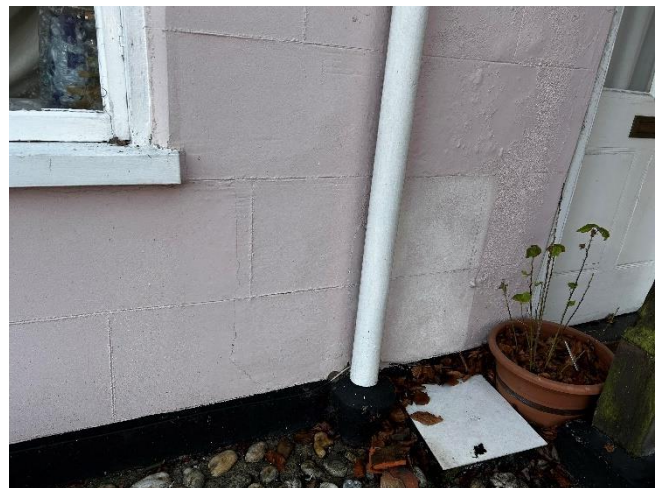
The render/ pargeting to the front elevation has a series of cracks particularly around window and door openings along the full extent of the elevation.

There is also evidence of damp penetration in the location of a number of the cracks leading to blistering of the render and painting.

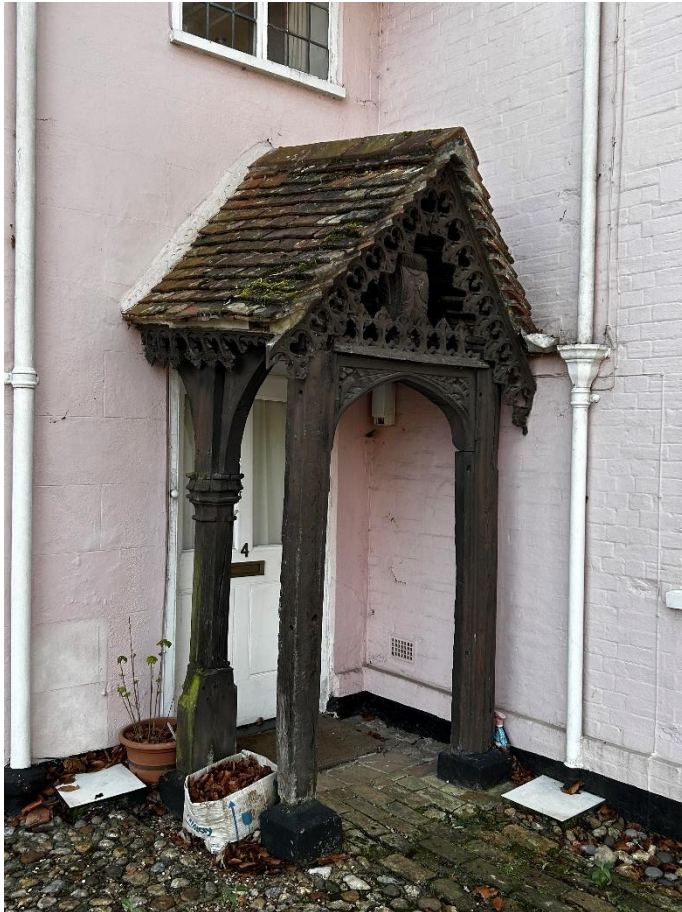
The level of the porch fails away considerably from the main house with subsequent gaps having been filled in the past.

The timber generally shows signs of weathering and the front LH post is decayed at low level potentially as a result of rising damp through the plinth below.

The timber fascia's are in a fairly poor condition with sections damaged or missing generally.

The posts are of different design and therefore it is assumed that they have been replaced at various points during repairs.

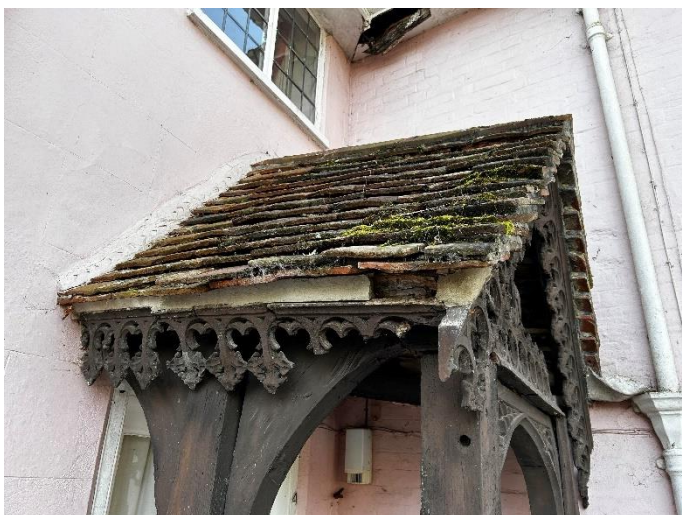
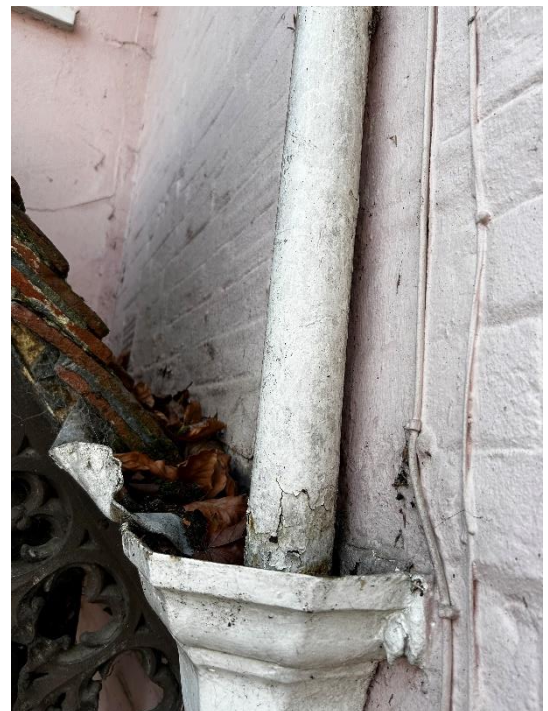
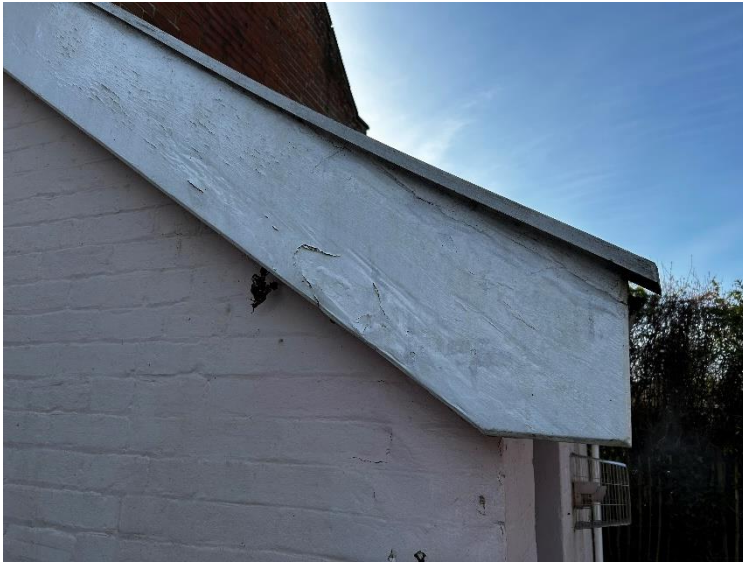
A lead lined valley gutter is located between the RH side of the porch and the brickwork to the main house. This extends and terminates into the rainwater downpipe adjacent. The gutter is blocked with leaves and debris.

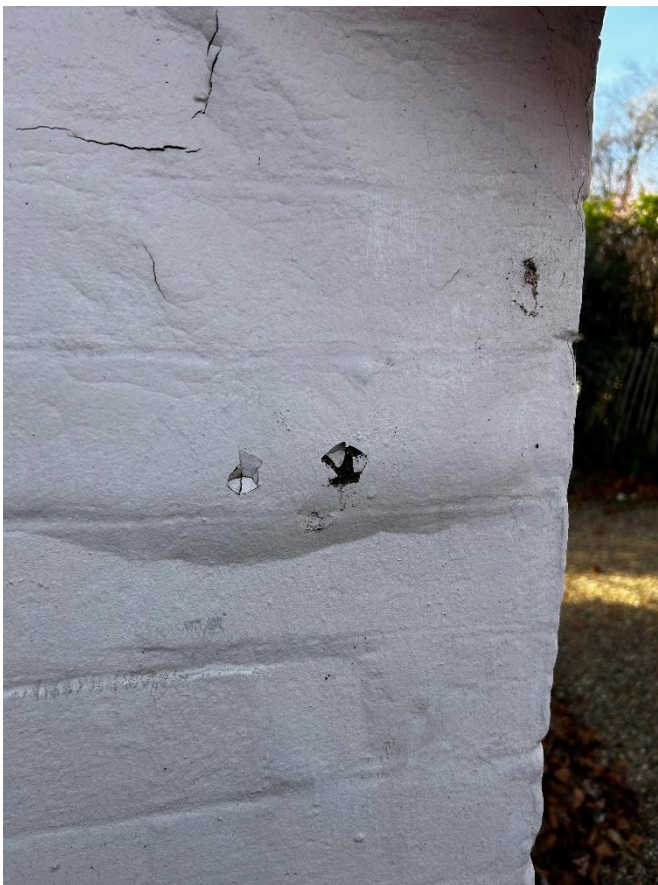
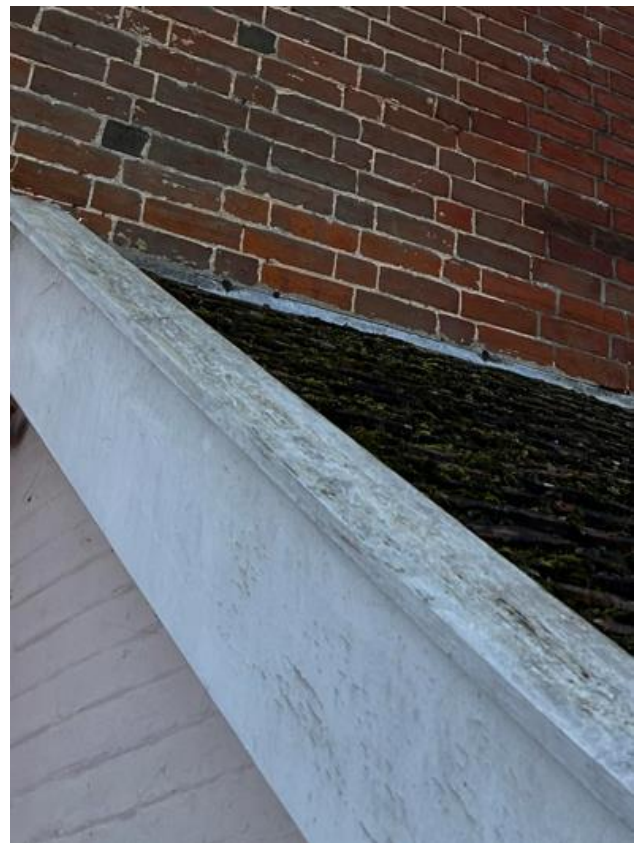
A single storey brick built projection is located at the RH end of the property with a mono-pitch roof. The projection contains a bin store and gas meters are located within. The painted surface to the brickwork is failing and there is a build up of debris behind the blown paint.

The flashing along the head of the roof appears inadequate and the roof covering itself is covered with a heavy layer of moss.

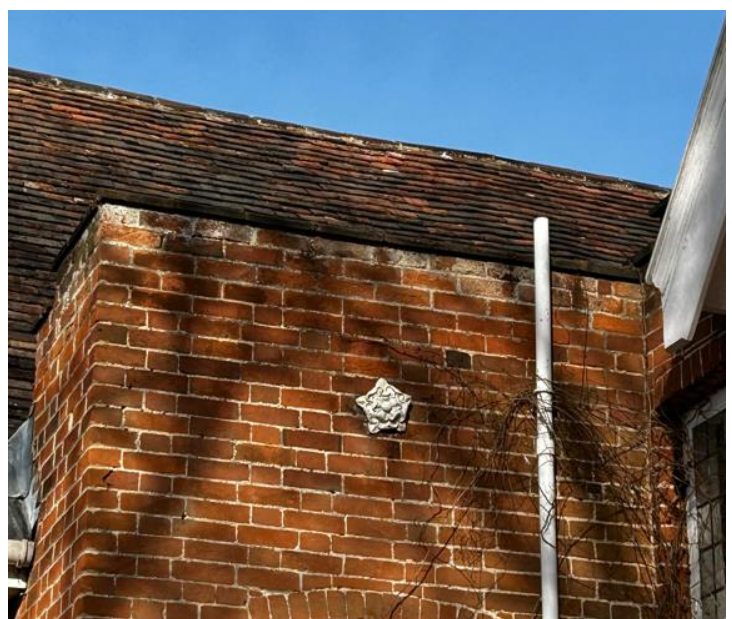
The brickwork at the head of the parapet to the section of flat roof is spalling and showing signs of generally damp penetration. This may indicate that the coping stones above require replacement.

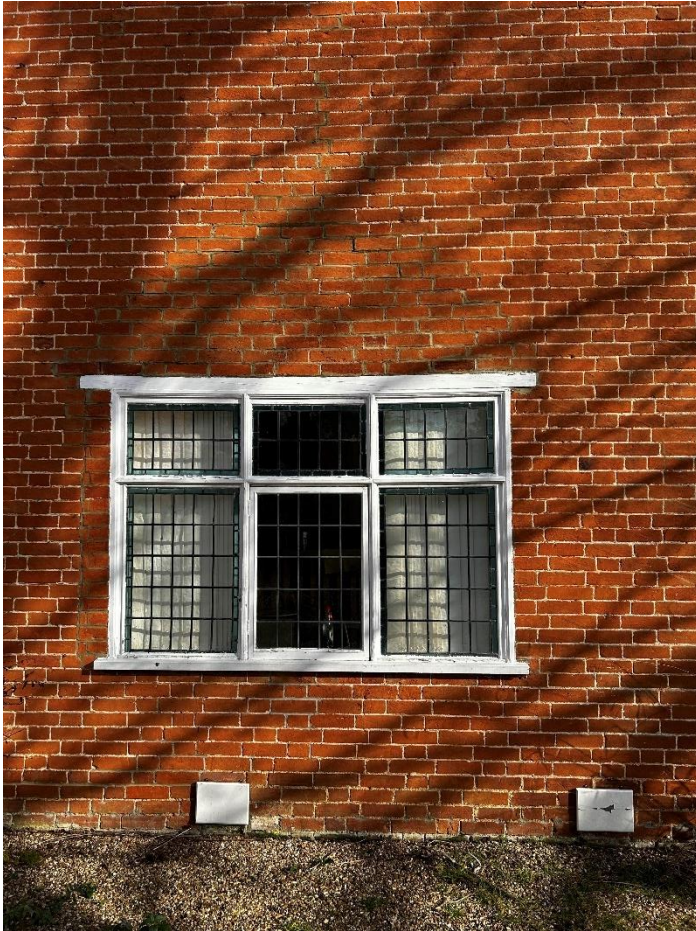
To the gable facing towards the LH end of the rear elevation, a repair has been carried out above the ground floor window. This type of repair is generally made when a lintel has failed over a window.

The brick coursing and in particular the vertical mortar joints in this location are also generally out of line.

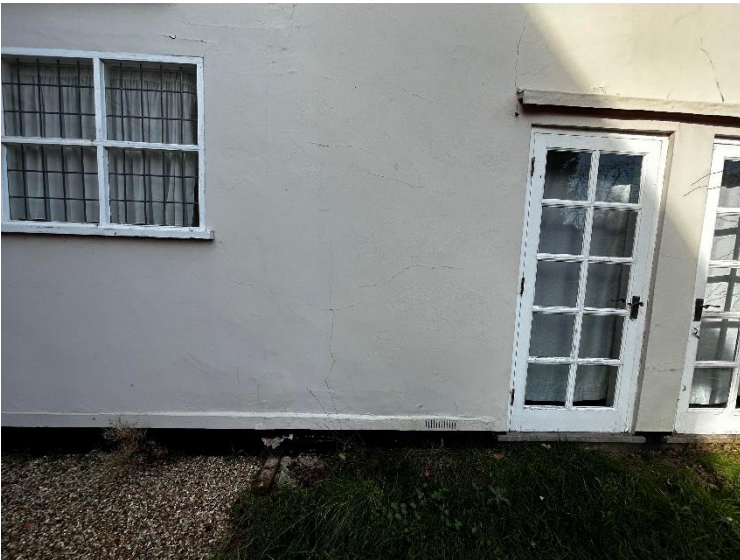
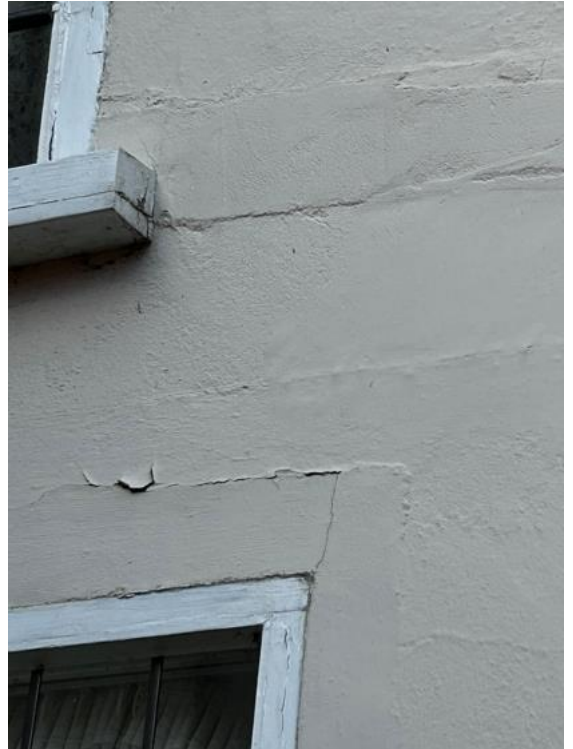
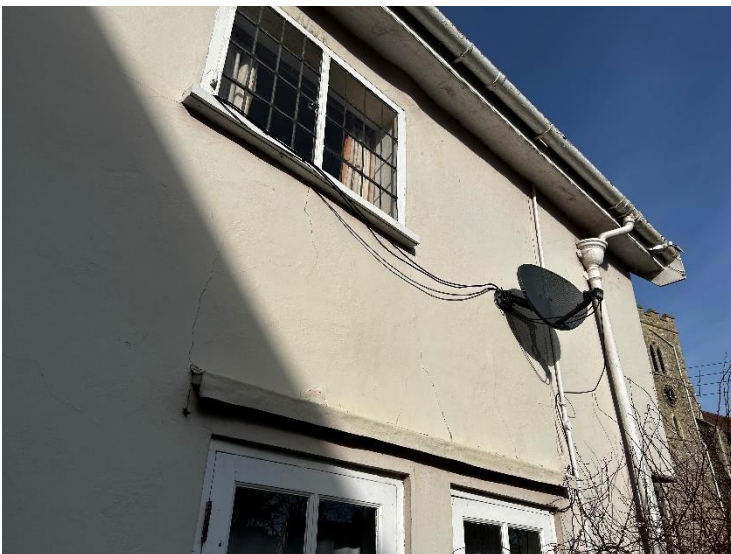
To the RH end of the rear elevation, the façade is rendered with several cracks evident across the rendered surface.

Cracking is particularly evident around the windows and doors at ground floor level.

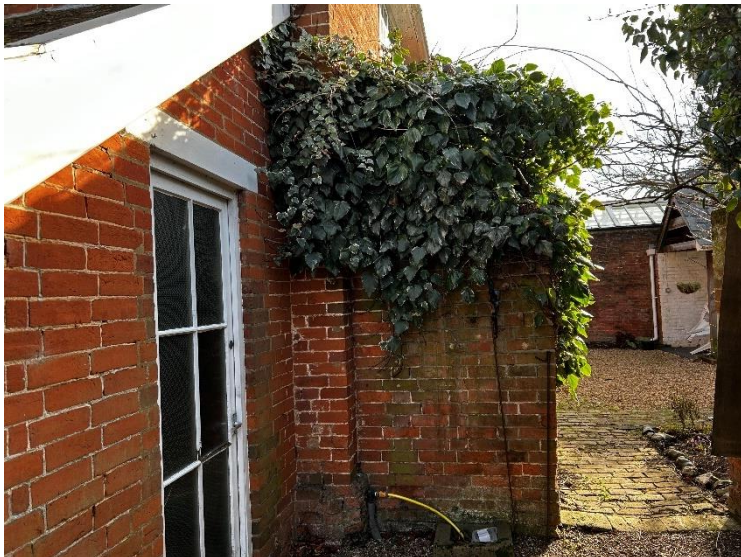
The side elevation to the right-hand end of the main house is comprised of facing brickwork. Vegetation is evident at high level around the rainwater guttering and downpipe at high level.

Previous repairs have been carried out above the ground floor window to the bathroom of flat 4.

The brickwork at low level is generally spalling with a number of faces blown.

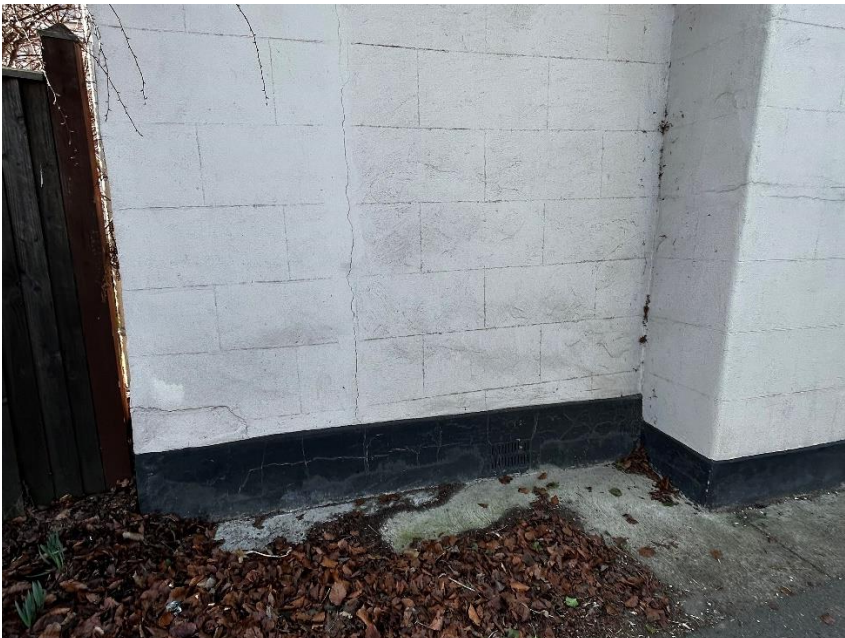
A series of horizontal and vertical cracks are evident across the whole of the elevation. These do not appear to be recent cracks and are assumed to be historic.

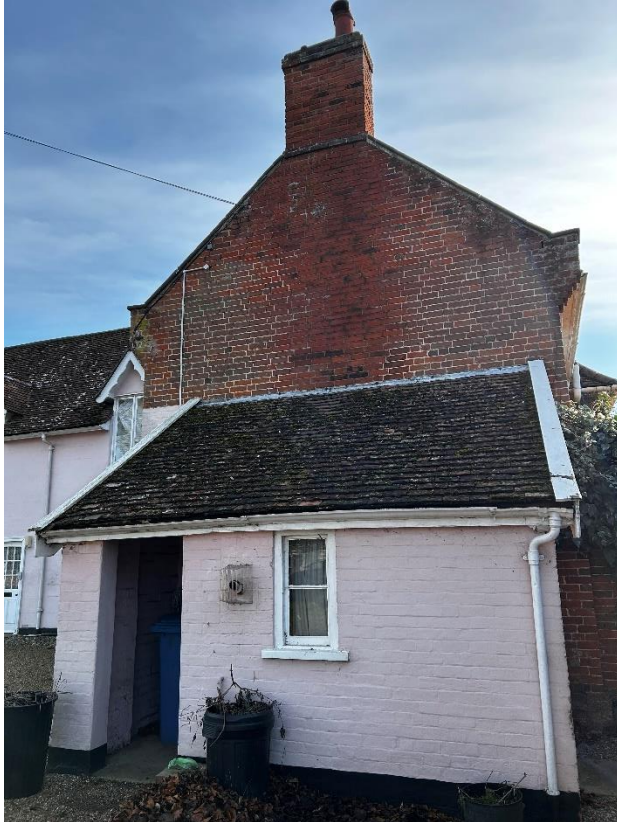
The main roof appears to be in fair condition although there are a few tiles that have slipped or are missing. A full roof inspection is advised to ascertain the condition of the tiles, flashings etc.

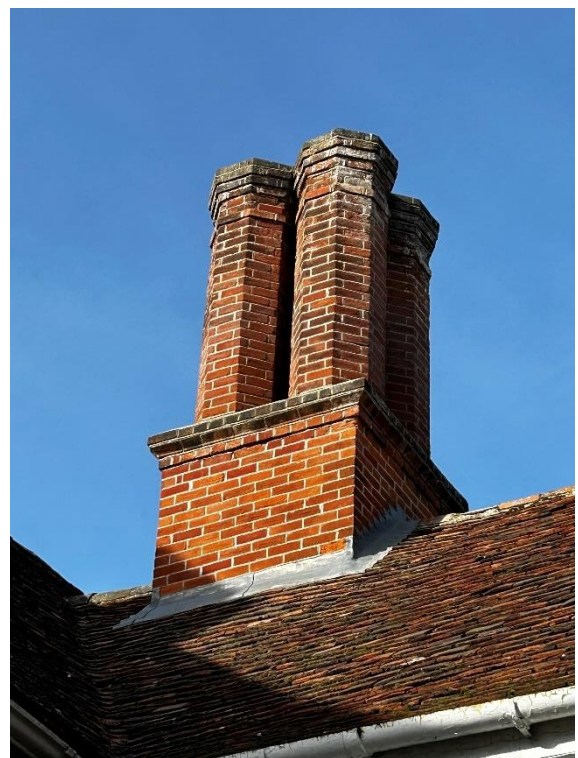
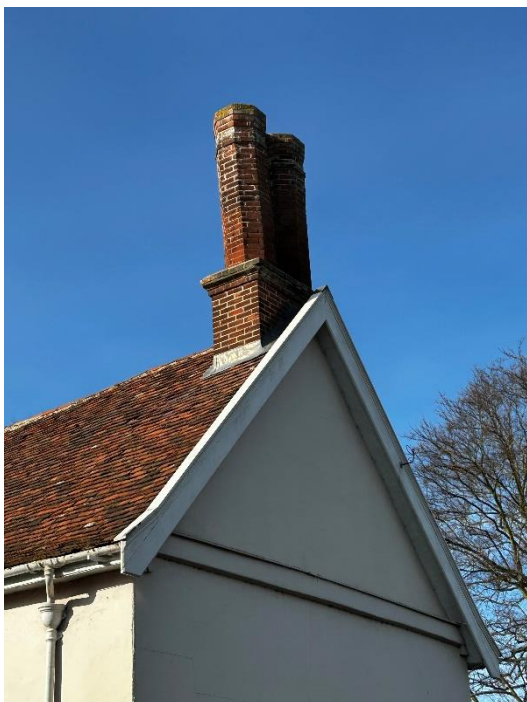
The chimneys to the main building are generally brick built with octagonal stacks rising from a brick plinth at roof level. Lead flashings and soakers are located at the base of each chimney. The stacks appear to be in good condition although pointing is failing in some locations.

The chimney located above the gable to the RH end of the main elevation appears to list slightly towards the building. There are no signs of recent movement. There is also heavy staining and dampness evident below the chimney to the full height of the elevation.

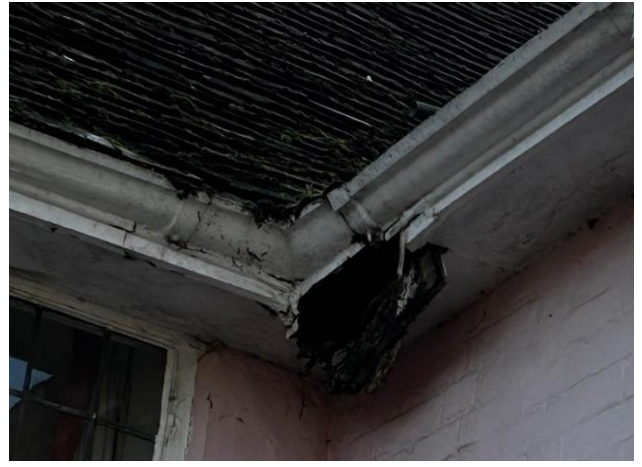
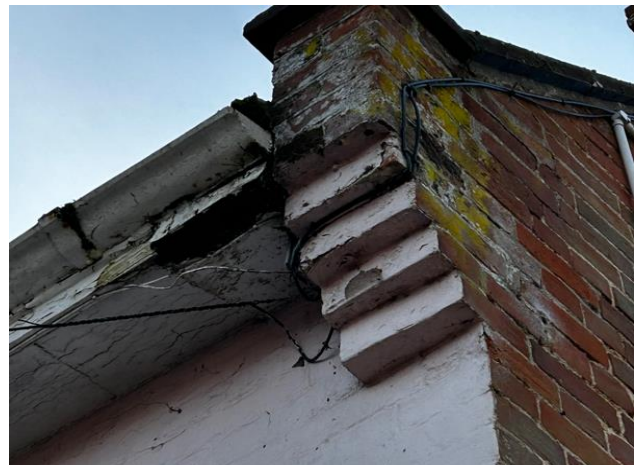
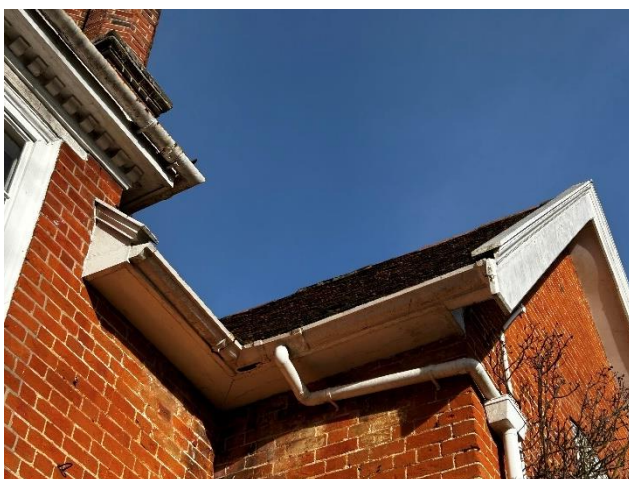
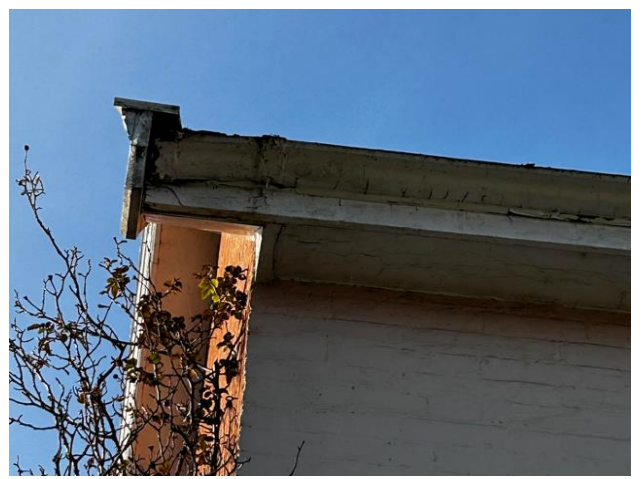
The chimney at the LH end (facing the front elevation) also appears to be listing towards the main roof although this does not appear to be recent movement.

There are also several spalling bricks although these are infrequent across all chimneys. The presence of chimney caps and the current function of the chimneys is not known.

The fascia's and soffits to the perimeter of the main house are generally in a poor condition and are showing signs of rot throughout.

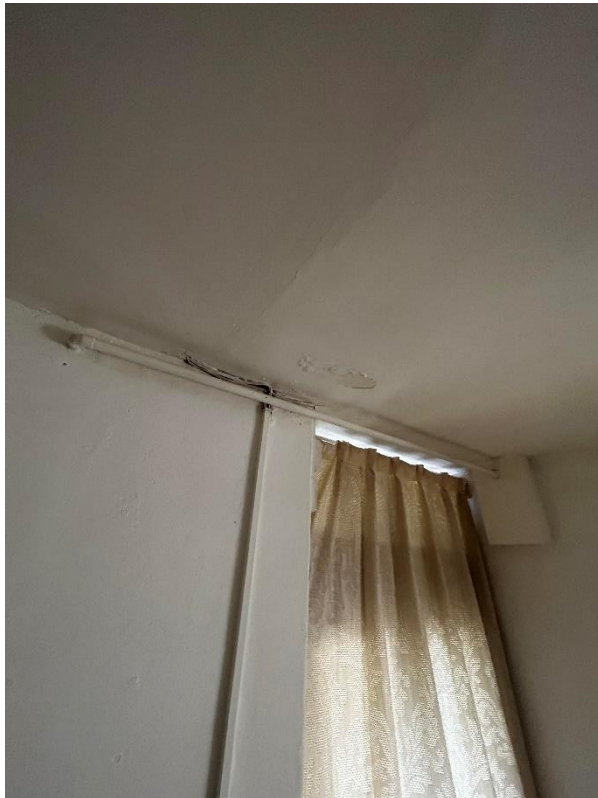
The ceilings show signs of historic cracks that have subsequently been repaired.

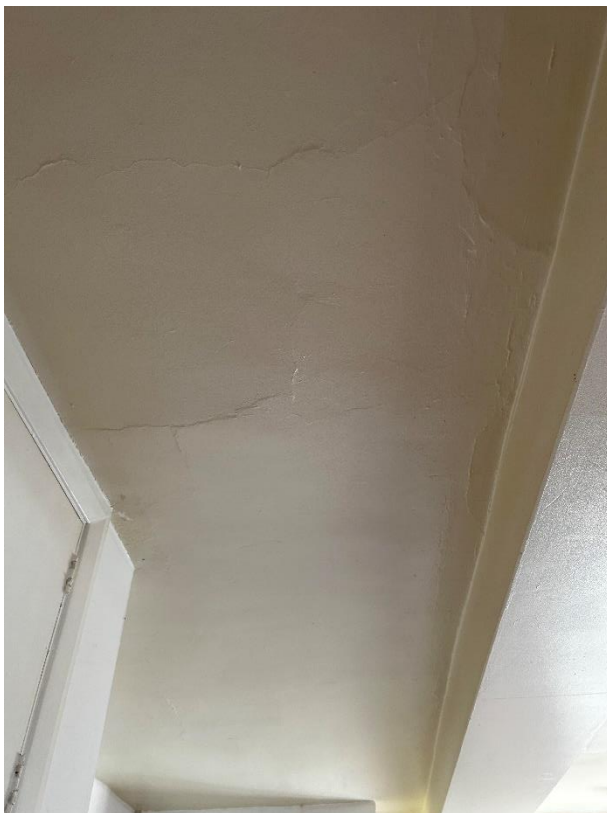
There is evidence of water ingress within flat 4 adjacent to the timber porch above the entrance door. It is not apparent whether this is connected to porch and blocked valley gutter adjacent.

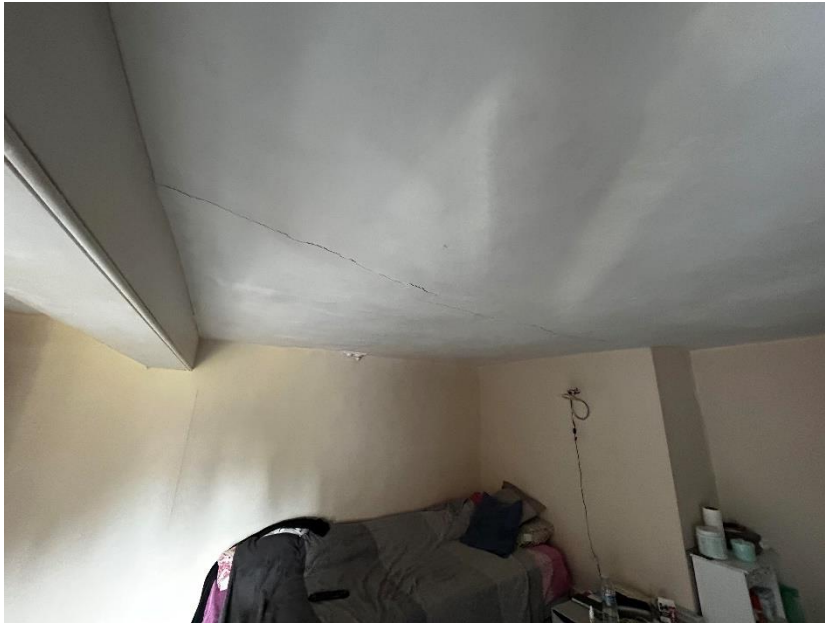
The ceiling within the kitchen to no. 4 is generally uneven and showing signs of historic cracking.

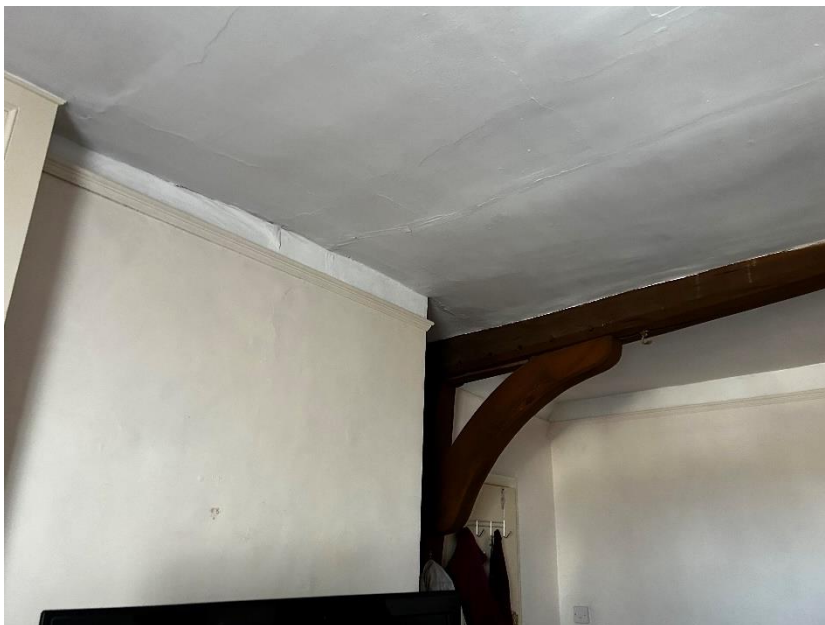
The bedroom ceiling at first floor level in no.1 has a sizeable crack running between the wall and down stand beam. The crack runs parallel to the side elevation.

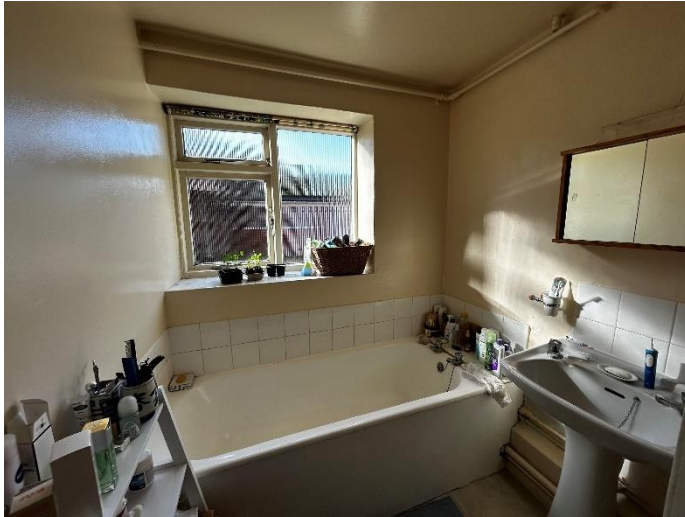
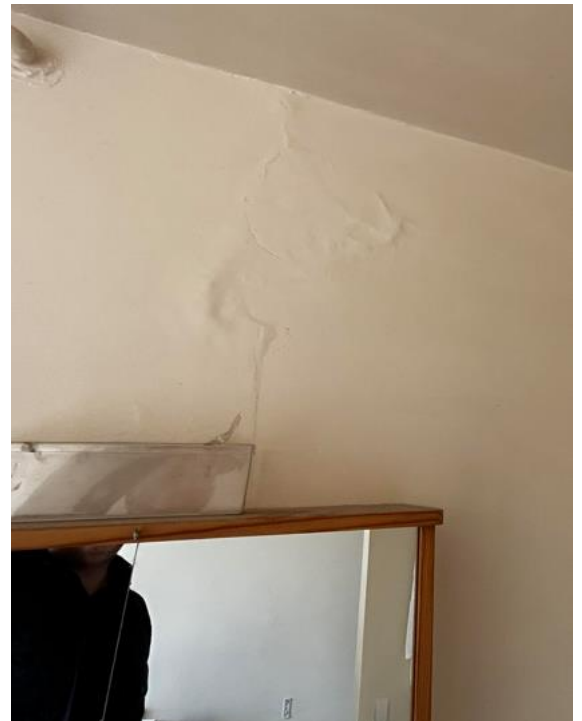
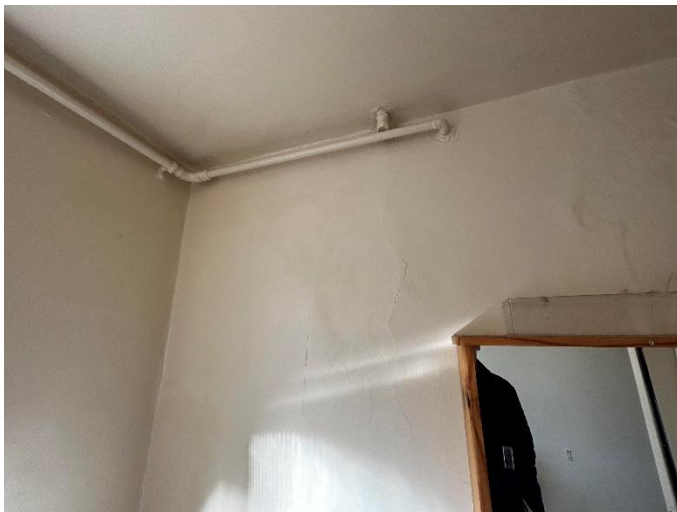
The wall between the kitchen and bathroom to no. 4 shows signs of vertical cracking extending behind the tiling and bathroom cabinet.

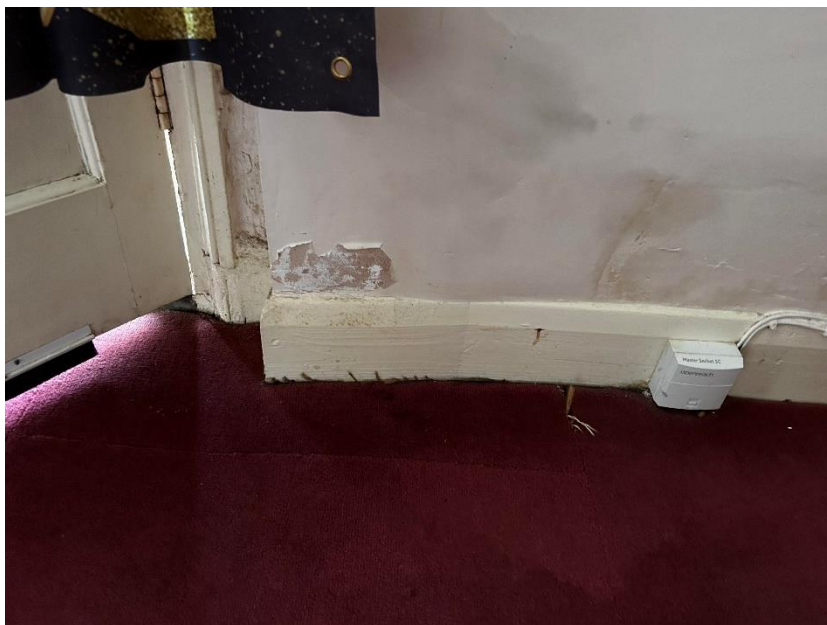
To the RH side of the entrance door to no.1, there is evidence of rising damp. This may be in relation to the external brick-built porch.

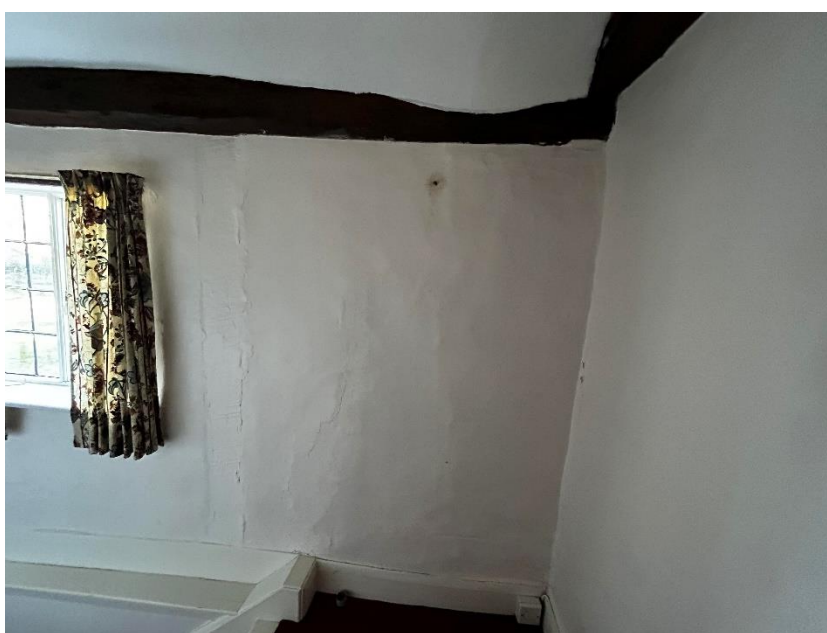
At first floor level in no.1, the external wall shows historic cracking and potential water ingress likely as a result of the failing rainwater down pipe externally.

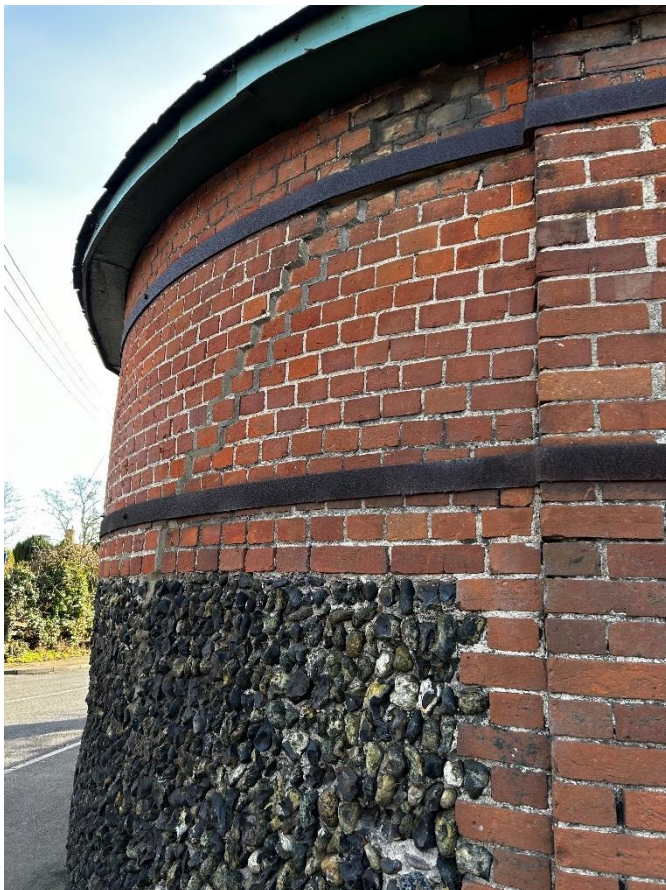
The curved section of wall has two steel straps that have been installed to prevent further movement to the brickwork and flint stone wall. Previous movement has been repaired but still sits prominently.

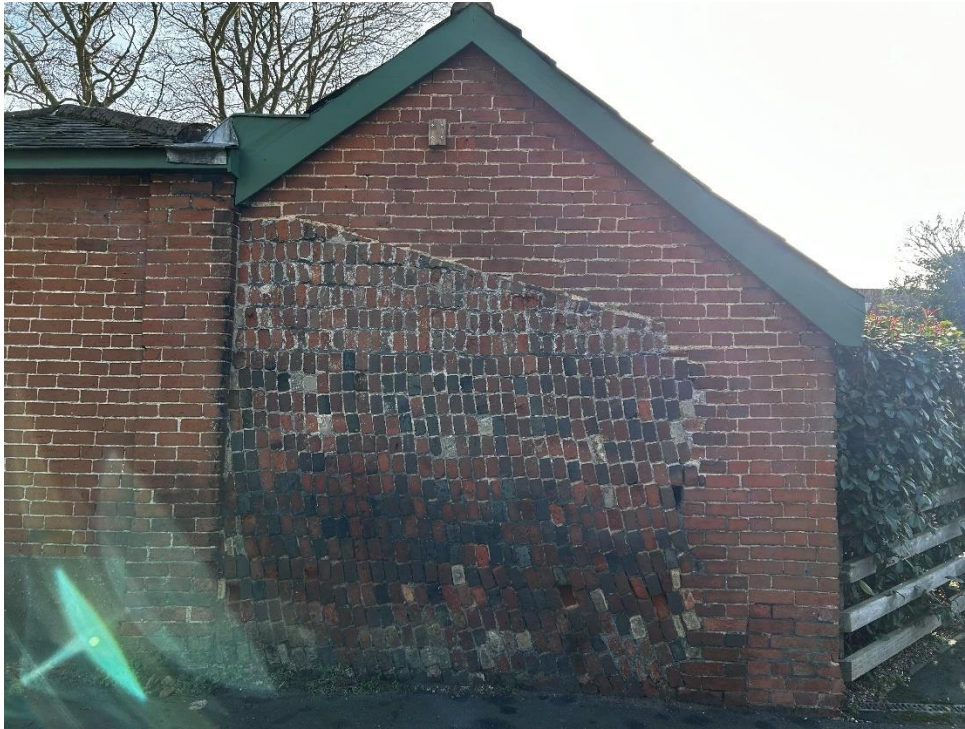
There is a section of brickwork facing the road that has been laid in an unconventional way. The reason for this is unclear but it appears to be an infill section of brickwork. A number of the bricks are worn and spalling, particularly at low level.

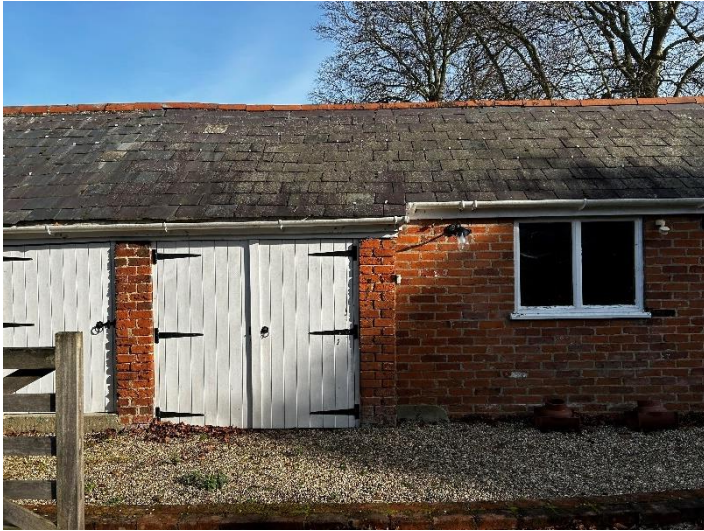
The joints between the ridge tiles has also deteriorated and, as a result water has reached the timber structure below.

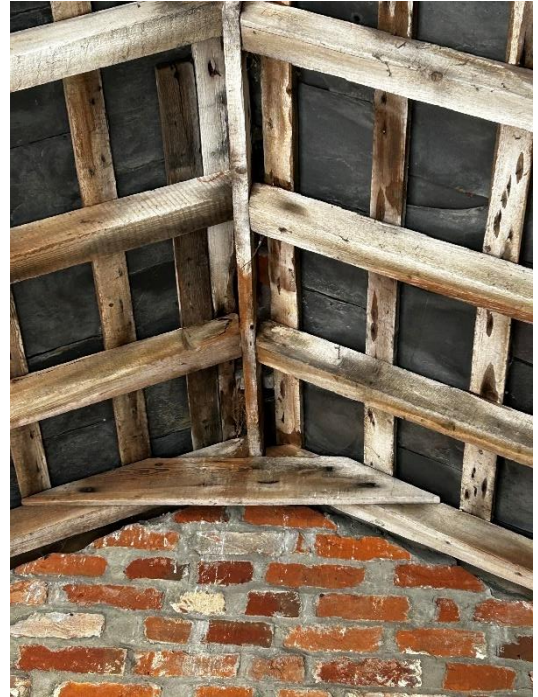
There does not appear to be significant damage. This issue is apparent along the full length of the ridge to the whole of the garage/ store.

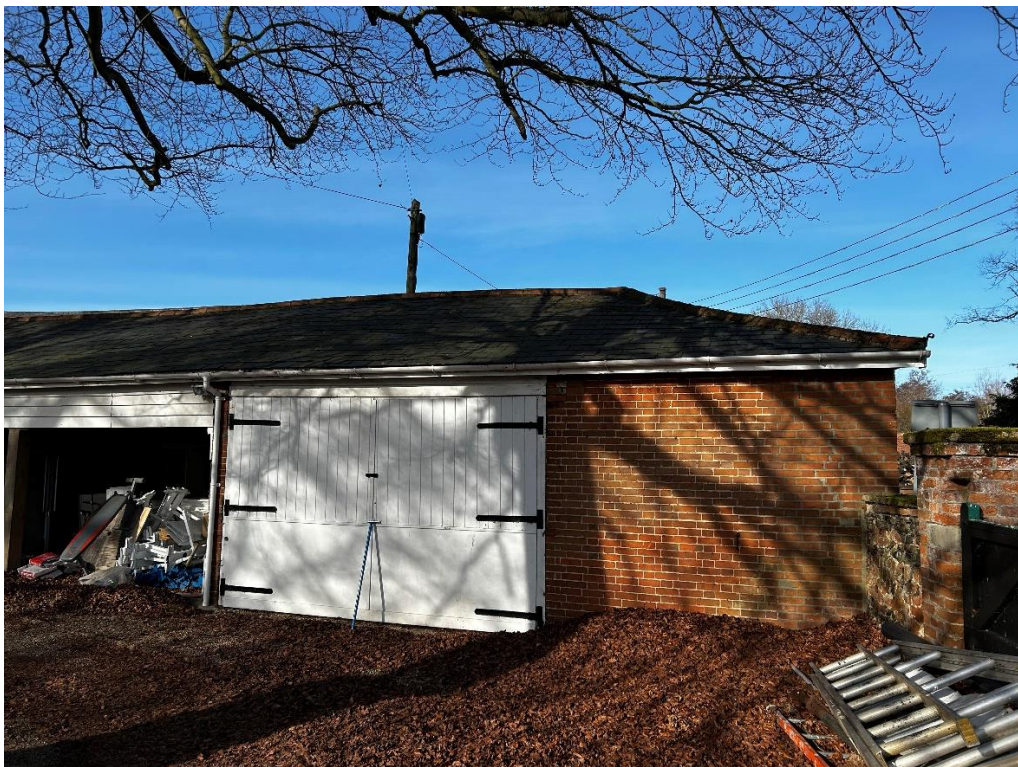
There is also a section of the ridge line along the roof running parallel with Lower Street that appears to have dipped.

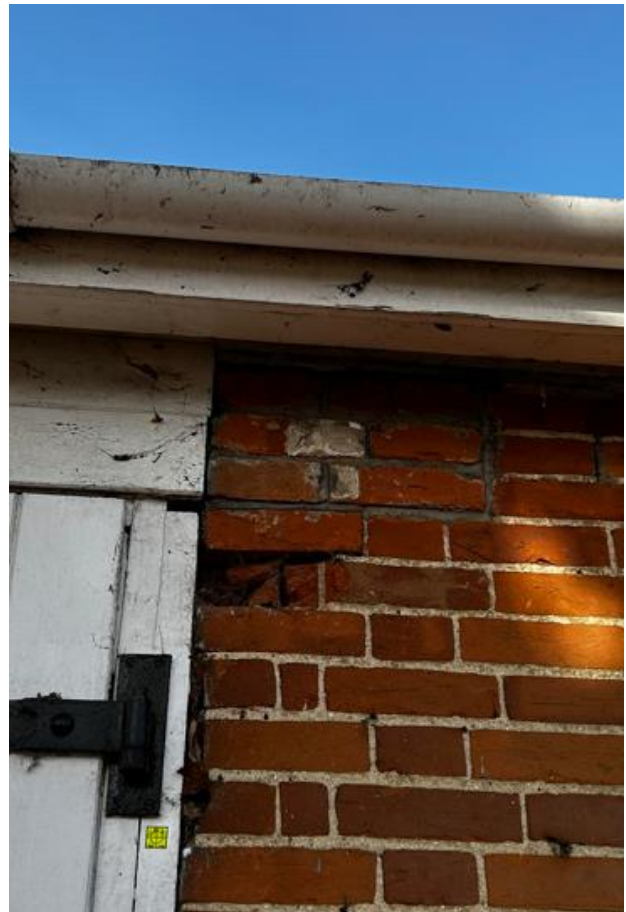
The brickwork and flint stonework to the garage/ store on the elevations facing the main house and driveway is generally in a reasonable condition with only individual damage or missing bricks / flints.

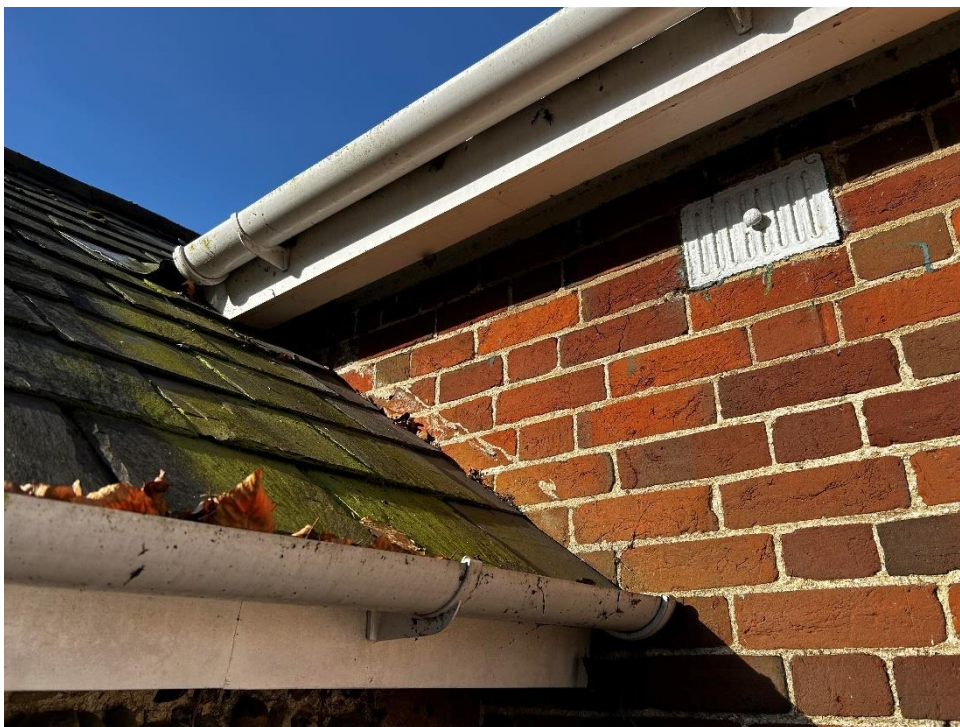
A section of flashing is missing at the juncture of the roof and brickwork on the internal corner of the 'L' shaped garage/ store block.
