CONDITION SURVEY

**1-4 Church Close,
Sproughton,
Suffolk,
IP8 3BD**

**Church Close
Properties Ltd**

Ref: 23002-CS rev 1

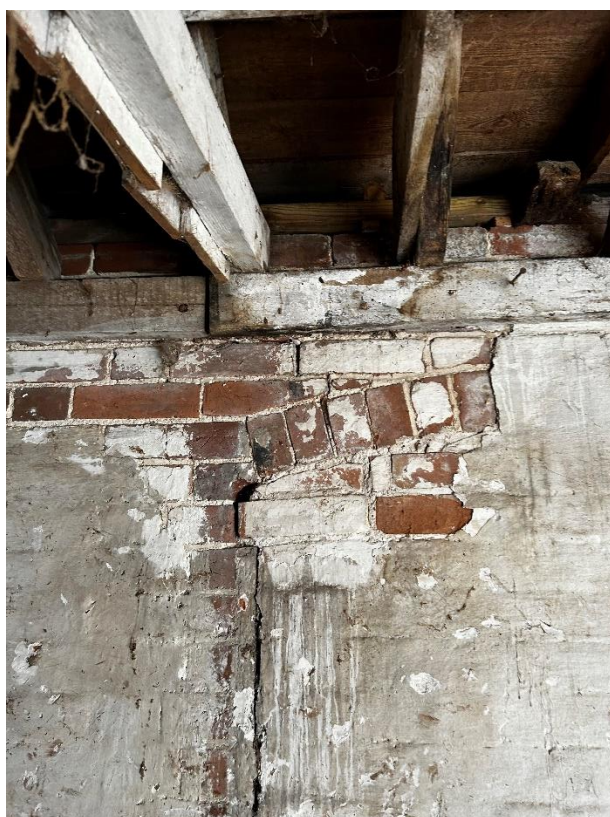
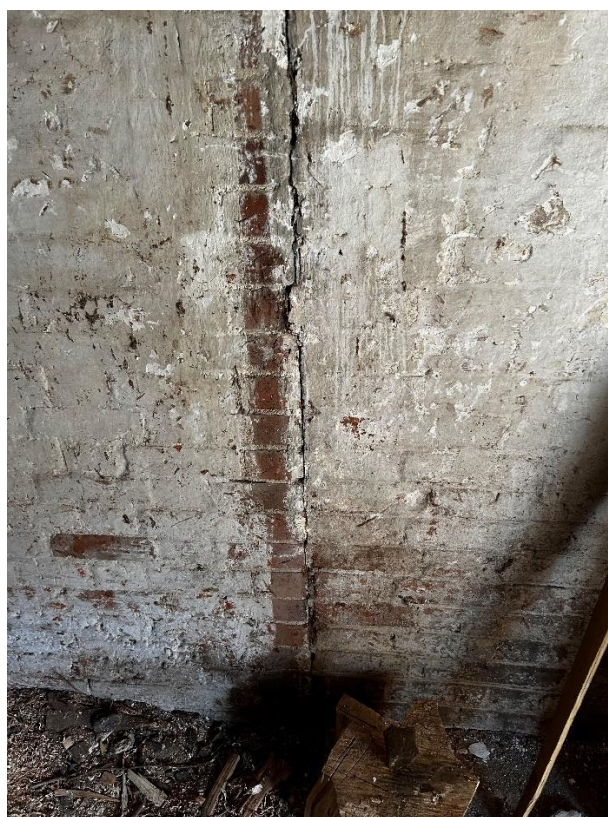
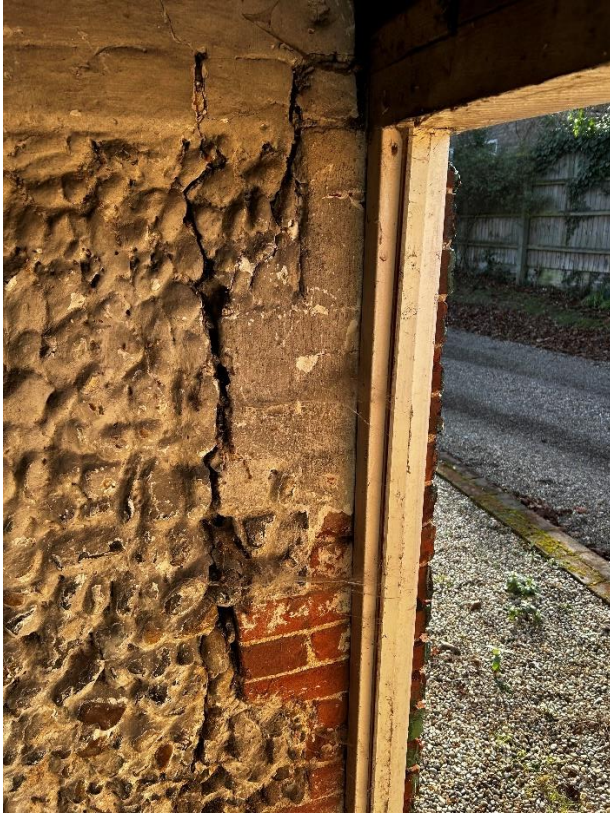
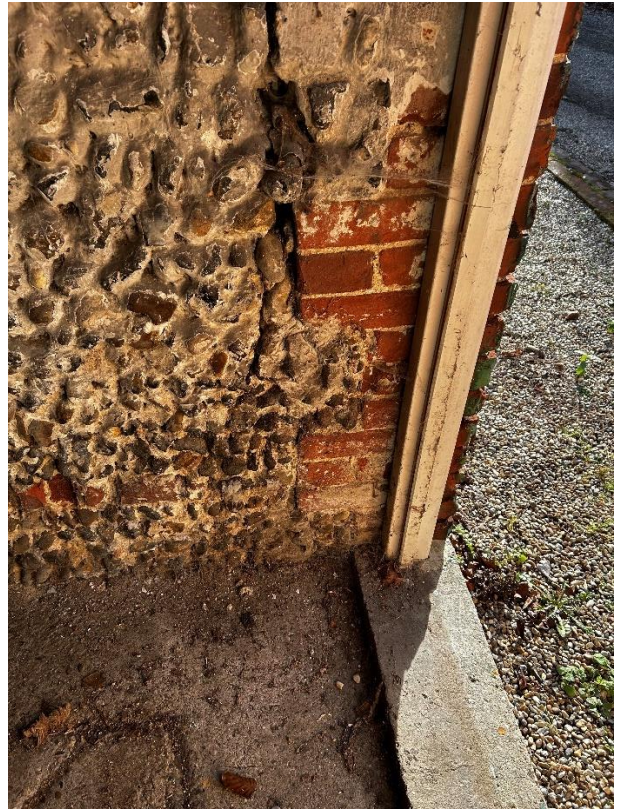
The walls were generally worn and there were a few cracks noted. These were primarily located in the store closest to the main entrance gate to the property and were located adjacent to a former opening that had been infilled and also adjacent to the entrance door to the store.

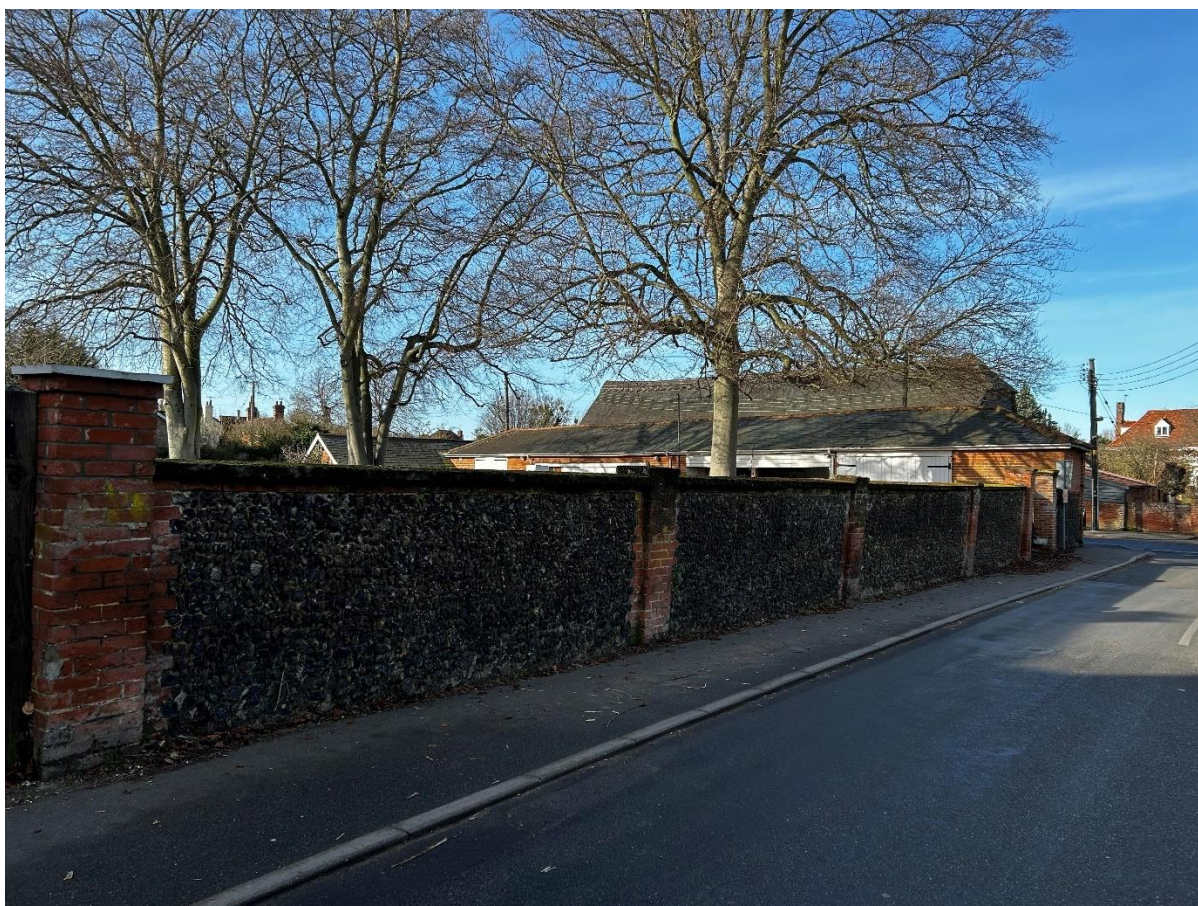
A flint stone wall with brick piers runs along the boundary shared with Church Lane. The wall is pitching towards the footpath.
