## PRELIMINARY SITE RISK ASSESSMENT TIER 1

**SITE:** SUNNYSIDE FARM  
CAMBROSE  
REDRUTH  
CORNWALL  
TR16 4HT

**Our Ref: A2210/PSRA/JW**

**Date: 03<sup>rd</sup> March 2023**

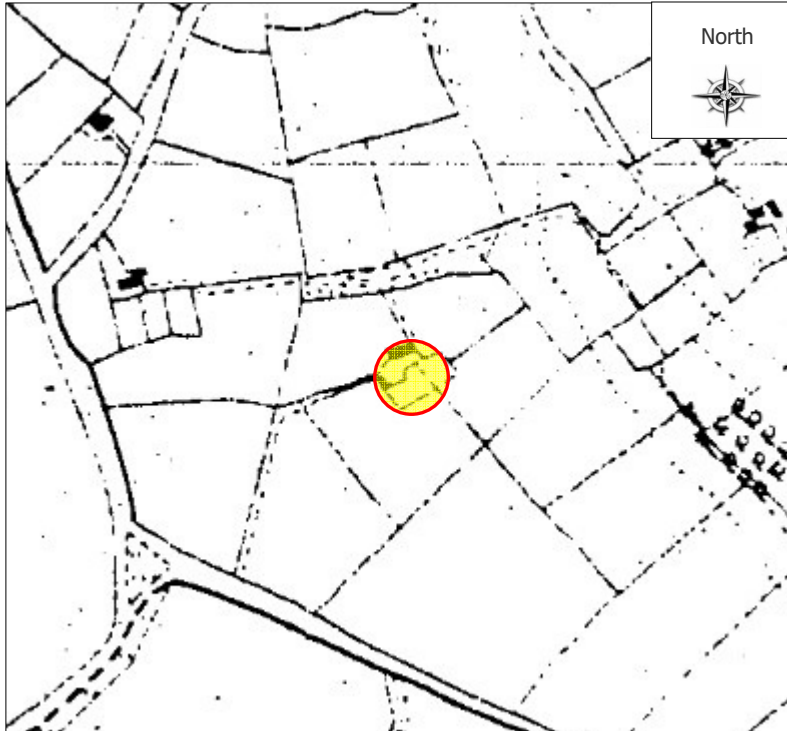
### Historical OS Map of 1888

The historical OS map of 1888 shows the site as an existing isolated farmstead.

The surrounding area is rural in nature and comprises of agricultural fields and further isolated farmsteads.

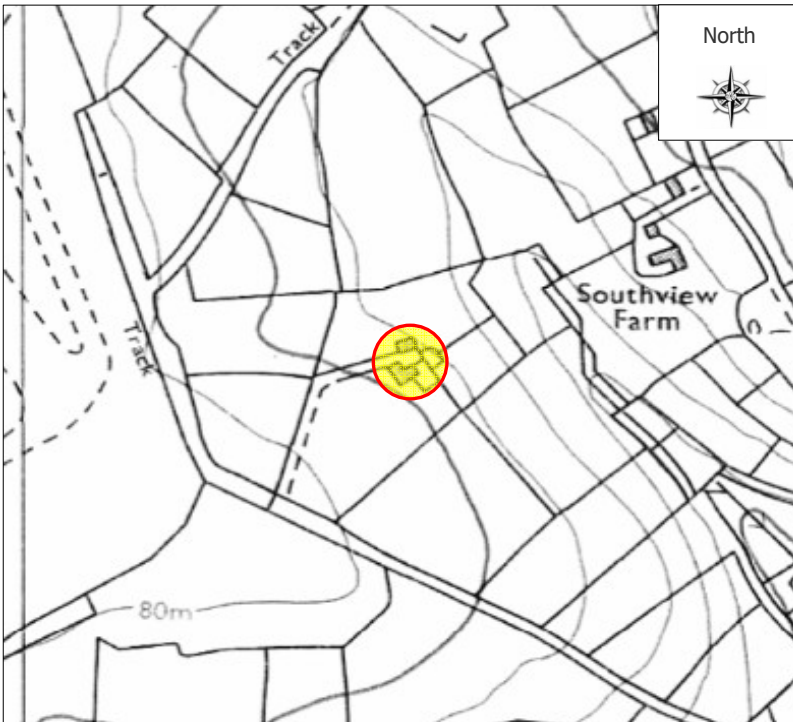
### Historical OS Map of 1982

The historical OS map of 1982 shows the farmhouse remaining unchanged, although additional outbuildings have been constructed within the site area.

An airstrip is shown to lie to the west.

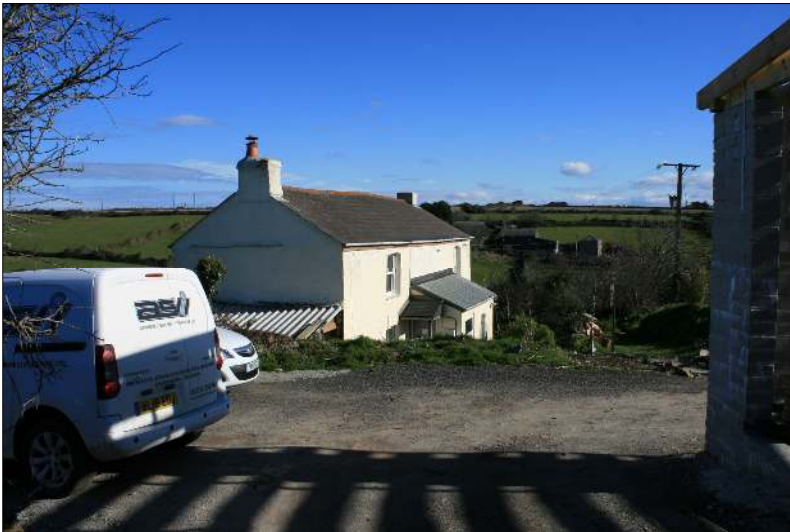
**Photograph 1.**

Looking from the private entrance area toward the application site and existing parking bay.

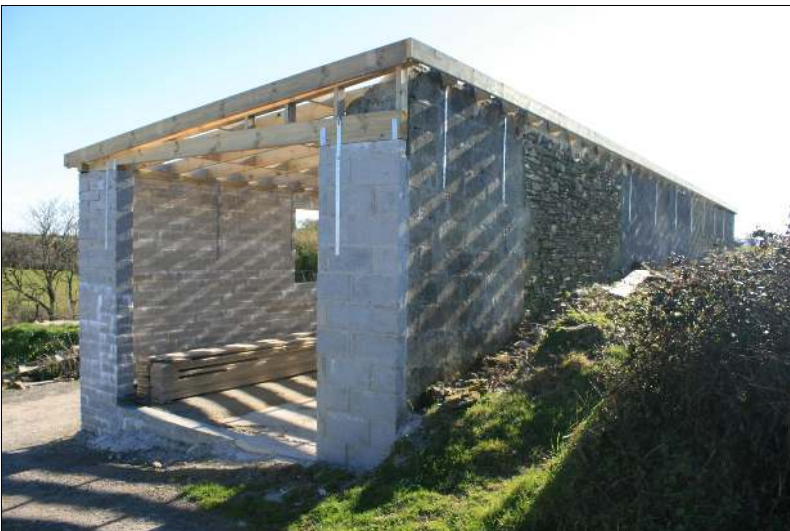
**Photograph 2.**

Looking from the entrance area toward the outbuilding located within the southern extent of the property.

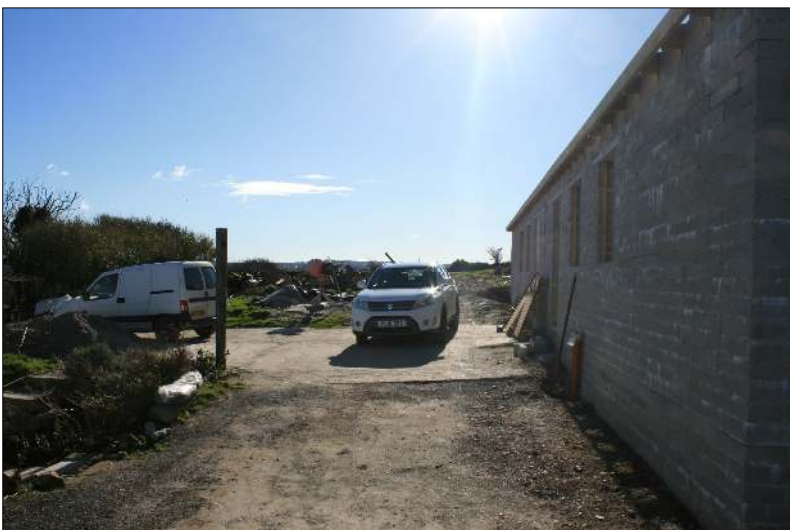
**Photograph 3.**

View along the front eastern elevation of the outbuilding which is currently undergoing renovation works.

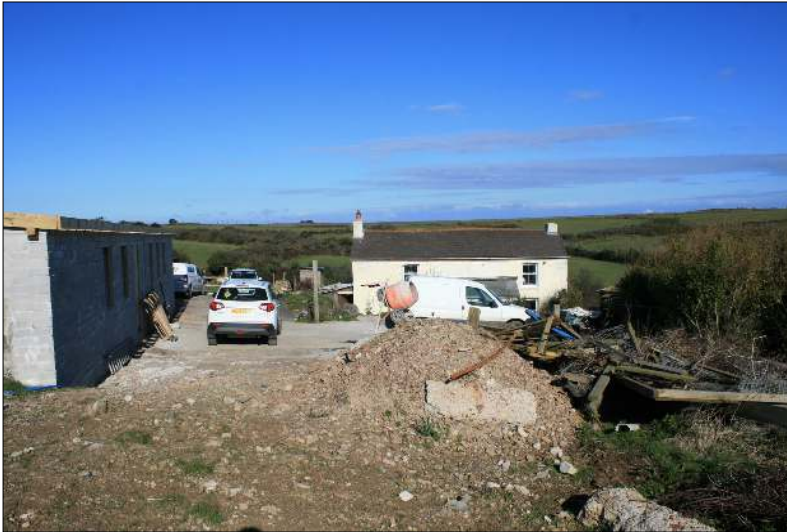
**Photograph 4.**

Looking back across the site from the southern boundary, with the materials shown toward the right of image being comprised of a subsoil heap and various items of timber and wire mesh.

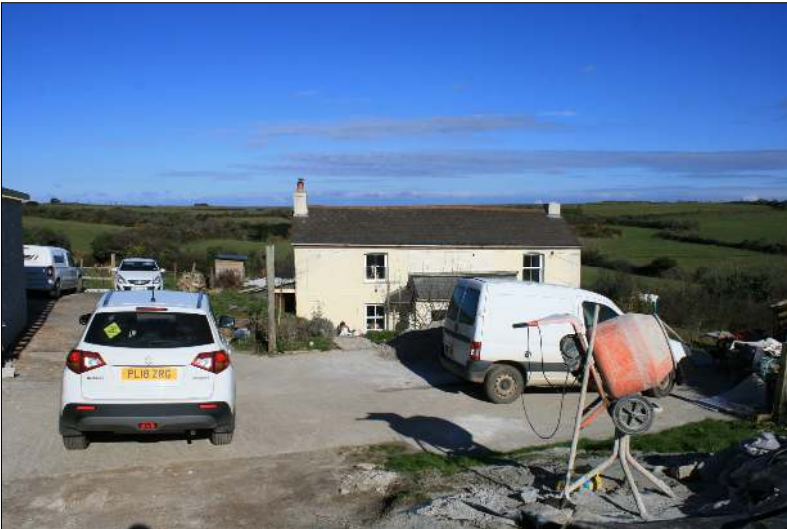
**Photograph 5.**

Looking toward the concrete plinth and parking area situated in front of the outbuilding.

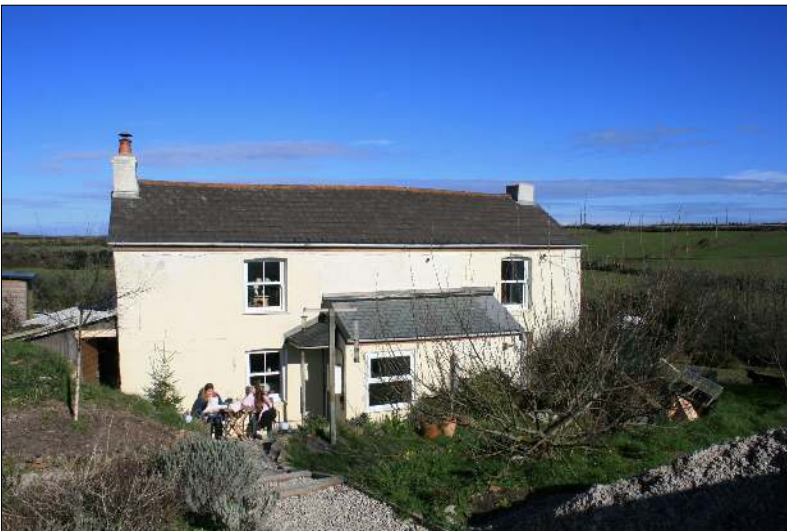
**Photograph 6.**

View of the existing cottage which is proposed to be demolished and replaced with a new residential dwelling.

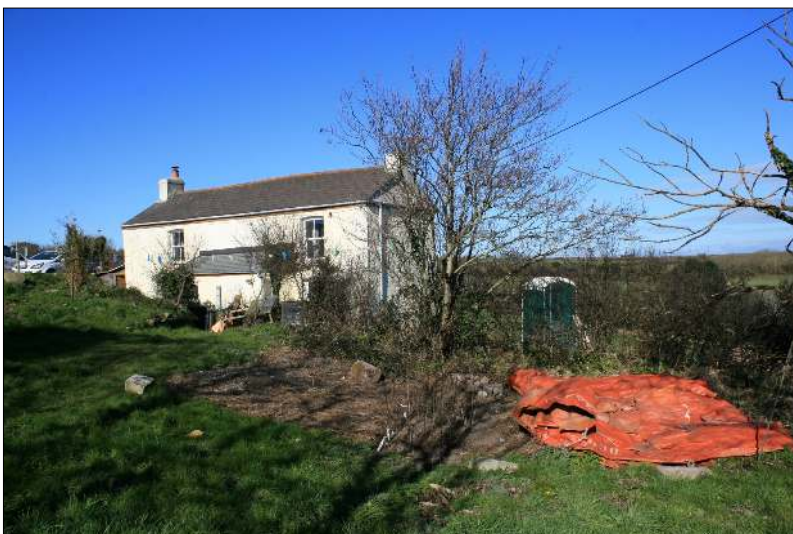
**Photograph 7.**

Looking across the existing garden amenity area located within the southeast extent of the site.

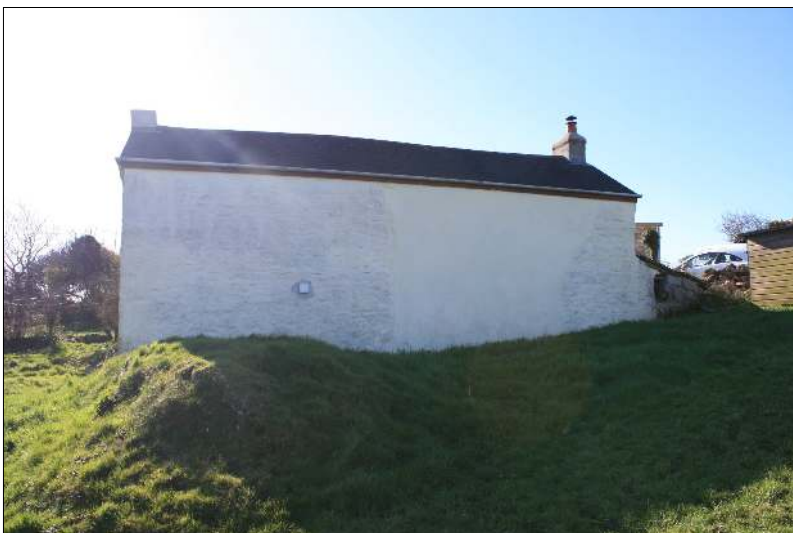
**Photograph 8.**

Looking to the rear elevation of the cottage and associated open land. The mound located within the foreground of the image was recorded to comprise of overgrown topsoil.

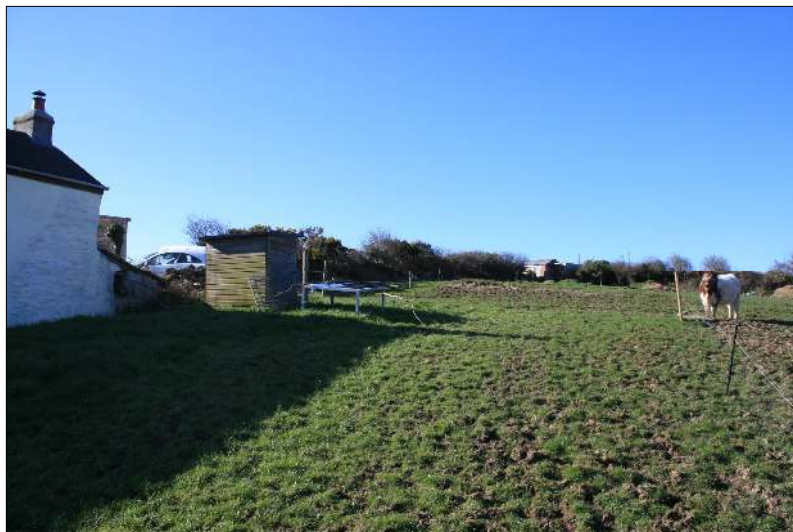
**Photograph 9.**

Looking to the continuation of open field land located to the rear of the cottage.
