# TREE REPORT

**PRE-DEVELOPMENT  
BS5837 TREE SURVEY  
PART TWO**

**Site:** Elms Farm  
Elms Road  
Govilon

**Date:** May 2008

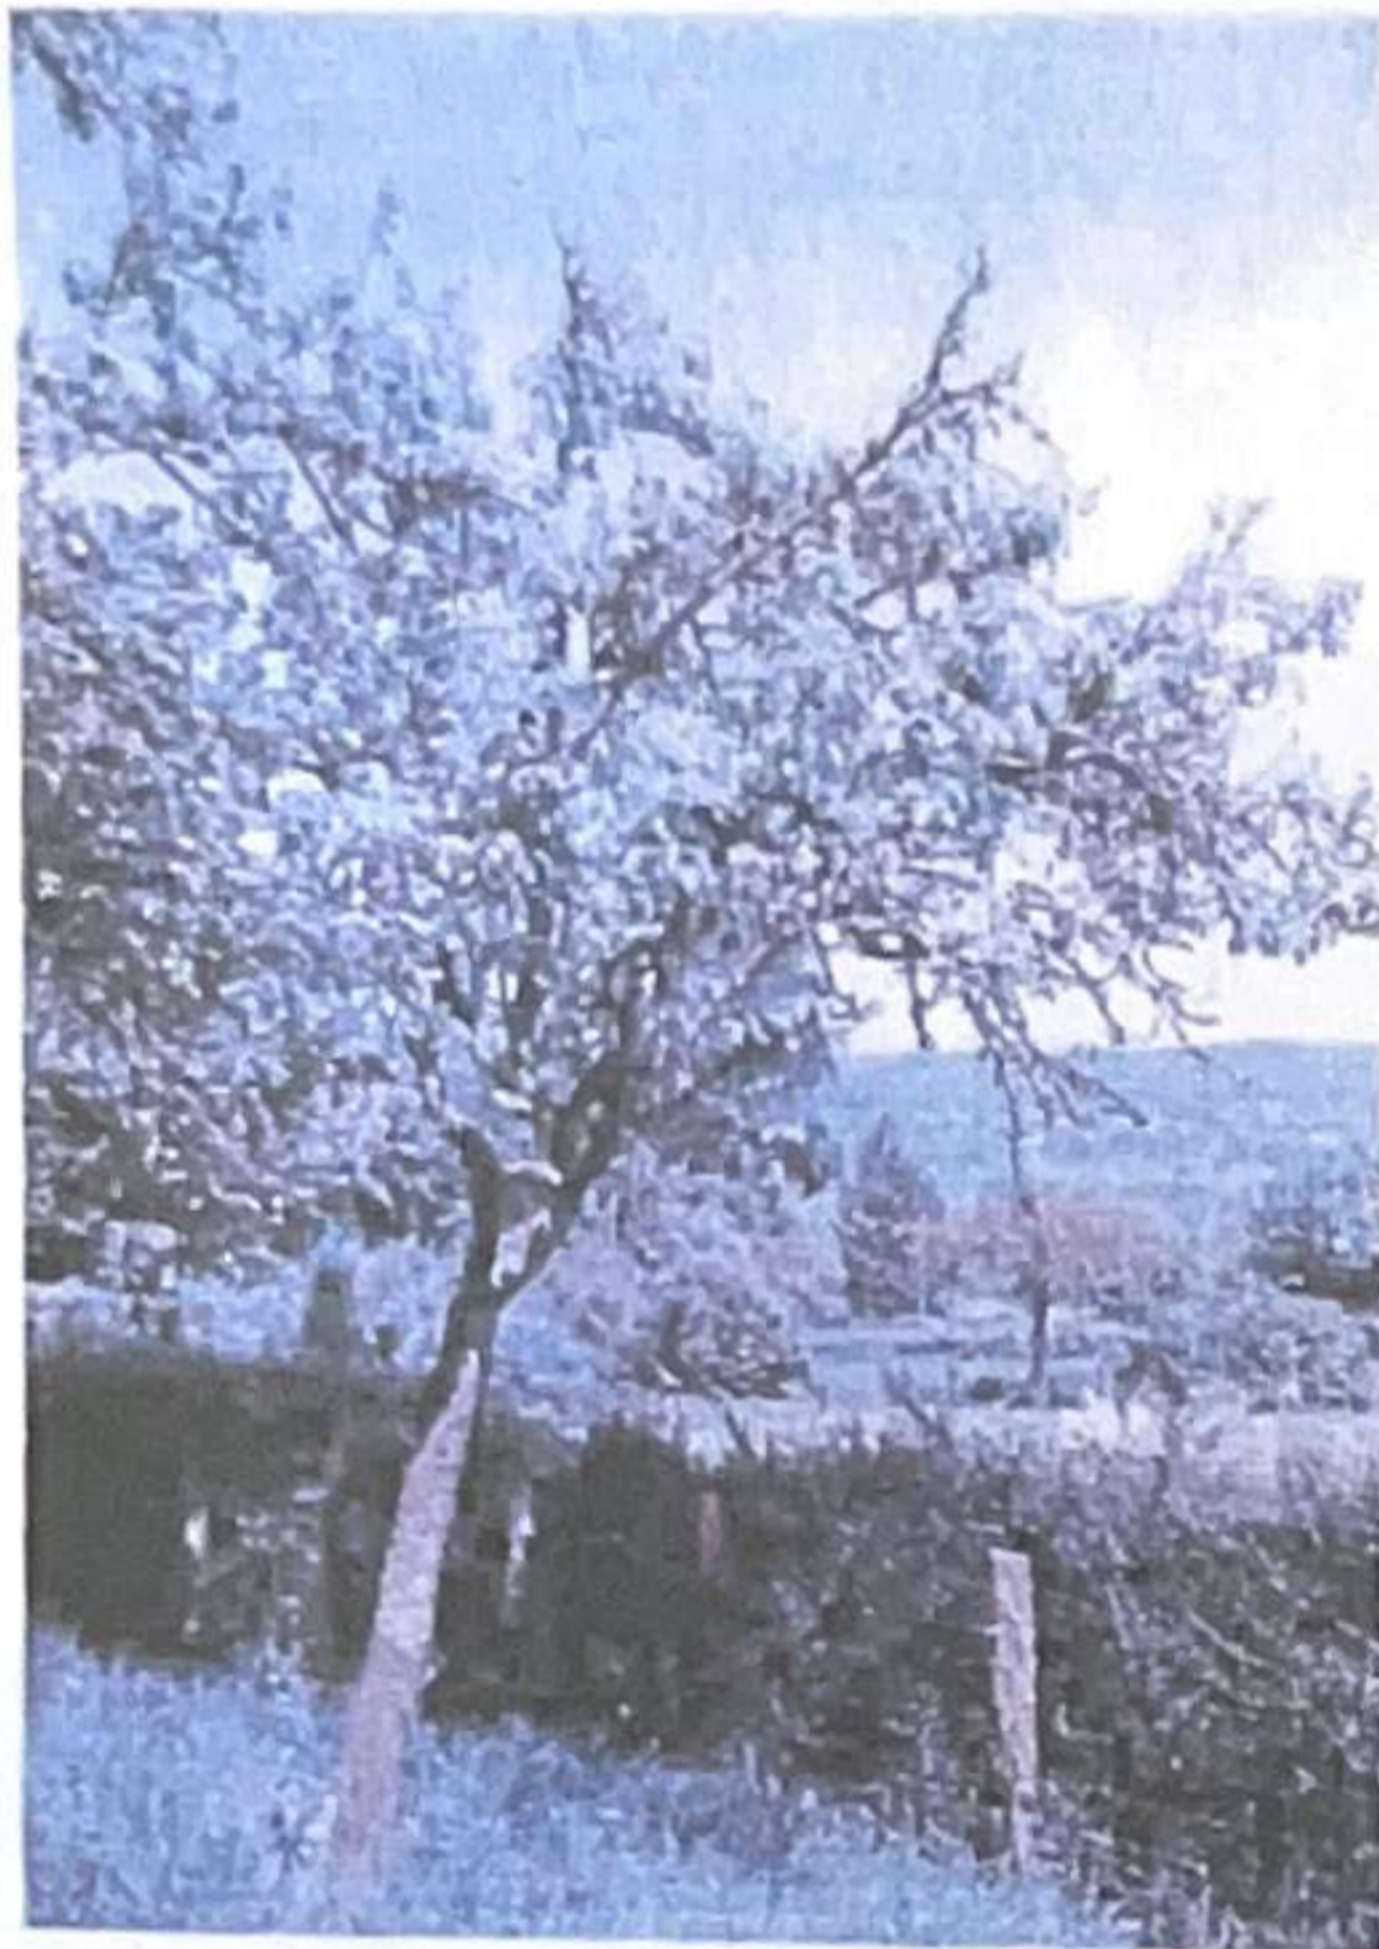
1807	Pear sp.	3	160	1.5	Mi	0.5	2	2.5	0.5	POOR	<ul style="list-style-type: none"> <li>• Severe dieback throughout crown</li> <li>• No obvious cause for decline</li> </ul>	FELL	0	R	12
1808	Pear sp.	4	200	1.5	Mi	2	1.5	1.5	1.5	POOR	<ul style="list-style-type: none"> <li>• Dieback present throughout crown</li> <li>• Leaning to North at 45° angle</li> <li>• Excessive growth around graft union point at base of trunk</li> </ul>	FELL	0	R	18
1809	Apple sp.	6	340	1.5	M	3.5	5	4	4	FAIR	<ul style="list-style-type: none"> <li>• Beneath 11Kv electric wires</li> <li>• Has been 'topped' in past</li> <li>• Good strong regrowth</li> <li>• Minor pruning wounds on lower branches</li> </ul>	Retain	20	B	52

T1807 – die back in crown

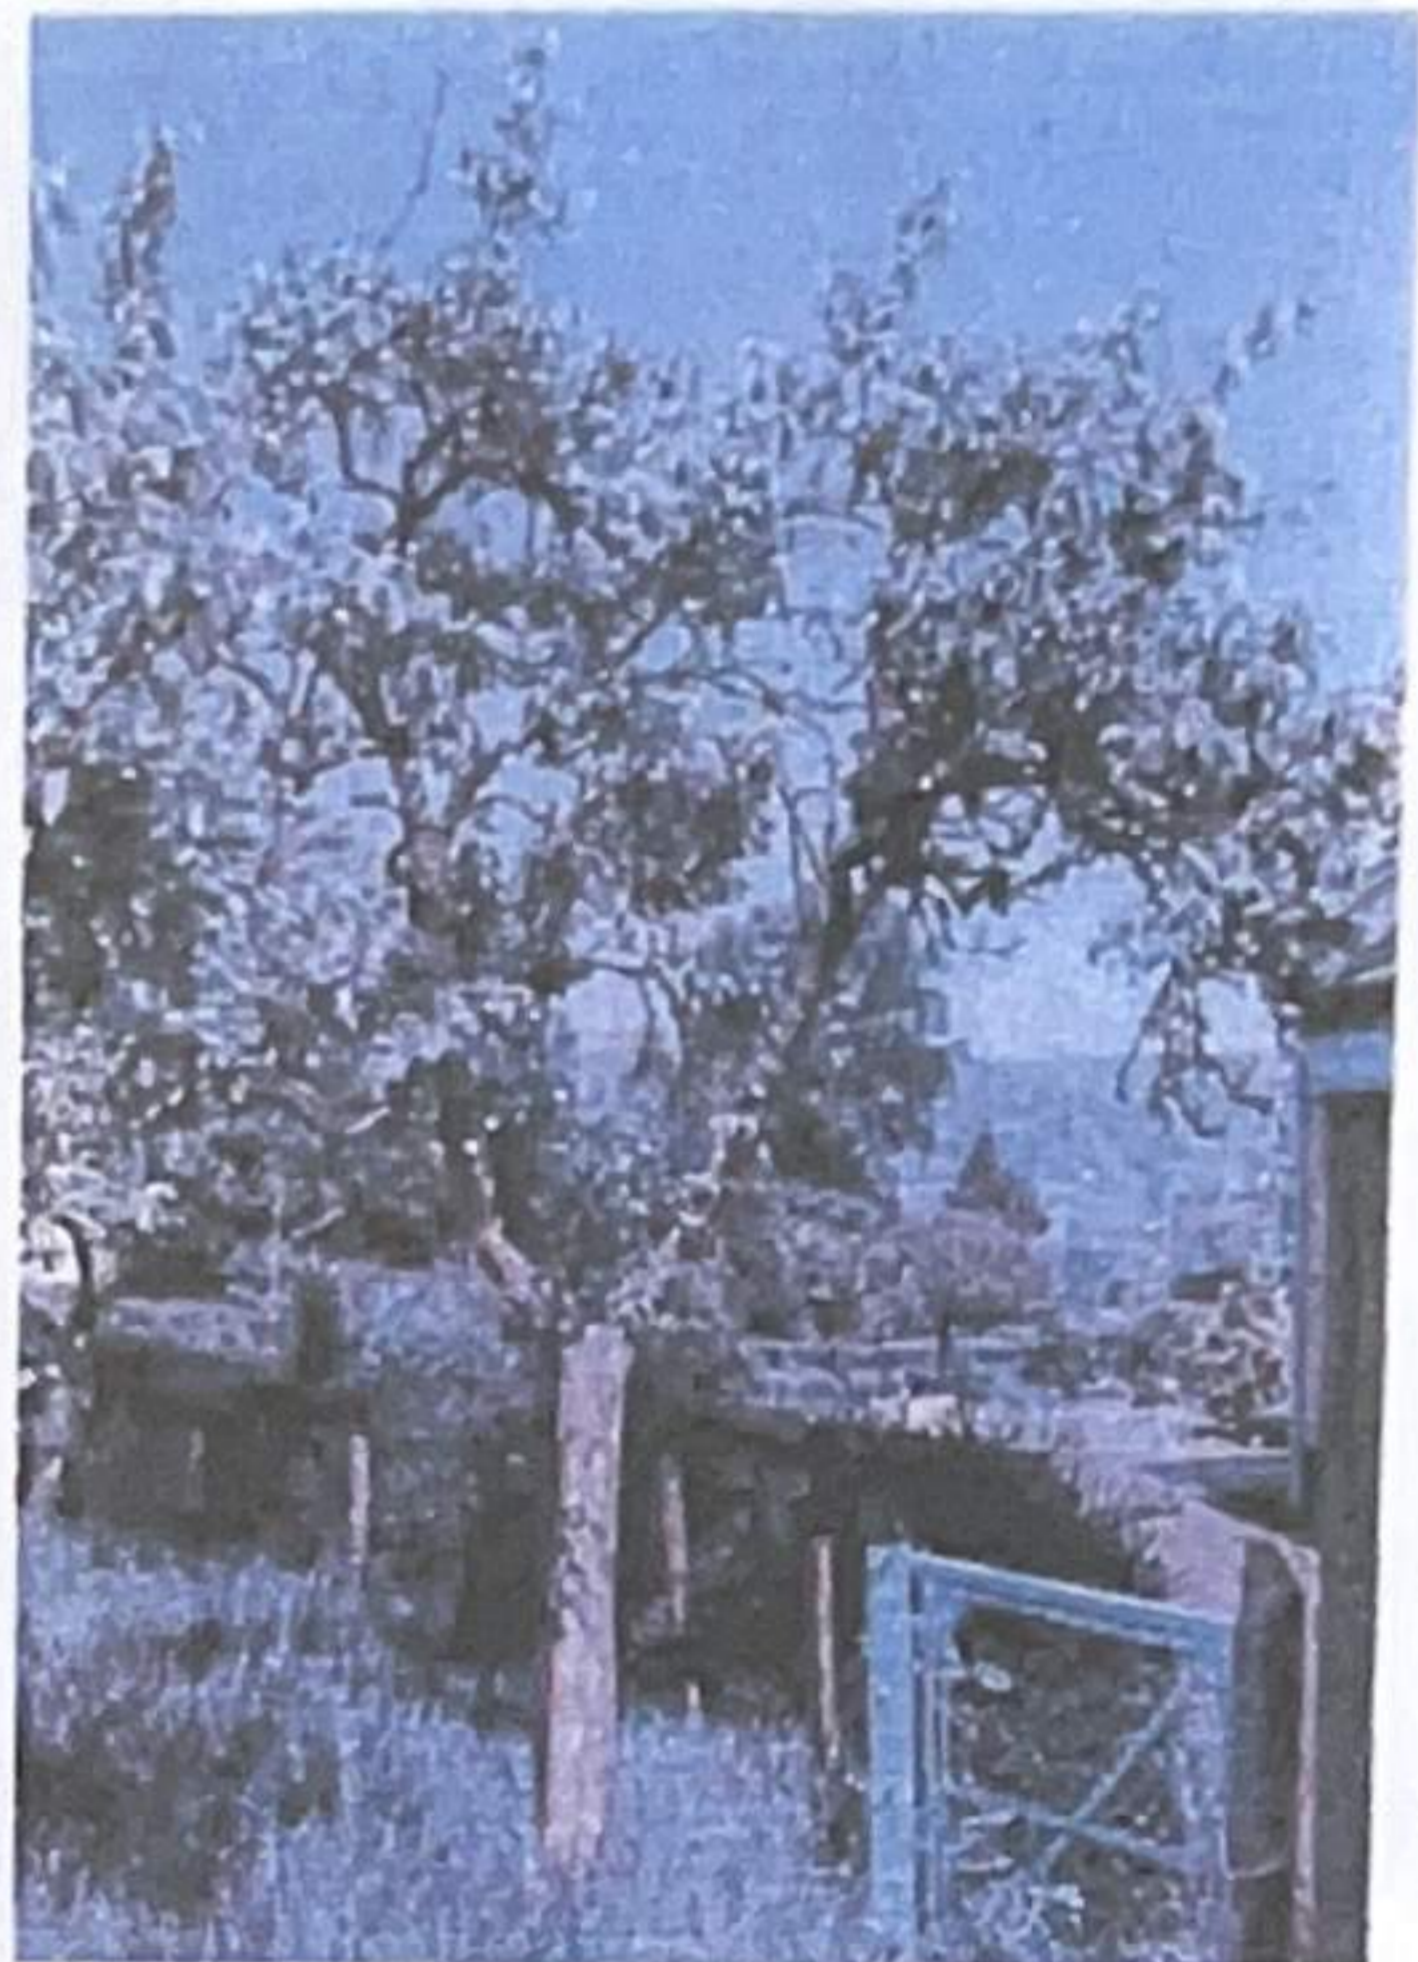
T1808 – die back in crown

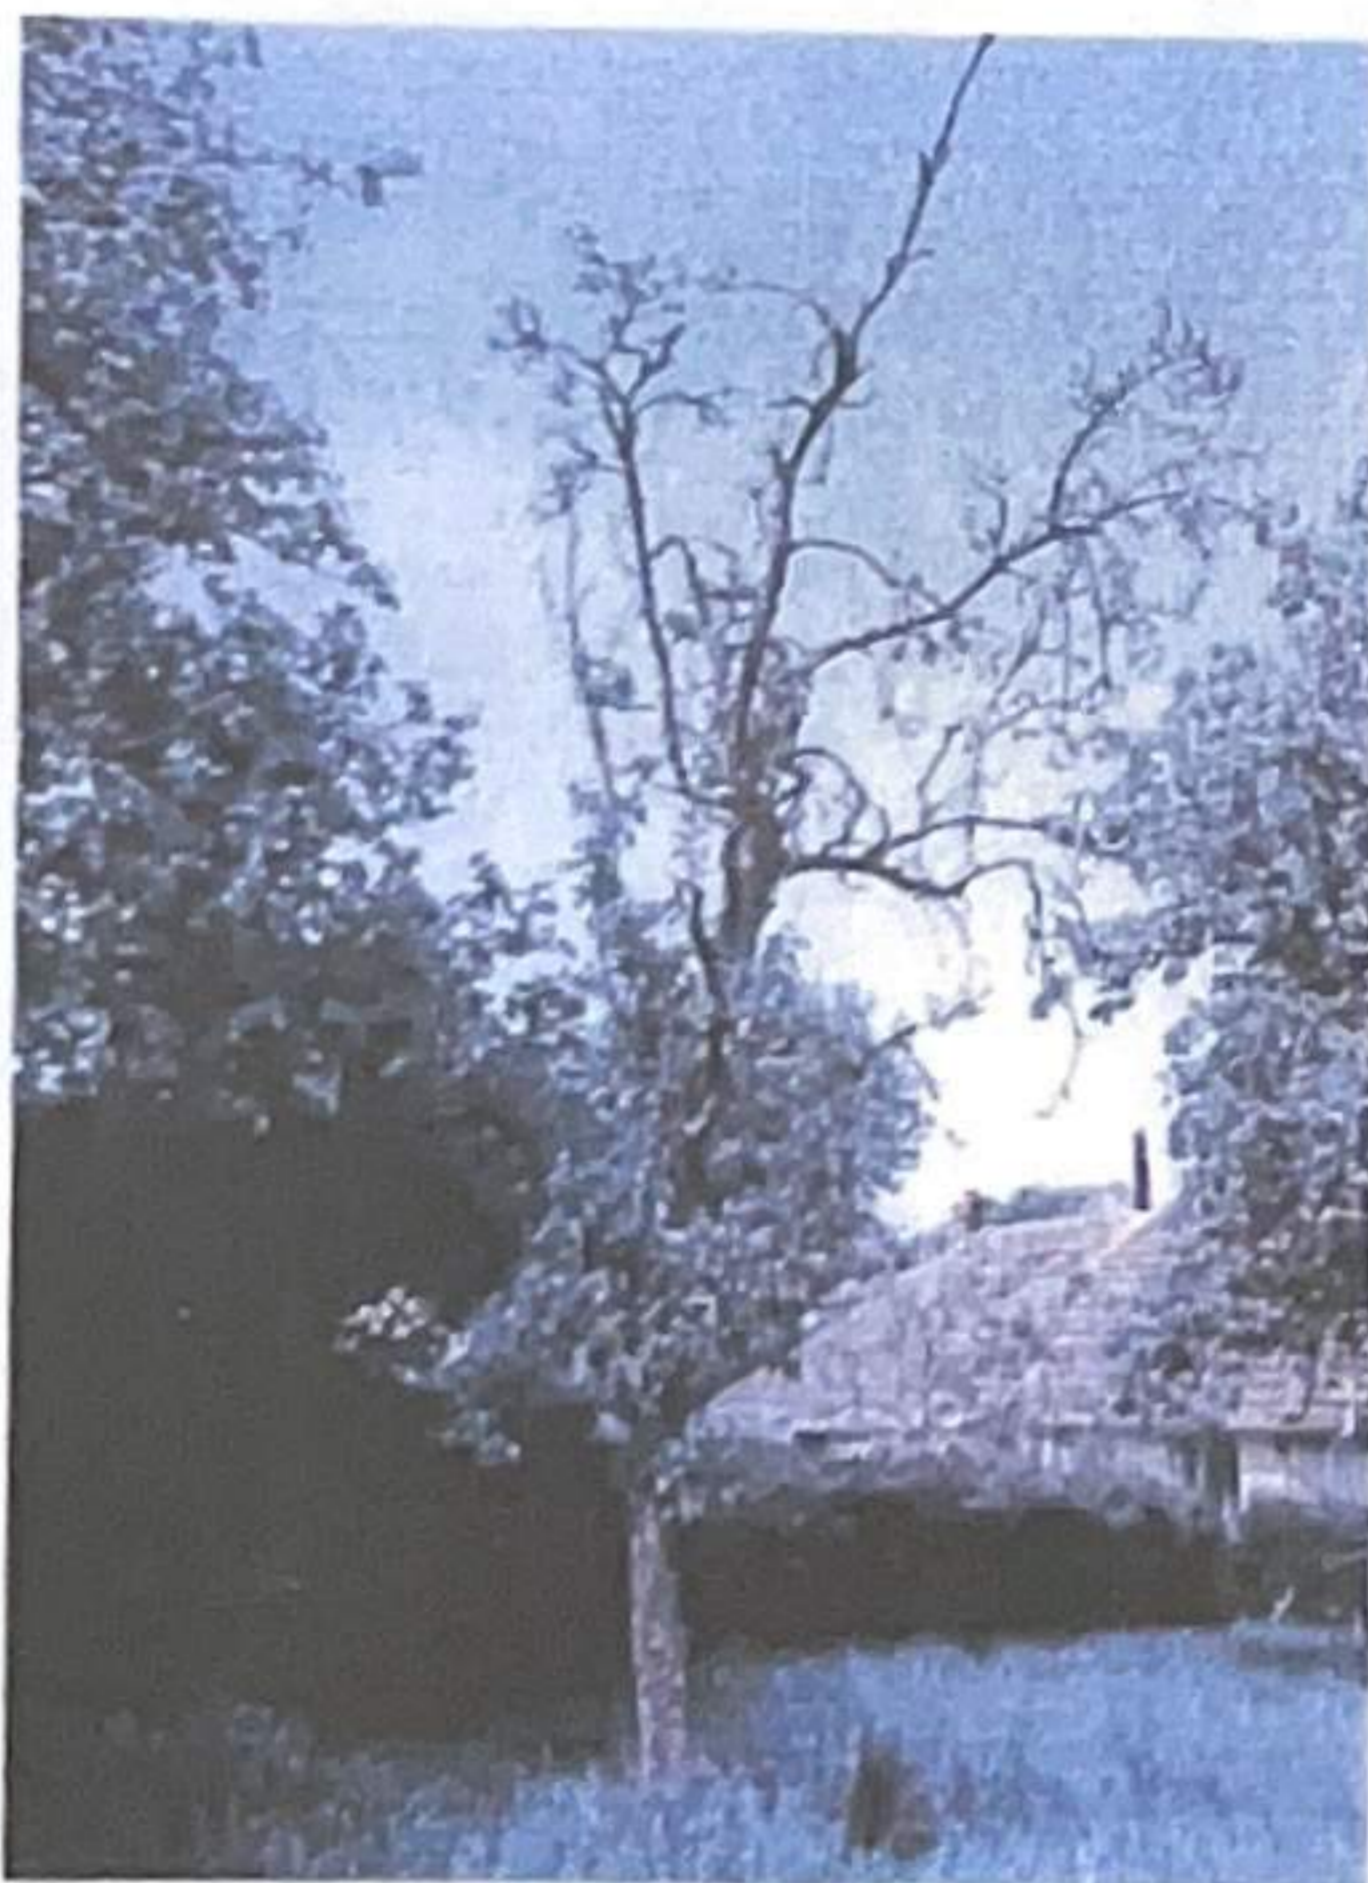
Tree Tag No.	Species	Height m	Stem diameter mm	Height crown clearance / m	Age Class	Branch spread (m)				Physiological Condition	Structural condition	Preliminary management recommendations	Est remain years	Category grading	RPA m <sup>2</sup>
						N	S	E	W						
1810	Pear sp.	4	180	1	Mi	1.5	1.5	1.5	1.5	POOR	<ul style="list-style-type: none"> <li>Severe dieback in upper crown</li> <li>Extensive area of dead bark on trunk</li> <li>No obvious cause for decline</li> </ul>	FELL	0	R	15
1811	Pear sp.	4	170	1.5	Mi	1	2	2	0.5	FAIR	<ul style="list-style-type: none"> <li>Slightly suppressed to North by T1795</li> <li>11Kv electric wires to East of tree</li> <li>No visible external defects</li> </ul>	Retain	20	B	13
1812	Apple sp.	4	250	1.5	Mi	2.5	3	4	3	FAIR	<ul style="list-style-type: none"> <li>11Kv electric wires to West of tree</li> <li>No visible external defects</li> </ul>	Retain	30	B	28
1813	Pear sp.	6	250	1.5	M	3	2.5	2.5	2.5	FAIR	<ul style="list-style-type: none"> <li>Situated directly underneath 11Kv electric wires</li> <li>Has been 'topped' in the past but recovered well with good regrowth</li> <li>No other visible external defects</li> </ul>	Retain	20	C	28

T1810 – severe die back in upper crown

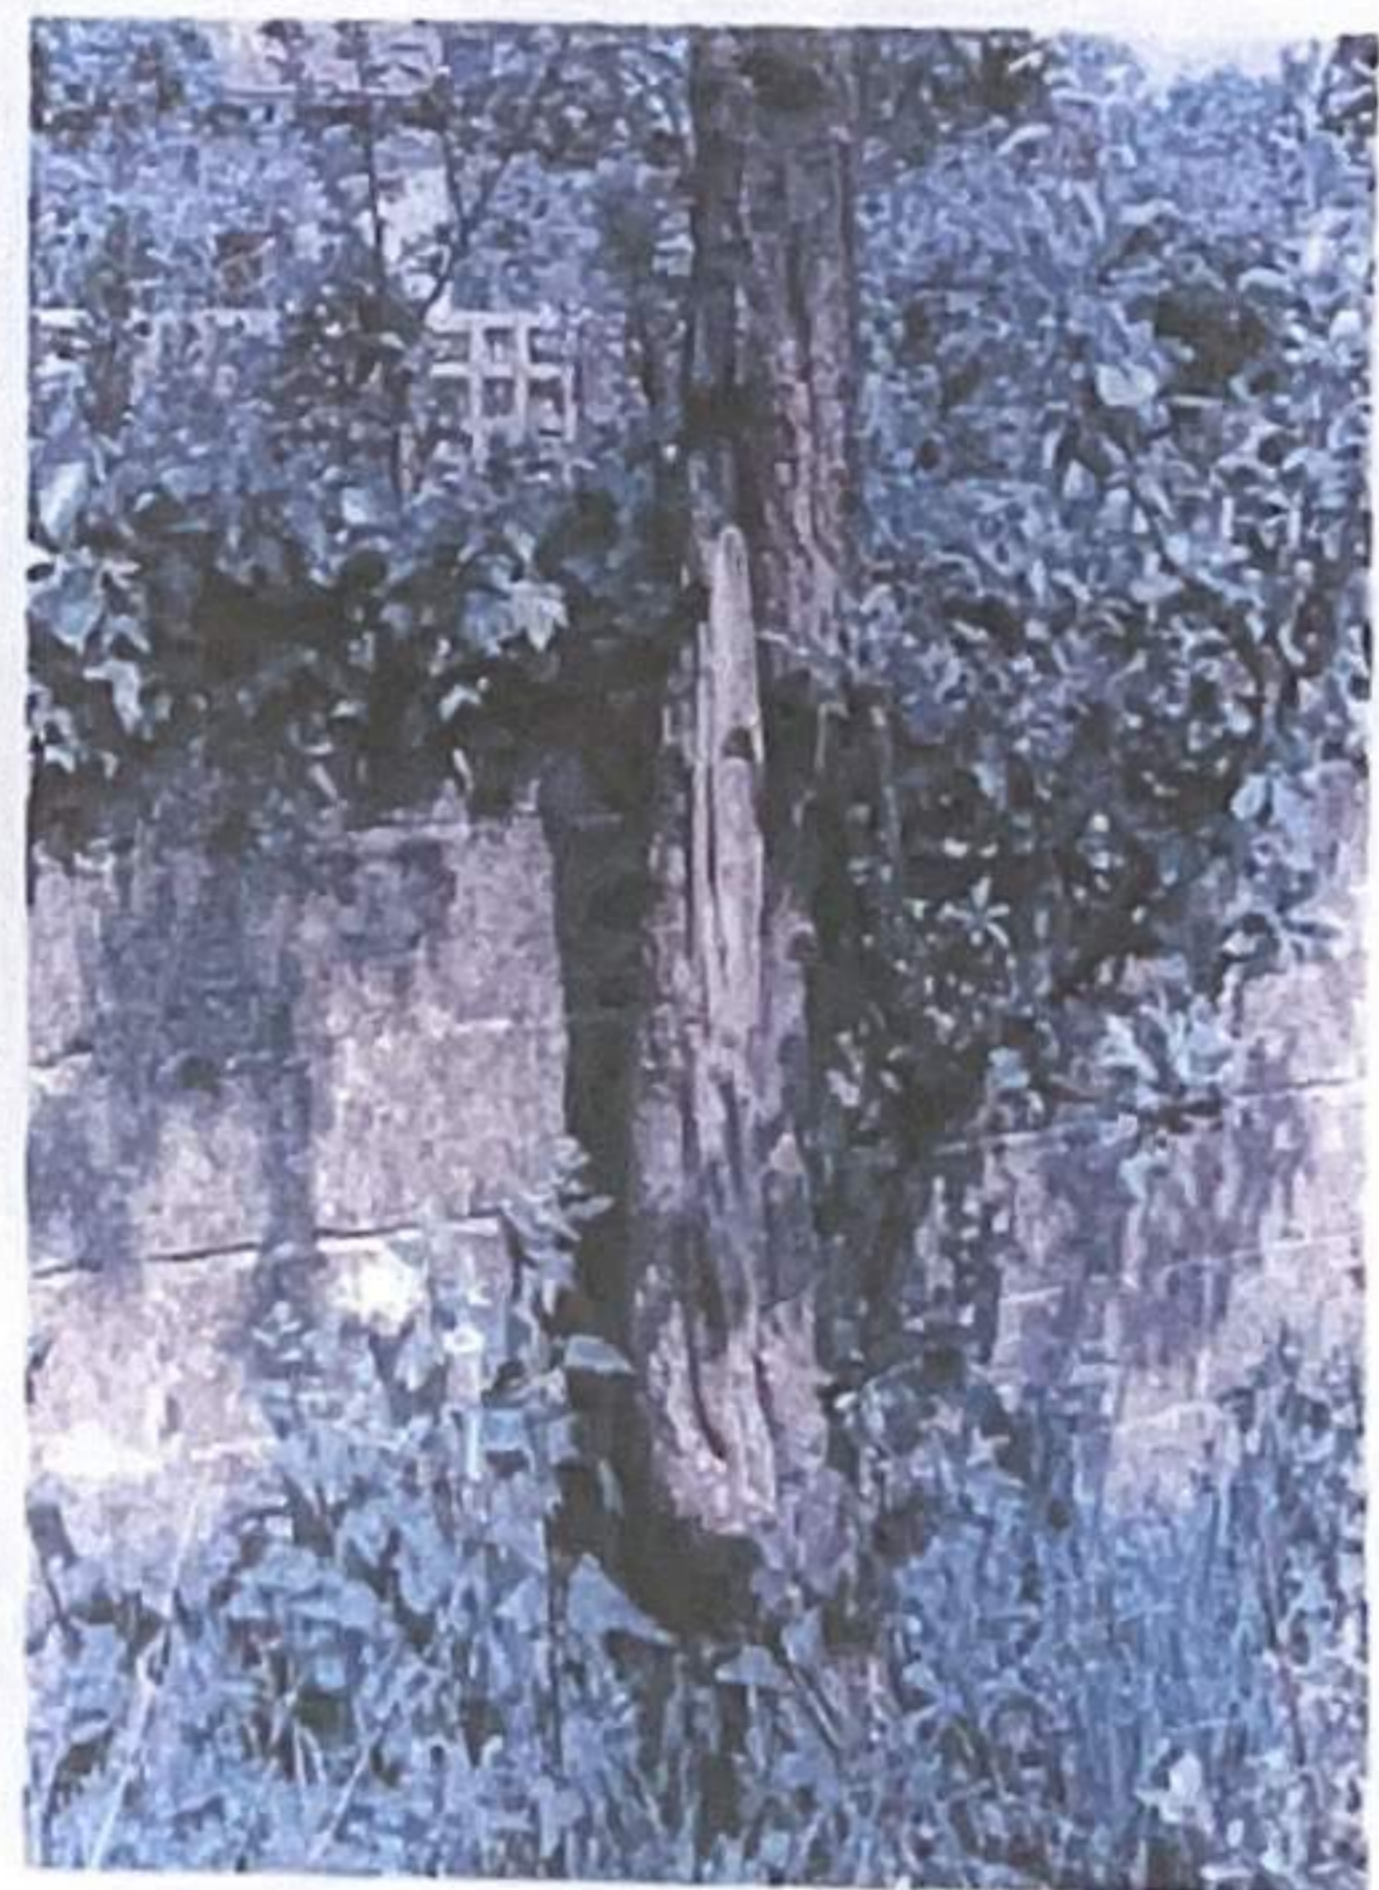
1814	Pear sp.	5	650	0	M	2	3.5	3	3	FAIR	<ul style="list-style-type: none"> <li>Twin stemmed</li> <li>Situated next to 11Kv electric wires</li> <li>Has been 'topped' in the past but recovered well with good regrowth</li> <li>No other visible external defects</li> </ul>	Retain	20	B	133
1815	Damson	4	140	1.5	Mi	2	1.5	1.5	2	POOR	<ul style="list-style-type: none"> <li>Severe dieback in crown</li> <li>Old large vertical wound on trunk with decay present</li> <li>Growing at base of wall</li> </ul>	FELL	0	R	9
1816	Apple sp.	4	310	1	M	4	4	4	4	GOOD	<ul style="list-style-type: none"> <li>3 old pruning wounds at top of trunk - occluding well</li> <li>No other visible external defects</li> </ul>	Retain	30	B	43

T1815 – vertical wound with decay present

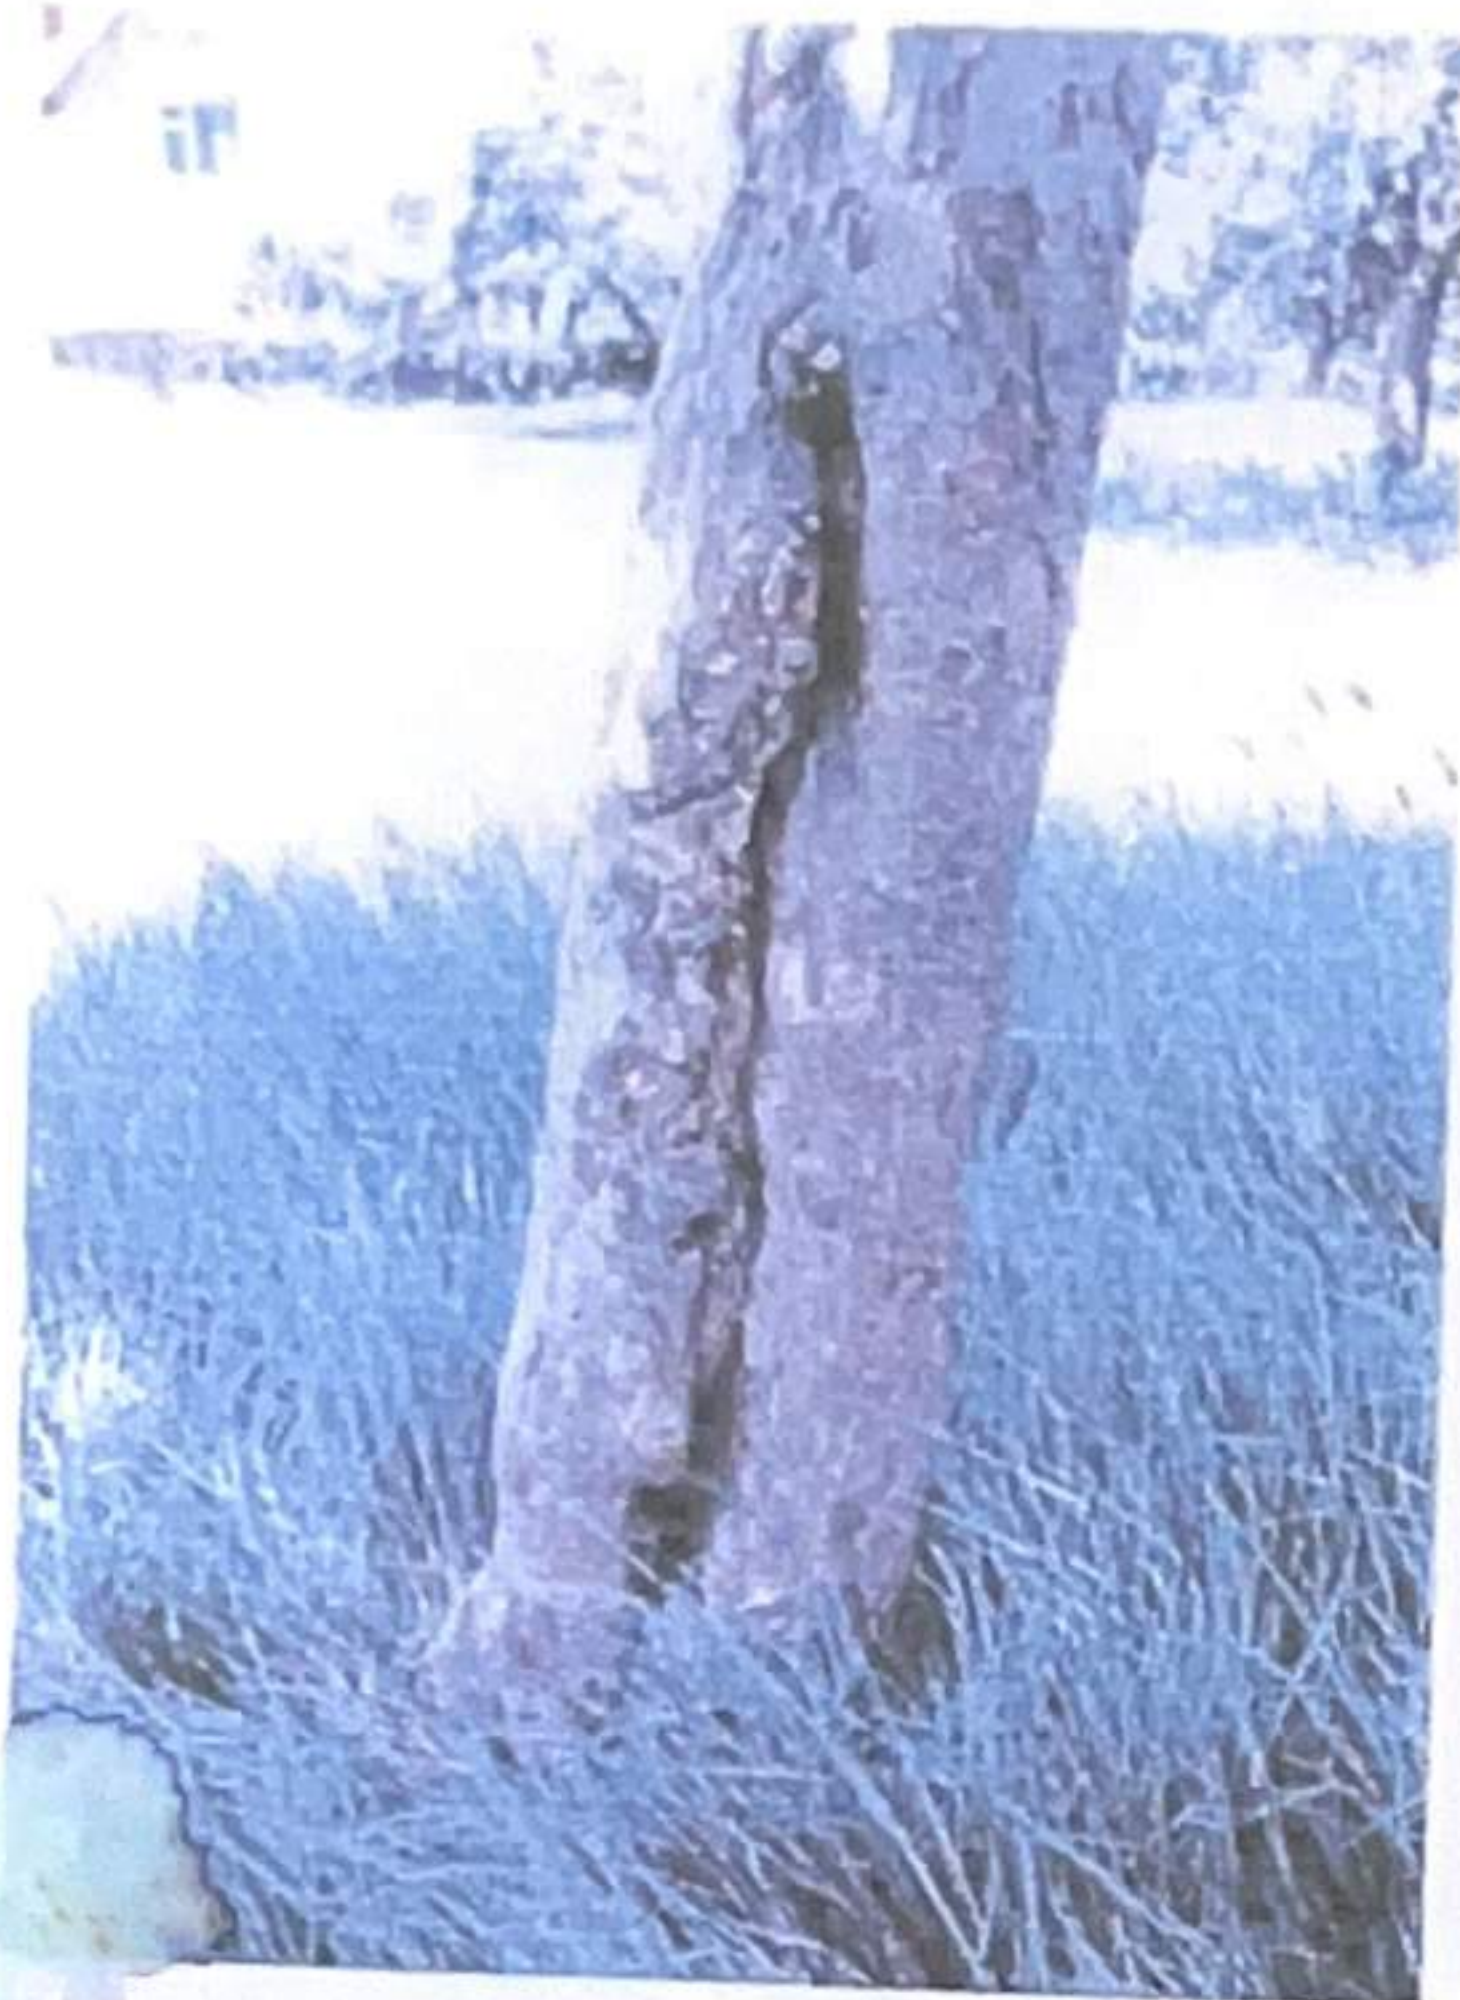
T1818 - vertical wound on trunk with decay present

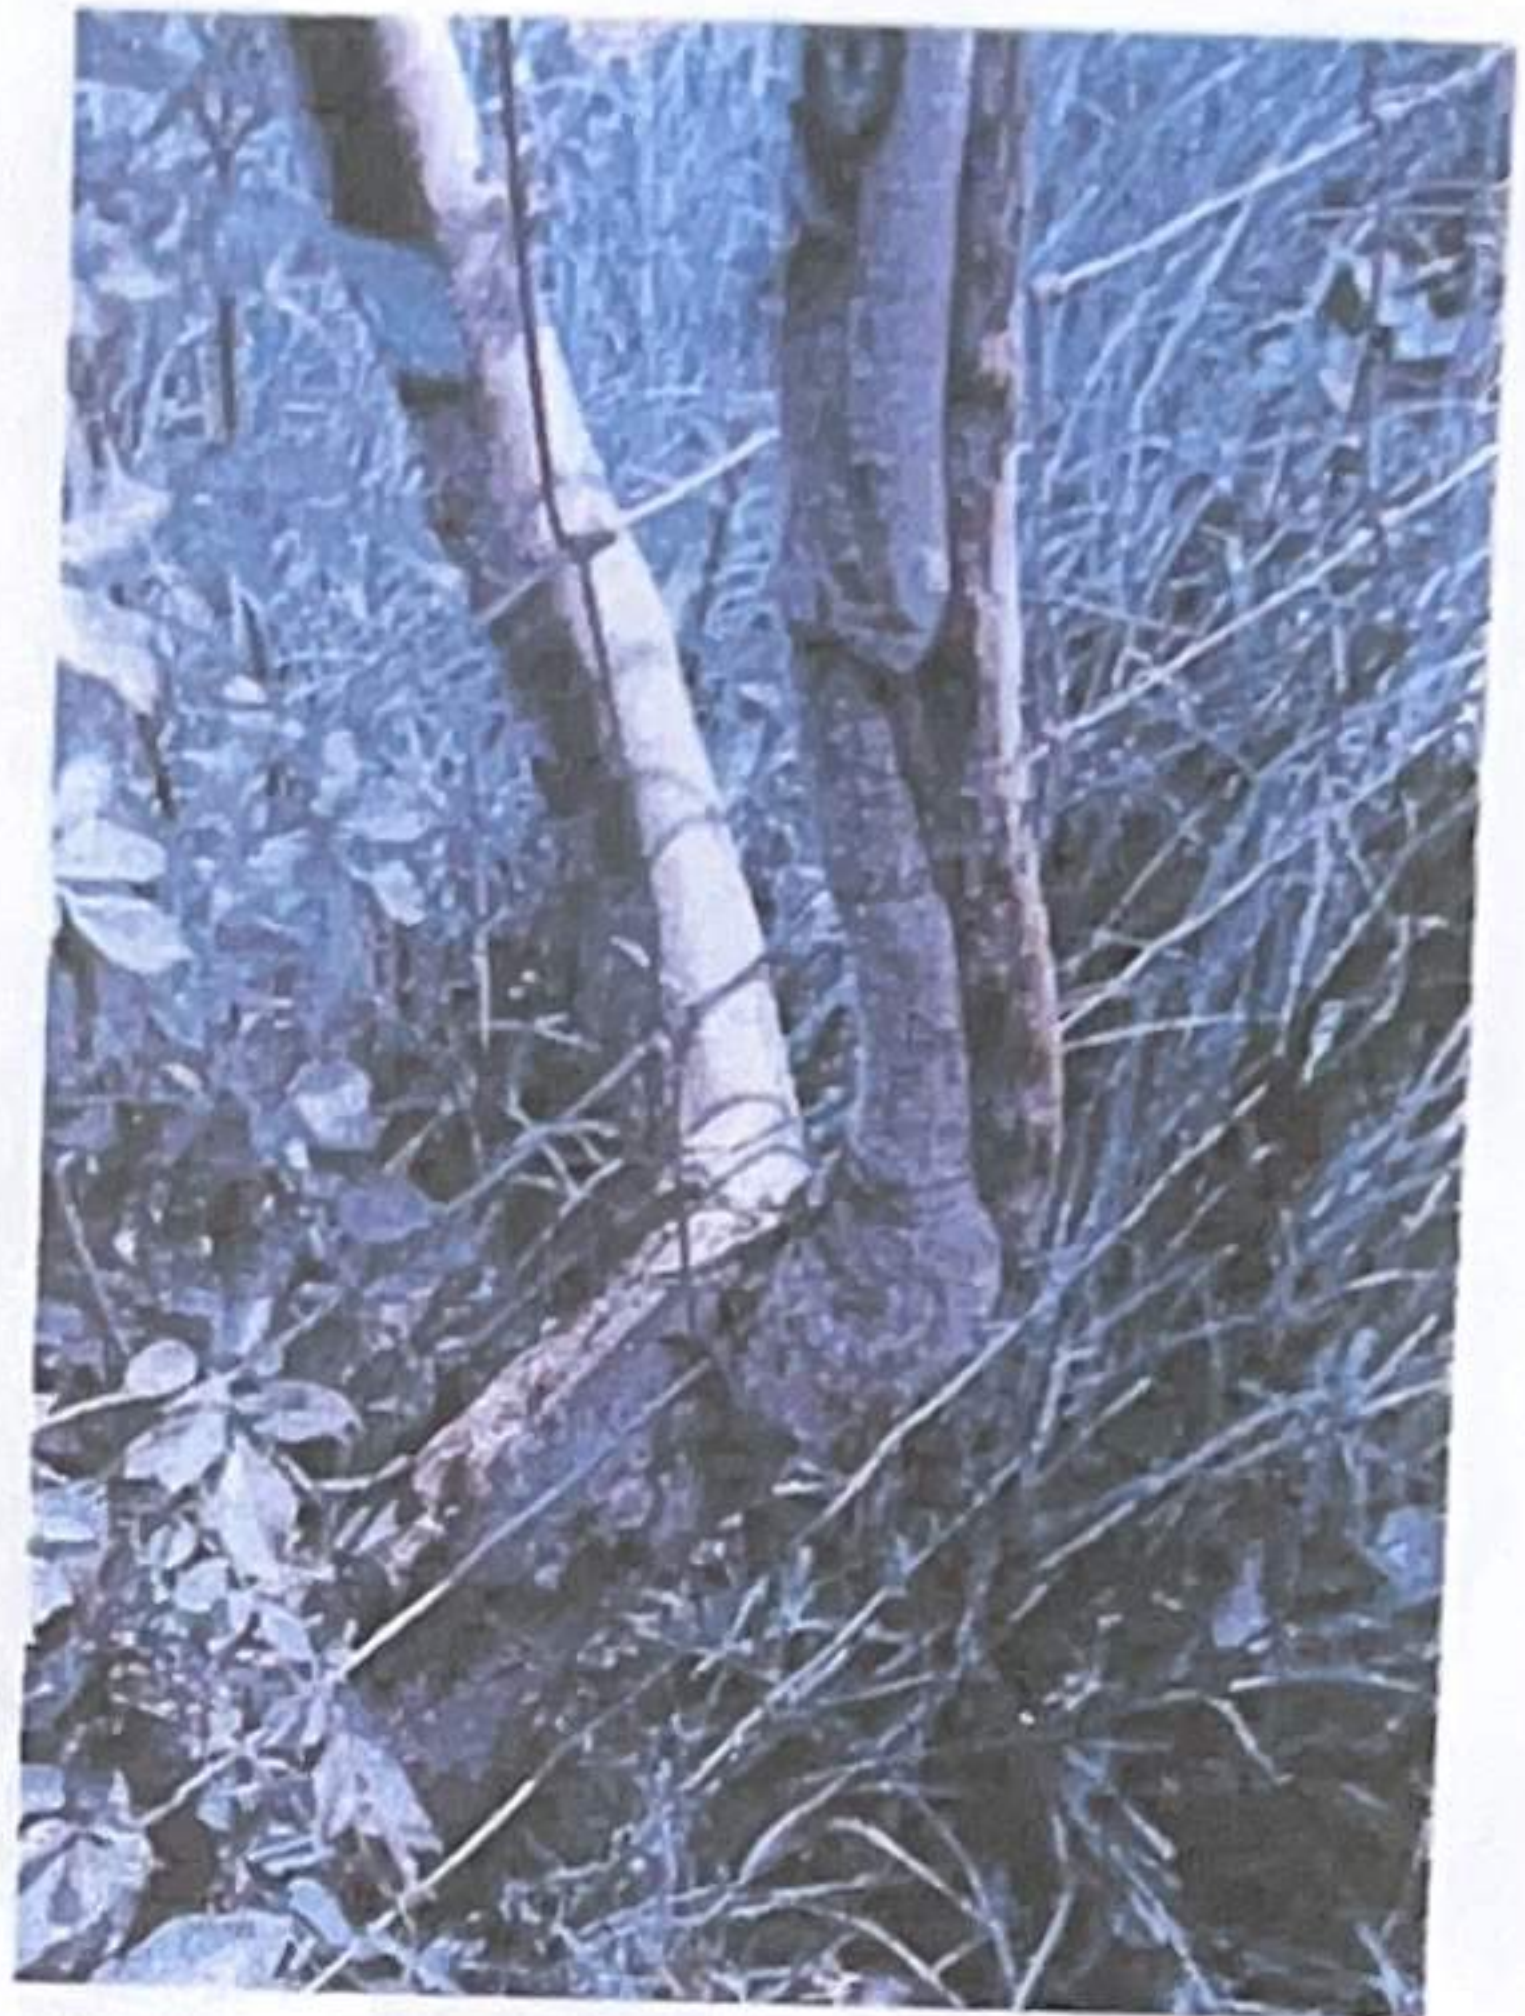
1821	Ash	3	90	1.5	Y	1	1	1	1	1	POOR	<ul style="list-style-type: none"> <li>Twin stemmed</li> <li>Bark damage from grazing</li> <li>Growing around wire stock fence at point of fork</li> </ul>	<b>FELL</b>	0	R	3
1822	Oak	12	1360	2	V	11	8	3	11	11	FAIR	<ul style="list-style-type: none"> <li><b>VETERAN TREE</b></li> <li>Old pollarded Oak</li> <li>Growing just NW of 11Kv electric wires</li> <li>SE crown has been severely cut back away from electric wires</li> <li>Trunk is hollow</li> <li>NW crown has very long end weighted limbs</li> <li>Vertical split in trunk on N side due to weight of crown to NW</li> </ul>	RETAIN  Crown reduce NW crown by maximum ONE THIRD only to remove end weight of limbs	40	B	837

T1821 - trunk growing around wire fence and vertical wound on stem

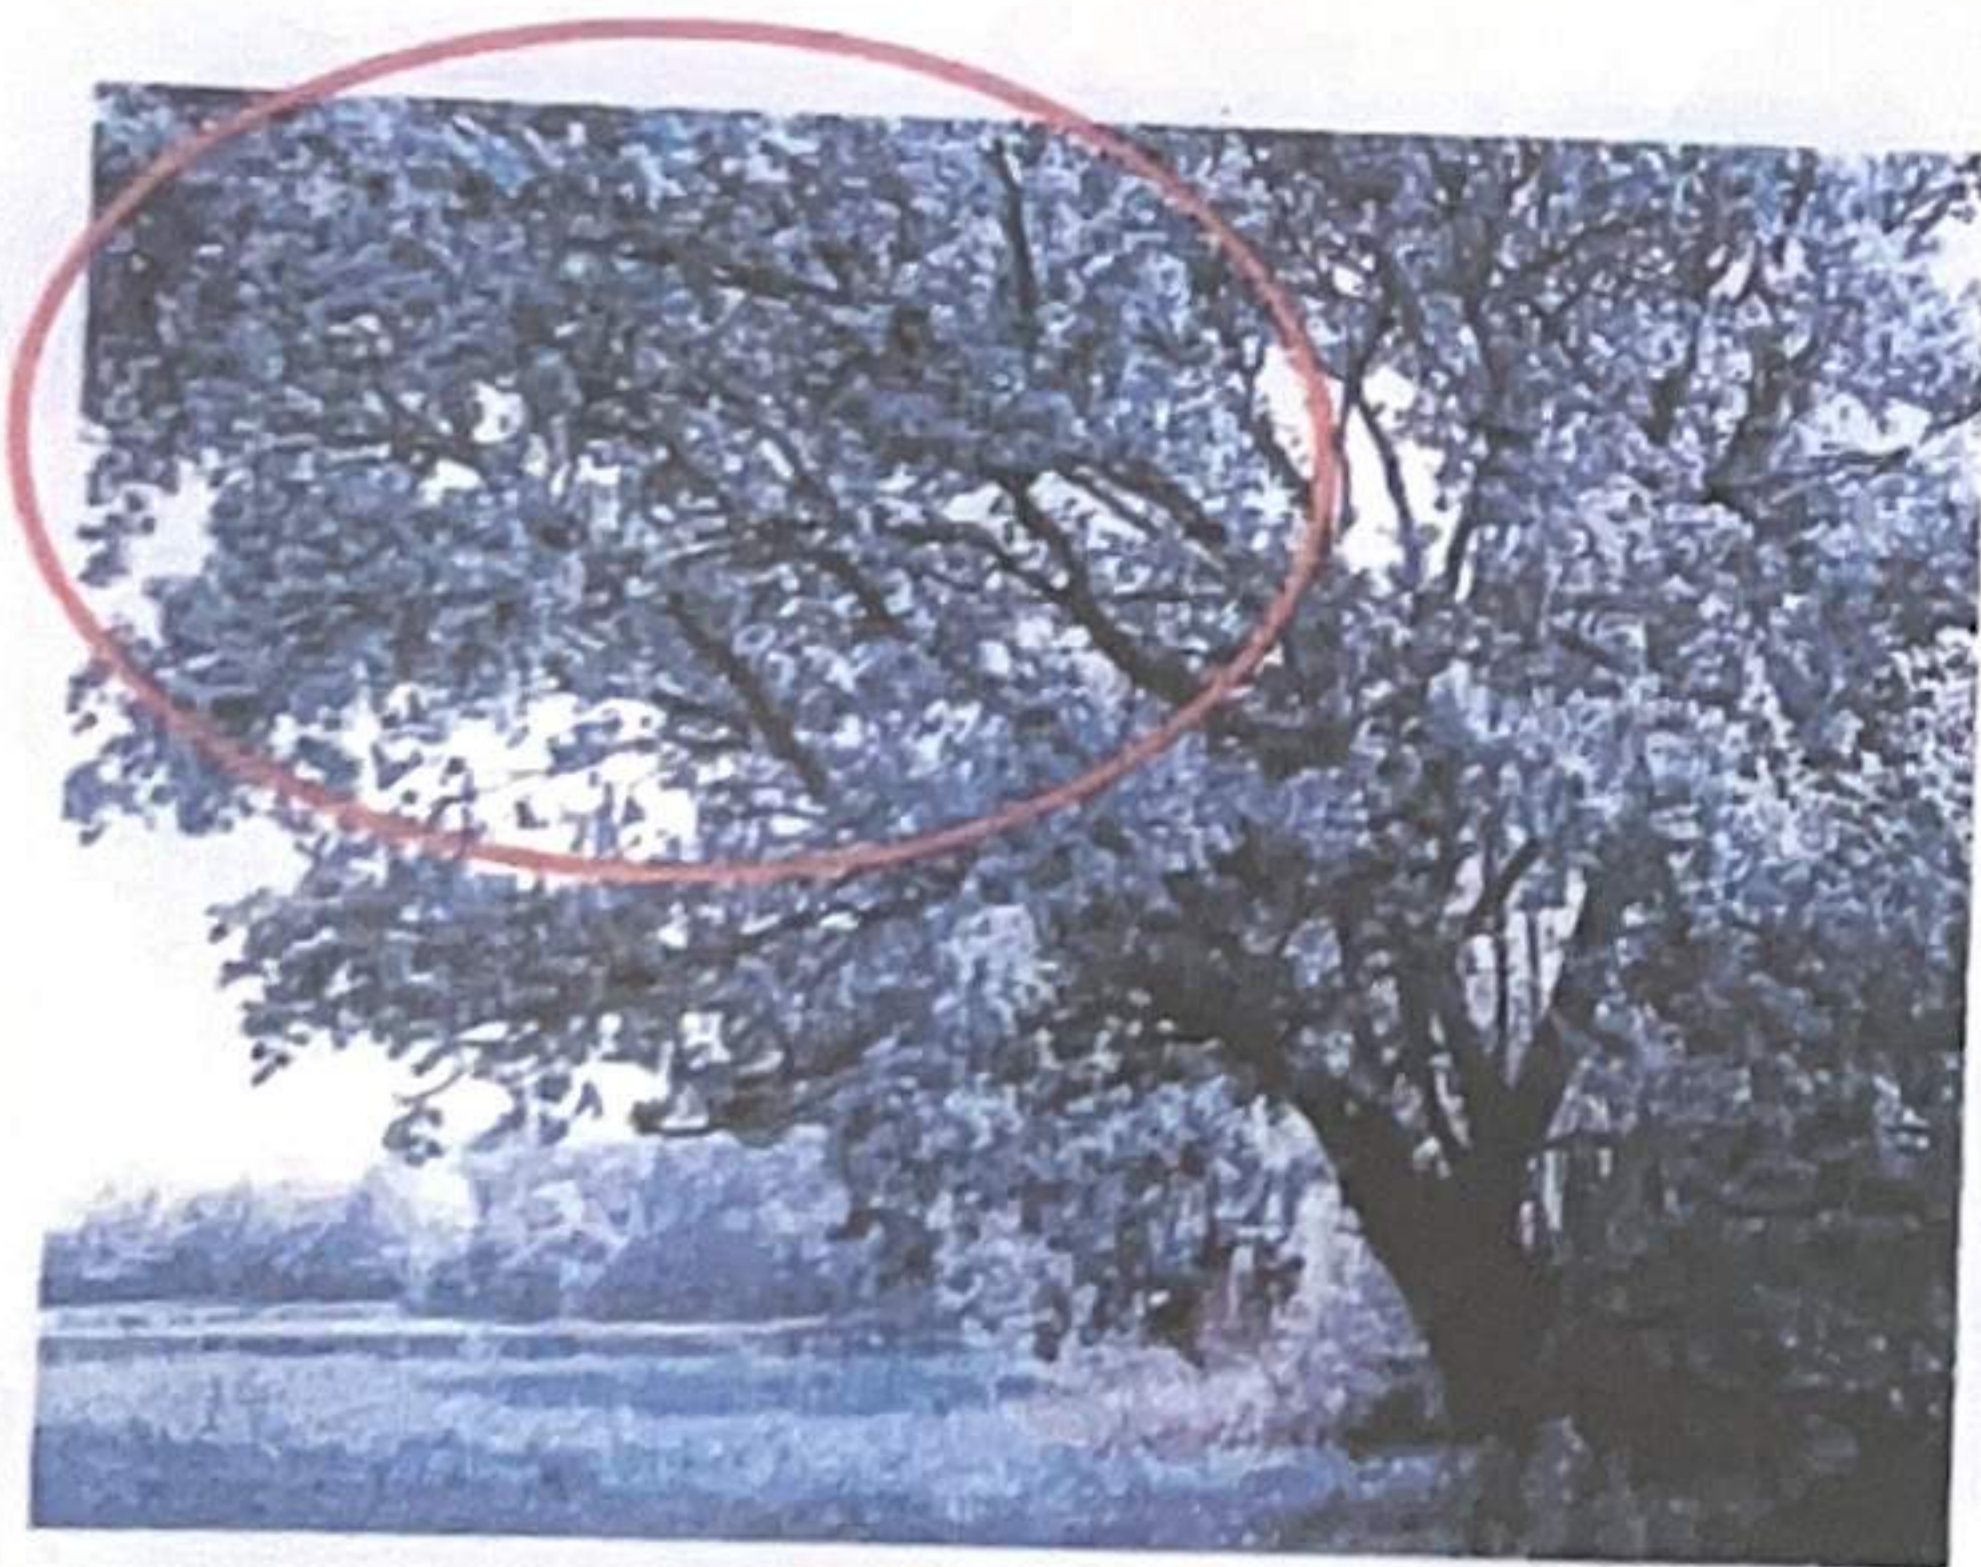
T1822 Oak is a veteran tree and has been recorded as such.

- 5.3 Tree 1822 is a veteran Oak tree and should be retained. Because of its age (estimated at 350 to 400 years old) it has great historic, wildlife and aesthetic value. It does require some remedial pruning works in the short term to reduce the end weight of limbs and prevent part of the crown and trunk splitting out.

T1822 - Oak to be crown reduced by removal of maximum of one third length of long lateral, end weighted limbs (red circle)

- Oak trees are inherently strong, and can reach a great age despite becoming hollow or retaining a smaller crown. Design of the site should allow for minimum intervention around or beneath the tree, thereby ensuring its survival for many decades to come.
