# TREE REPORT

**PRE-DEVELOPMENT  
BS5837 TREE SURVEY  
PART TWO**

**Site:** Elms Farm  
Elms Road  
Govilon

**Date:** May 2008

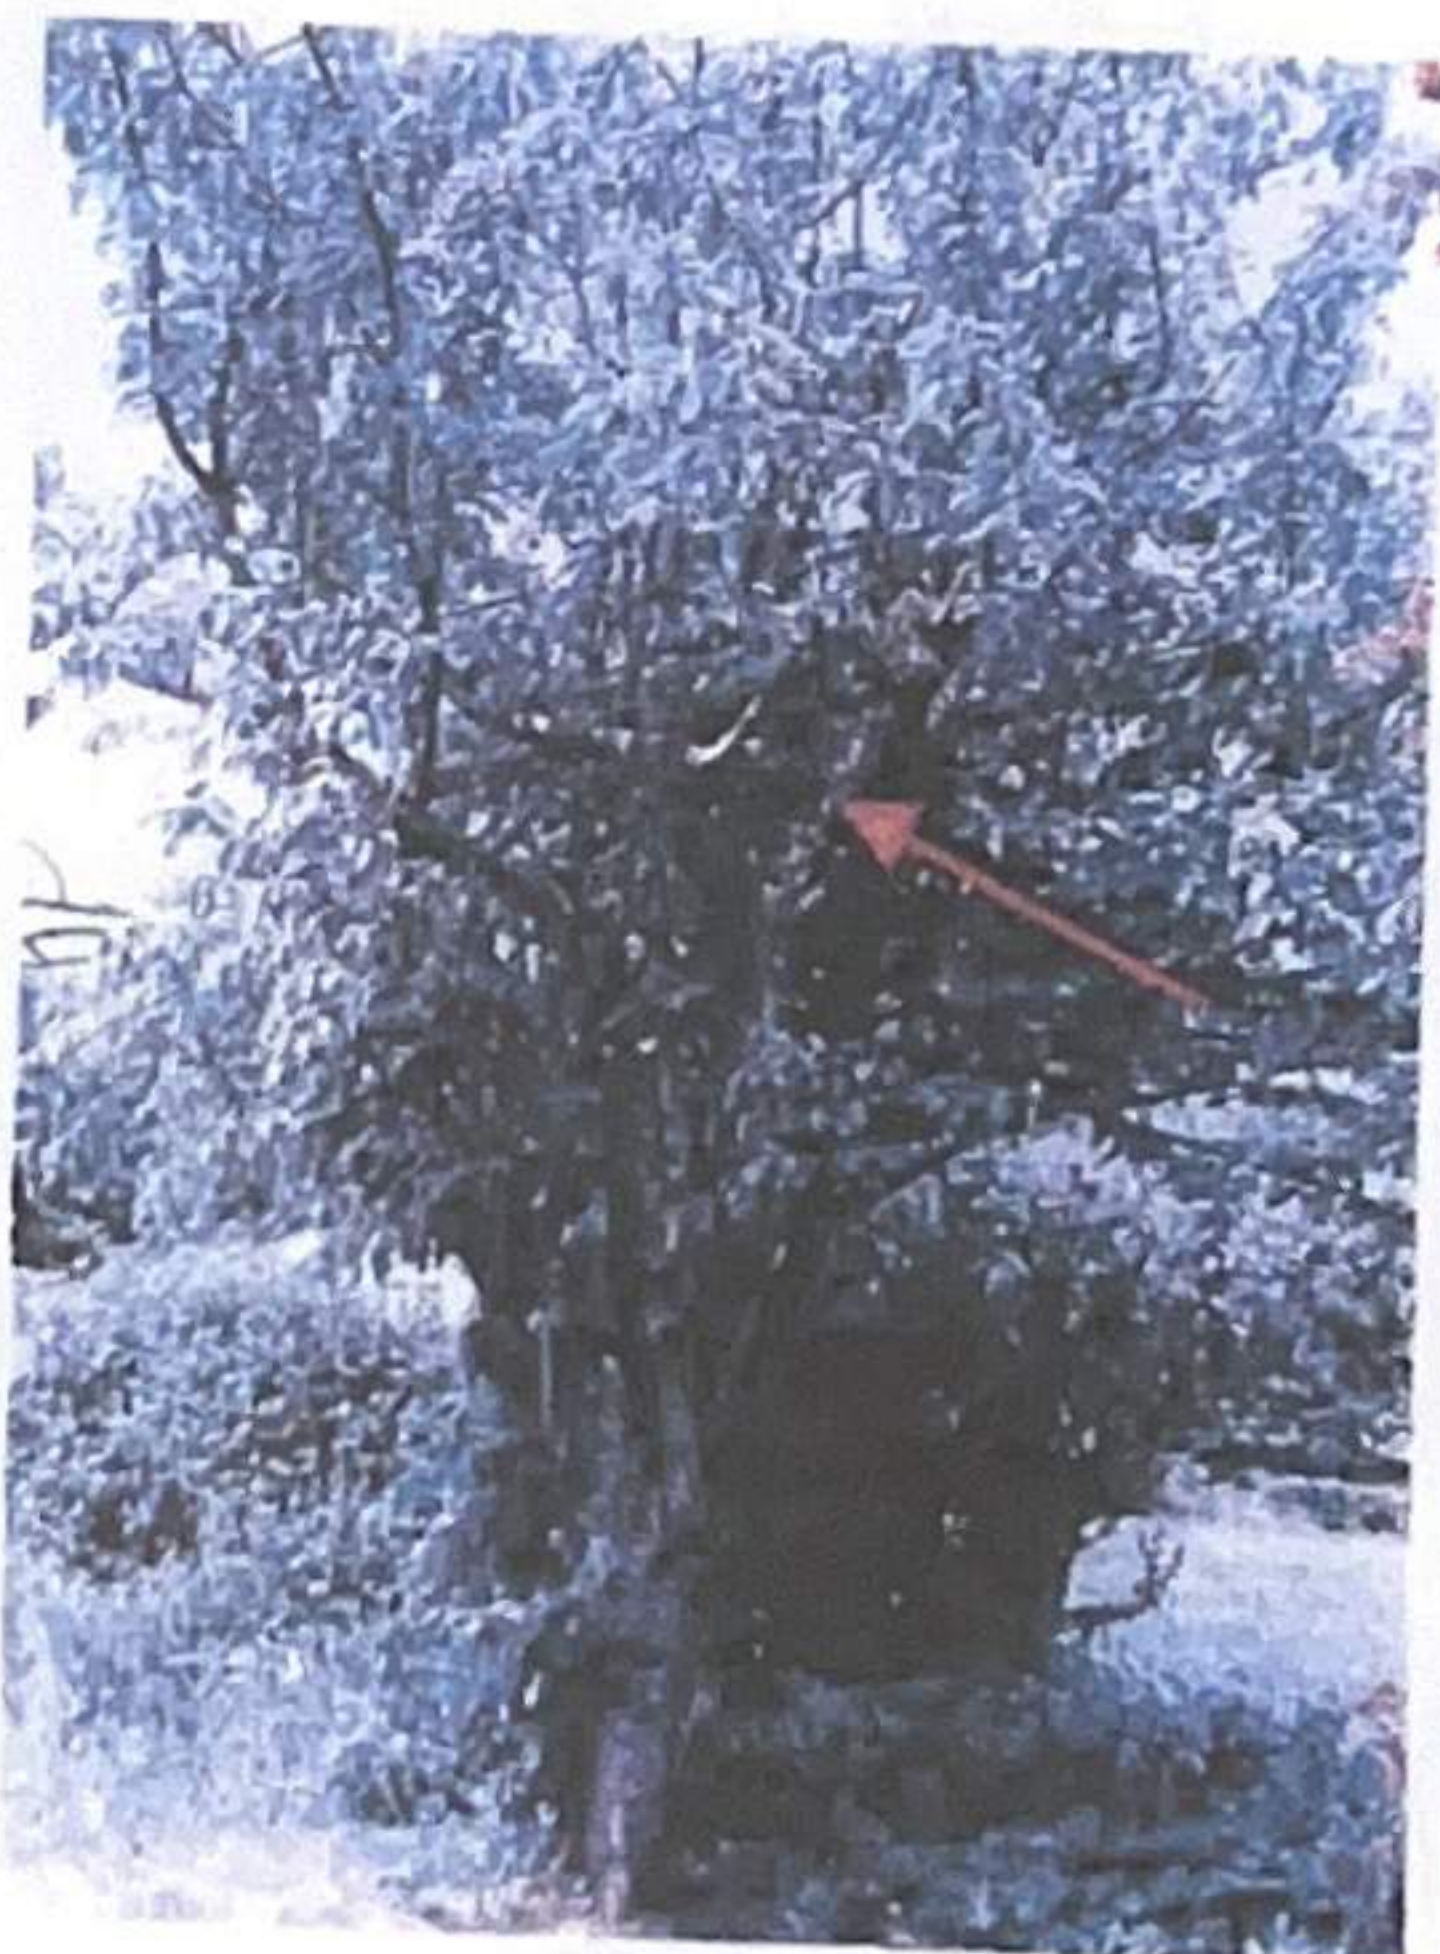
T1832 - dead branches in Cherry (red arrow)

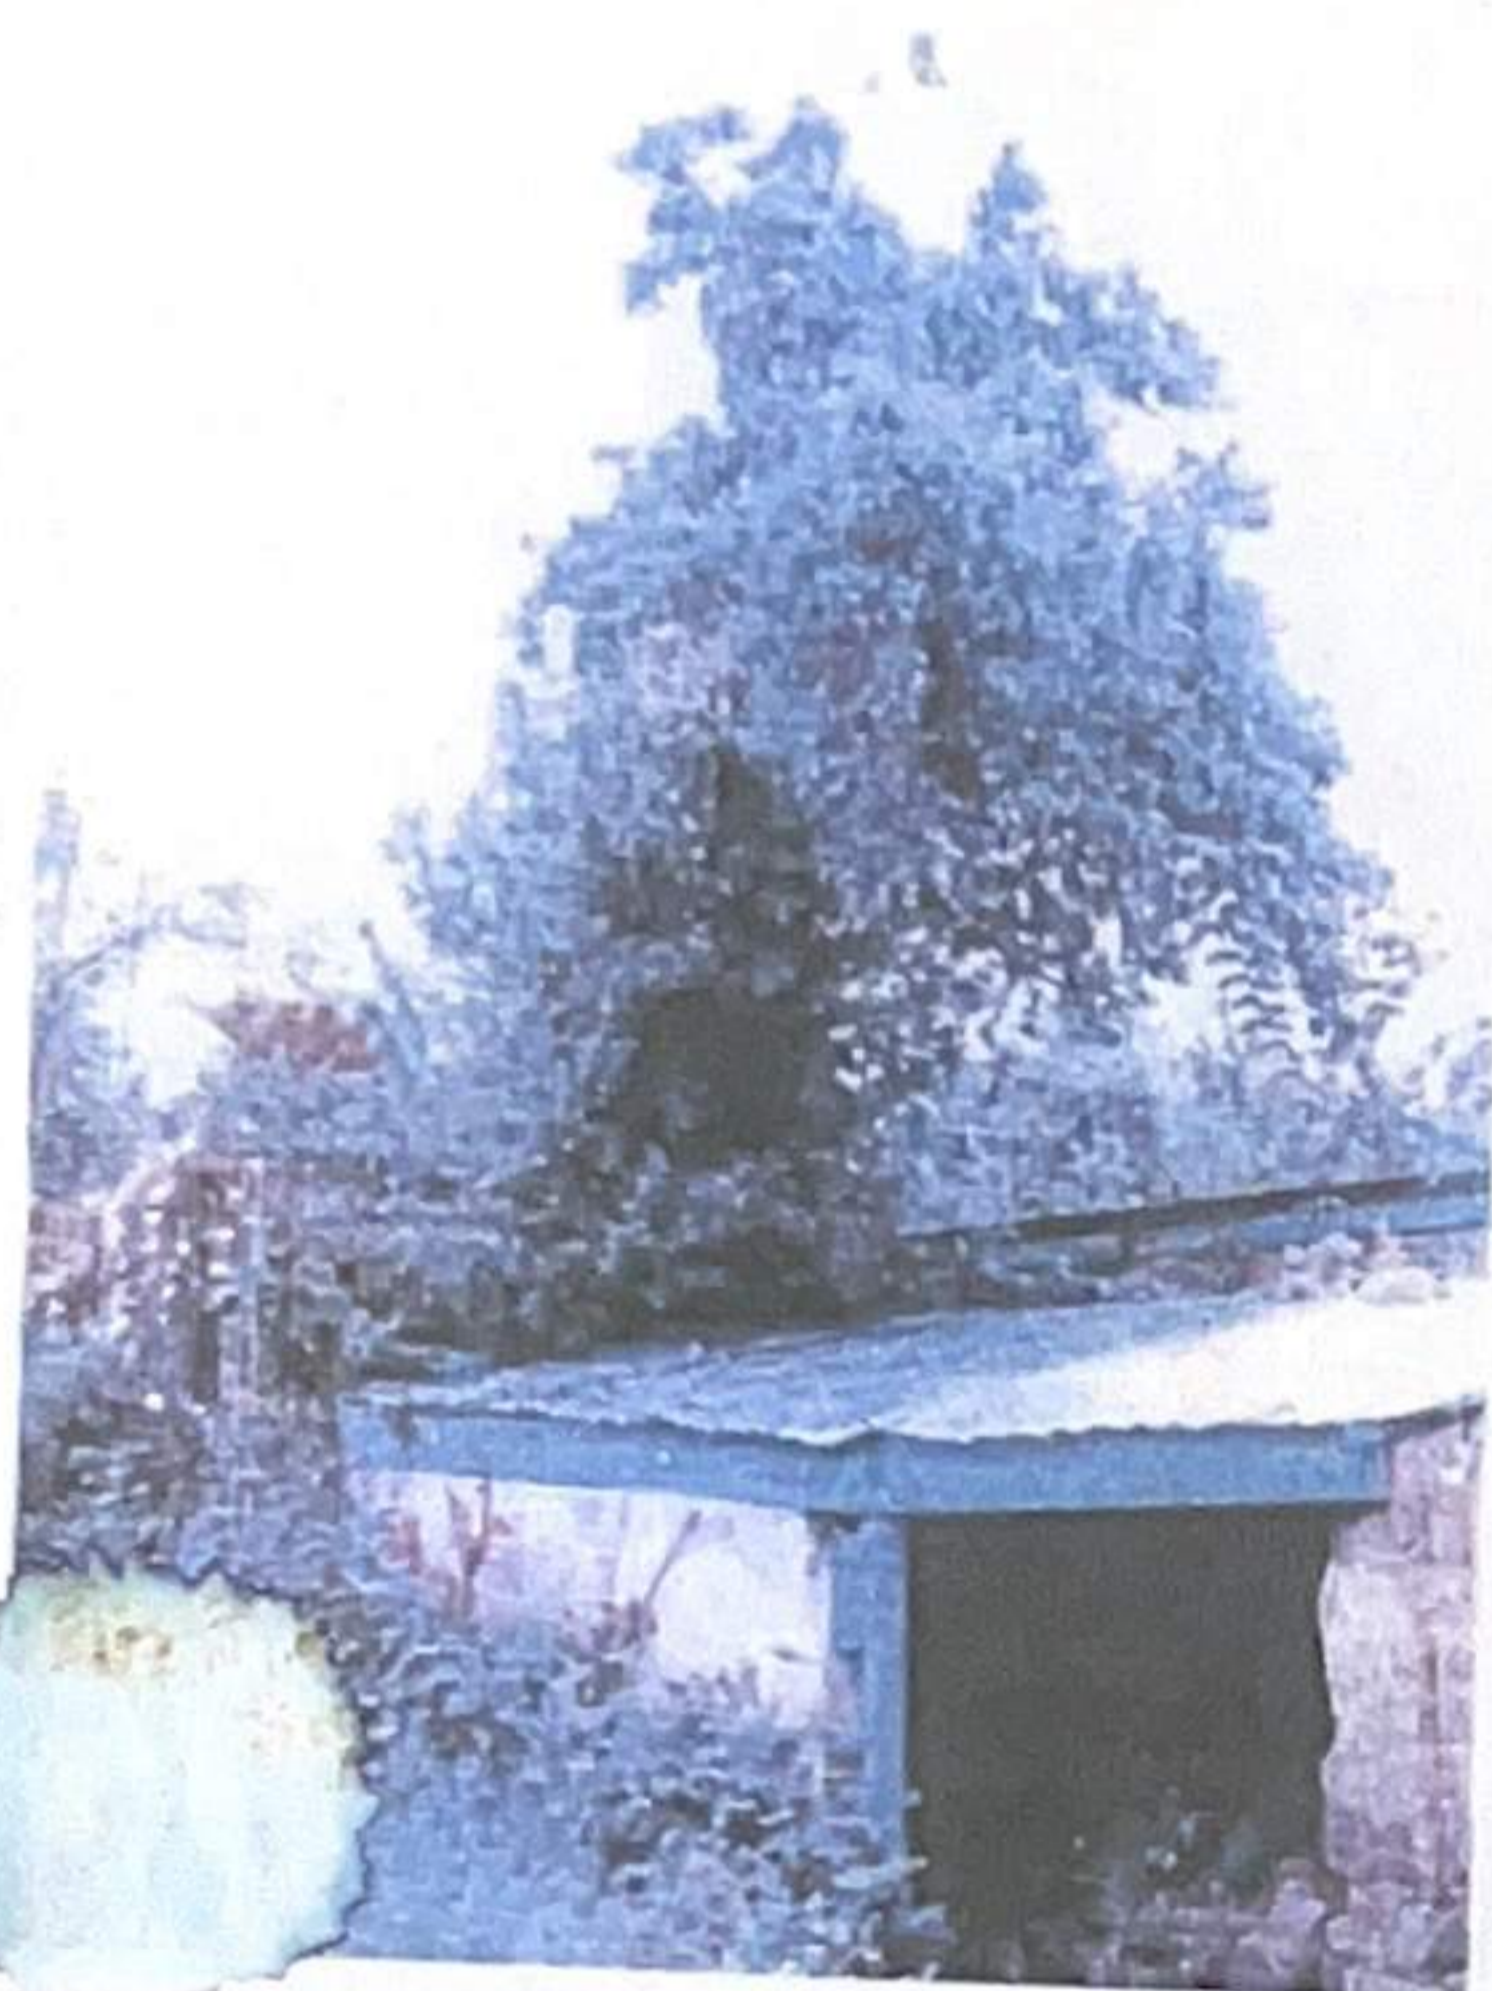
1834	Pear sp.	5	250	1	M	3	2	1.5	2	FAIR	<ul style="list-style-type: none"> <li>Twin stemmed</li> <li>Growing at base of wall sandwiched between the wood shed, oil tank and garage</li> <li>No room to develop</li> </ul>	FELL	0	R	20
1835	Ash	4	120	1	Y	1	1	1	1	POOR	<ul style="list-style-type: none"> <li>Old stump at base of wall behind garage that has re-sprouted</li> <li>No room to develop</li> </ul>	FELL	0	R	7

T1834 – Pear sandwiched between garage, oil tank and wood shed

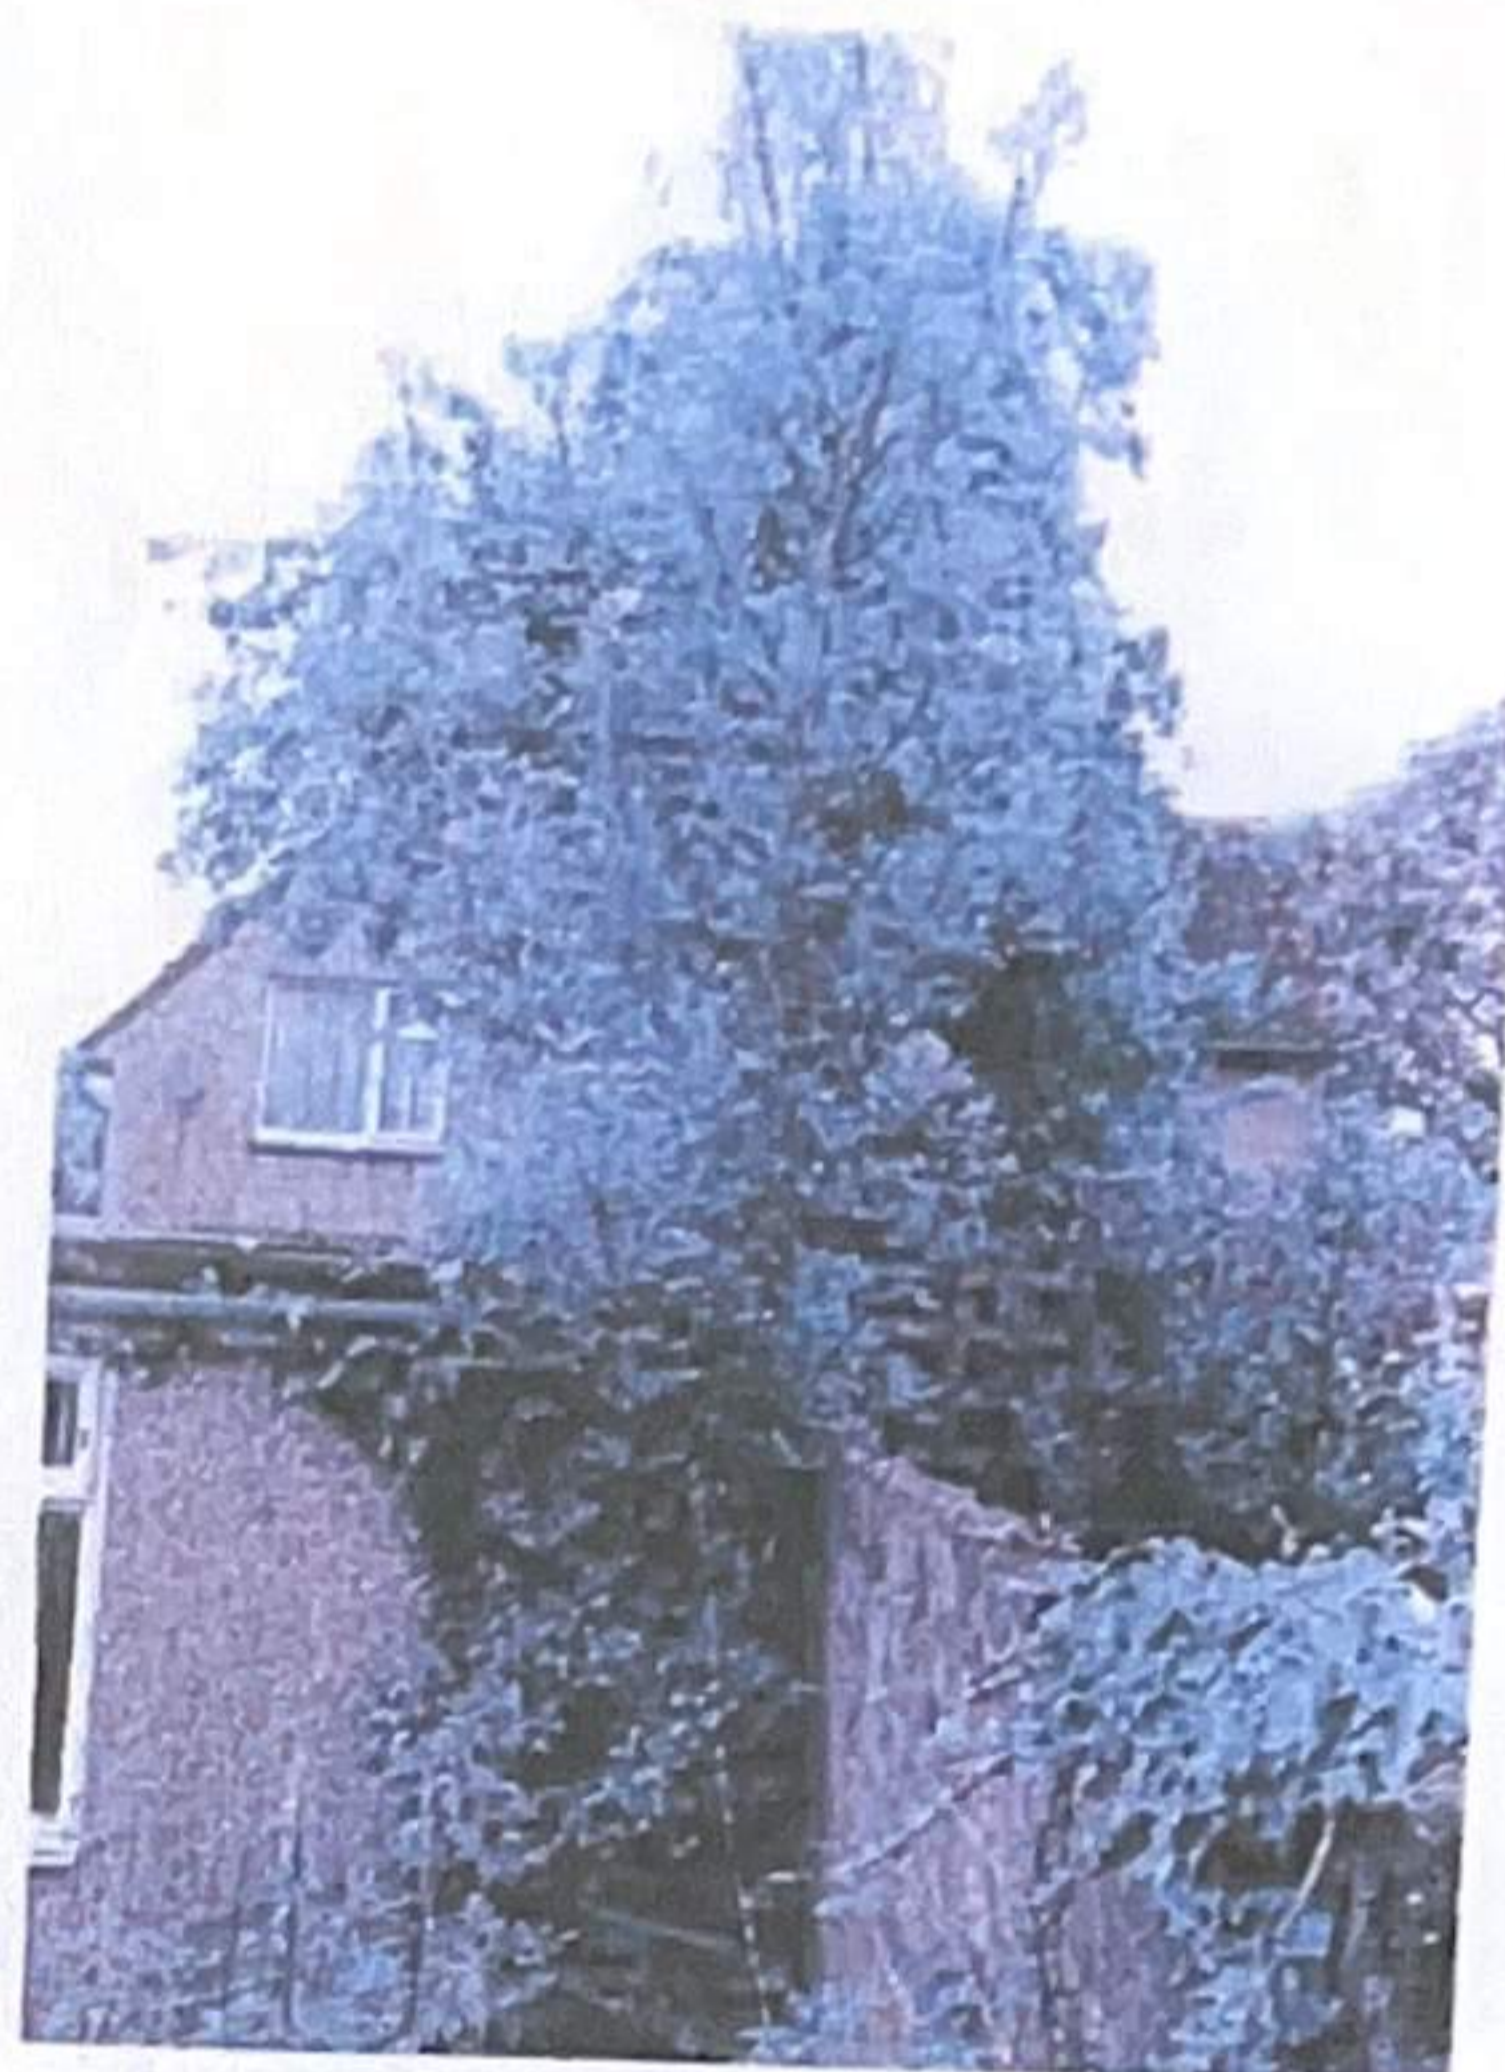
T1835 – Growth from old Ash stump at base of wall
