Ms A Fairbanks
The Old George
Dymock
Gloucestershire
GL18 2AJ

11th July 2023

Structural Appraisal of the Ground Floor Timber Structure over the Cellar at The Old George, Dymock, Glos.

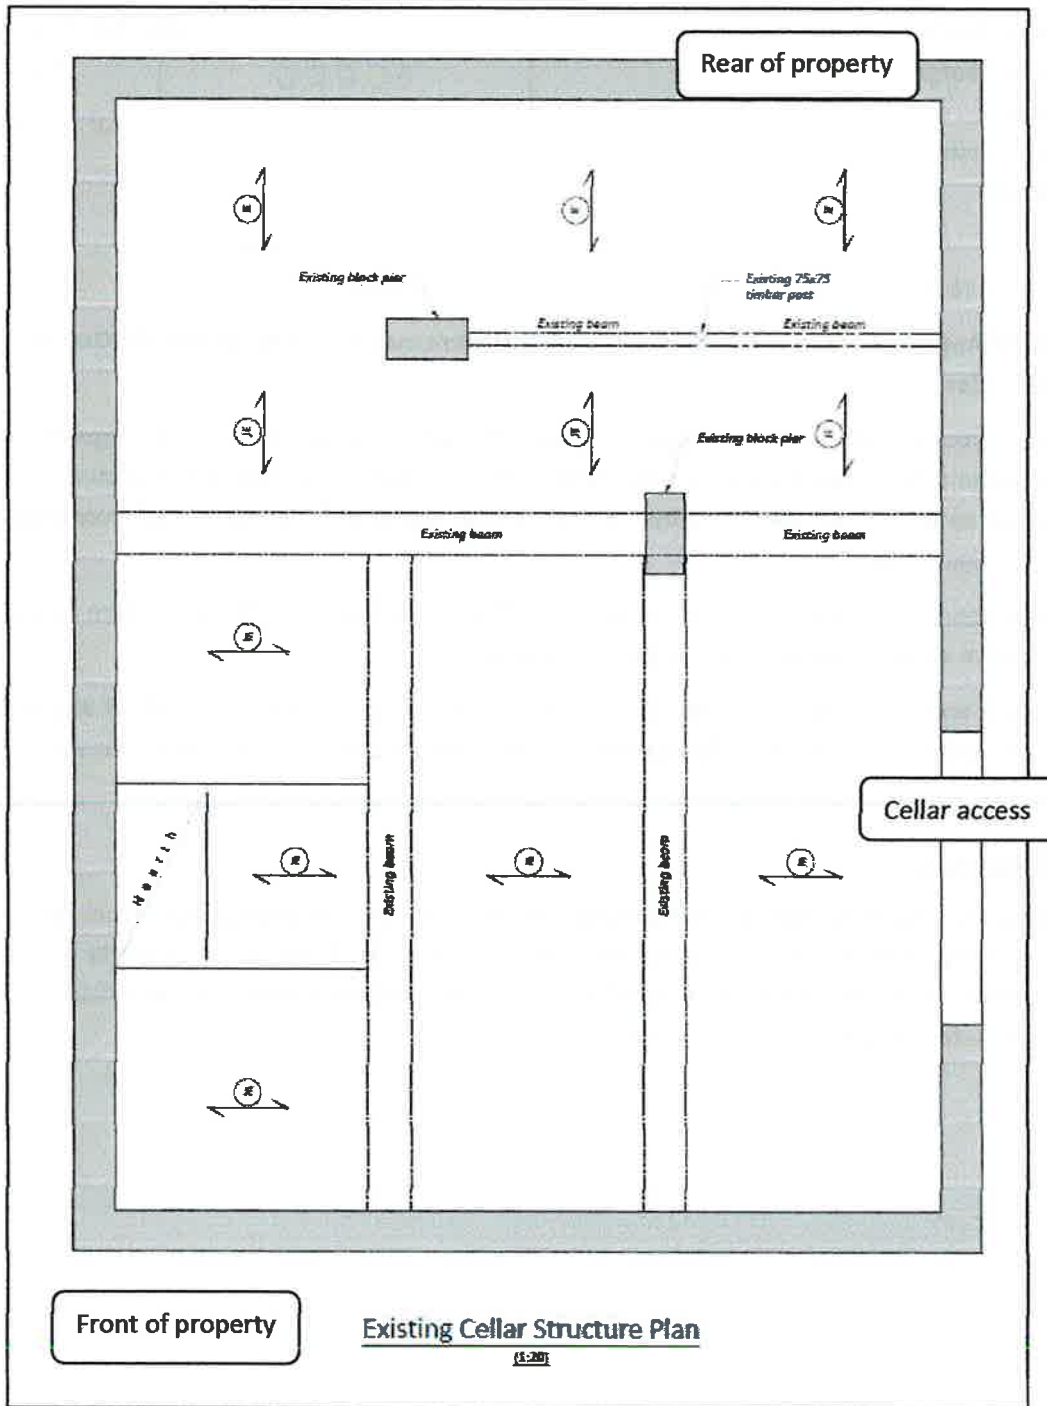
Figure 1: Ground Floor Structure Plan

The property comprises a two-storey dwelling of traditional build, comprising a cut timber roof, timber floors and load bearing masonry walls. The ground floor to the front of the property is of timber construction. Additional masonry piers and a timber beam have been added at a later date to support the floor. Refer to figure 1 and photographs 1 and 2 below.

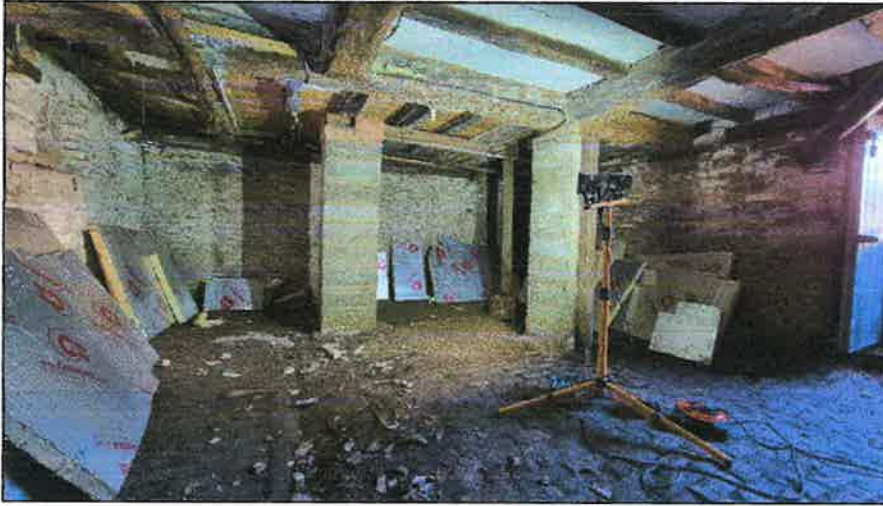
Photograph 1: View of Cellar looking towards the rear of the property

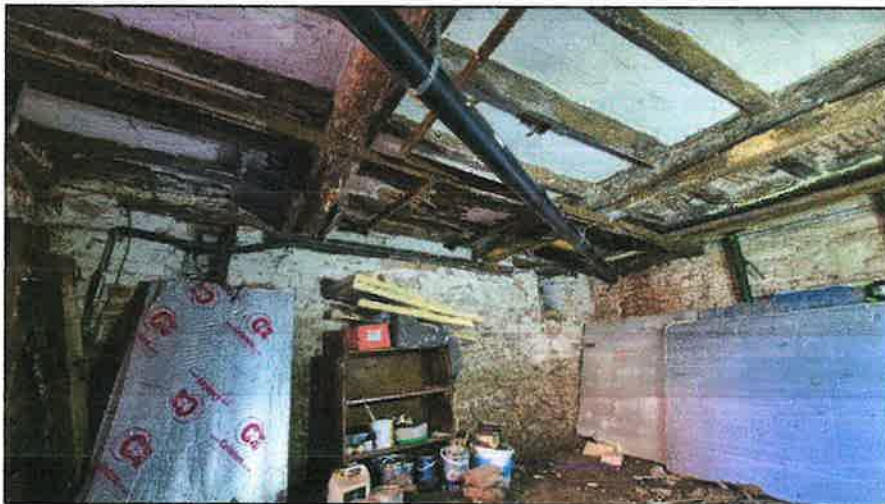
Photograph 2: View of Cellar looking towards the front of the property

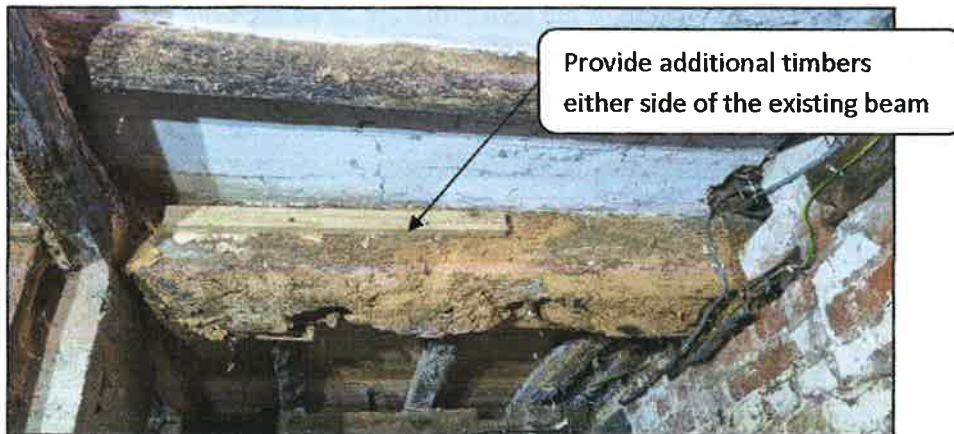
The section of floor beam spanning from the masonry pier to the external side wall (adjacent to the cellar doors) has deteriorated significantly.

The deteriorated section of floor beam spans a short distance between a block pier and the external side wall. The beam supports a short section of floor to the rear section of the cellar. The reduced cross section of the floor beam should be capable of supporting the floor area. However we would suggest new timber beams are located either side of the existing beam to support the floor.

Photograph 3: Rotten timber floor beam

Provide 2x 150x47 C24 timber joists either side of the rotten floor beam. The timbers can bear into the external wall, although the ends of the timbers will require protection in the form of a DPM wrapped around the joists at the bearing. Alternatively the timber can be fixed to the masonry/timber beam using joists hangers. Refer to photograph 3 below.

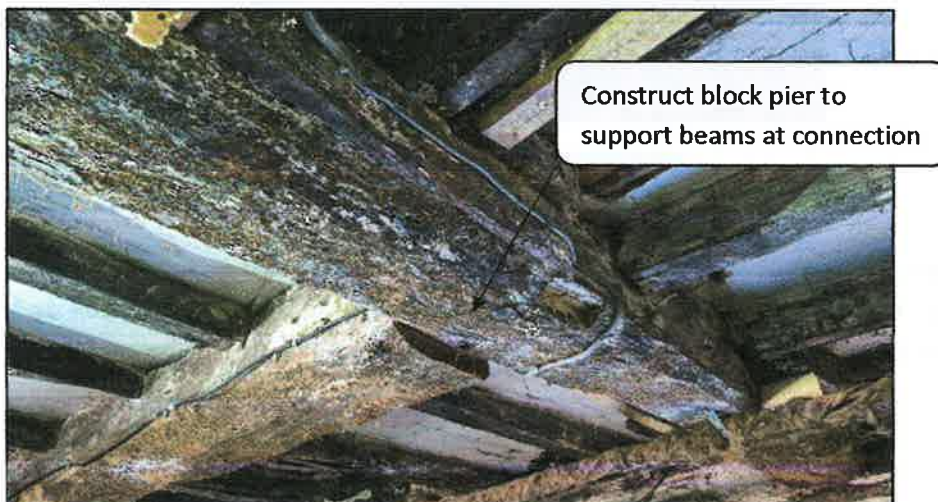
Photograph 4: Existing timber floor beam connection

A further masonry pier constructed at the other floor beam junction will aid the support of the floor.

A block pier should be built to support the other timber beam junction. The blockwork laid on its side, can be built off the cellar floor using 7N blocks. Refer to photograph 4 below.

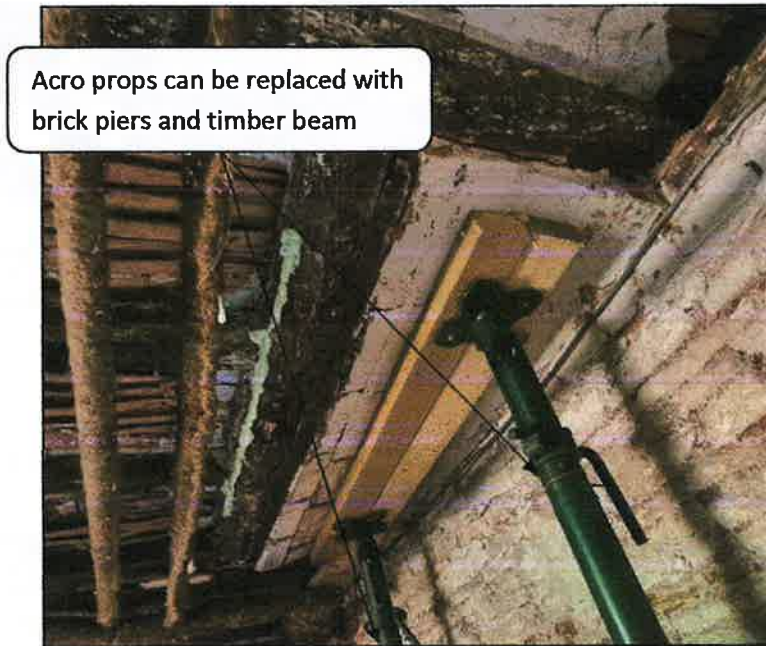
Additional supports have been added to the fireplace hearth in the form of two acro props and timber planks. The hearth is formed with vaulted brickwork supported off trimmer timbers.

The acro props and timber planks are adequate to support the brick vaulted hearth. An alternative would be to construct a couple of engineering brick piers with timber support beams.

Photograph 5: Chimney hearth support

Although not a specific requirement, if the acro props are to be replaced then 2x 215mm x 215mm engineering brick piers should be constructed to support a 100mm x 100mm timber beam fitted to the underside of the hearth. Refer to photograph 5 below.

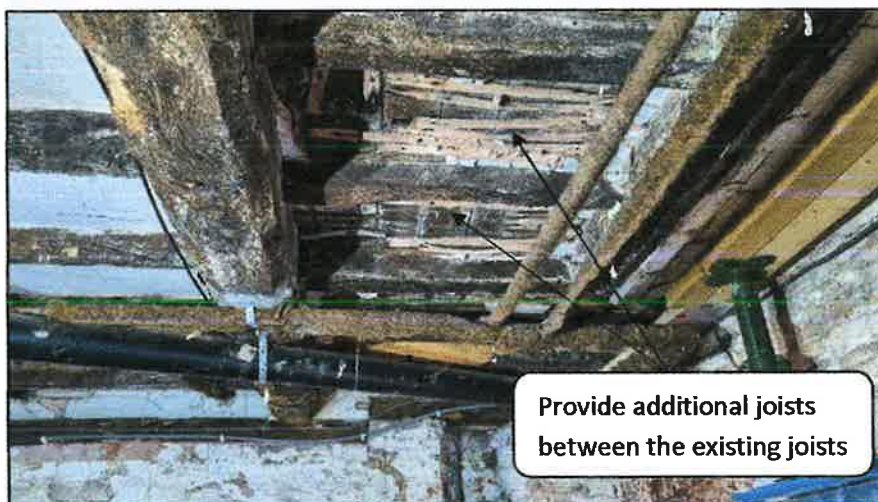
The ground floor has a couple of dips which can be felt when walking on the floor. The dips are located in front of the hearth and between the next two adjacent beams.

Where the ground floor dips, the existing timber joists are adequate to support the floor. The boards between the joists are likely to be causing the dip. Additional joist can be added between the existing joists. The new joists can be lightly jacked into place to removed some of the dip.

Photograph 6: Floor adjacent to hearth

At the floor dip locations additional 120mm x 75mm C24 joists should be located between the existing floor joists. The new joists should be 'lightly' jacked into place to stiffen the floorboards. The joists can be fixed to the adjacent timbers with joist hangers. Refer to photograph 6 below.
