ARBORICULTURAL ASSESSMENT REPORT

PRI Ref: 267823

Survey Date: 04/08/2023

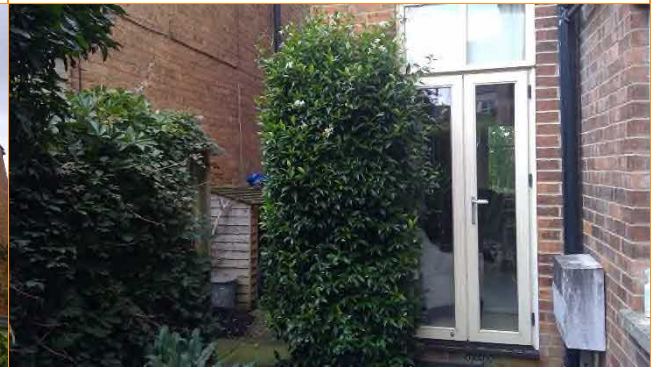
C1 - Star Jasmine

Tree No	Common Name	Age Class	Condition	Height (m)	Crown Spread (m)	Stem diam. (mm)	Dist to bldg. (m)	Roots Implicated	Pruning history	Recommendation	Tree work constraints	Notes	Owner address	Owner
C1	Star Jasmine	Mature	Fair	2.8	0.6	10*	0.1	N	Subject to past management.	No work required.	Access through side/rear gate.		6 Kensington Avenue Cheltenham GL50 2NQ	PH
C2	Star Jasmine	Mature	Good	2	0.50	15	1.4	N	Subject to past management.	No work required.	Access through side/rear gate.		6 Kensington Avenue Cheltenham GL50 2NQ	PH
CG1	Wisteria	Mature	Fair	3*	1.0*	25*	3.3*	N	Subject to past management.	No work required.	Access through side/rear gate.		7 Kensington Avenue Cheltenham GL50 2NQ	P3P
S1	Rose	Mature	Fair	1.4	0.4	10	0.2	N	Subject to past management.	No work required.	Access through side/rear gate.		6 Kensington Avenue Cheltenham GL50 2NQ	PH

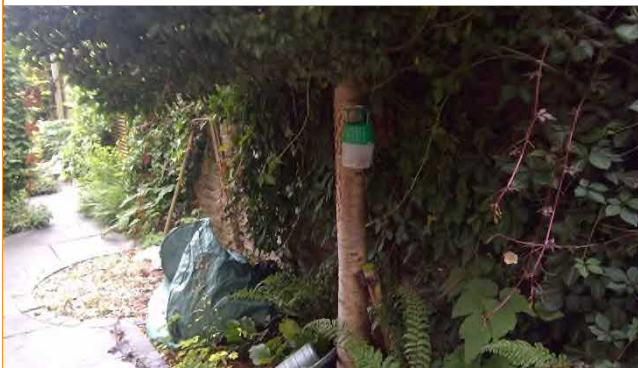
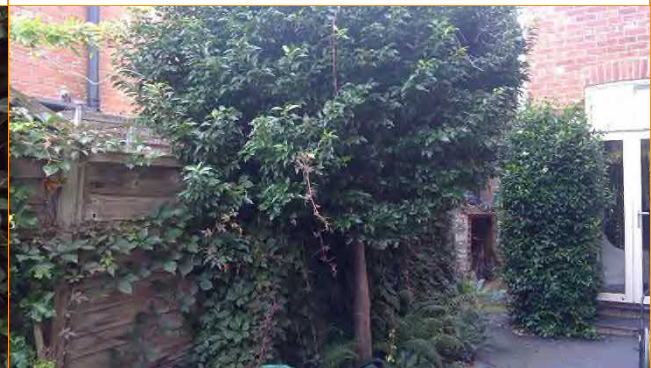
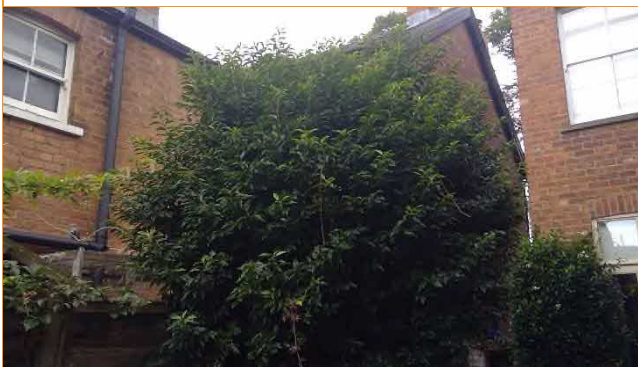
T1 - Laurel (Portuguese)

Tree No:	Species	Works Required	CA	TPO	Ownership
T1	Laurel (Portuguese)	Fell and treat stump with eco plugs (broadleaved)	Yes	No	PH
T2	Hornbeam	Fell and treat stump with eco plugs (broadleaved)	Yes	No	PH

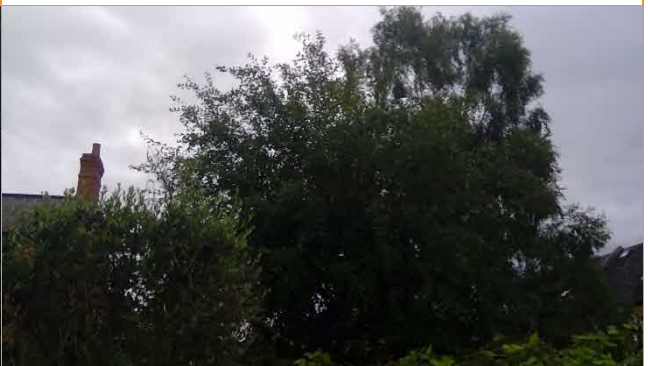
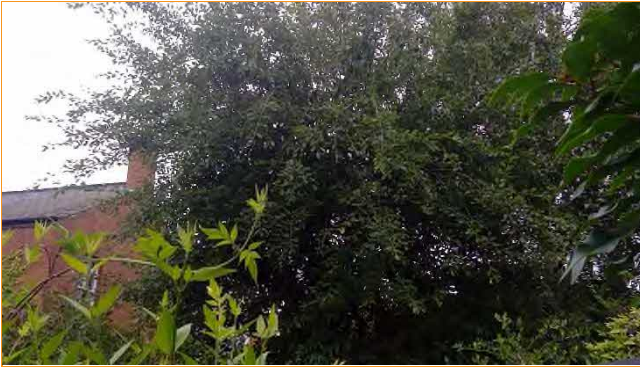
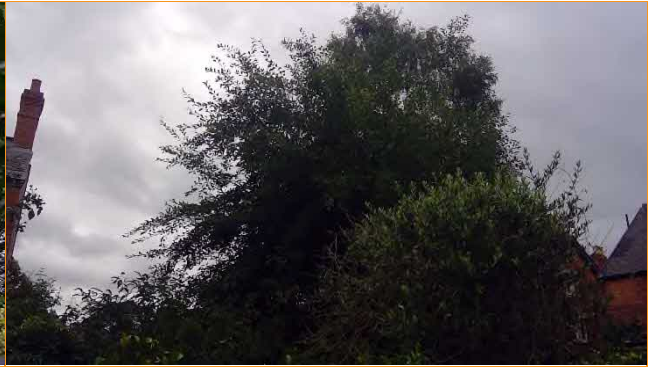
T4 - Willow

T4	Willow	Mature	Fair	9.5*	6*	270*	10.02*	N	Subject to past management. No significant recent management.	No work required.	Access through side/rear gate.		4 Kensington Avenue Cheltenham GL50 2NQ	P3P

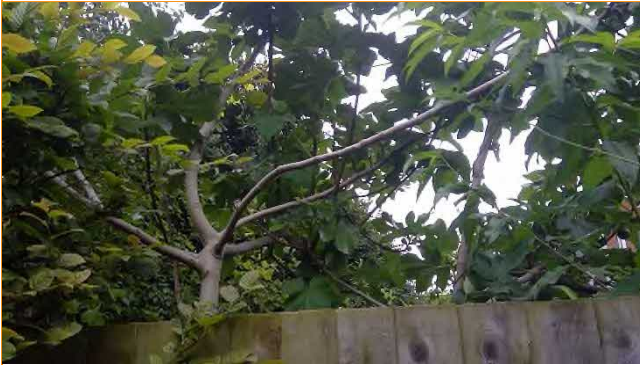
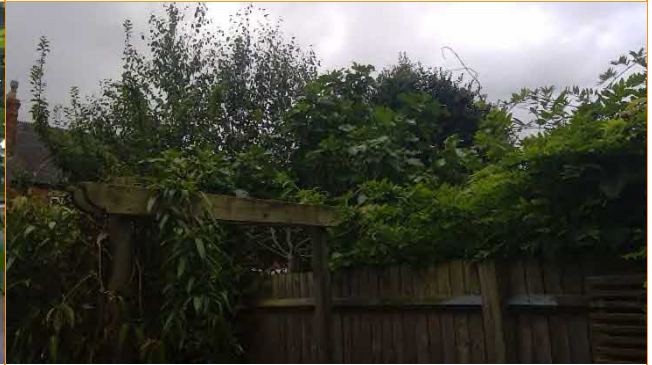
S2 - Fig

Tree No	Common Name	Age Class	Condition	Height (m)	Crown Spread (m)	Stem diam. (mm)	Dist to bldg. (m)	Roots Implicated	Pruning history	Recommendation	Tree work constraints	Notes	Owner address	Owner
S2	Fig	Mature	Fair	4.5*	3.35*	70*	7.02*	N	Subject to past management.	No work required.	Access through side/rear gate.		7 Kensington Avenue Cheltenham GL50 2NQ	P3P
T1	Laurel (Portuguese)	Mature	Good	4.5*	2.25*	120	2.5	N	Subject to past management.	Fell and treat stump with eco plugs (broadleaved).	Access through side/rear gate.		6 Kensington Avenue Cheltenham GL50 2NQ	PH
T2	Hornbeam	Mature	Fair	2.7	1.35	100	0.86	Y	Tree managed into hedge in an espalier fashion.	Fell and treat stump with eco plugs (broadleaved).	Access through side/rear gate.		6 Kensington Avenue Cheltenham GL50 2NQ	PH
T3	Olive	Mature	Fair	3.3*	1.8*	35*	3.51*	N	Subject to past management.	No work required.	Access through side/rear gate.		5 Kensington Avenue Cheltenham GL50 2NQ	P3P

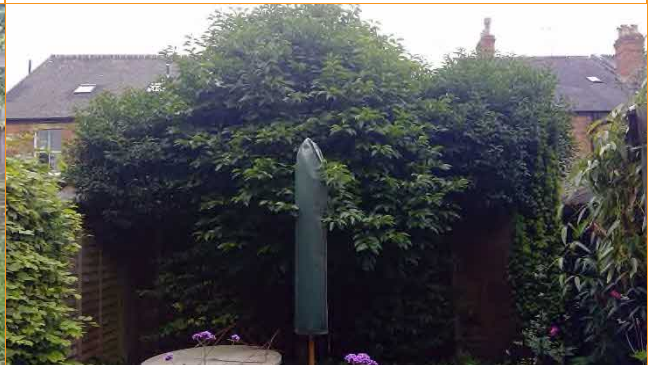
TG1 - Mixed species group

Tree No	Common Name	Age Class	Condition	Height (m)	Crown Spread (m)	Stem diam. (mm)	Dist to bldg. (m)	Roots Implicated	Pruning history	Recommendation	Tree work constraints	Notes	Owner address	Owner
TG1	Mixed species group	Mature	Fair	4.5	3.0	90*	9.3	N	Subject to past management. No significant recent management.	No work required.	Access through side/rear gate.	Group consists of Portuguese Laurel, Hornbeam and Yew. With a DBH range of 50mm - 150mm.	6 Kensington Avenue Cheltenham GL50 2NQ	PH
