The Head Of The River
Folly Bridge
St Aldates
Oxford
OX1 4LB

Safety Survey

Prepared for Fuller's

July 2023

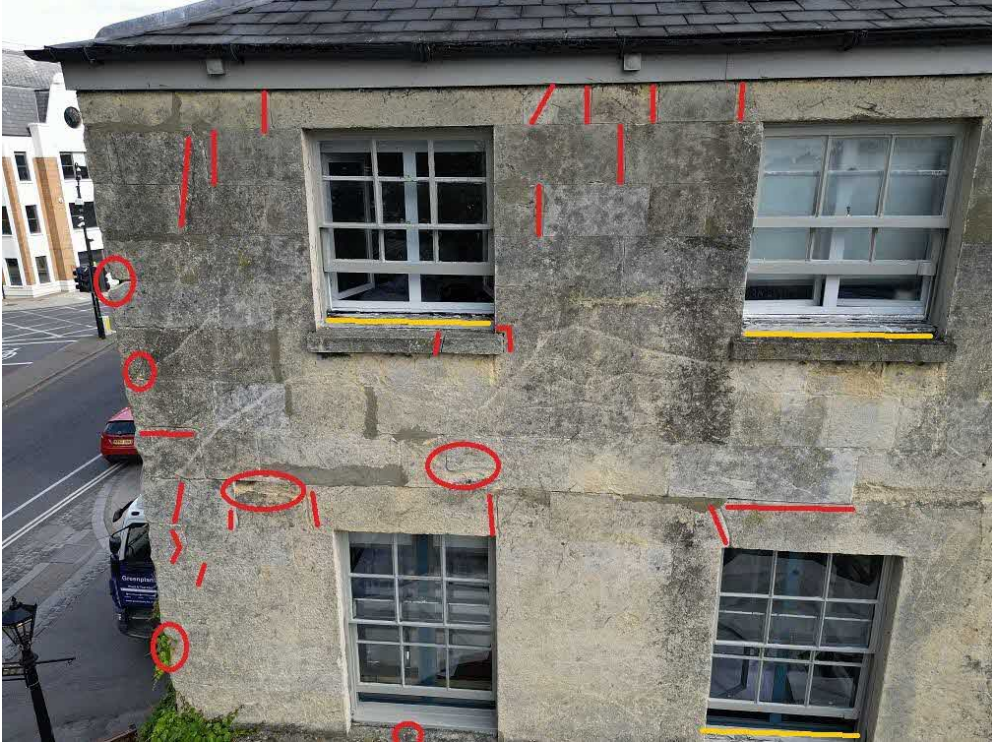
<p>The photograph shows a two-story stone building facade with four windows. Red dashed lines and circles are drawn over the image to highlight specific defects. The annotations include: vertical lines along the mortar joints between stones; horizontal lines along the window sills; and several red circles highlighting areas of mortar loss, spalling, and open joints, particularly around the window frames and on the lower level of the facade.</p>	<p>Open joints, minor spalls and sills to be replaced</p>

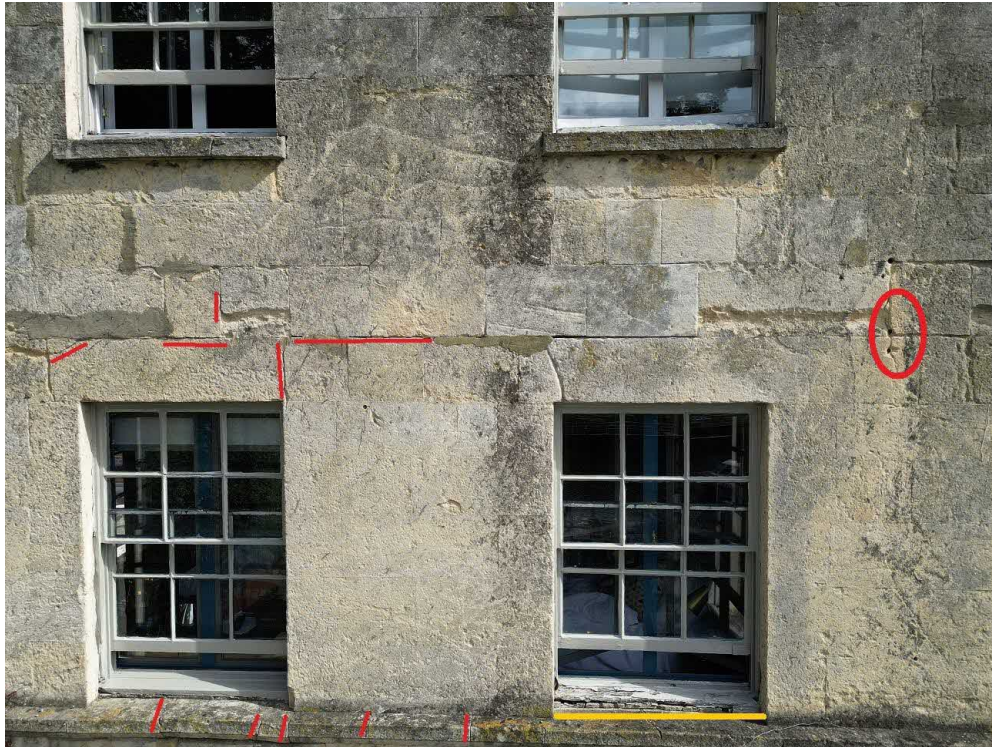
4

Open joints and
one sill to be
replaced

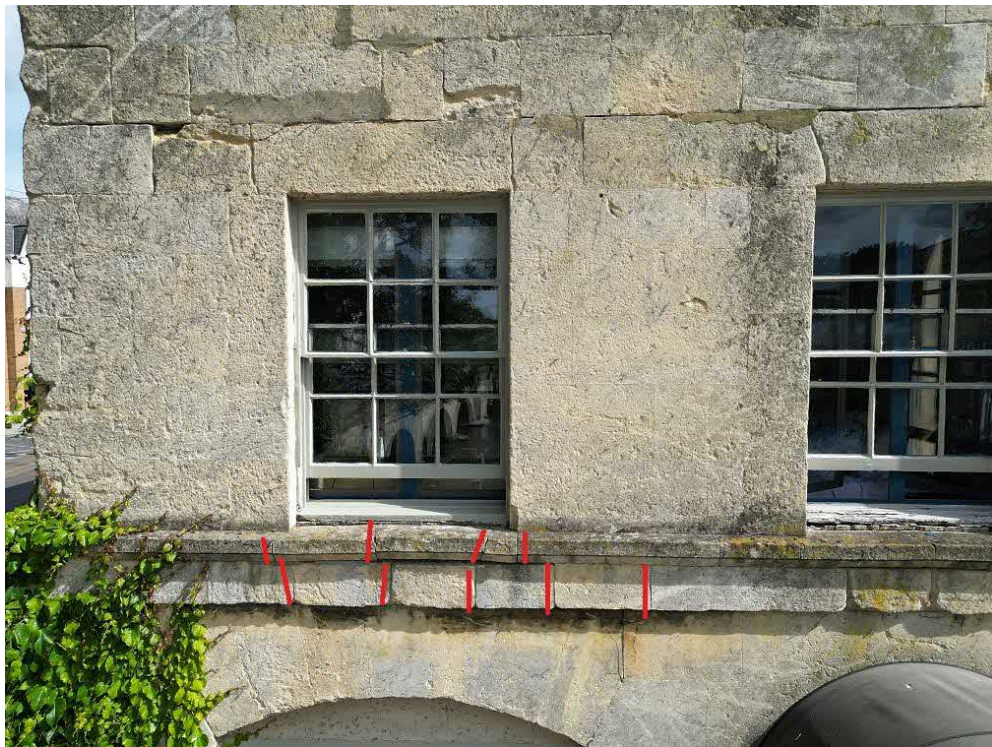
4

Open joints to
string course

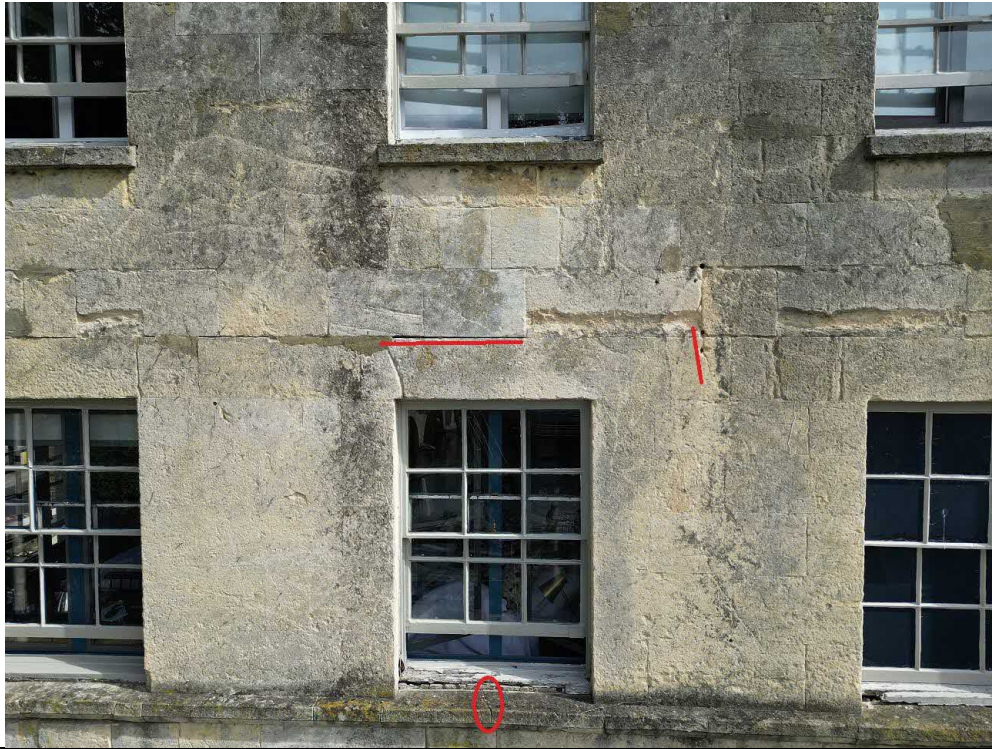
7

Open joints

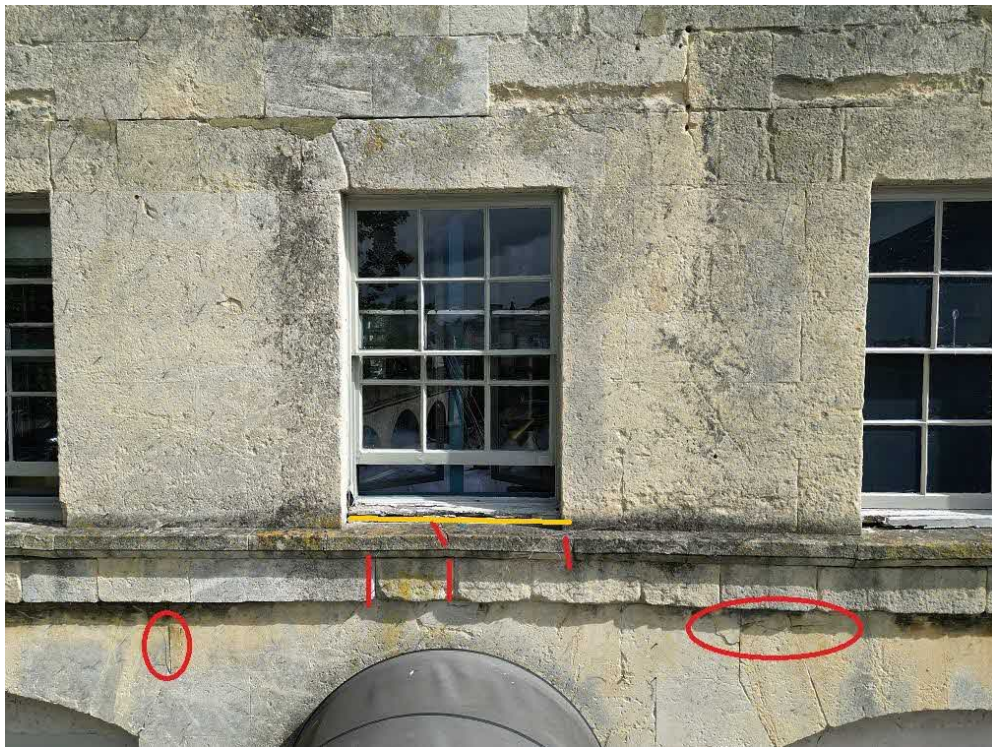
7

Open joints and
sill to be
replaced

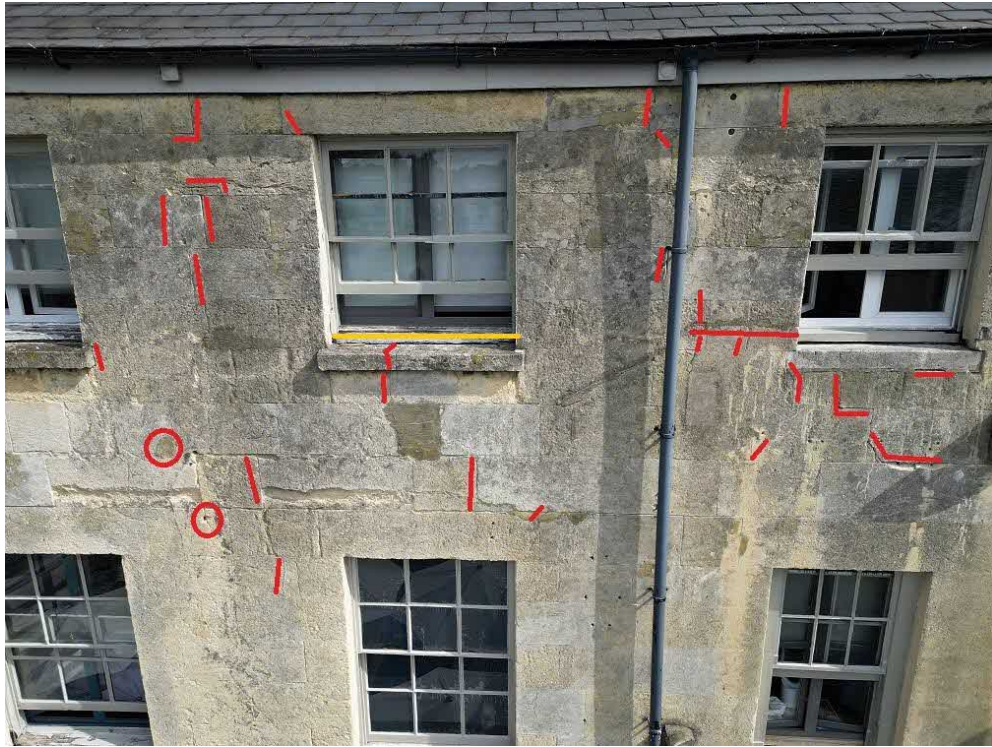
9

Open joints and sill to be replaced

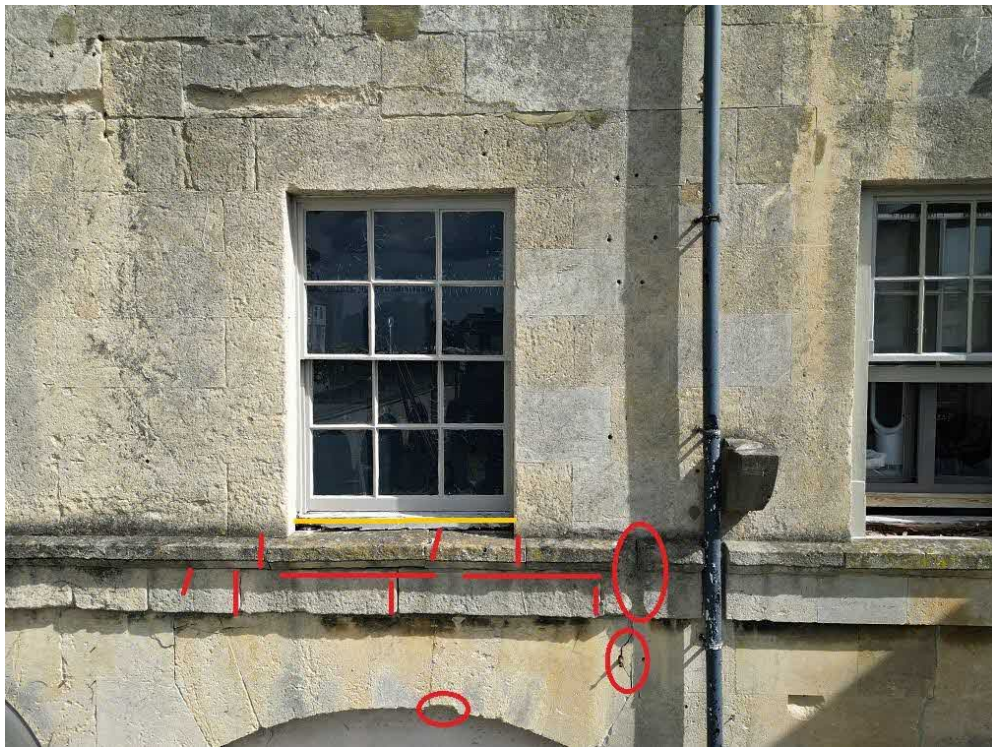
10

Open joints and sill to be replaced

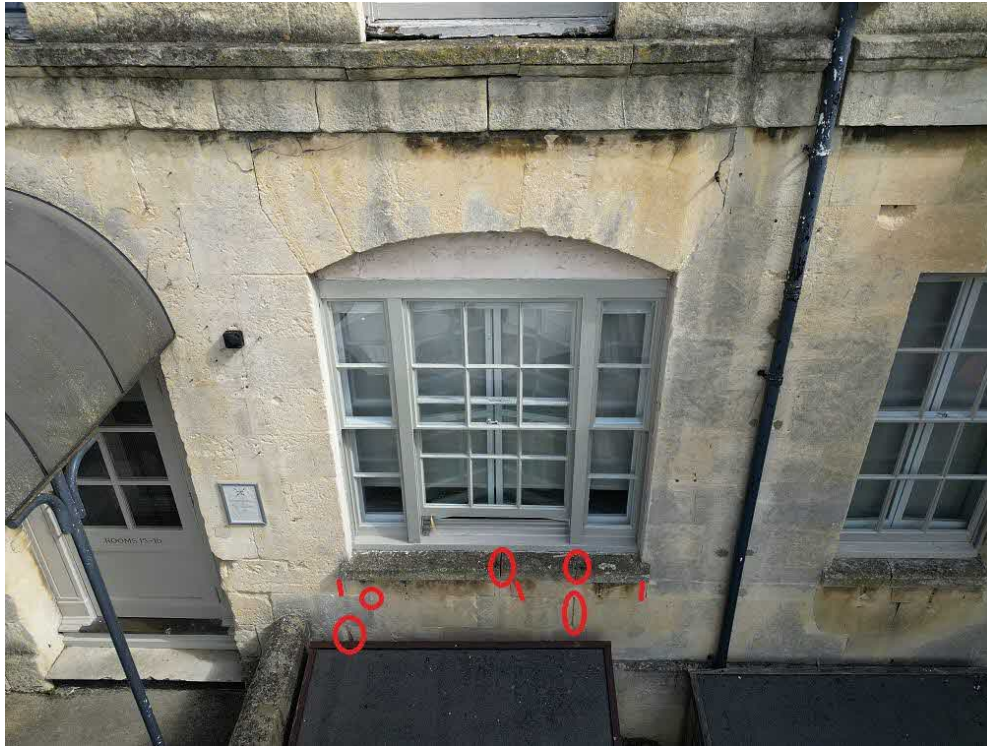
11

Open joints

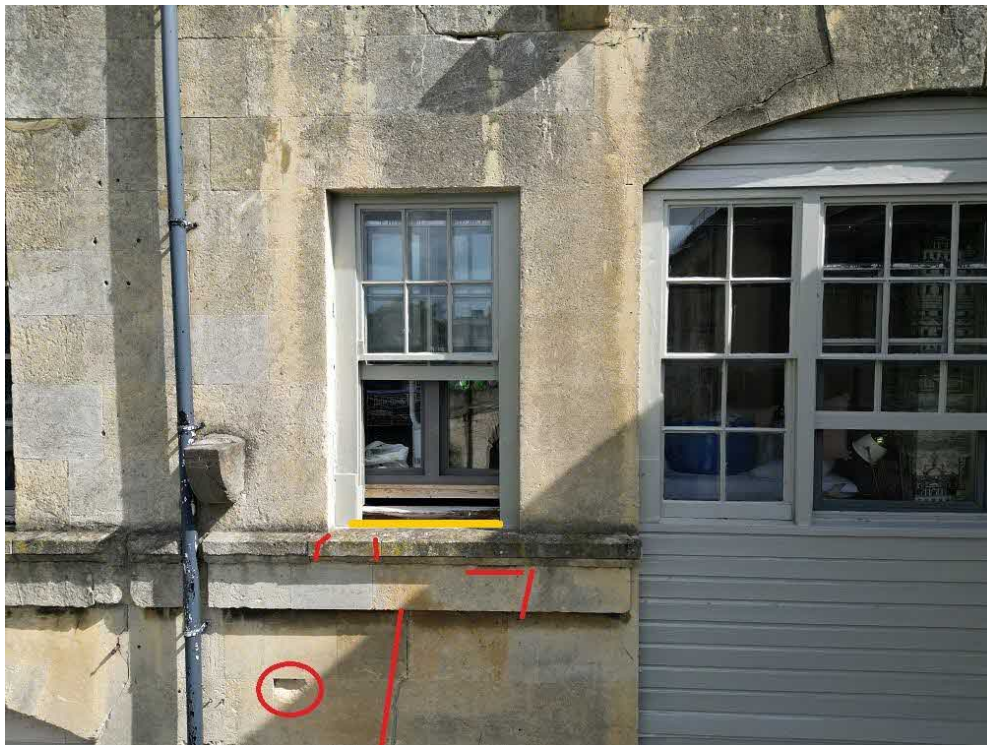
13

Open joints and sill to be replaced

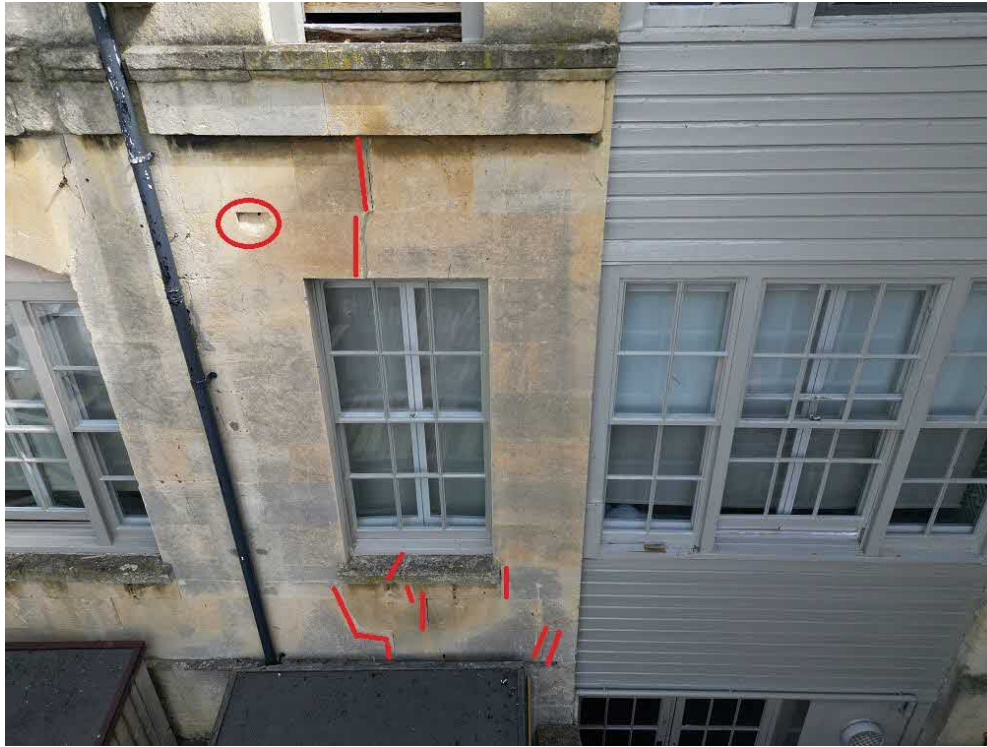
14

Open joints and spall to be indented

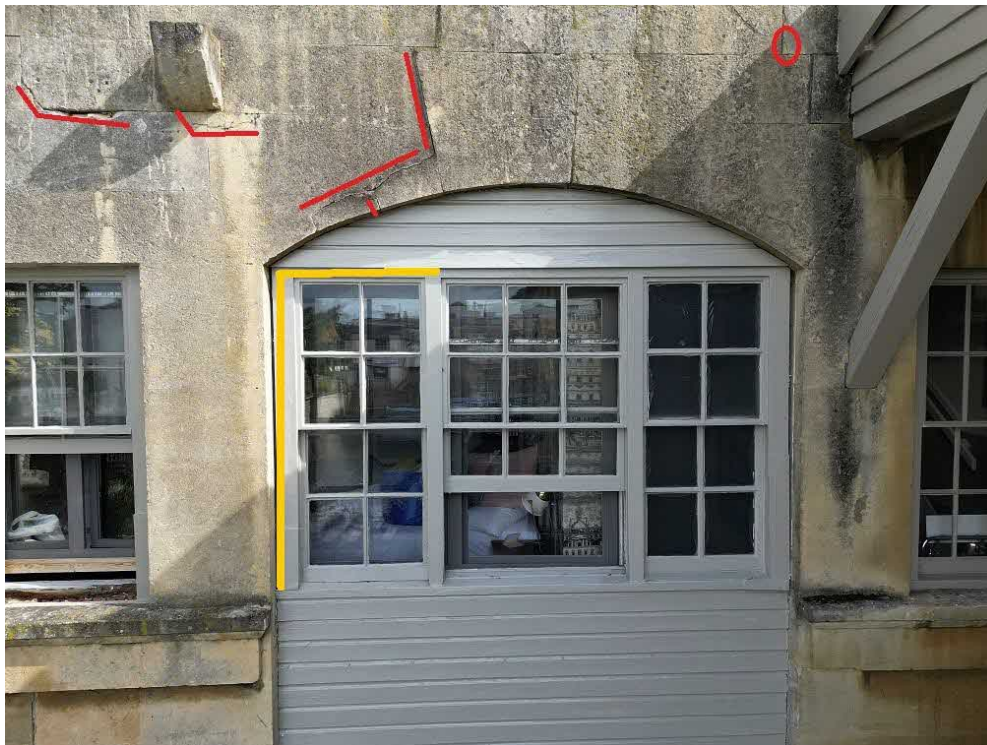
15

Open joints, spall to be indented and timber to be replaced

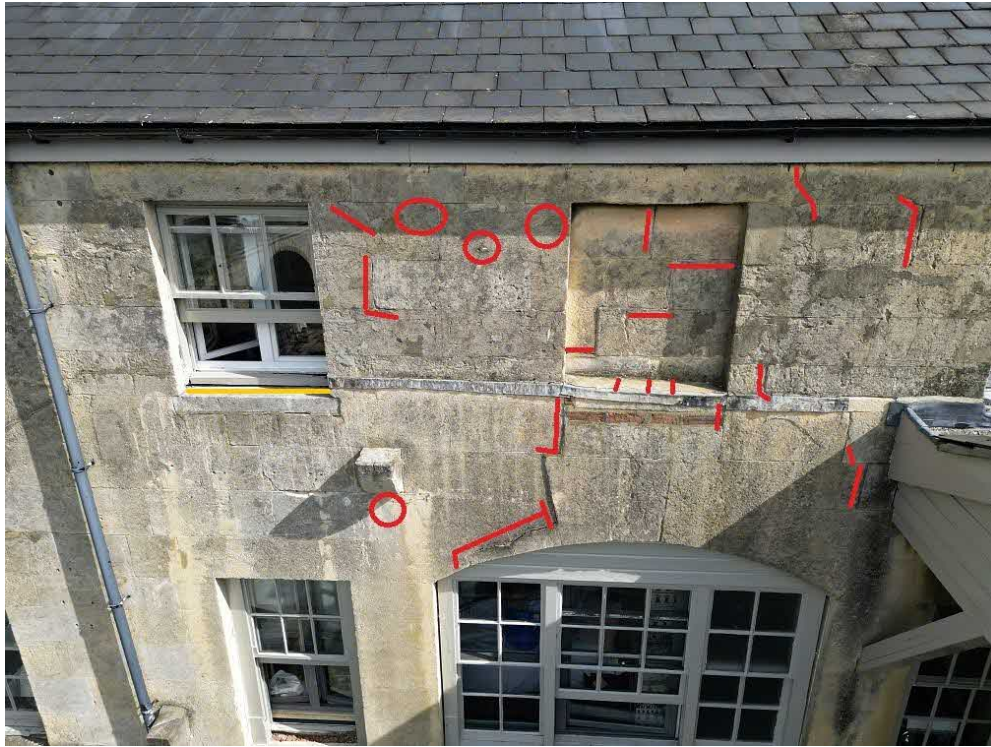
15

Open joints and sill to be replaced

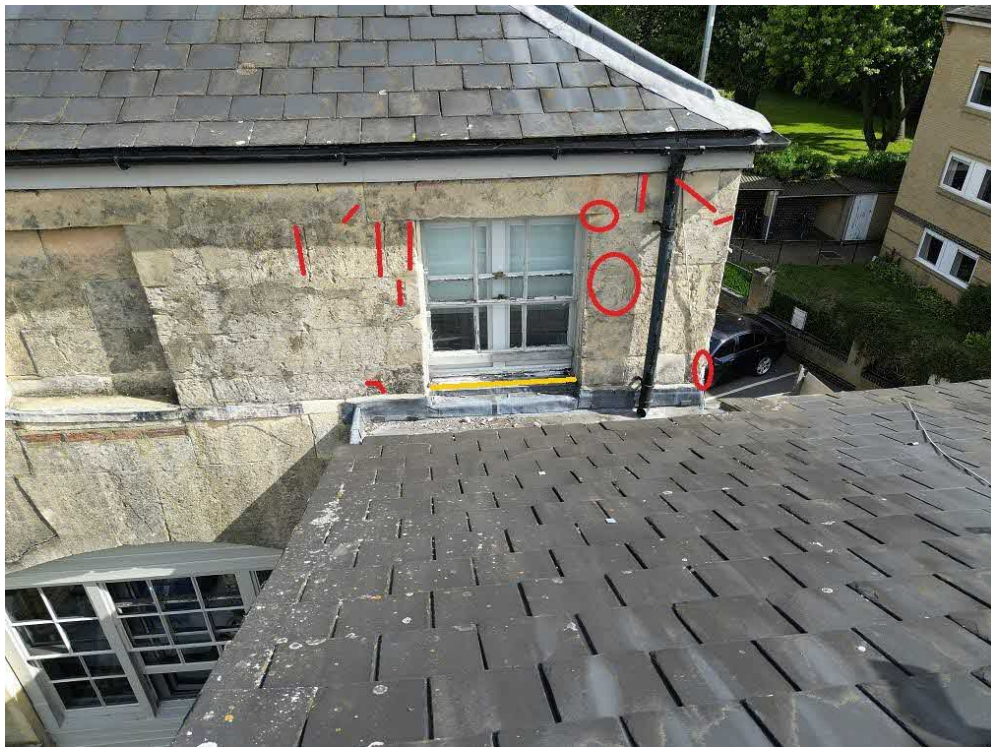
16

Open joints and sill to be replaced

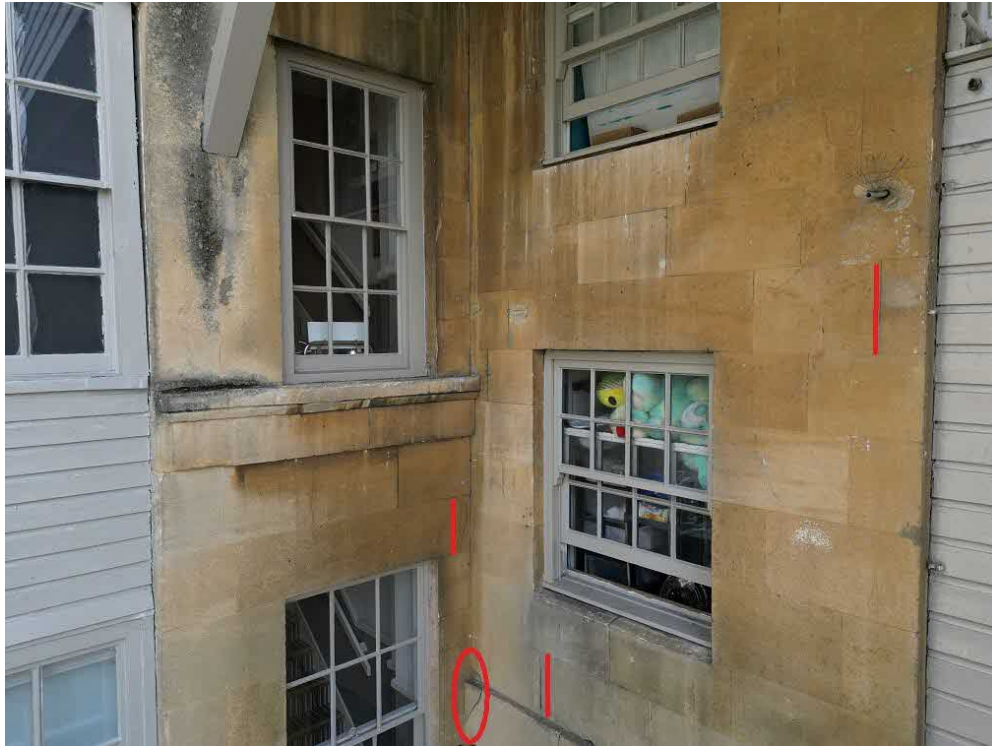
17

Open joints

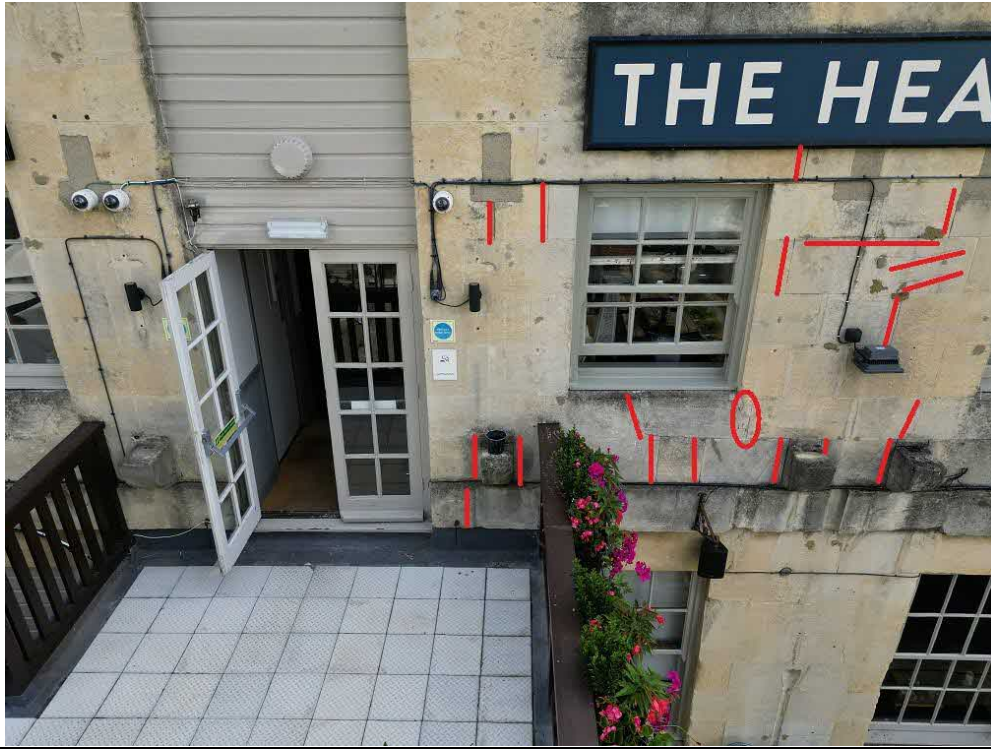
28

Open joints

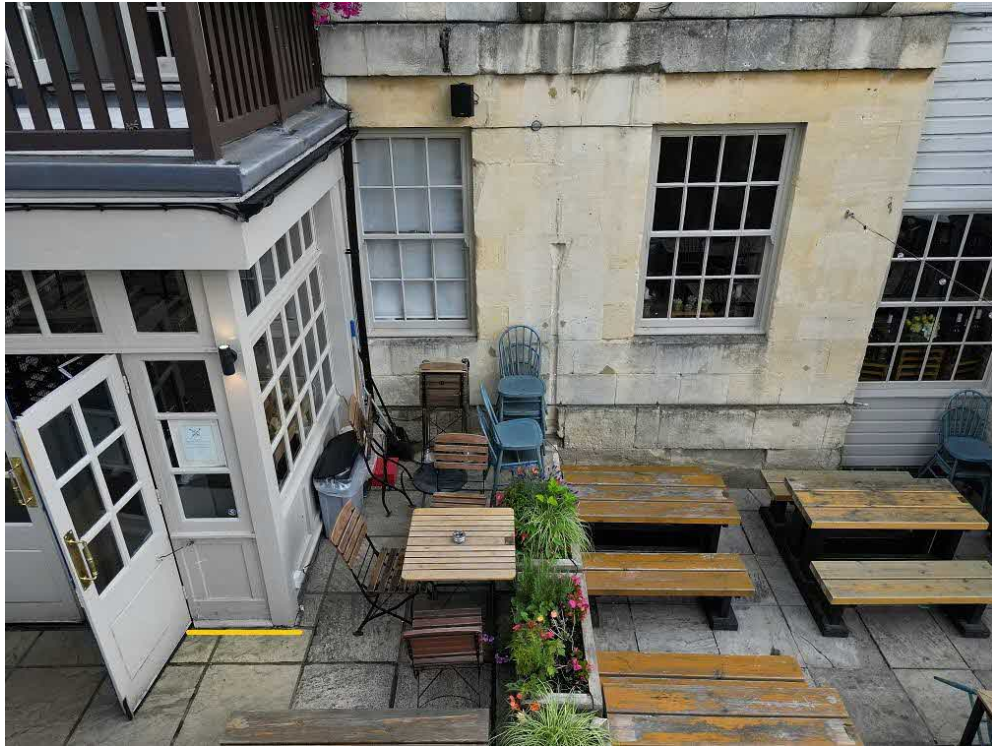
29

Timber to be replaced

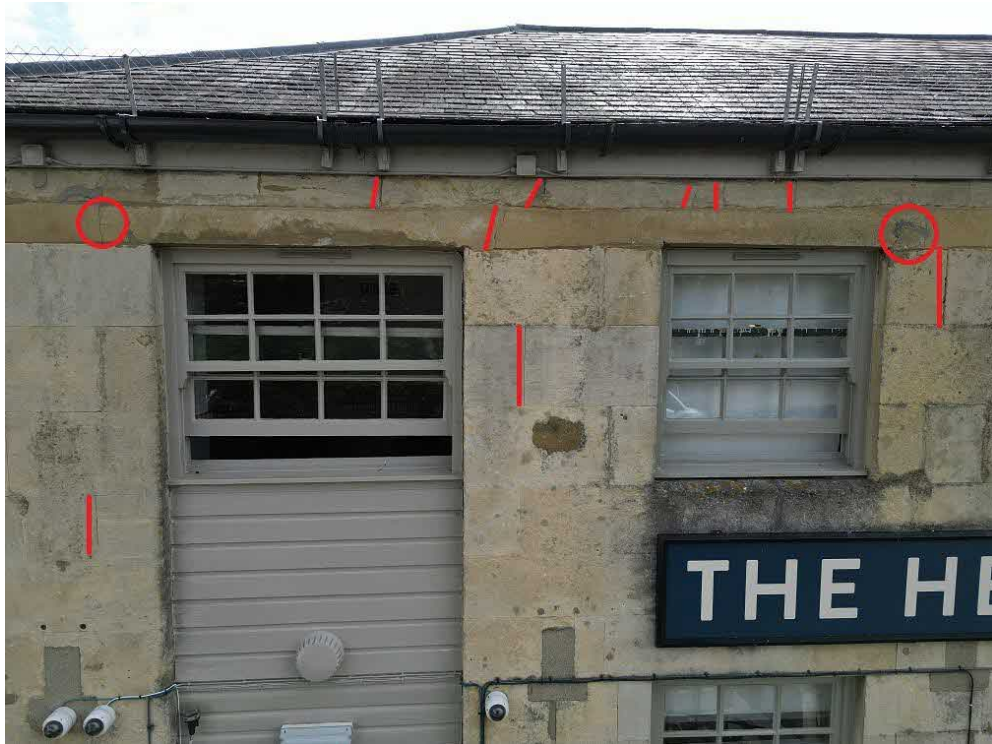
30

Open joints

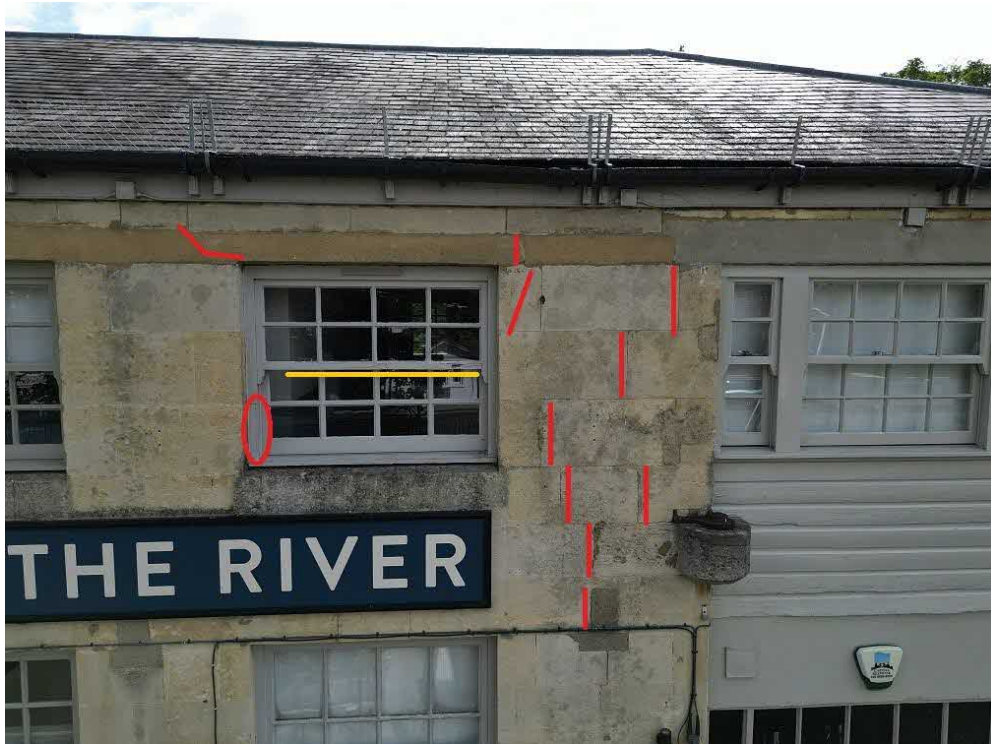
38

Open joints and
timber rail to
be replaced

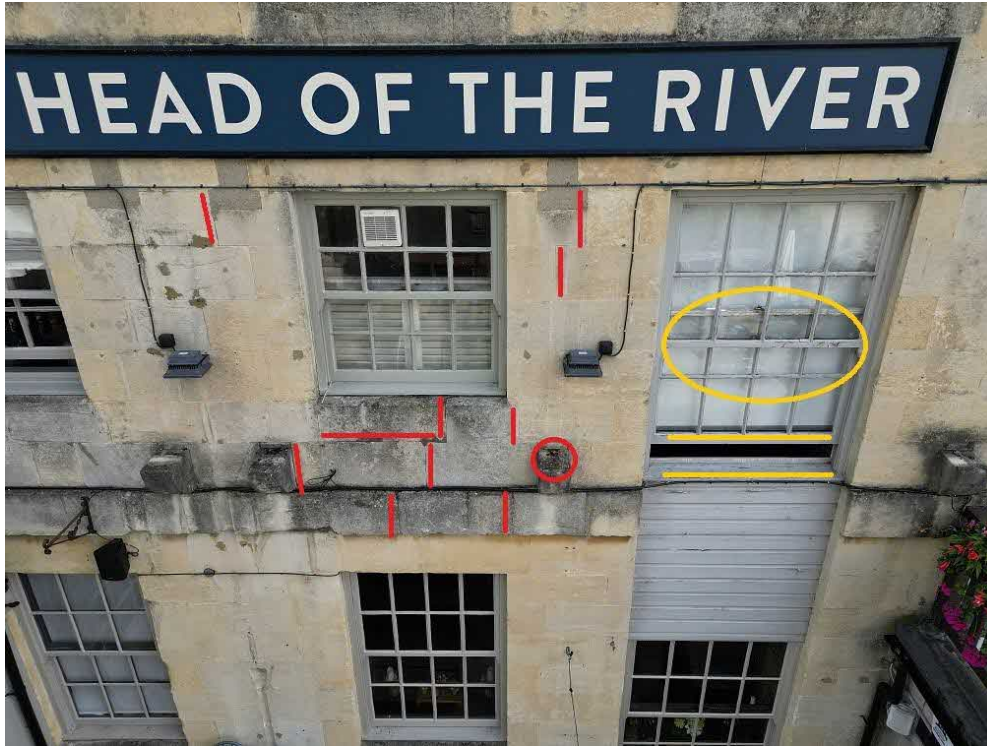
39

Open joints and
timber rail to
be replaced

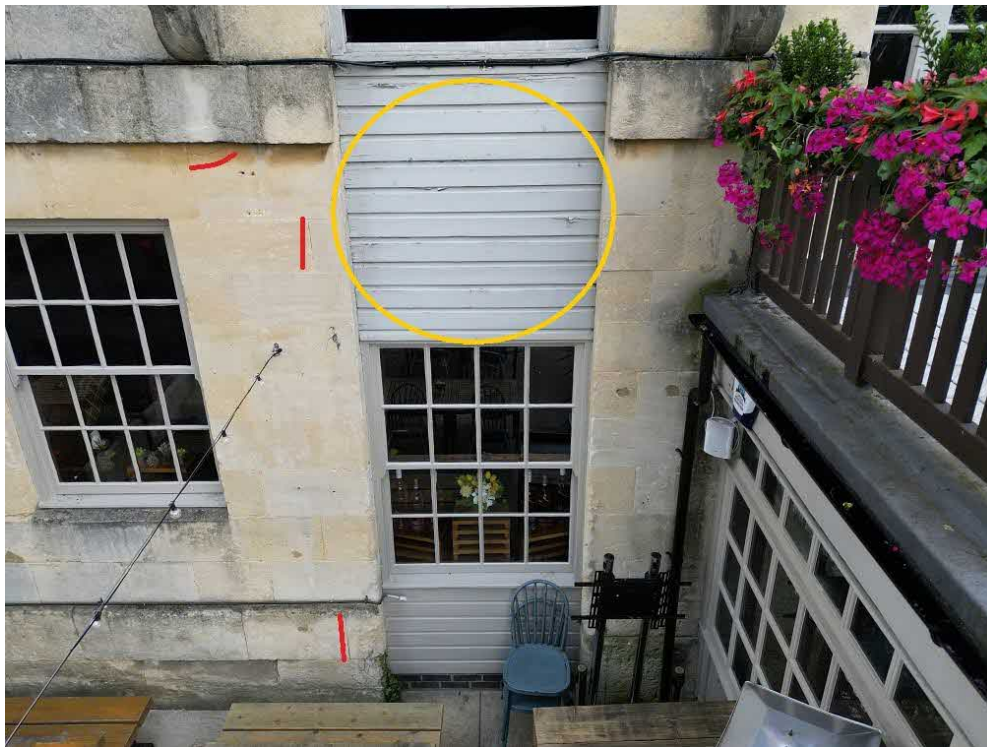
40

Open joints and
timber panels
to be replaced

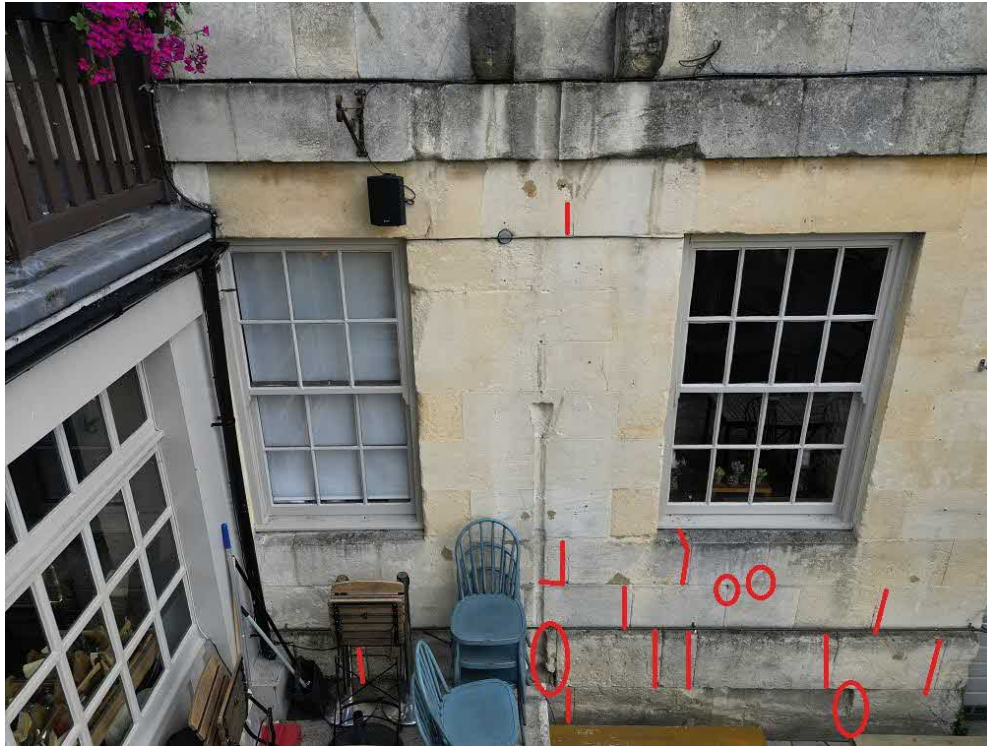
40

Open joints

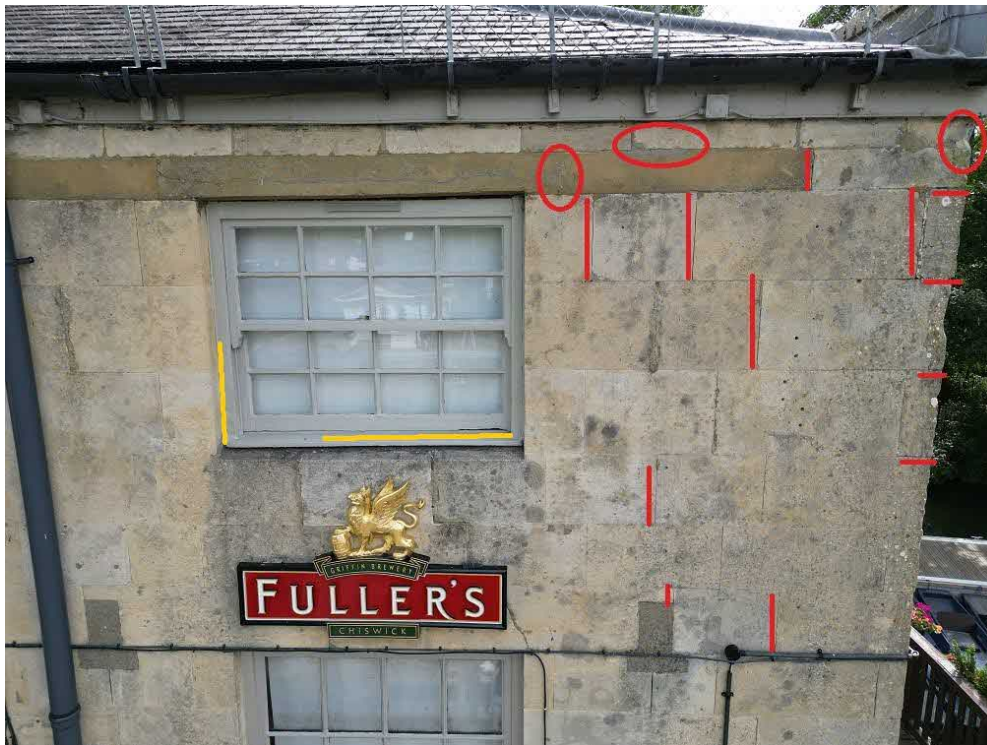
44

Open joints
Timber to be replaced

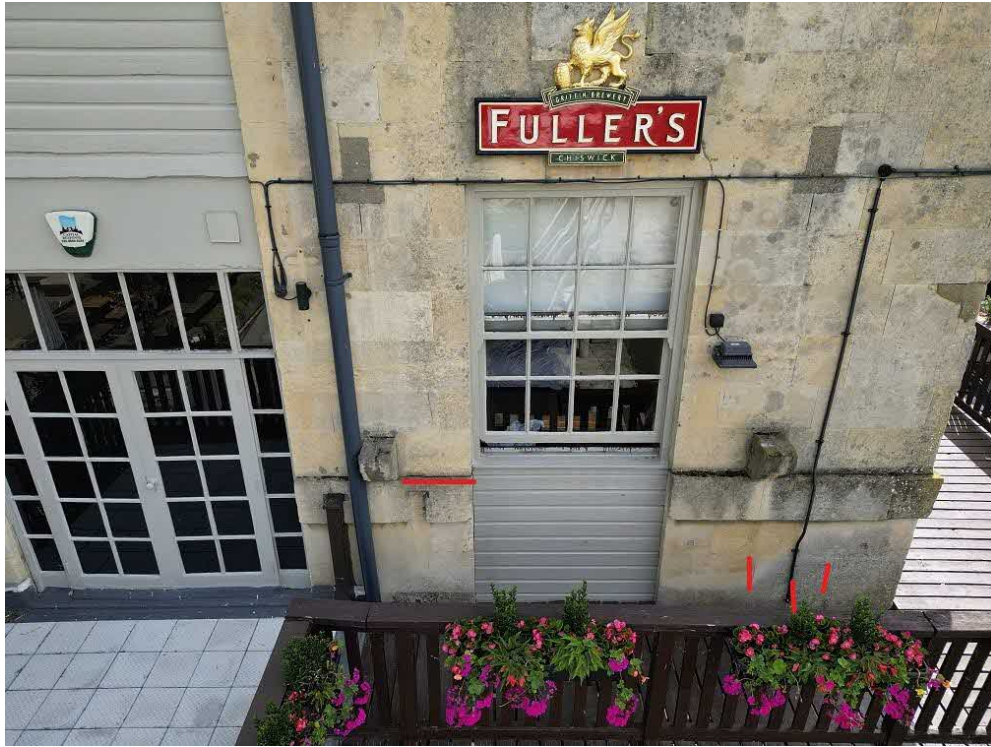
45

Open joints

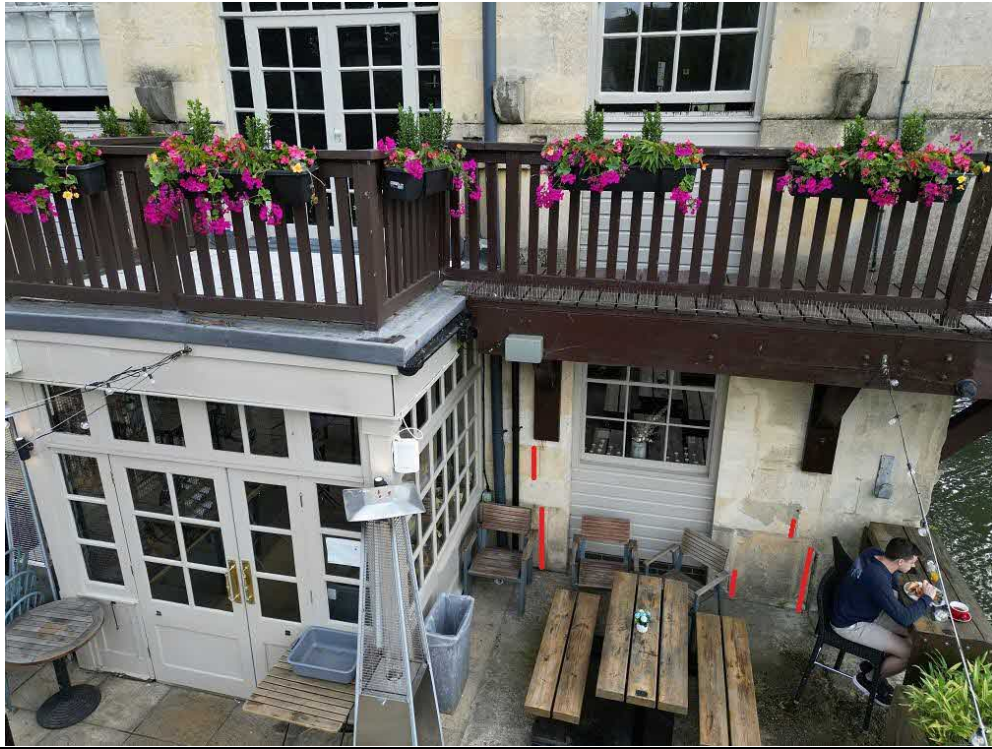
47

Open joints

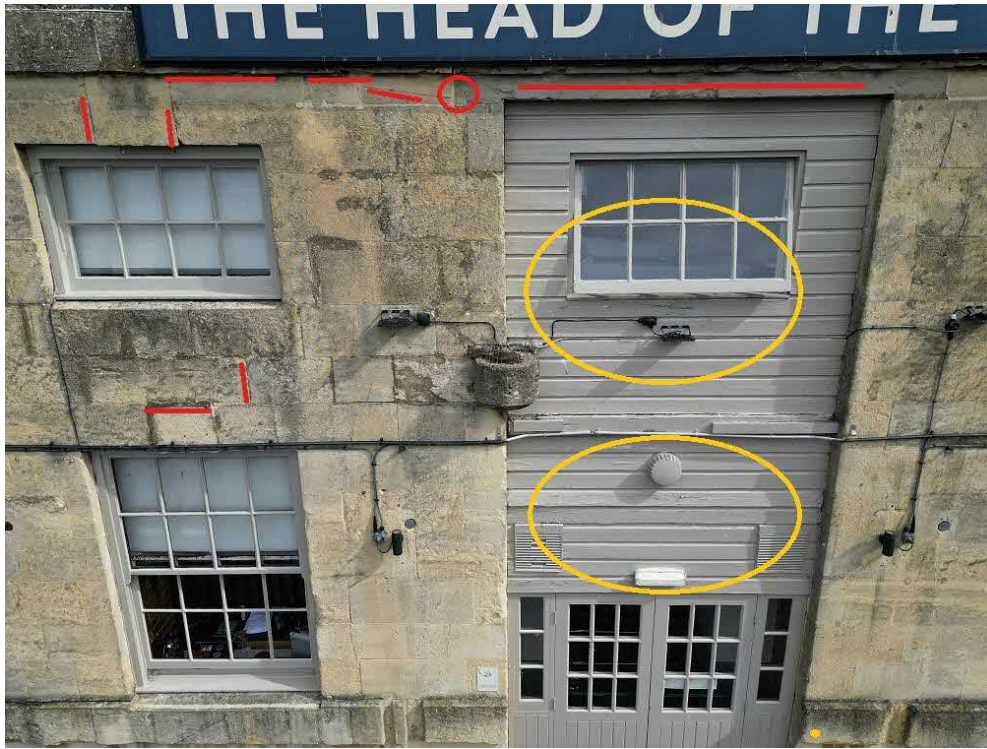
48

Open joints,
Timber panels
to be replaced

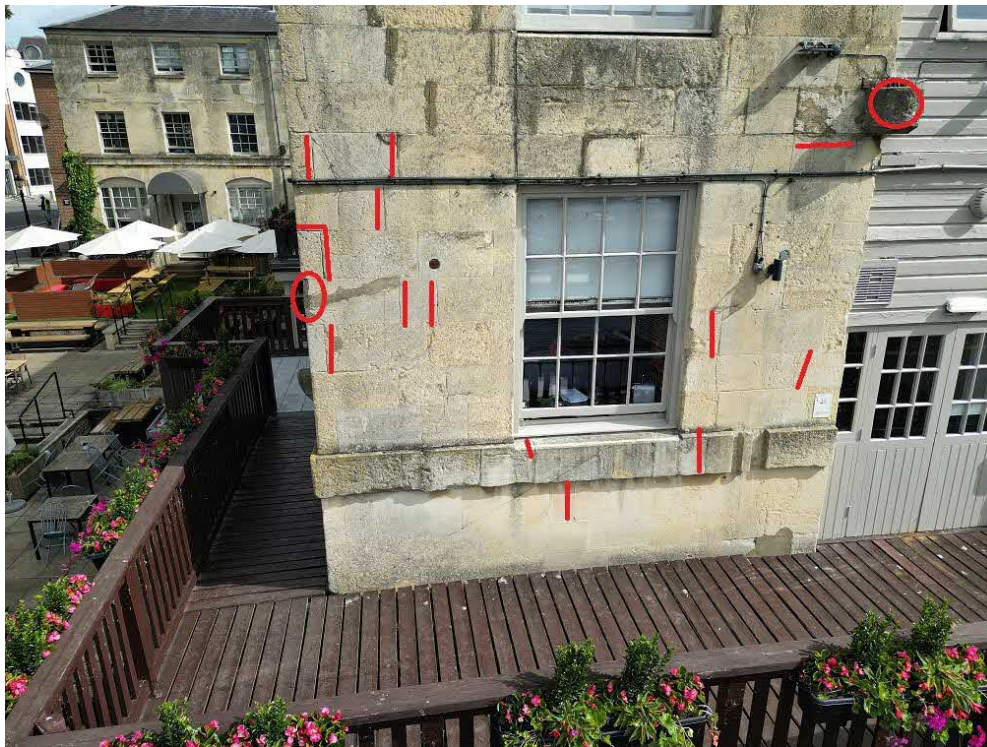
49

Open joints

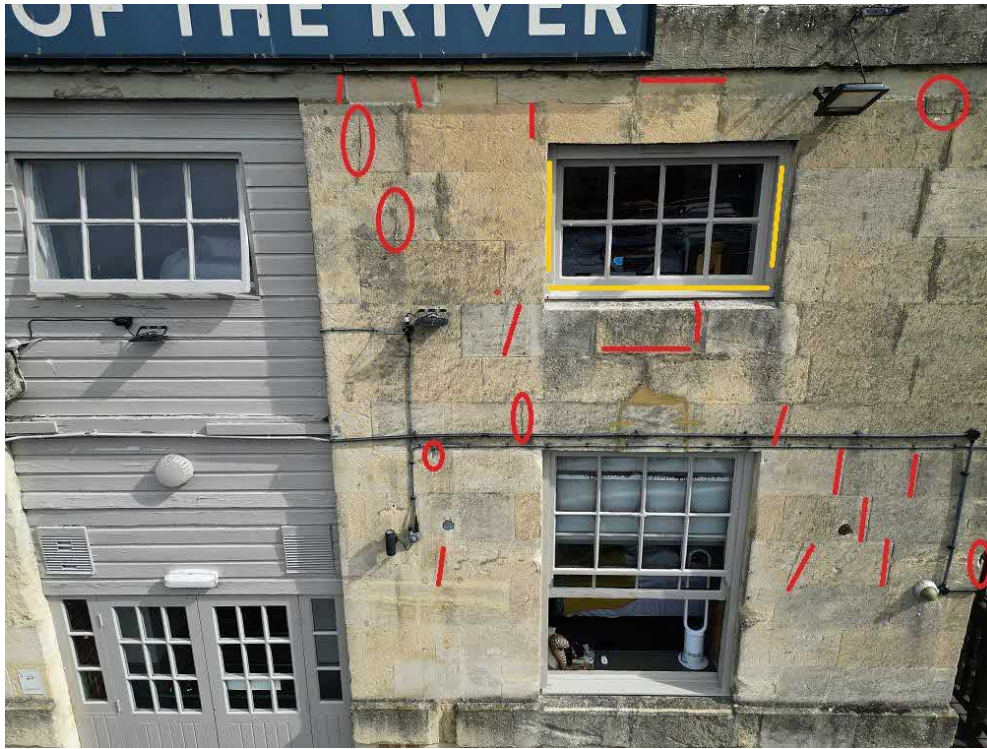
54

Open joints,
Timber to be
replaced

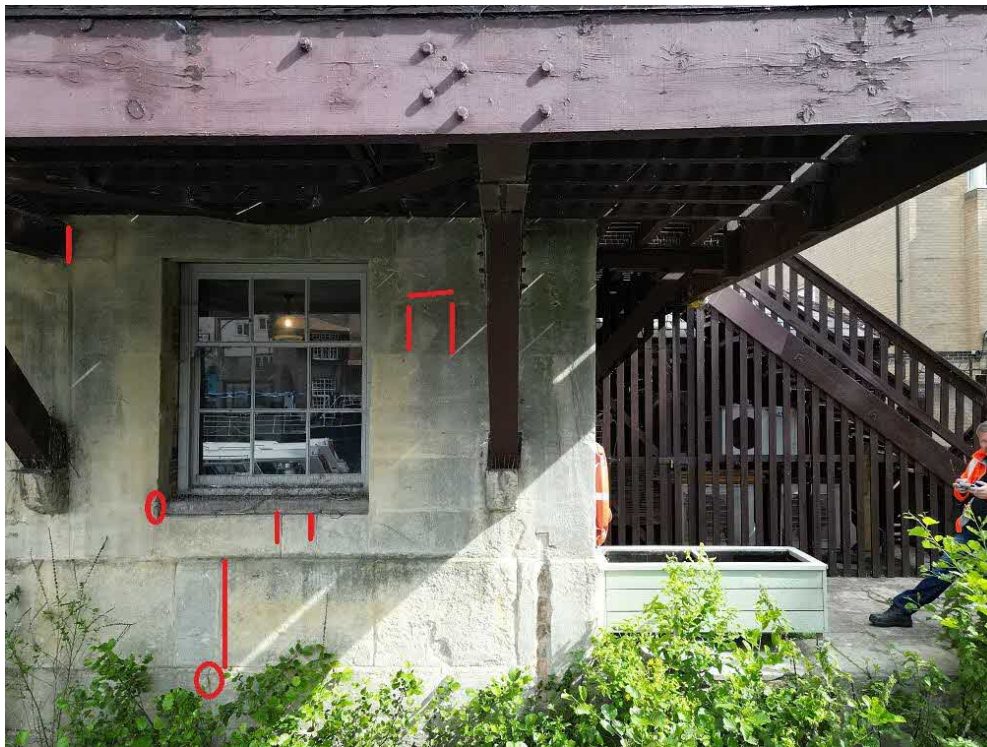
56

Open joints

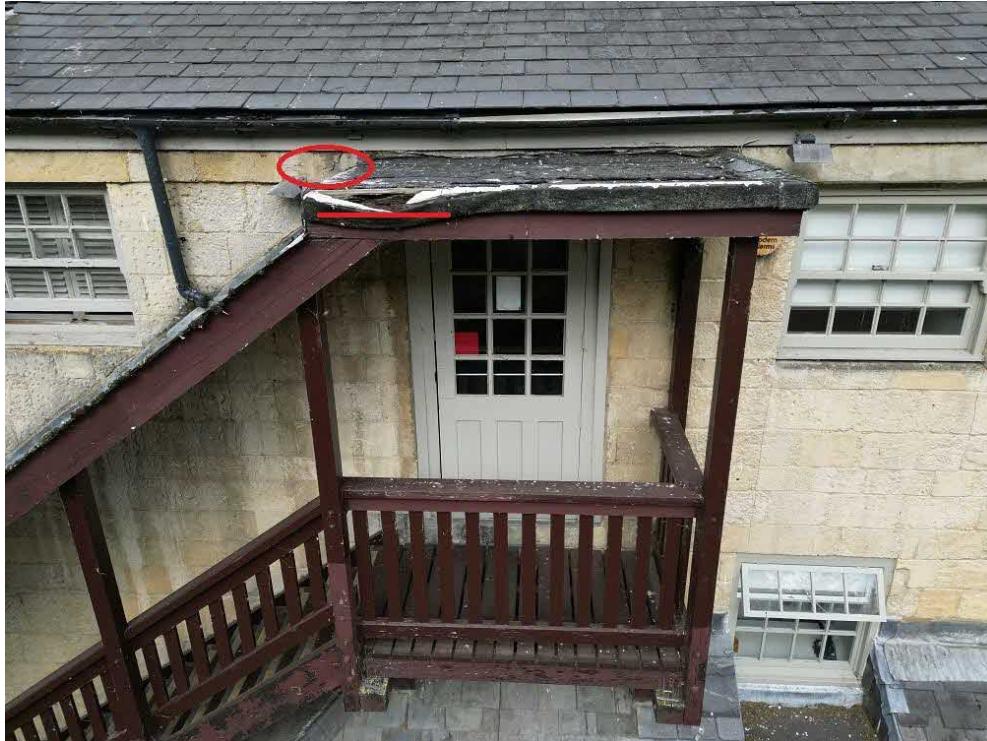
3

Fracture

Roof to staircase to be replaced

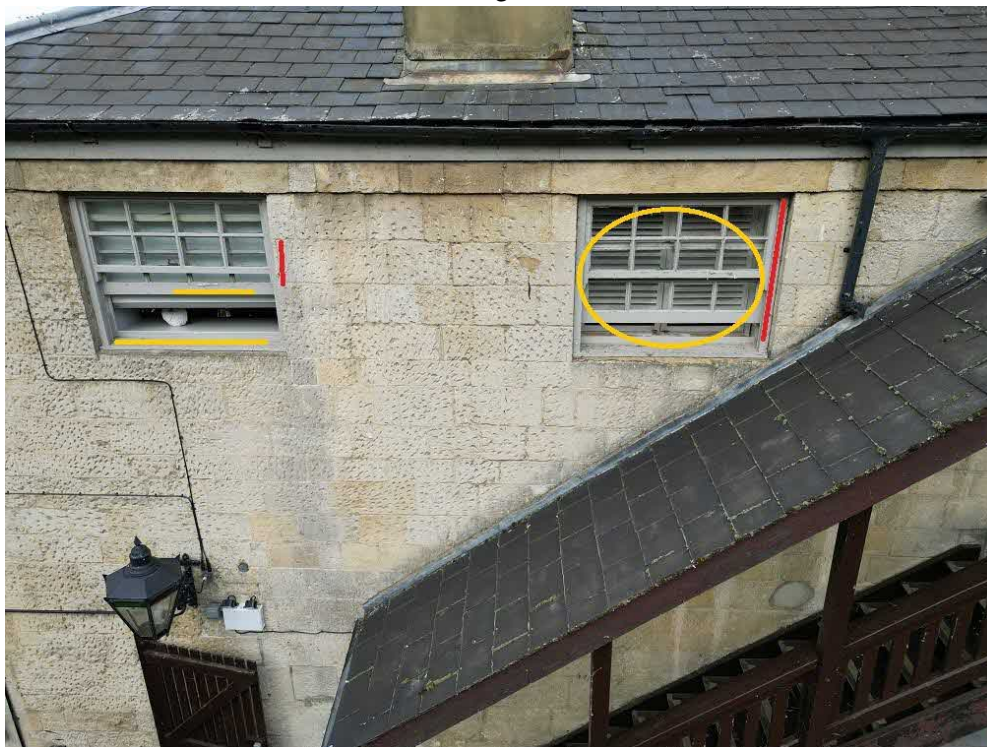
3

Open joints

Timber to be replaced

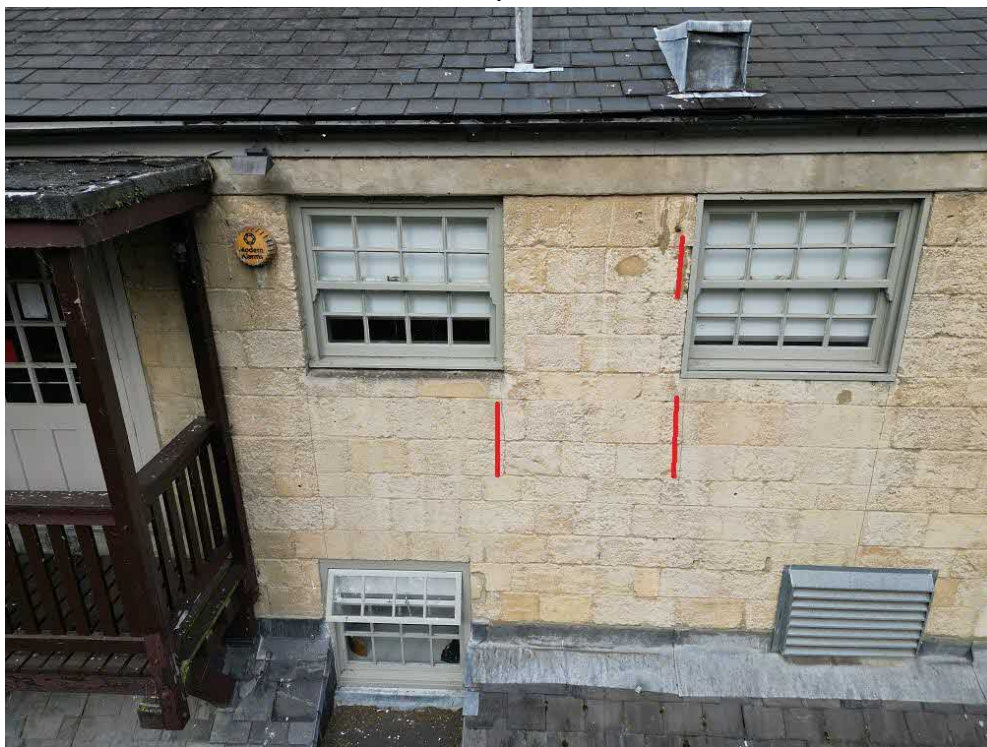
7

Open joints
