The Head Of The River
Folly Bridge
St Aldates
Oxford
OX1 4LB

Safety Survey

Prepared for Fuller's

July 2023

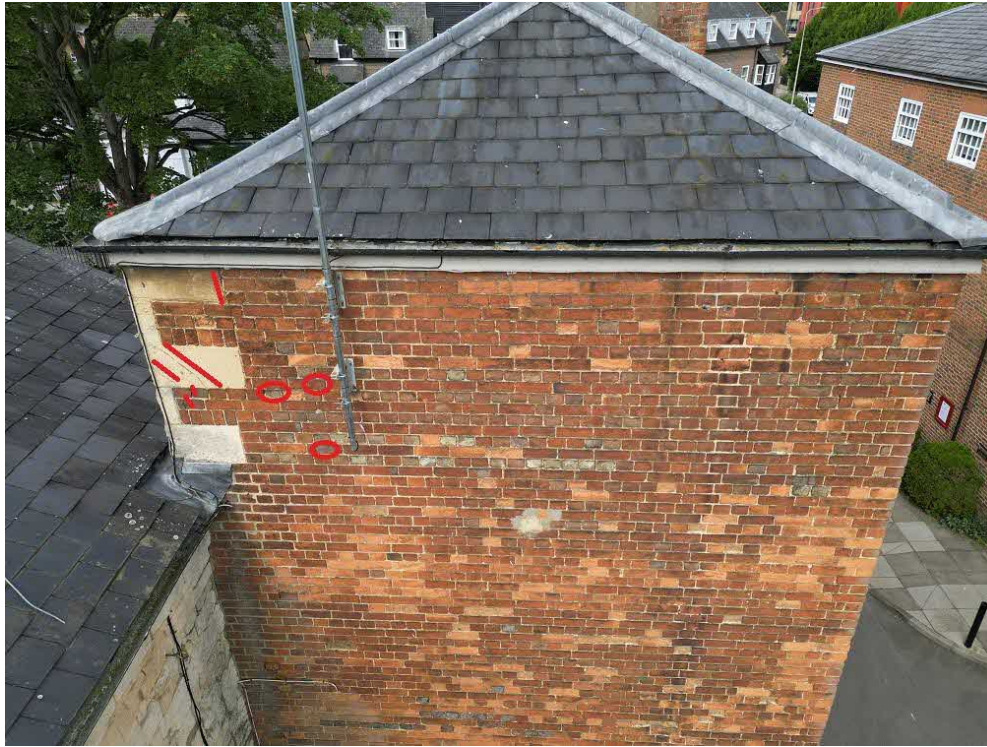
0

Open joints and
minor fractures

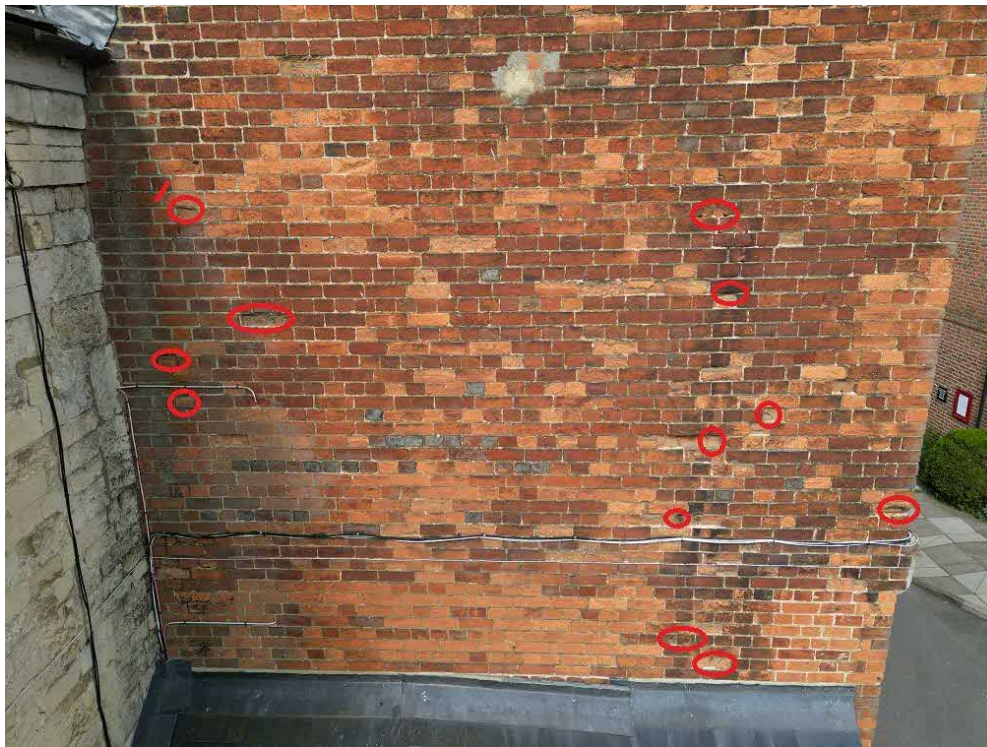
0

Spalled
brickwork

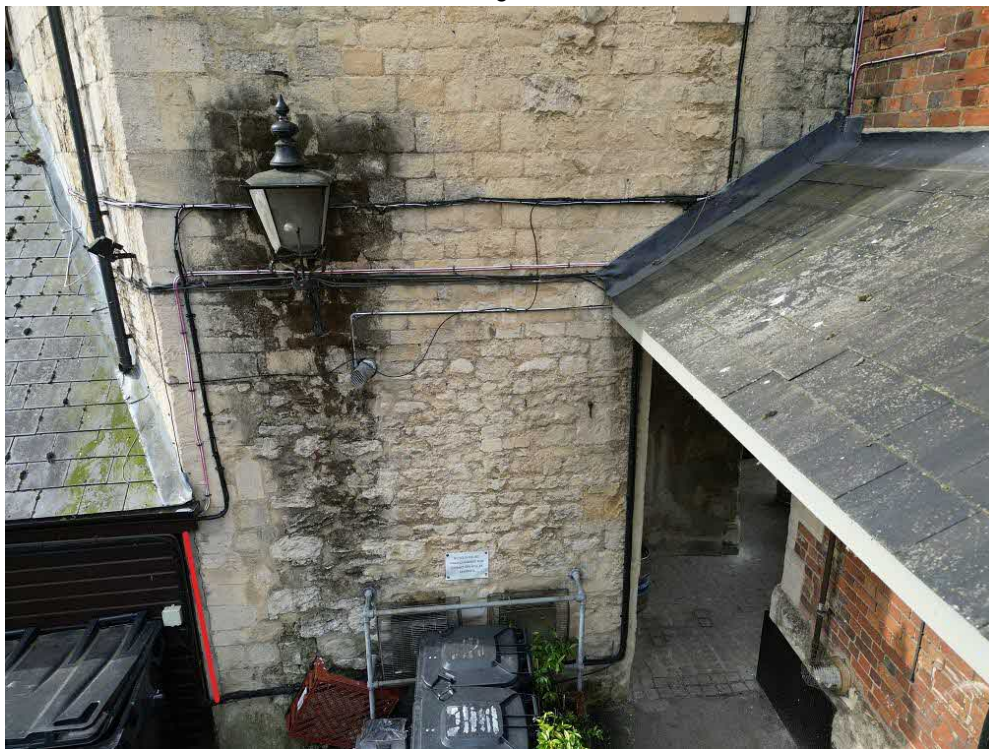
0

Fractured corner

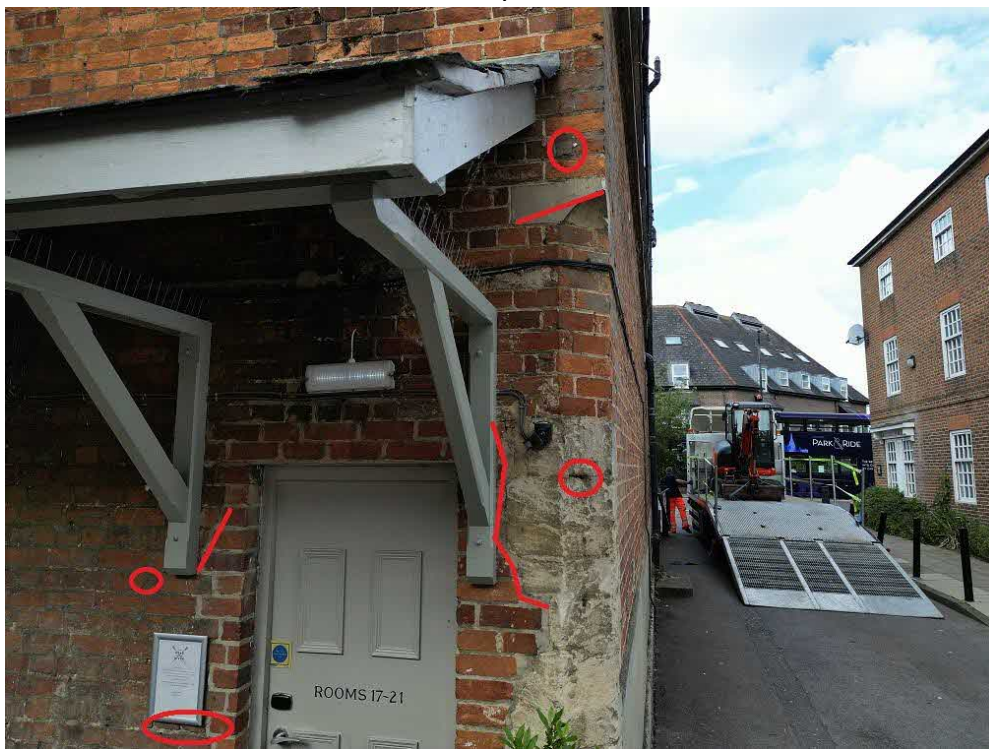
4

Fractures
Open joints

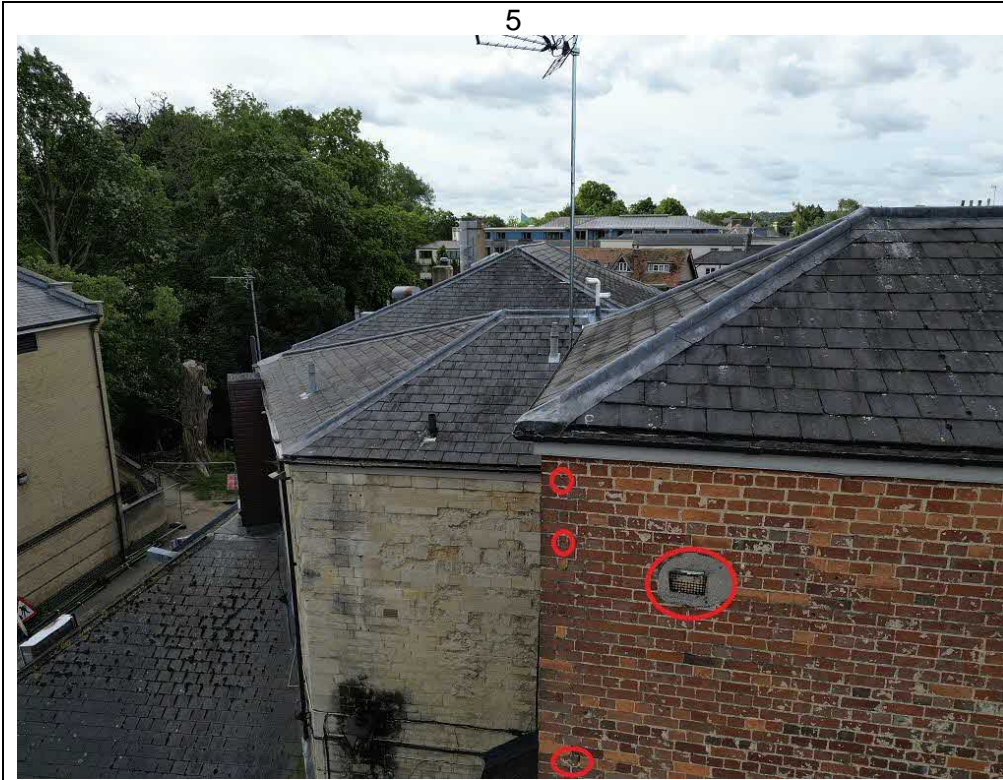
Spalling
brickwork

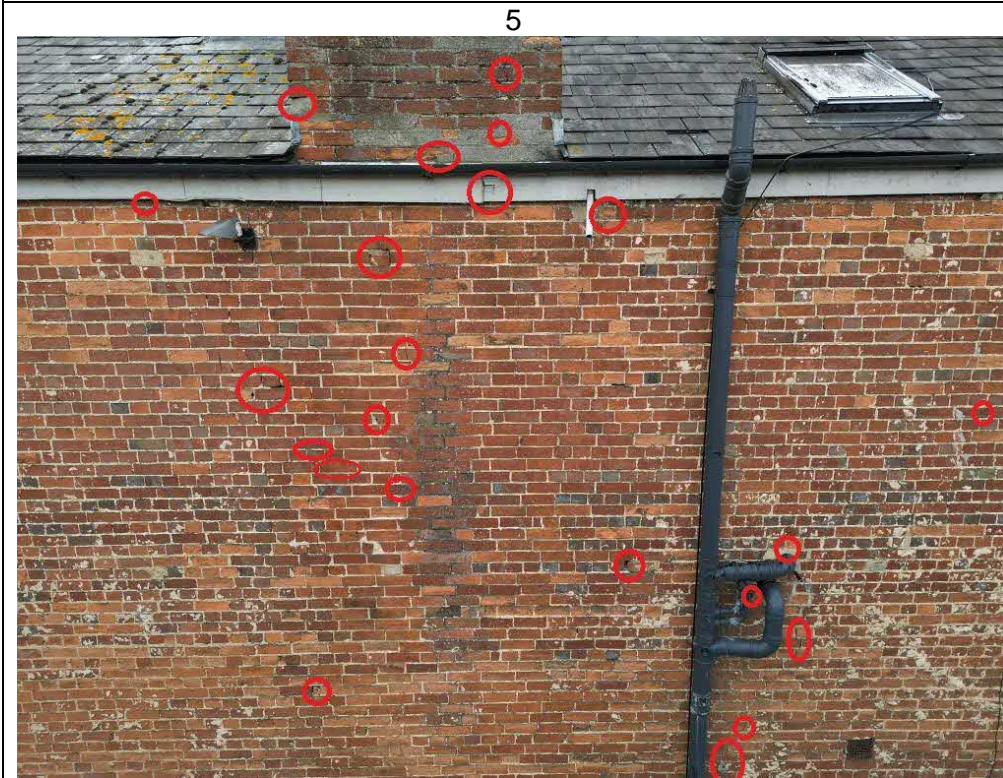
Spalling
brickwork

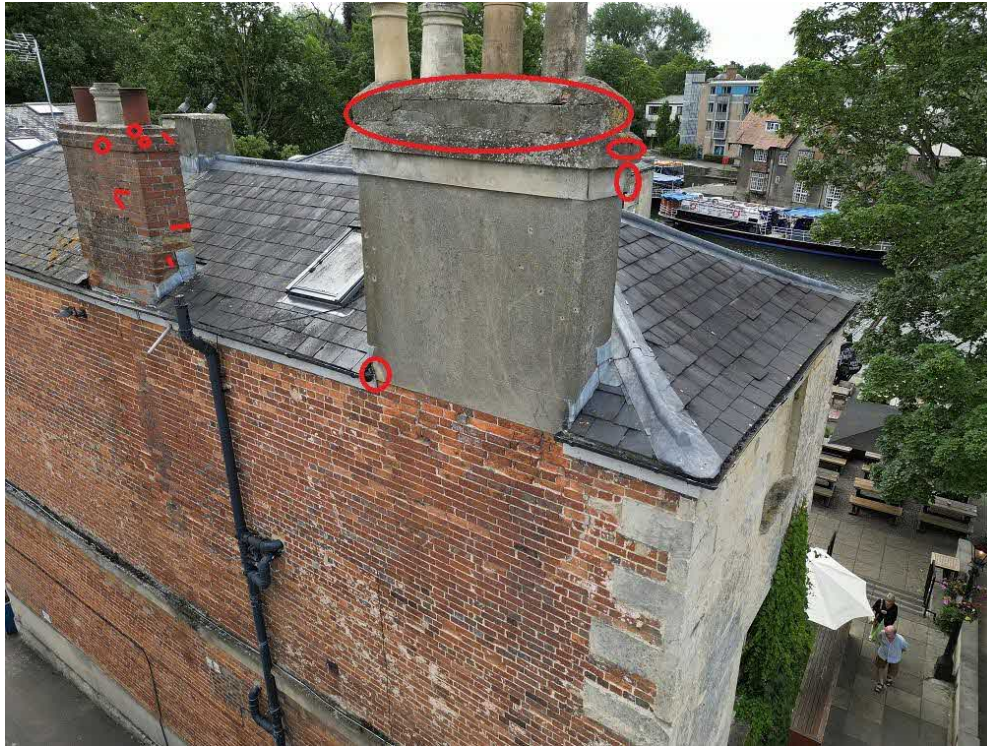
6

Fractured
flaunching

Spalled render

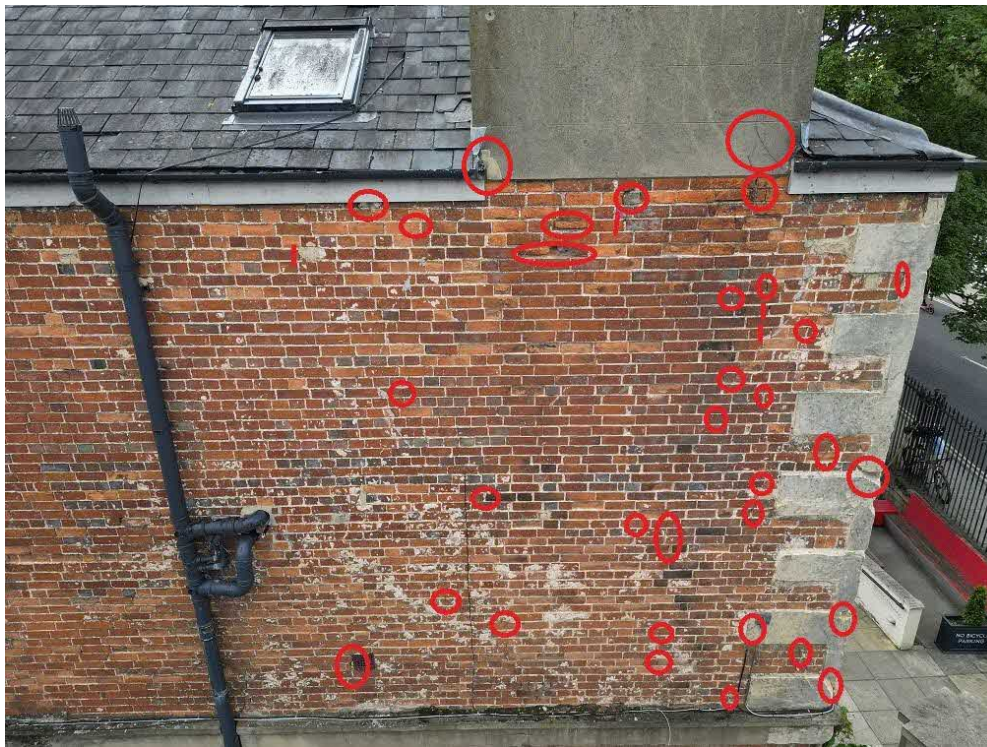
6

Spalled
brickwork

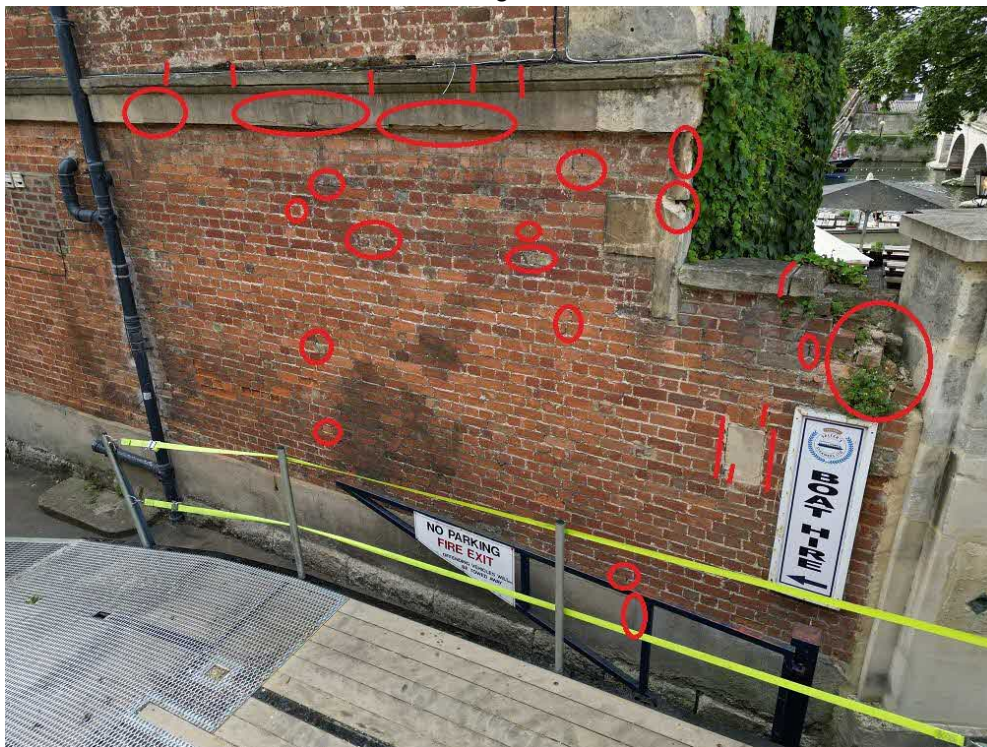
6

Spalled
brickwork
Open joints

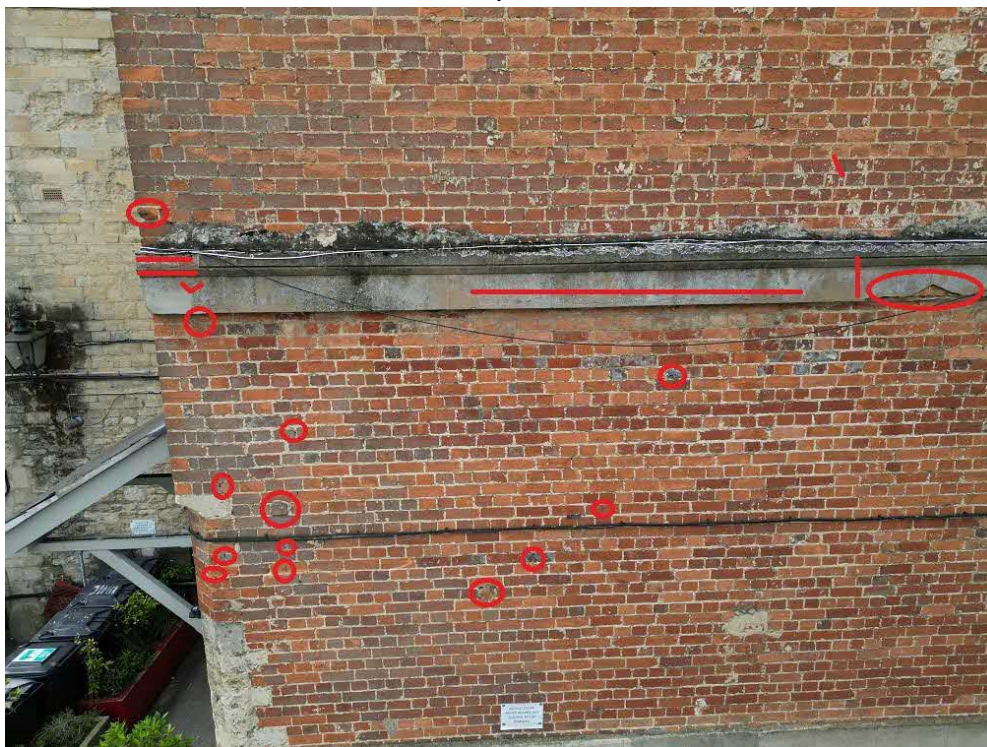
7

Spalled
brickwork
Detached
render

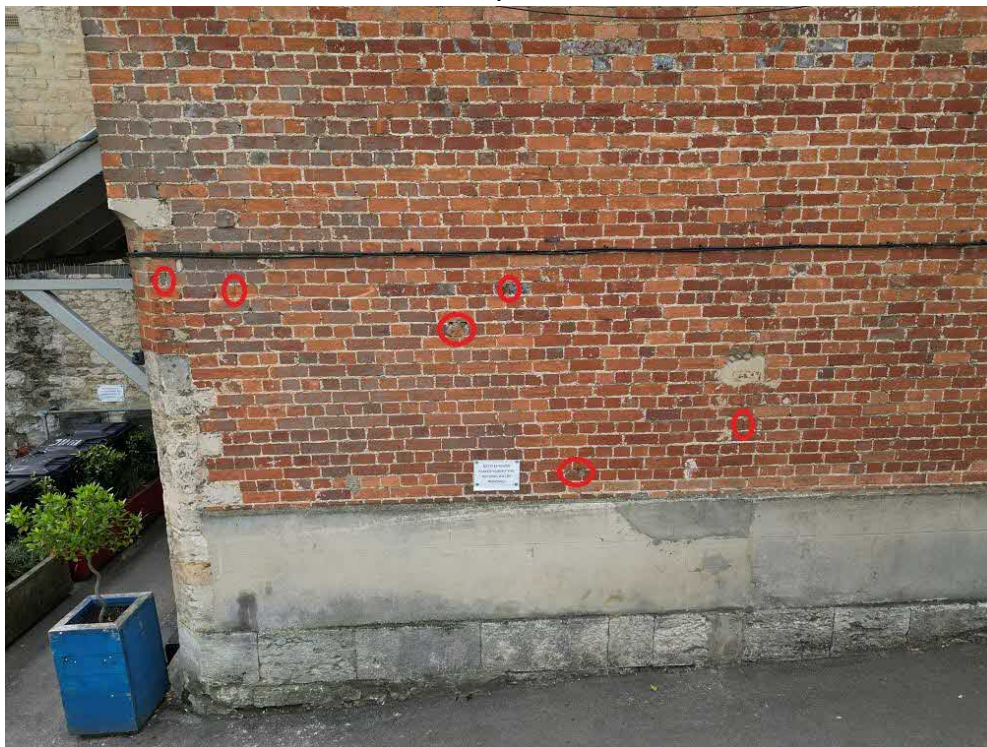
7

Spalled
brickwork

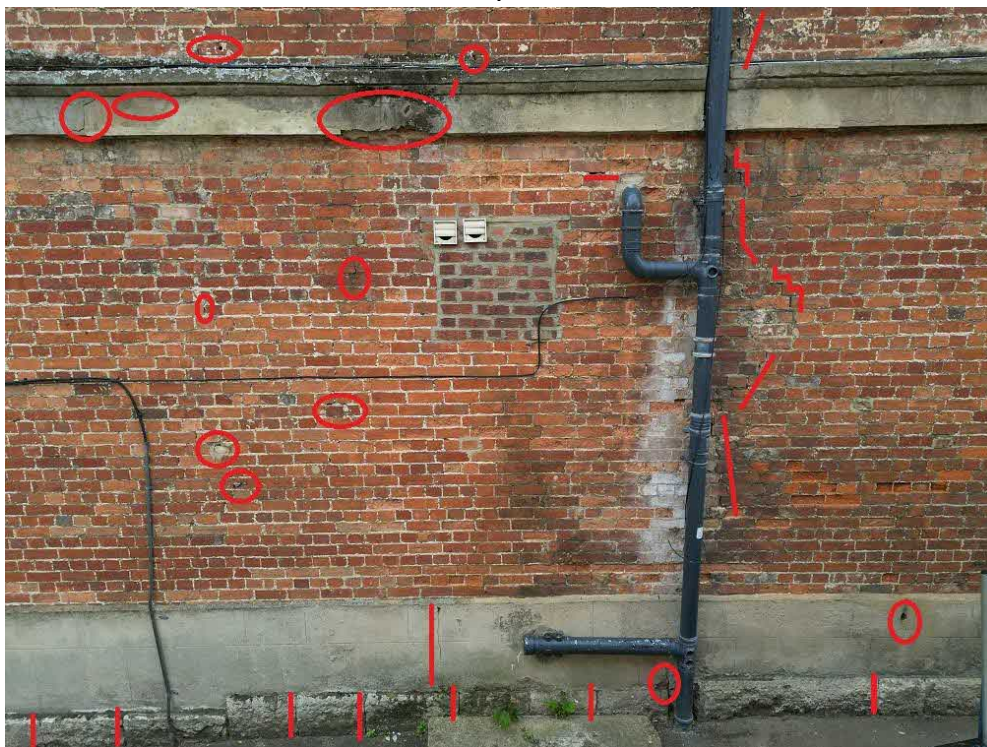
7

Spalled
brickwork

Fractured
render

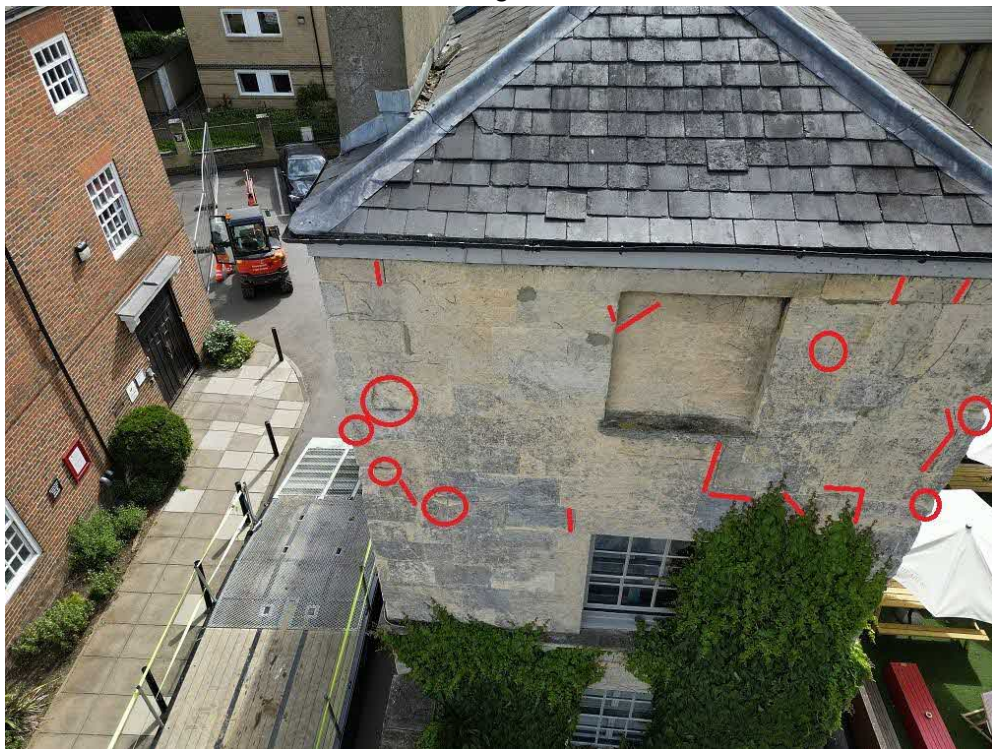
8

Open joints

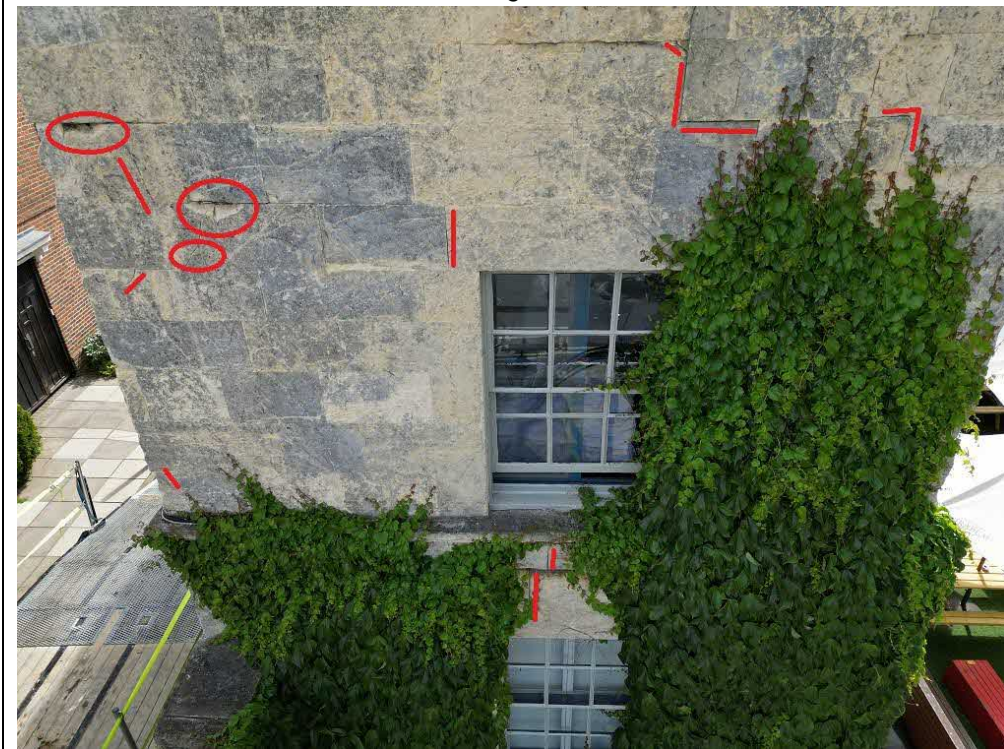
Open joints

Spalled stone

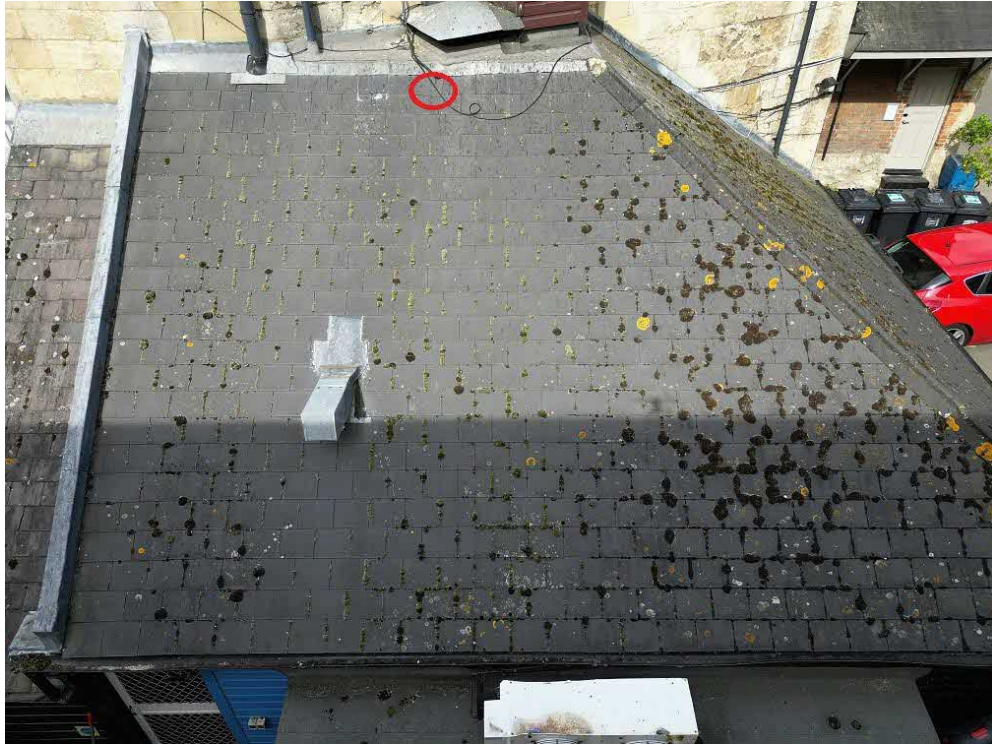
Section A

Slipped/broken
slate

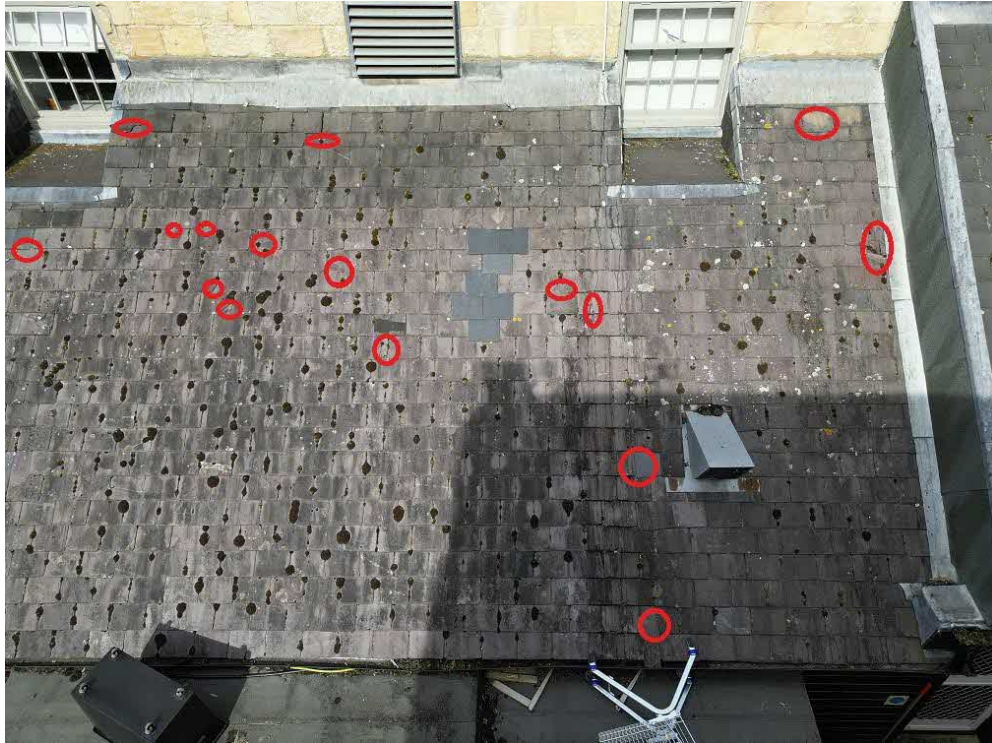
Section B

Slipped broken
slate

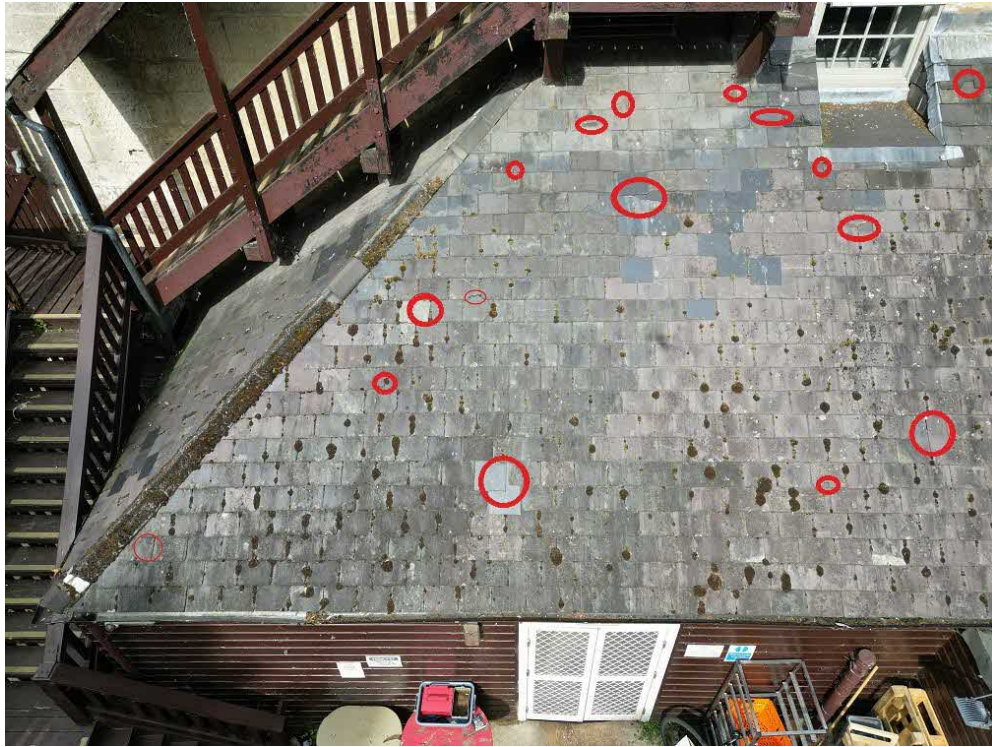
Section C

Slipped/broken
slate

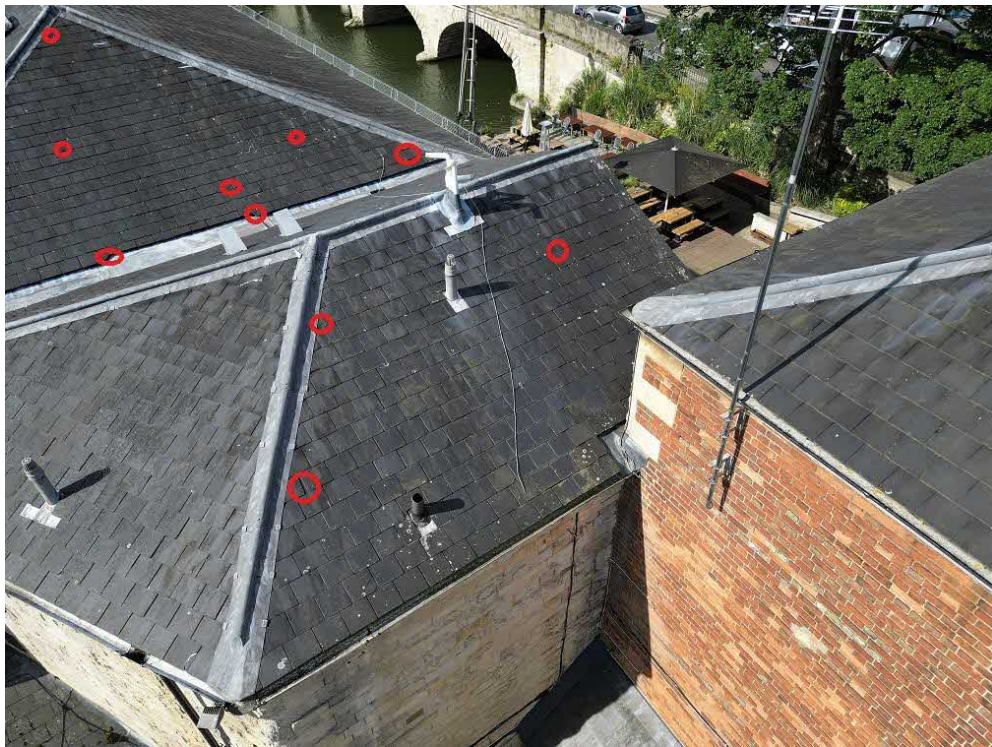
Section D

Slipped broken
slate

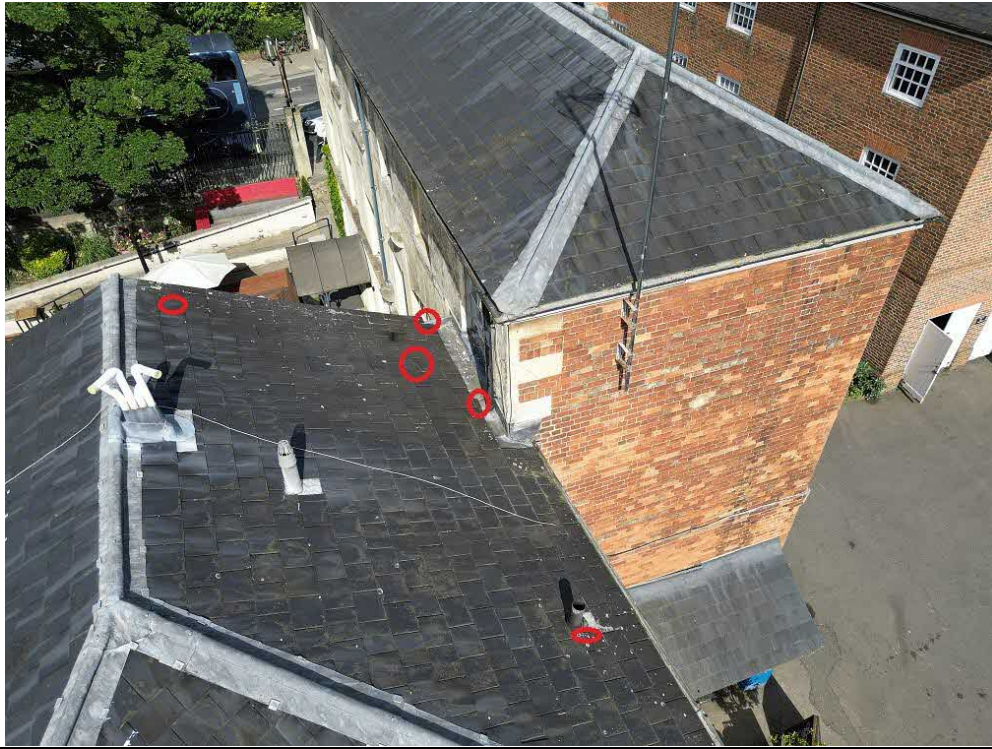
D

Slipped broken
slate

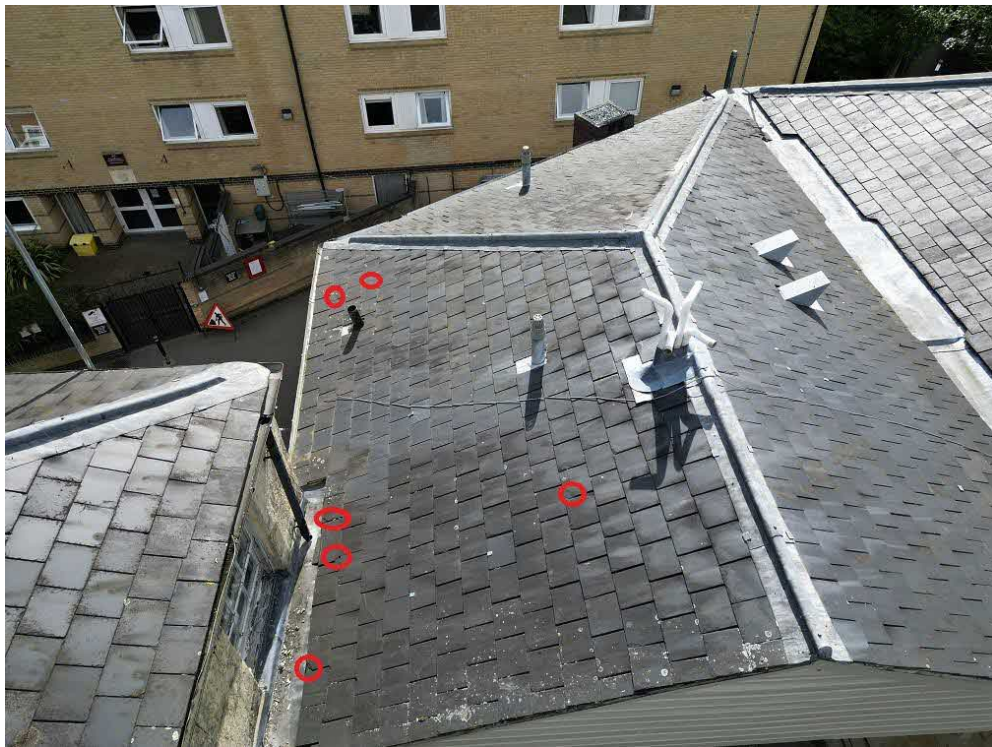
D

Slipped/broken
slate

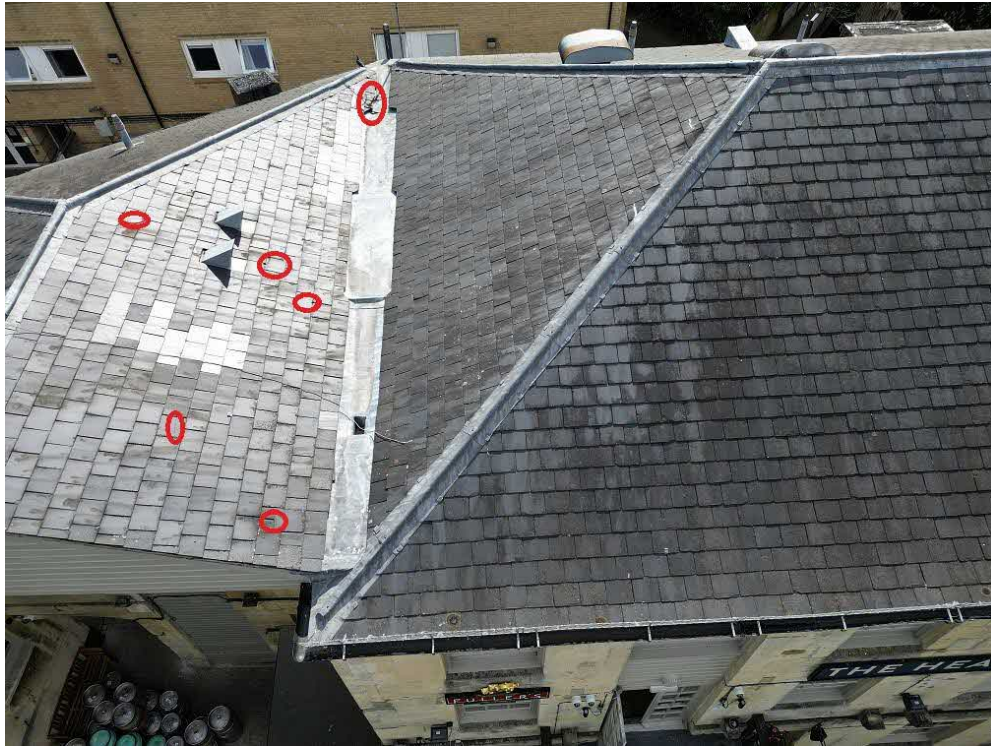
D

Slipped/broken
slate

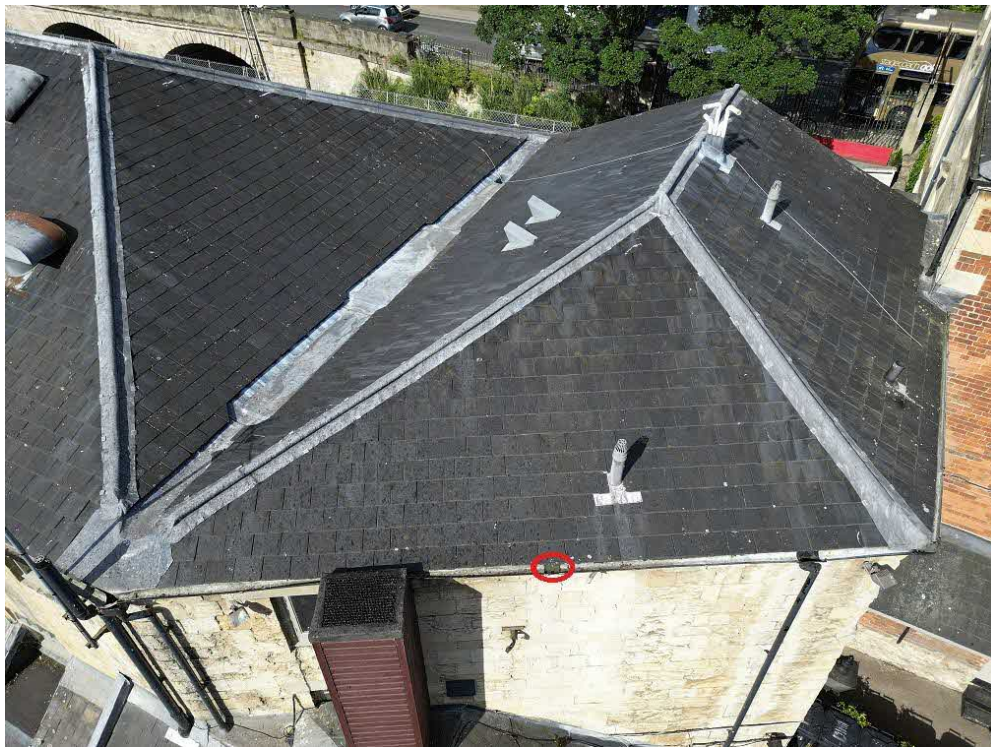
D

Slipped/broken
slate

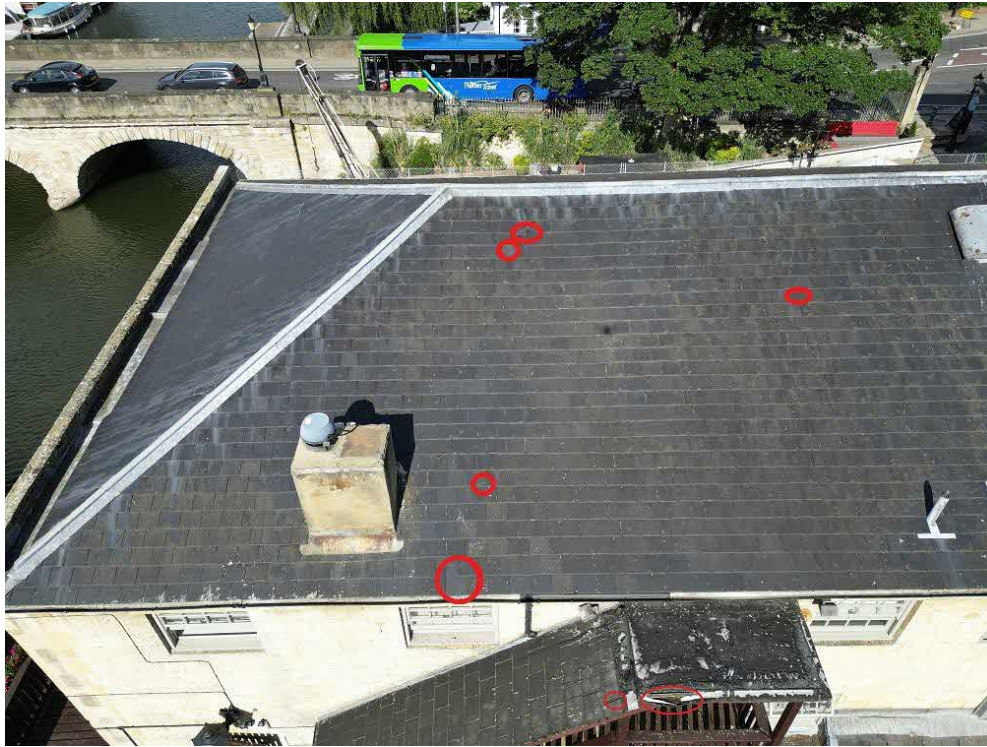
Section E

Slipped/broken
slate

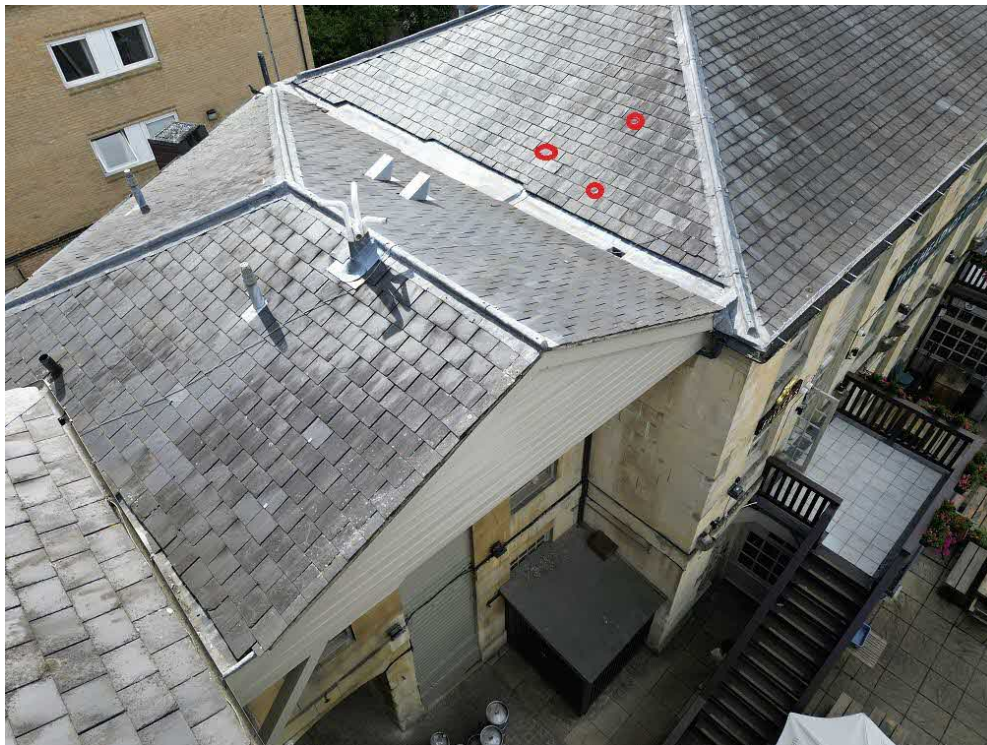
Section F

Slipped
broken/slate

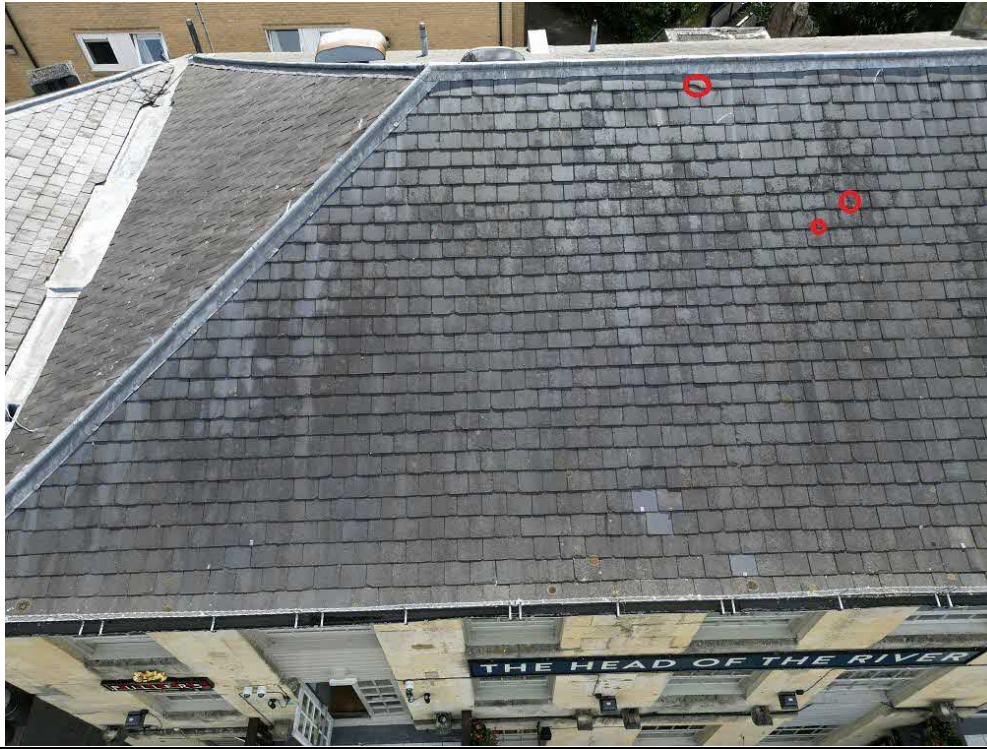
Section G

Slipped
broken/slate

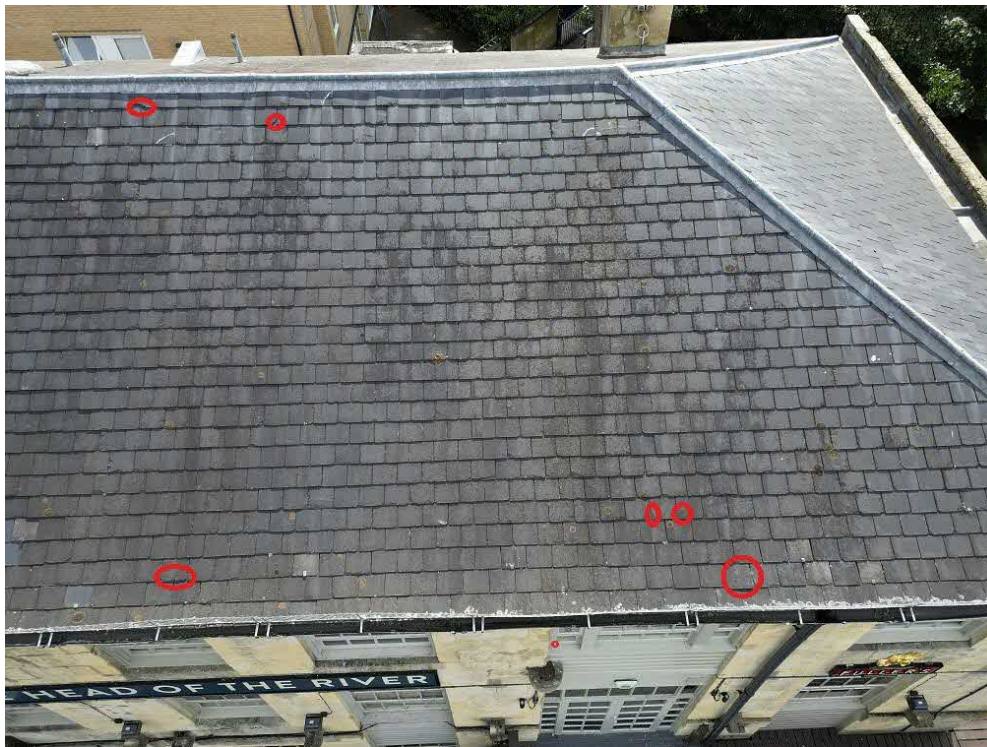
G

Slipped/broken
slate

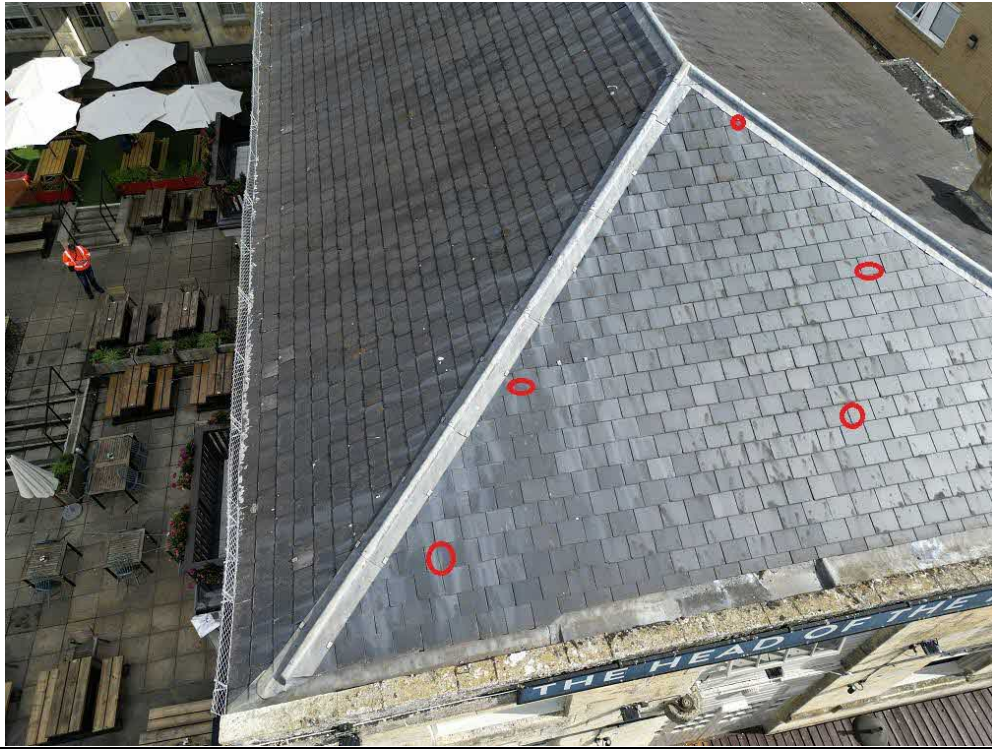
Section H

Slipped/broken
slate

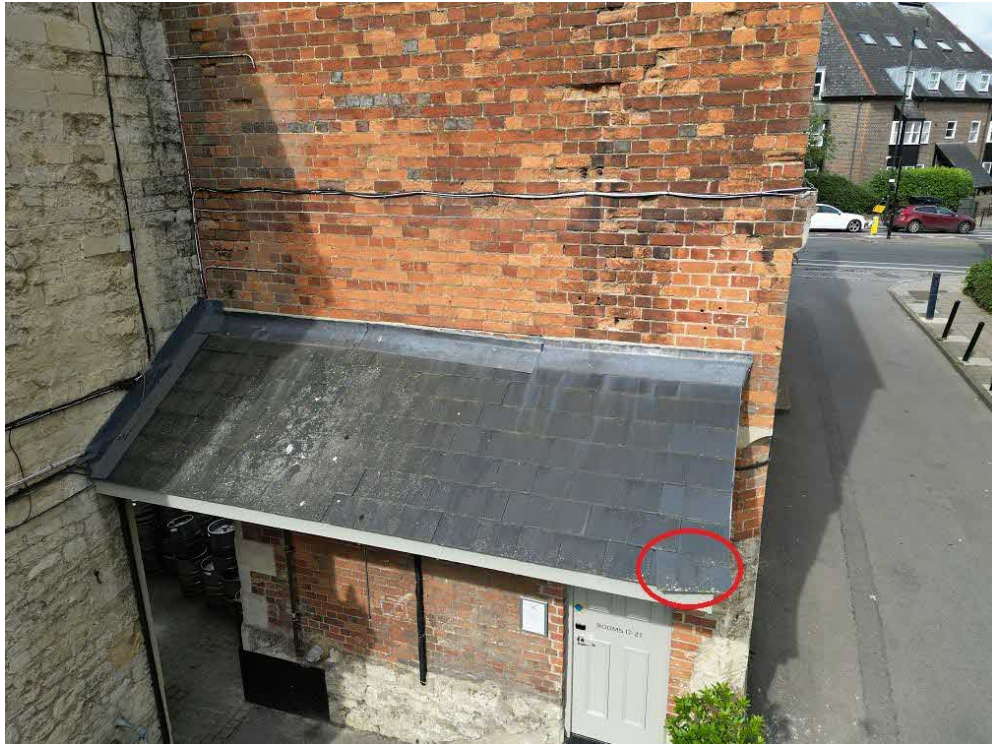
Section I

Slipped/broken
slate

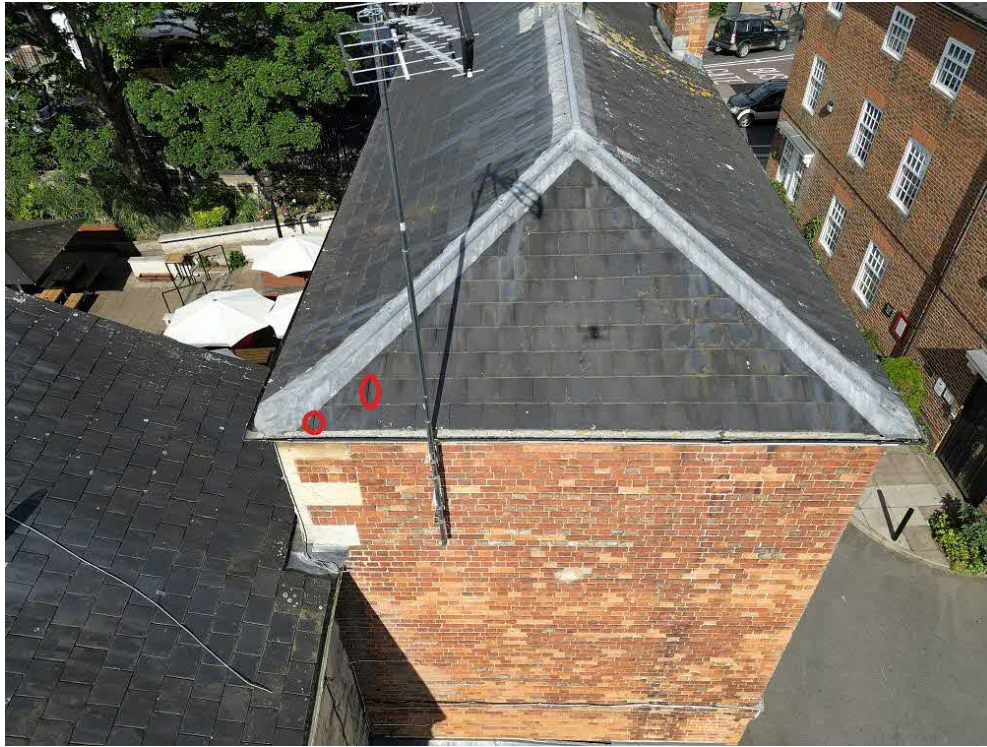
Section J

Slipped/broken
slate

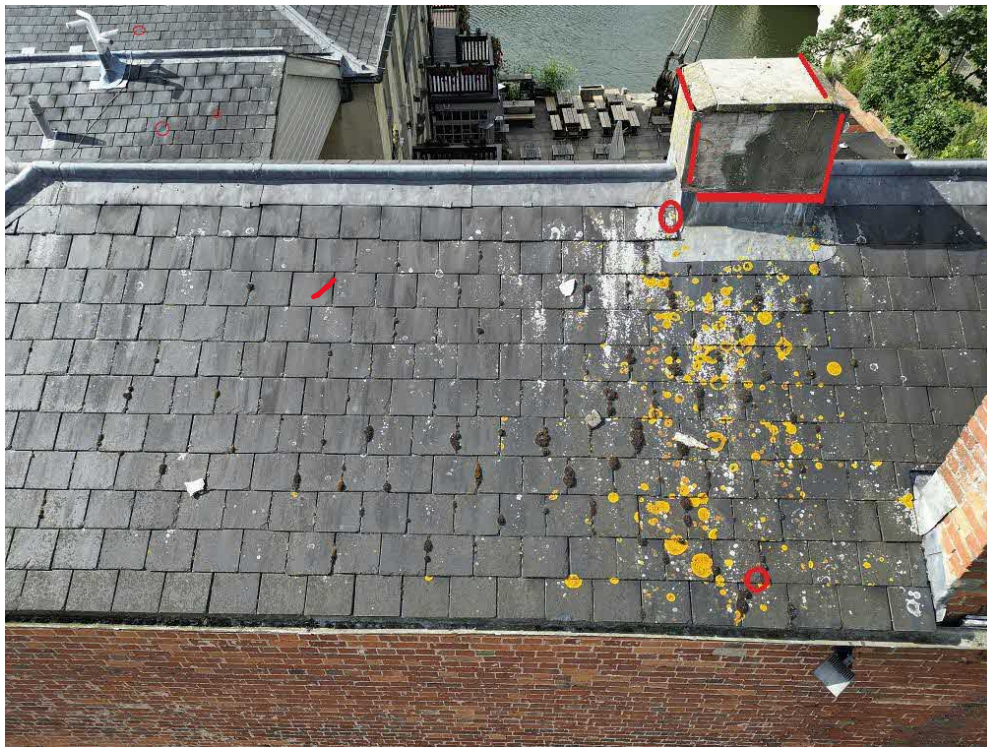
Section K

Slipped/broken
slate

Fractured
render

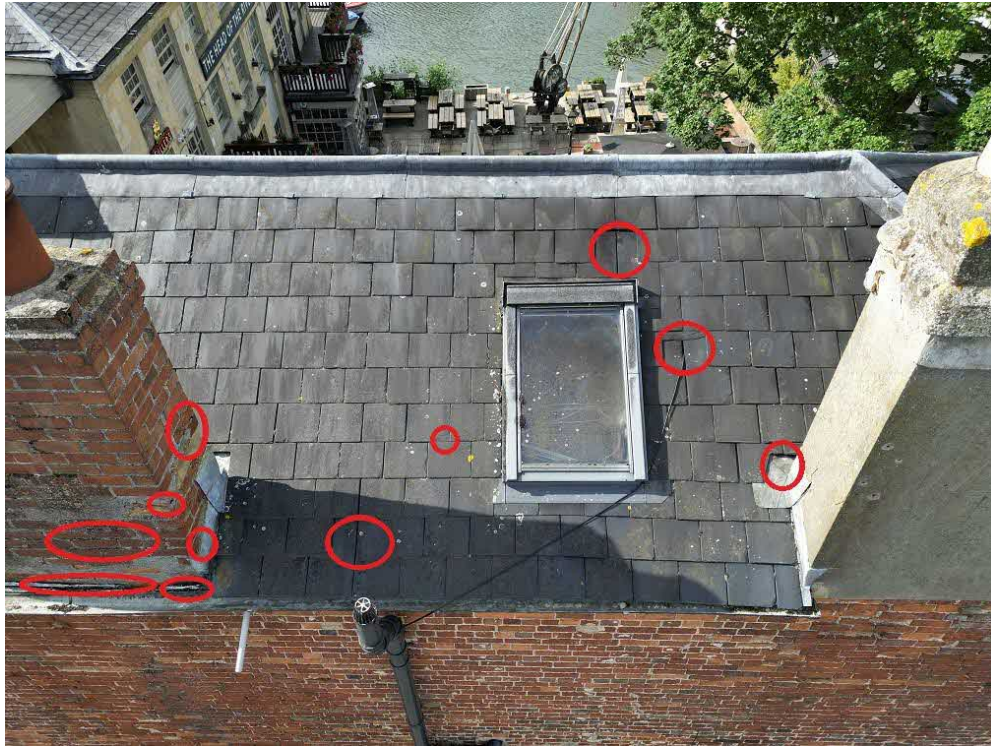
K

Slipped/broken
slate

Spalling render
