The Head Of The River
Folly Bridge
St Aldates
Oxford
OX1 4LB

Safety Survey

Prepared for Fuller's

July 2023

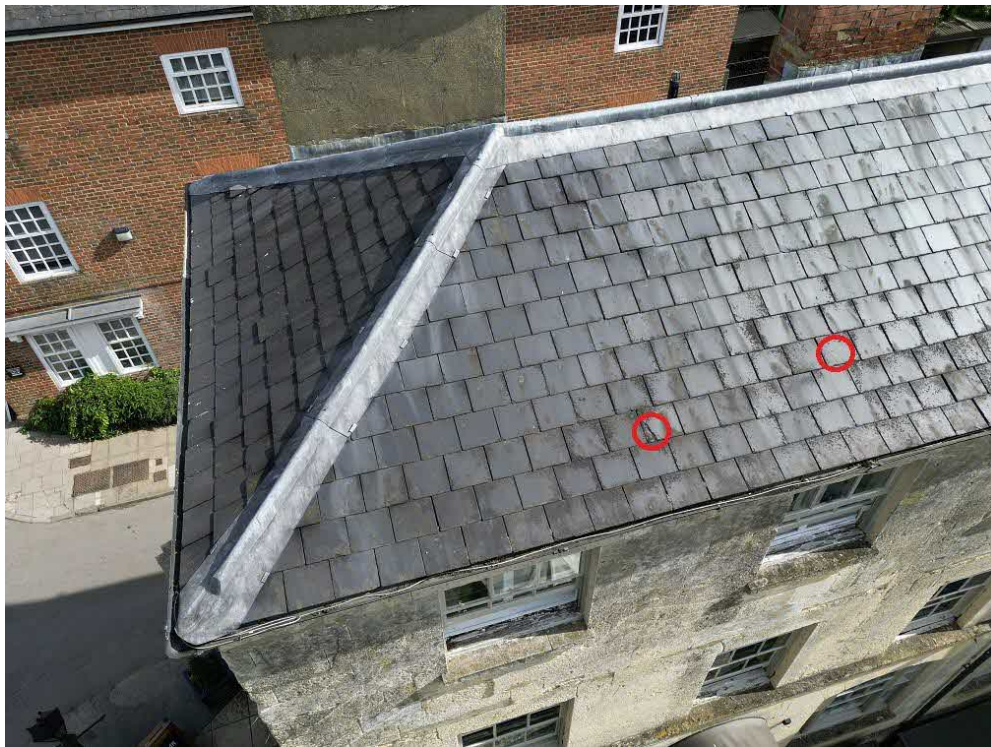
Section L

Slipped/broken
slate

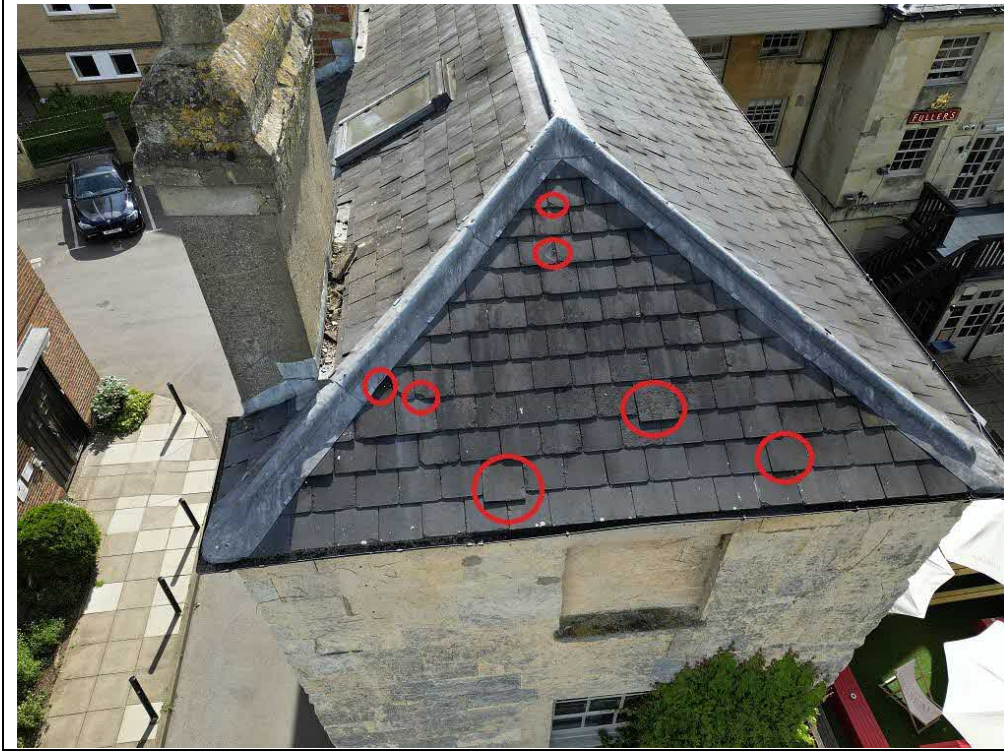
Section M

Slipped/broken
slate
