Structural Condition Report

Existing Outbuilding

58 Main Street, Coln St Aldwyns

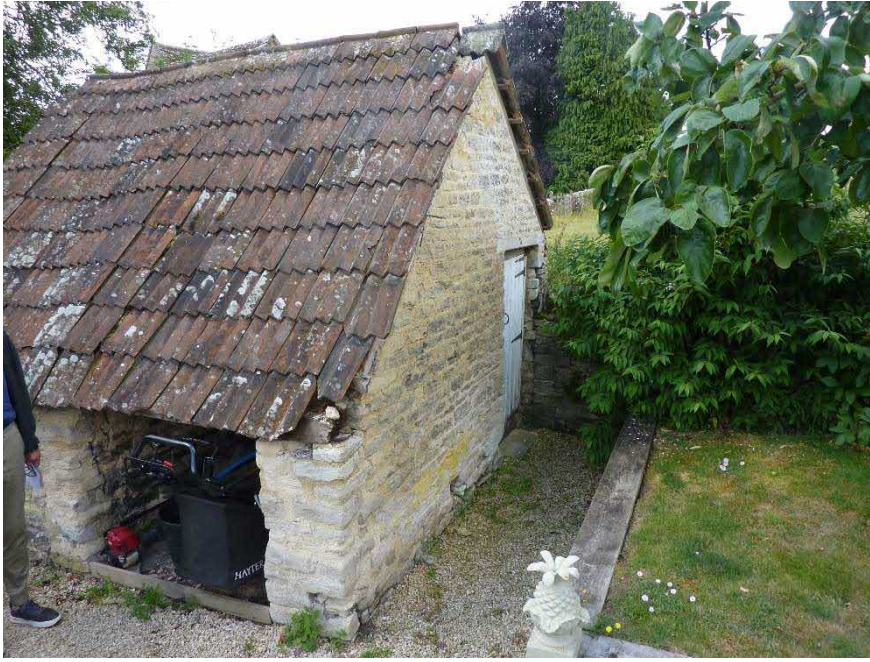
The stonework on the north gable is of a generally good condition and the wall maintains a good vertical alignment over its height. Some weathering of the wall has occurred at the lower level immediately above ground level, resulting in some loose stonework and mortar loss.

Photograph 1
View on to gable end wall of North Elevation

Based upon the above findings, it is my considered professional opinion, that the existing solid stone walls of the north and south gables can be retained, as they are both of an acceptable structural condition. Similarly, the west elevation boundary wall can also be retained.

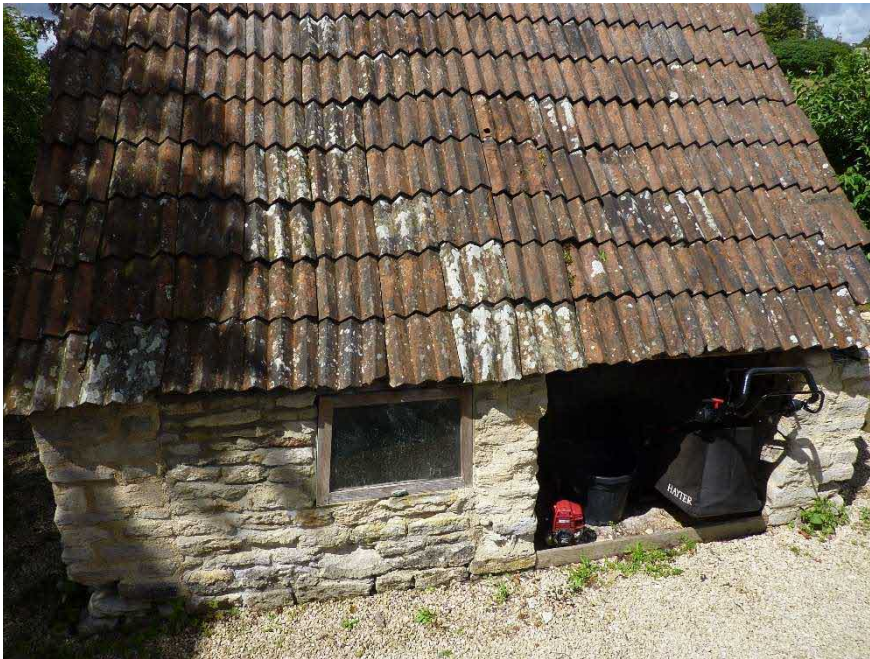
Photograph 2
East Elevation showing low eaves level and distortion in the roof structure.

The existing east facing elevation currently has a very low eaves, so this makes it impractical to gain access into the building interior from this side. Therefore, it is recommended that the existing eaves level be raised to match the eaves level on the opposing west elevation.

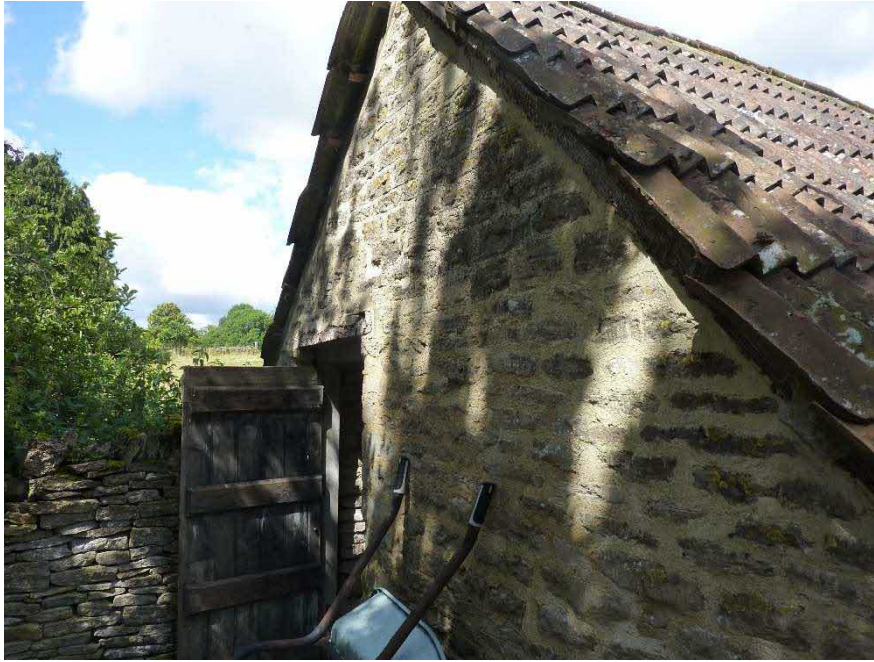
The stonework on the south gable is of a generally good condition and the wall maintains a good vertical alignment over its height. The timber lintel above the door opening has decayed, which has resulted in some cracking within the stone walling above.

Photograph 3
View on to gable end wall of South Elevation.

The south elevation gable wall will require some modification to infill the existing door opening, which is to be replaced with a new double door opening centred on the ridge line. This will provide the opportunity to remove the existing decayed timber lintel and make good any sections of walling as required. The new lintel to the external face of the wall over the new double door should be oak, so that it is in keeping with the original. Precast concrete lintels should be provided behind the oak lintel to suit the existing wall thickness.

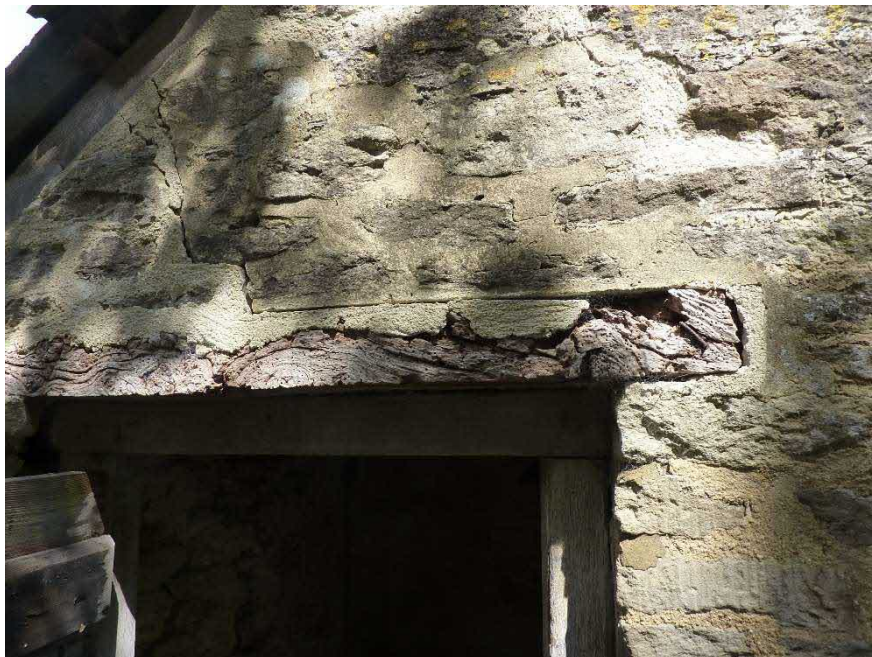
Photograph 4
Decayed timber lintel over door opening in South Elevation gable.

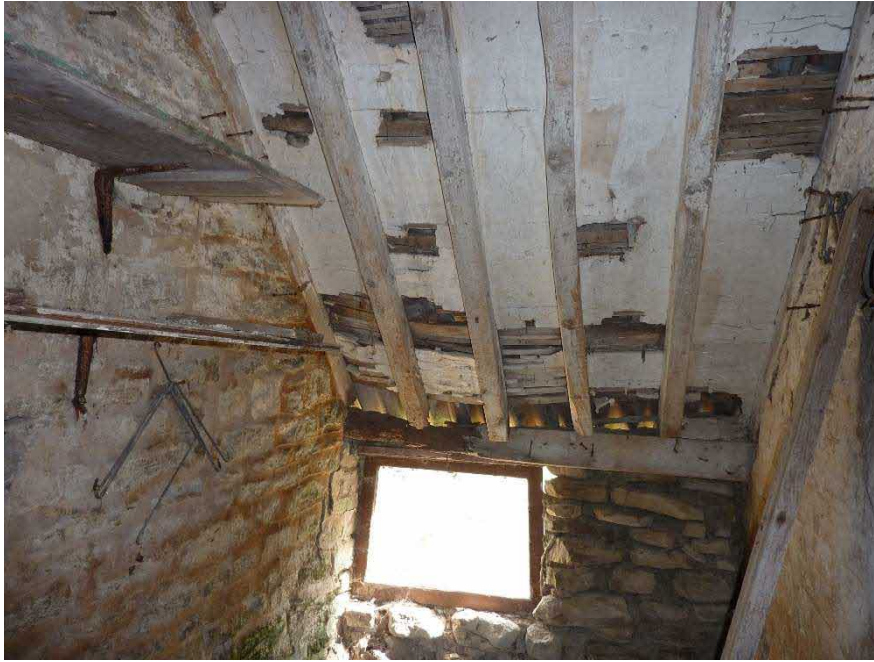
The condition of the rafters is generally poor, with widespread decay of the rafter feet noted at the bearings on to the supporting walls. In addition, some deflection of the rafters was also noted. Some loss of the internal plaster finish has occurred due to deterioration of the timber laths from water ingress, as no roofing felt is provided under the external tiling.

Photograph 5
View to underside of roof structure within building interior (south side).

Given the overall poor condition of the existing timber roof structure, it is recommended that this be replaced with new rafters, ridge beam, wall plates and eaves beams.

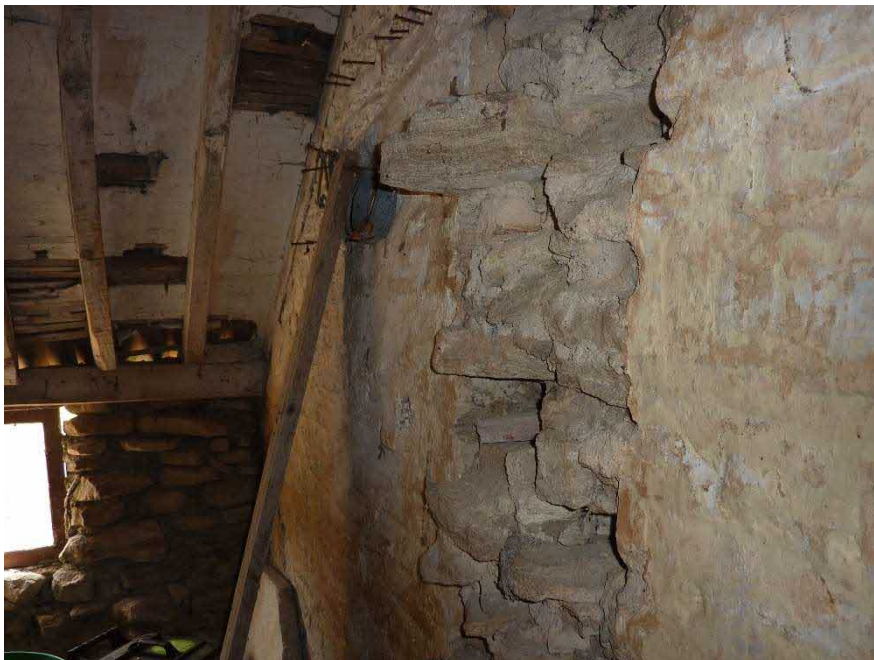
Access into the two enclosed interior spaces, is made via door openings located within the north and south gable end walls. Within the area to the south of the building, there is evidence of a section of original spine wall having been removed. The wall that has been removed, is on the same alignment as the remaining internal wall to the north side of the central dividing wall.

Photograph 6
Evidence of wall removal within building interior adjacent to South gable.

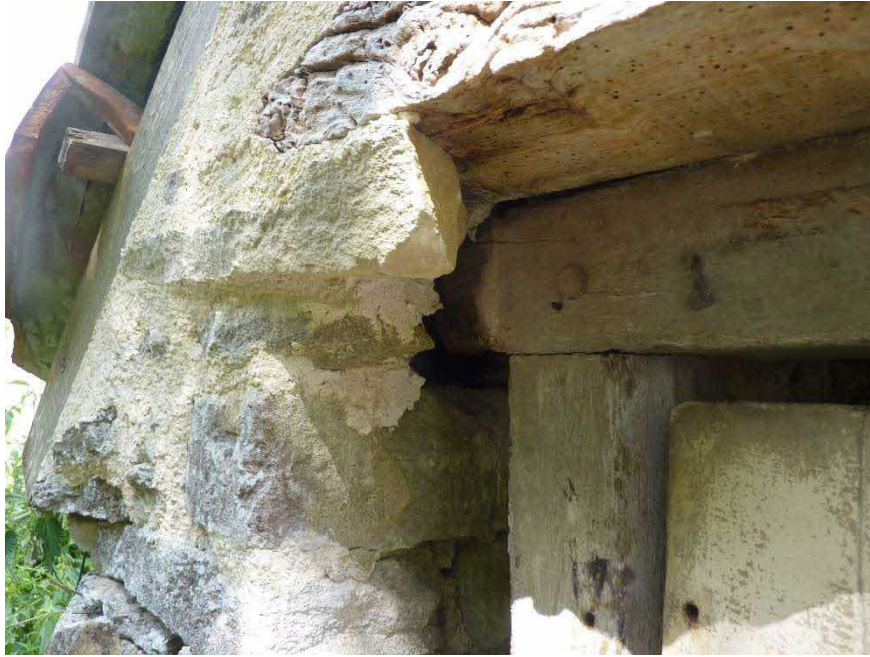
Photograph 7
Poor condition of stonework below lintel bearing on South gable.

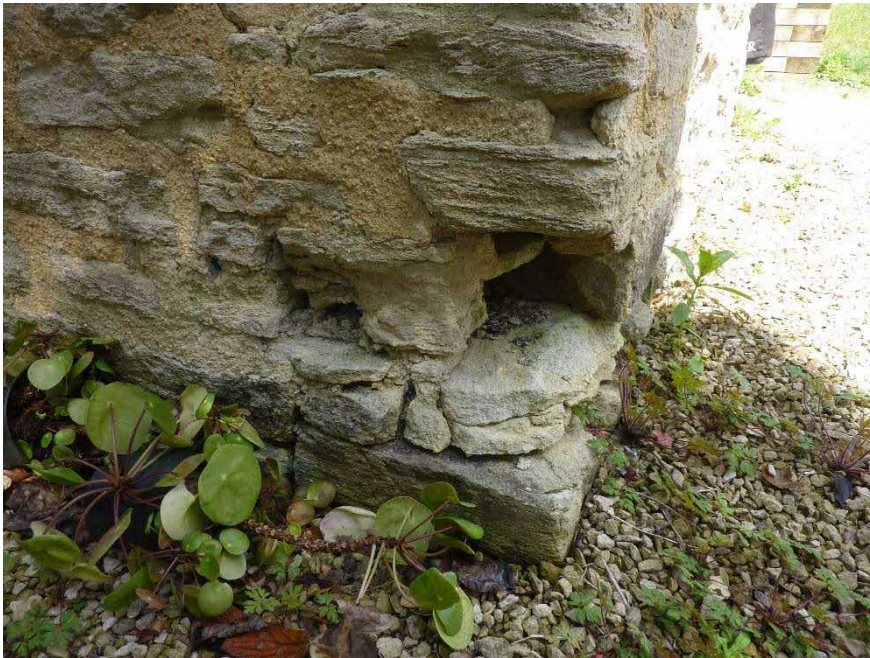
On the south-east corner of the wall, there is a small section of stonework missing at the lower level.

Photograph 8
Loss of low level stonework on South-East corner.

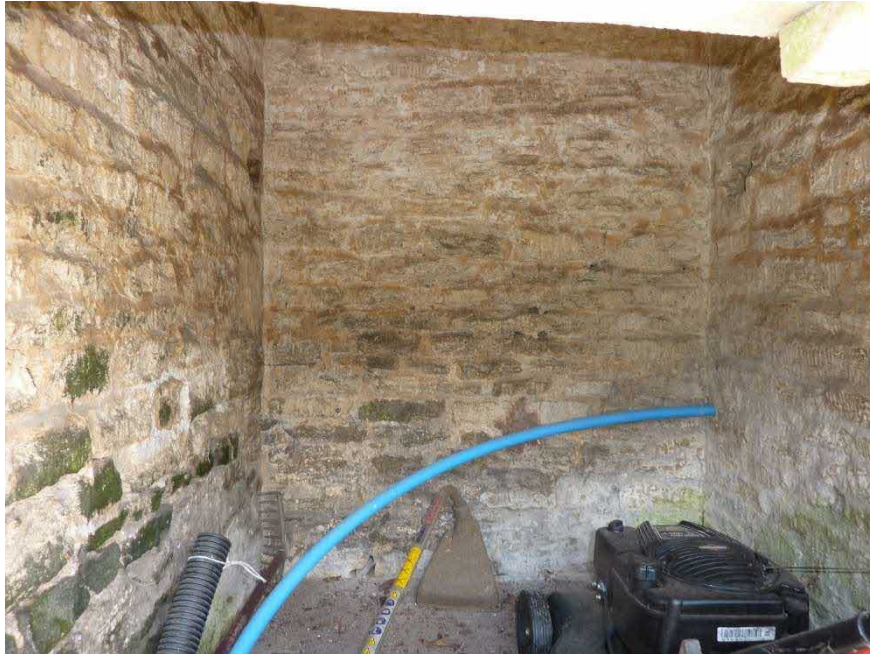
Photograph 9
Interior space as viewed from open frontage in East Elevation.

To make the building more usable, the partial removal of the existing internal cross wall should be considered. This will provide a single secure and lockable area, with the existing covered outdoor area to the east side retained in its original form, albeit with a raised eaves level.

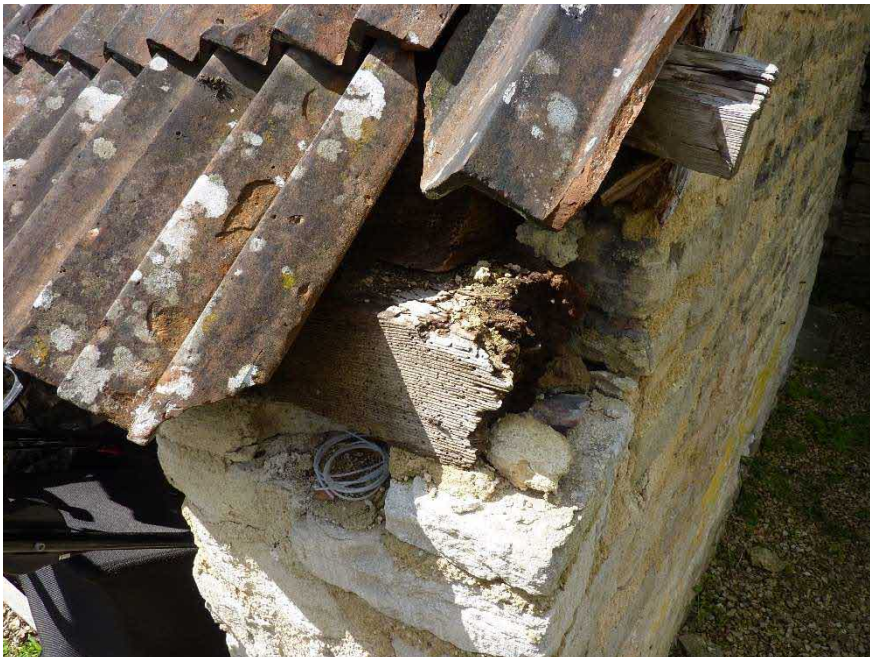
Photograph 10
Decay to timber eaves beam on North-East corner.

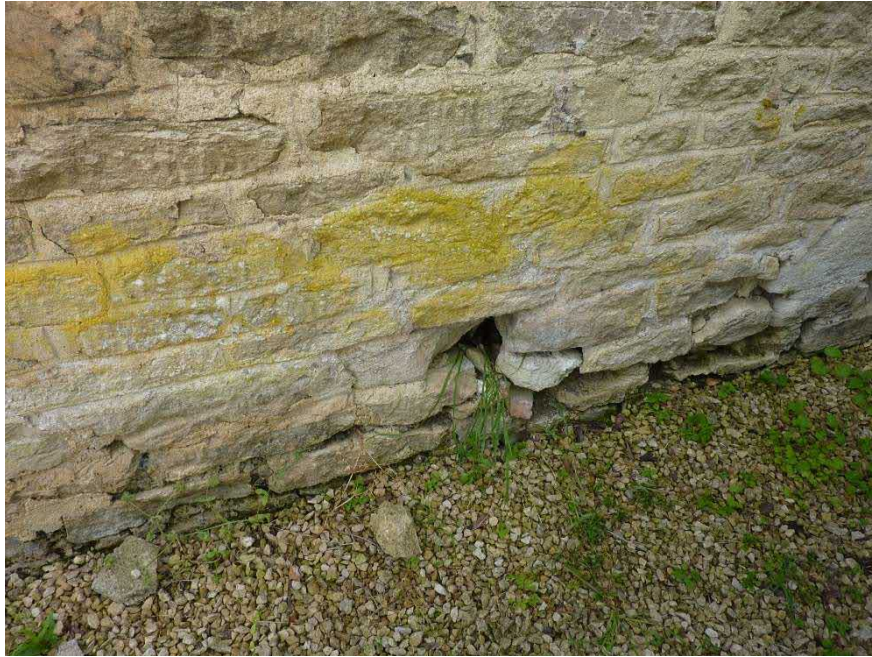
Photograph 11
Weathering of low level stonework on North Elevation gable.

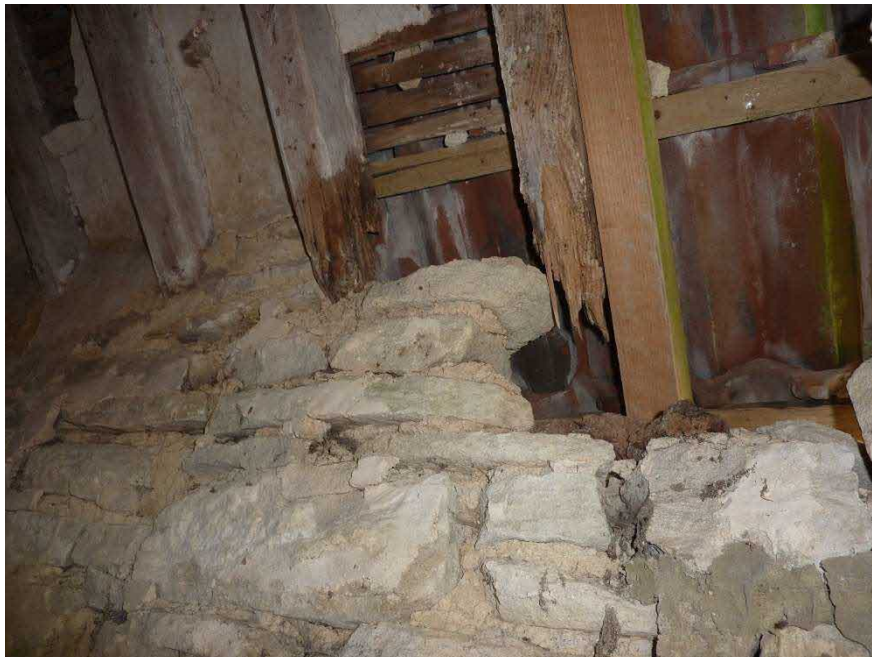
Photograph 12
Decayed rafter end bearings on to West Elevation wall.

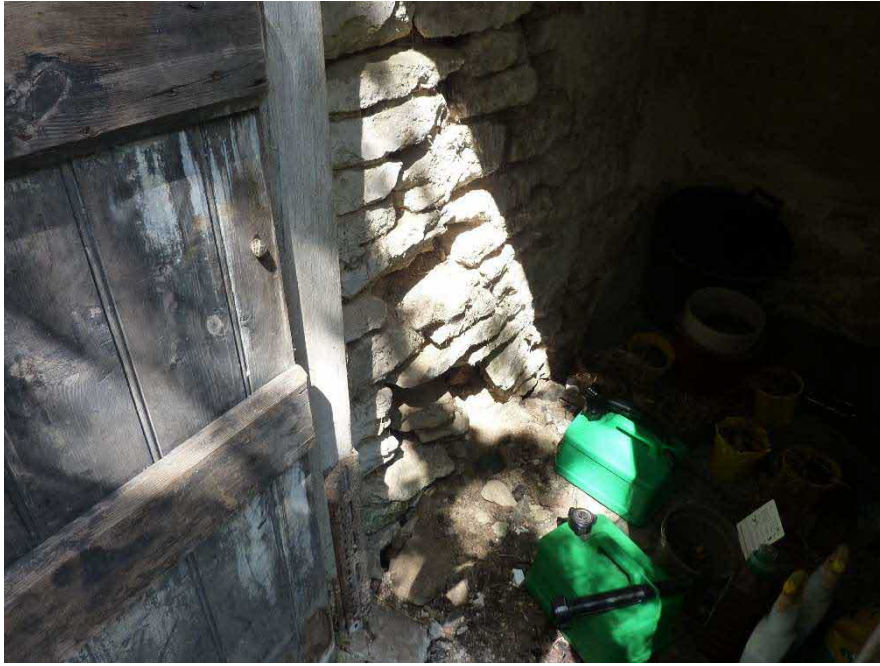
The external face of the wall was not inspected from the neighbouring field, so its condition was not confirmed. The internal wall face contained some loose stonework, particularly at the lower level where the wall is retaining and at the wall head around rafter bearings.

Photograph 13
Poor condition of internal wall face of West elevation adjacent to door opening.

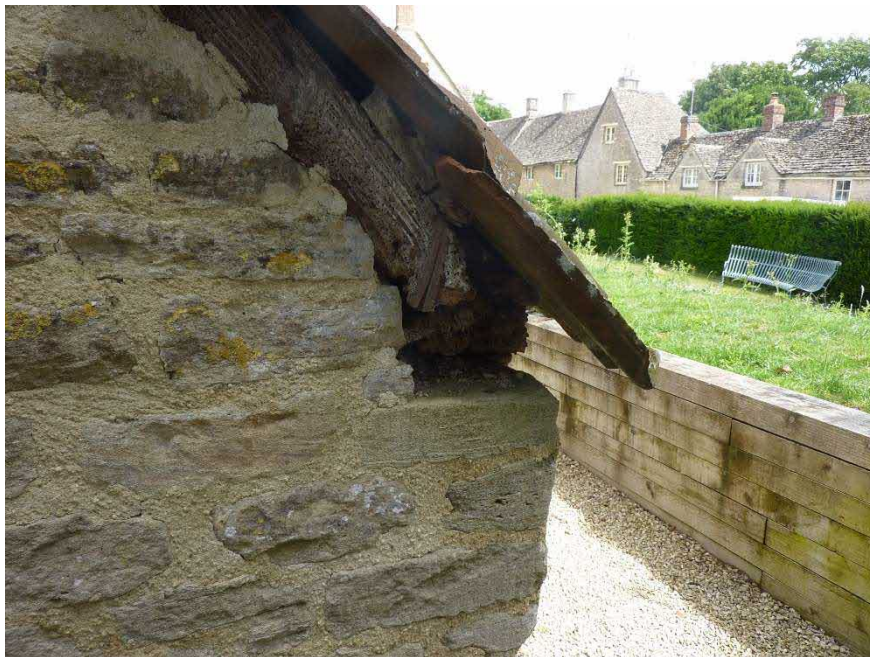
Photograph 14
Decayed verge rafter and eaves beam/wallplate on South-East corner.
