Structural Appraisal of Existing Barn for Conversion to Residential Accommodation

Westbrook Barn, Evercreech,
Shepton Mallet BA4 6DS

1857

17 October 2023

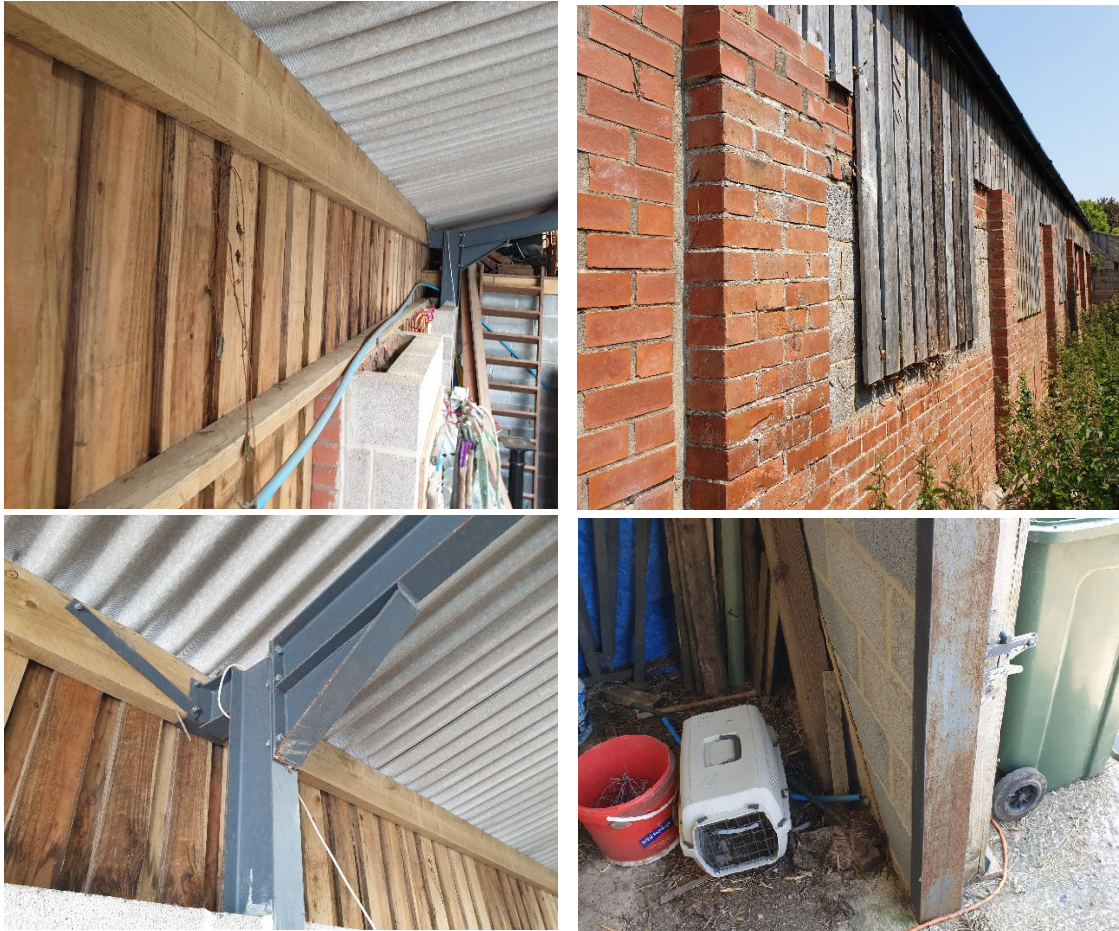
Figure 5 Perimeter wall construction

The barn is supported by 178 x 102 x 19 Universal Beam section structural steelwork columns to the main portal frames. The main barn doors and timber cladding on the gable elevation are restrained by 125 x 65 PFC cantilever wind posts. Minor superficial corrosion was noted to the PFCs exposed to weathering; this should be repaired protected within the conversion works. The brickwork outer leaf steps out past column locations to form load brickwork piers and retain the cavity. The inner leaf is constructed with 140mm wide medium dense blockwork with stainless steel wall ties to the outer brickwork. The timber board cladding is restrained by timber side rails spanning between portal frames and fixed to the masonry walls.

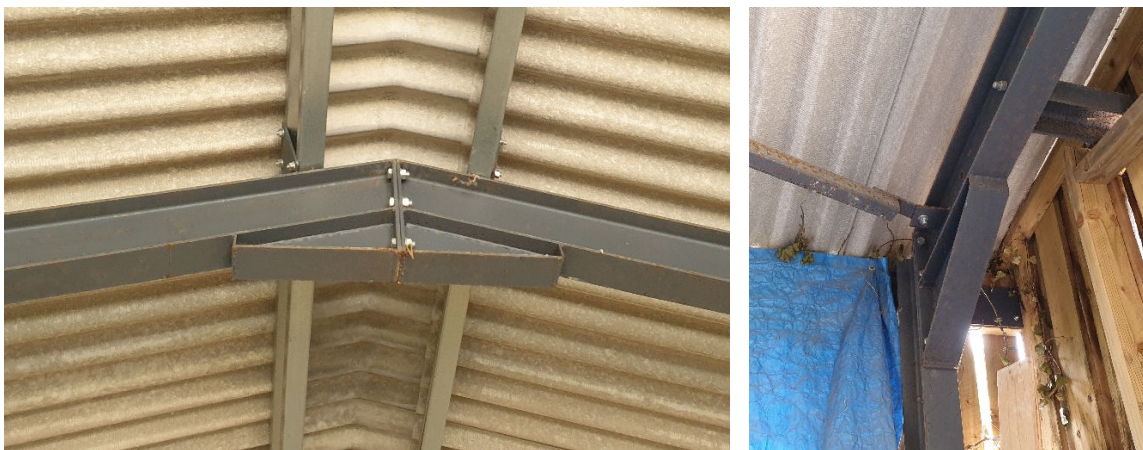
Figure 6 Roof construction

Barn roof is covered with corrugated cementitious roof sheeting supported by 172mm depth light gauge cold formed steelwork purlins at 1.4m centres. The purlins are supported by portalised principal rafters, these are 178 x 102 x 19 UBs with haunches at eaves and apex. There is steelwork 50 x 50 square hollow section (SHS) plan bracing in the end bay transferring lateral load to the side walls. Perpendicular to the portal frames stability appears to be provided by the shear capacity of masonry walls built into the webs of steel columns.
