STRUCTURAL INSPECTION AND REPORT

OUTBUILDINGS to

HOLLY TREE FARM

REFERENCE: 5315

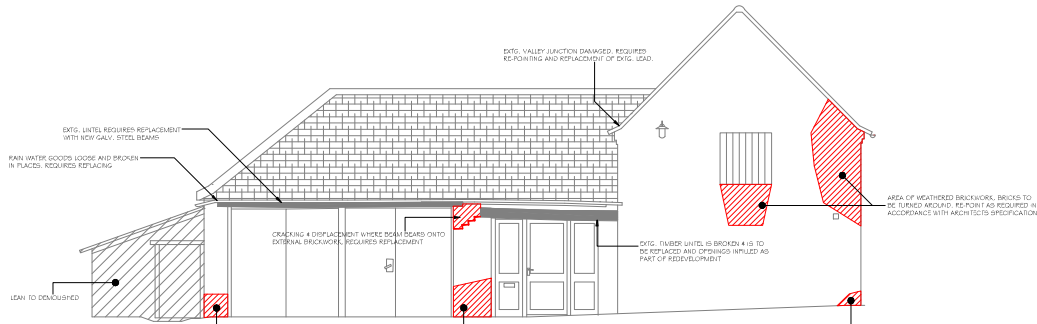
ELEVATION B
 (SCALE 1:50)

- 2.3.2 Moss growth was noted in patches around the base of the buildings indicating rising damp.
- 2.3.3 The side elevation (noted as Elevation B) also had areas of frost damaged brickwork/ weathering and areas of rising damp / moss growing up the walls. The existing timber lintels on this elevation were exposed and damaged and where the beams bear onto the external wall, cracking and displacement of the masonry had occurred.

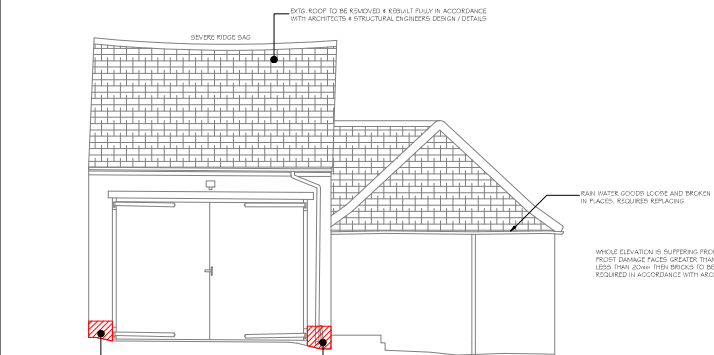
ELEVATION C
 (SCALE 1:50)

- 2.3.1 The front elevation to the garage (Elevation C on drawing ref: ST-02) had areas of frost damaged brickwork and areas of rising damp / moss growing up the walls.

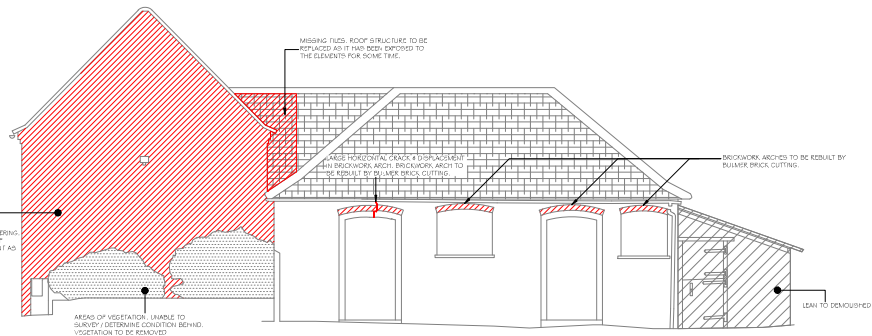
ELEVATION D
 (SCALE 1:50)

- 2.3.4 The whole of opposite side elevation to the garage (noted as Elevation D) had suffered from frost damaged brickwork/ weathering. The opening within this side elevation had been formed with brick arches over however, a large horizontal crack was noted within one of the arches and the other arches were not in good condition either.

WHOLE ELEVATION IS SUFFERING FROM FRONT DAMAGE. WEATHERING. REPAIR DAMAGE FACES GREATER THAN 25mm TO BE REPLACED. IF LESS THAN 25mm THEN BRICKS TO BE TURNED AROUND. REPOINT AS REQUIRED IN ACCORDANCE WITH ARCHITECTS SPECIFICATION
