Leigh Ecology Ltd

75 Hammerton Street,
Burnley.

Bat Scoping Survey Report

HAMM/01/23

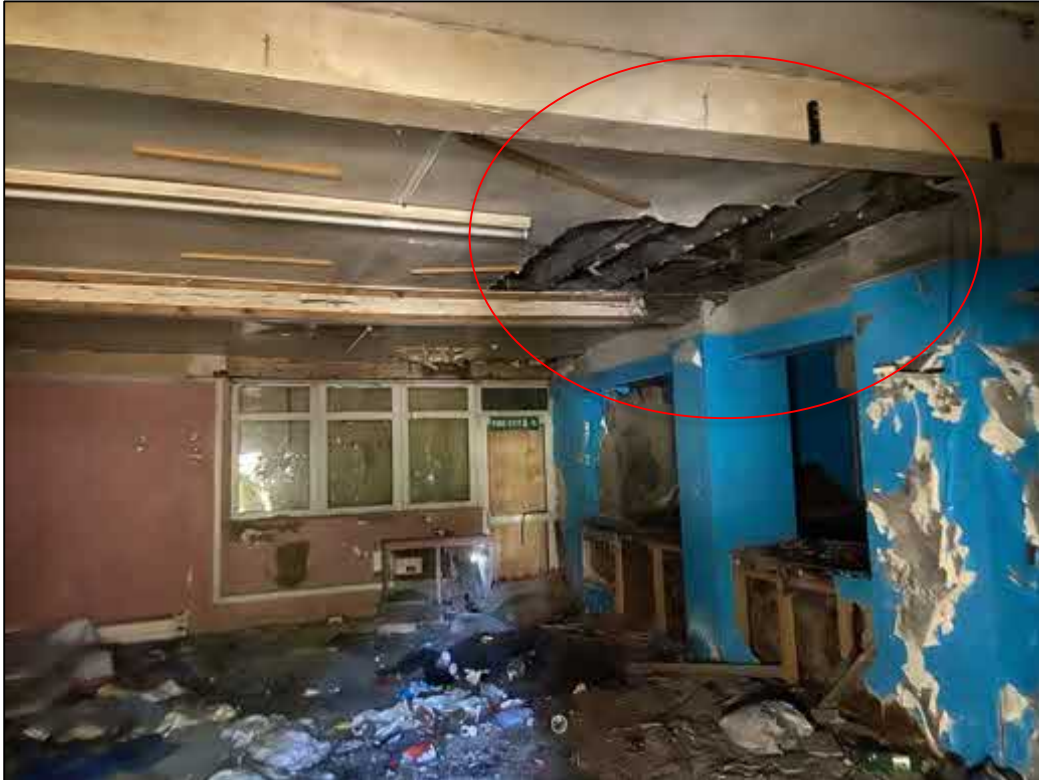
Fig 2: An internal view of the lower floor within the target building. The lower floor features extensive fire damage to the ceiling (circled).

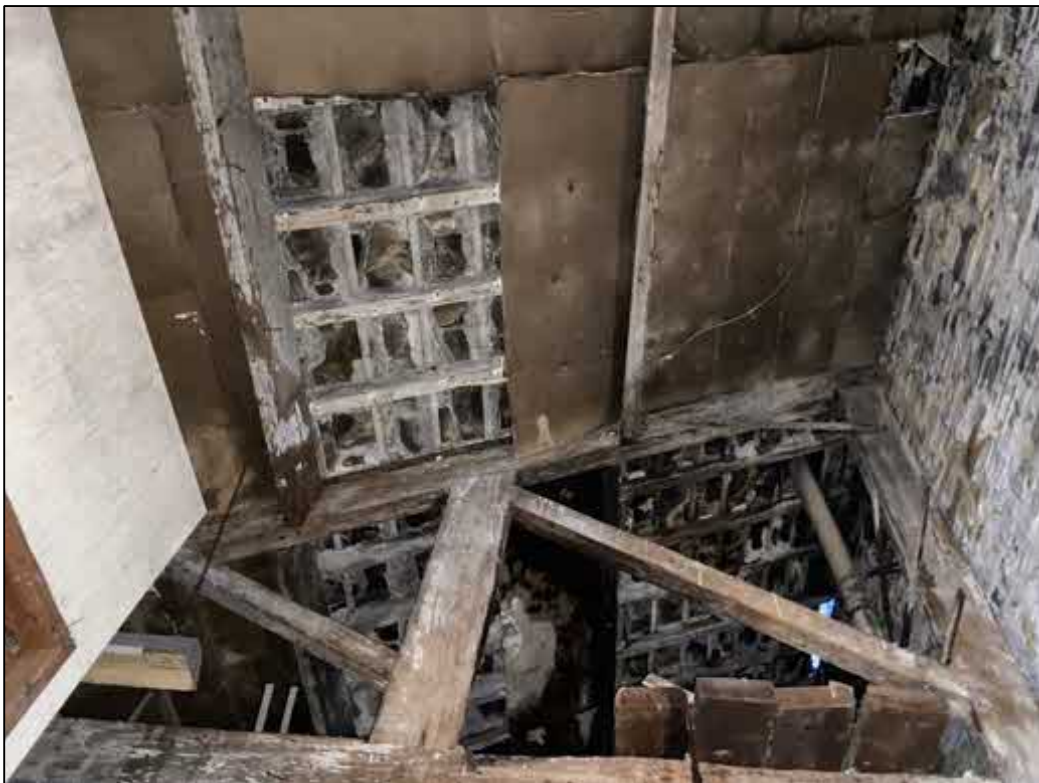
Fig 3: An internal view from the accessible staircase leading to the upper floor. The hard boarding that features beneath the roof has been extensively damaged by previous fires. Day light is clearly seen from within across several sections of the roof.

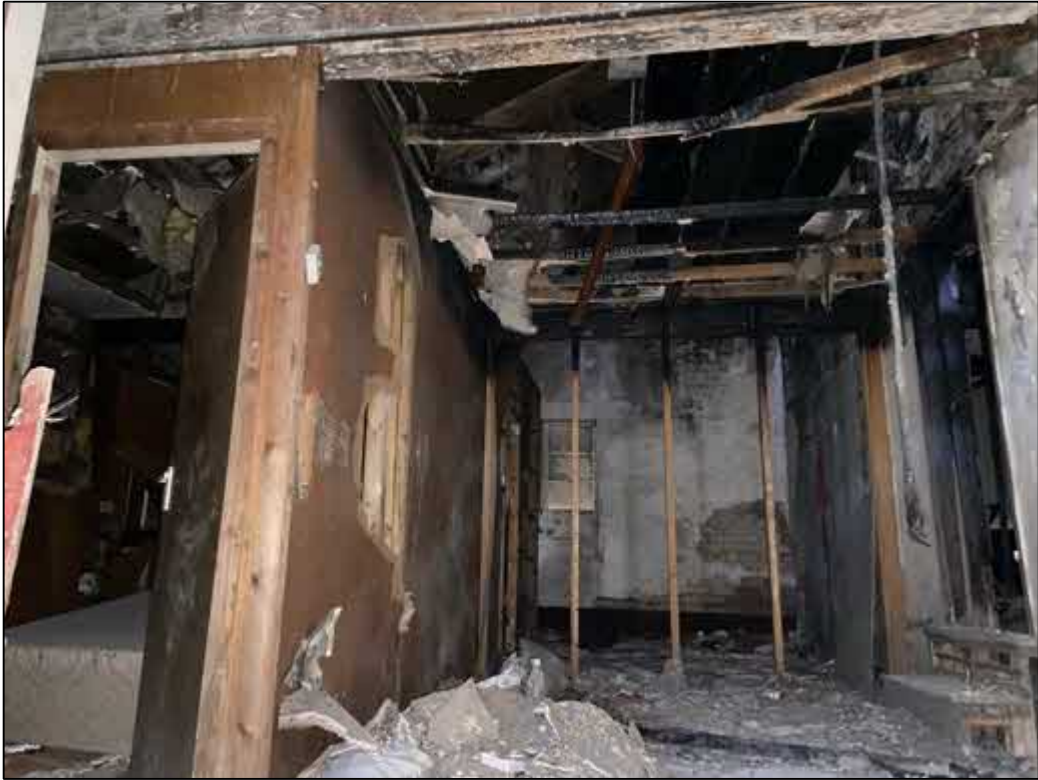
- 2.2.7 The building's upper floor has been heavily damaged by previous fires, resulting in the upper rooms and internal roof space being inaccessible and unable to be comprehensively assessed during the survey. The upper floor was only assessed from within the confines of the staircase area.

Fig 4: The upper floor of the subject building. The structural integrity of the upper floor is poor, meaning an extensive check could not be undertaken.

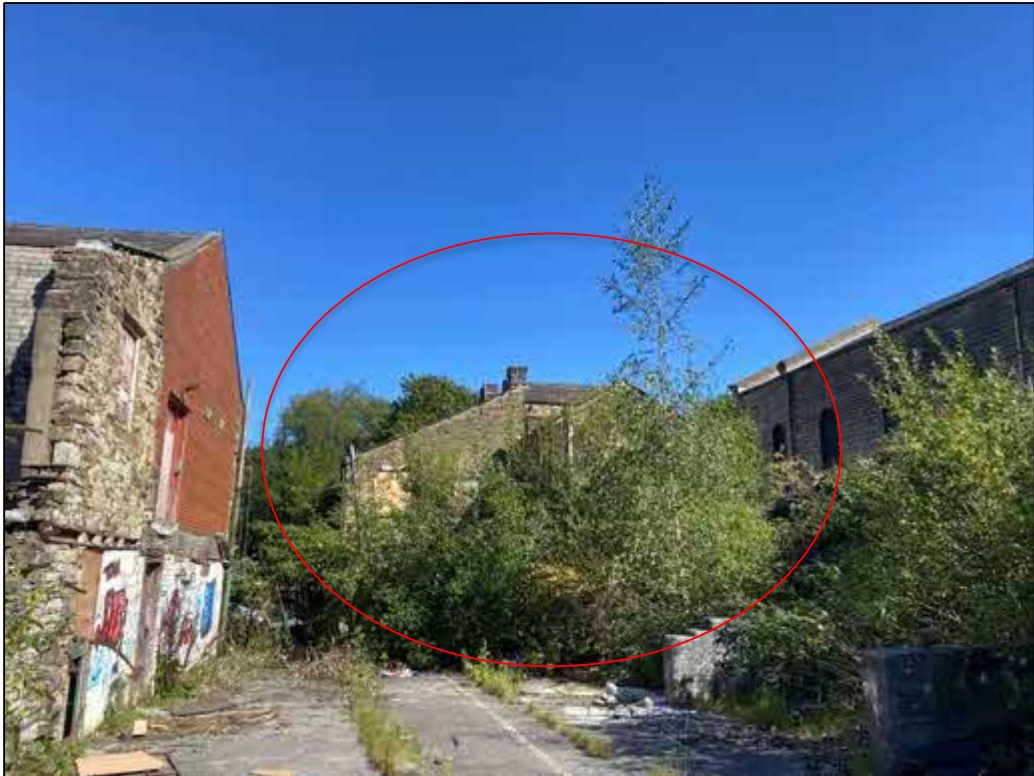
Fig 5: A rear view of the subject building. The building features several differing roof sections and smaller chimneys.

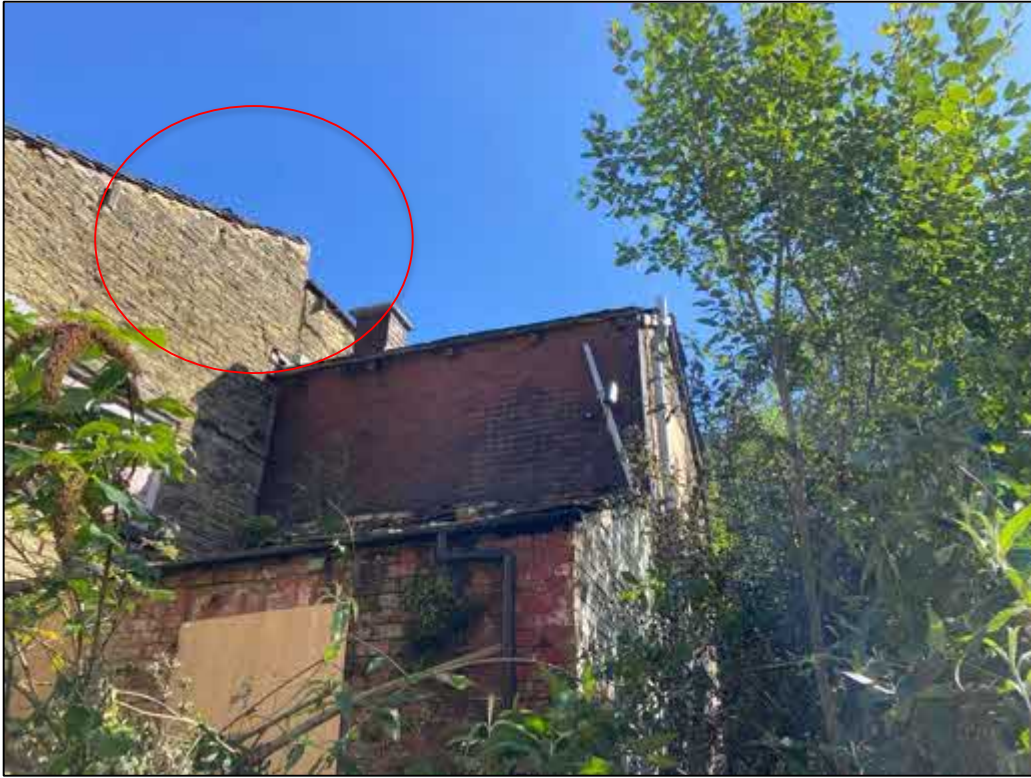
Fig 6: A closer view of the rear of the building. A differing brick section which has likely been added more recently is in fair condition. The fascia lining of the main building is in poor condition (circled).

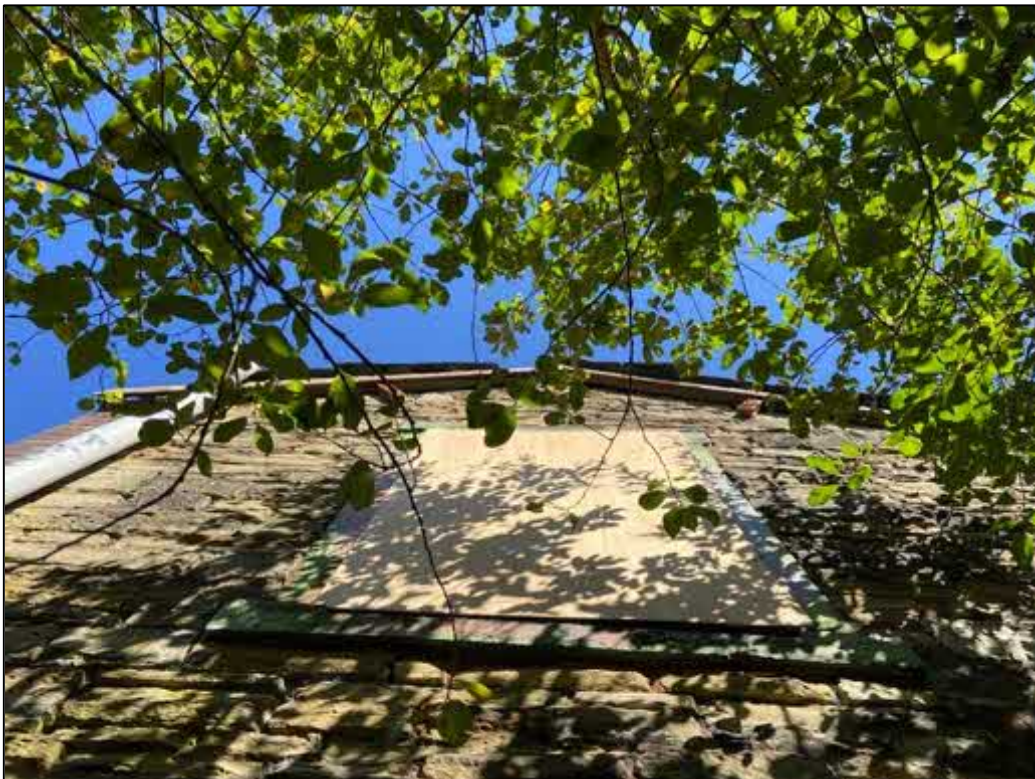
Fig 7: A view of an external wall of the building. The large brick composition creates ideal openings leading to internal wall cavities.

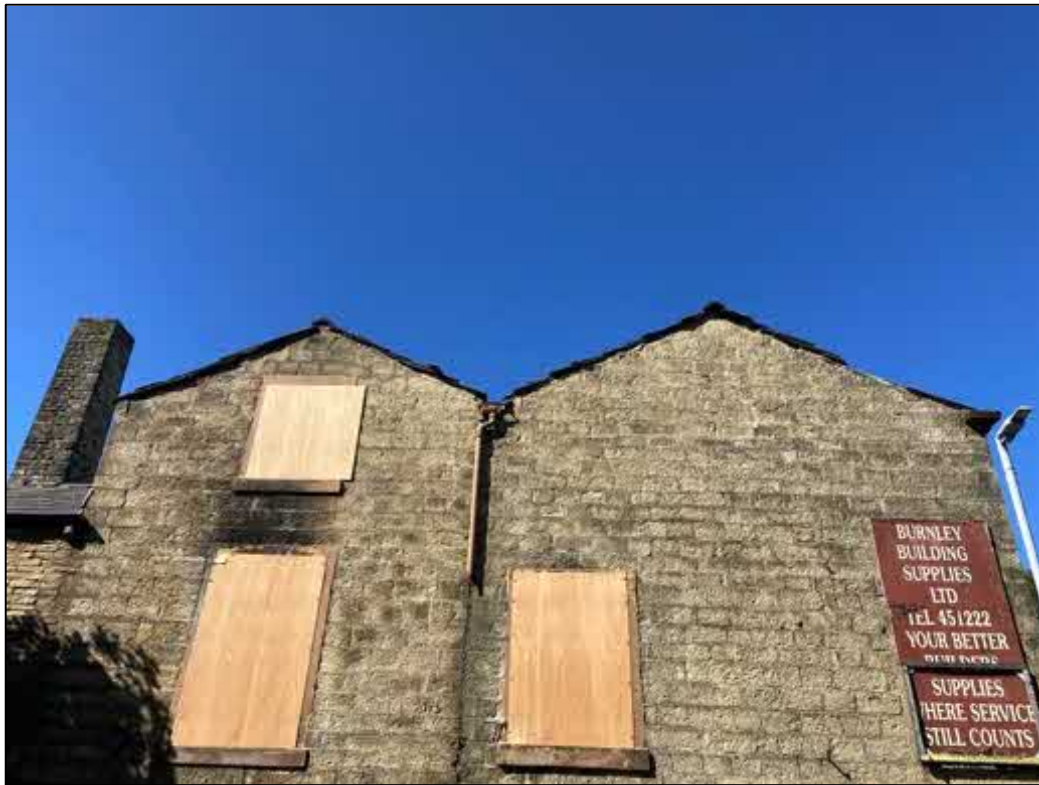
Fig 8: A view of the southern face. The twin fascia lining is in fair condition.

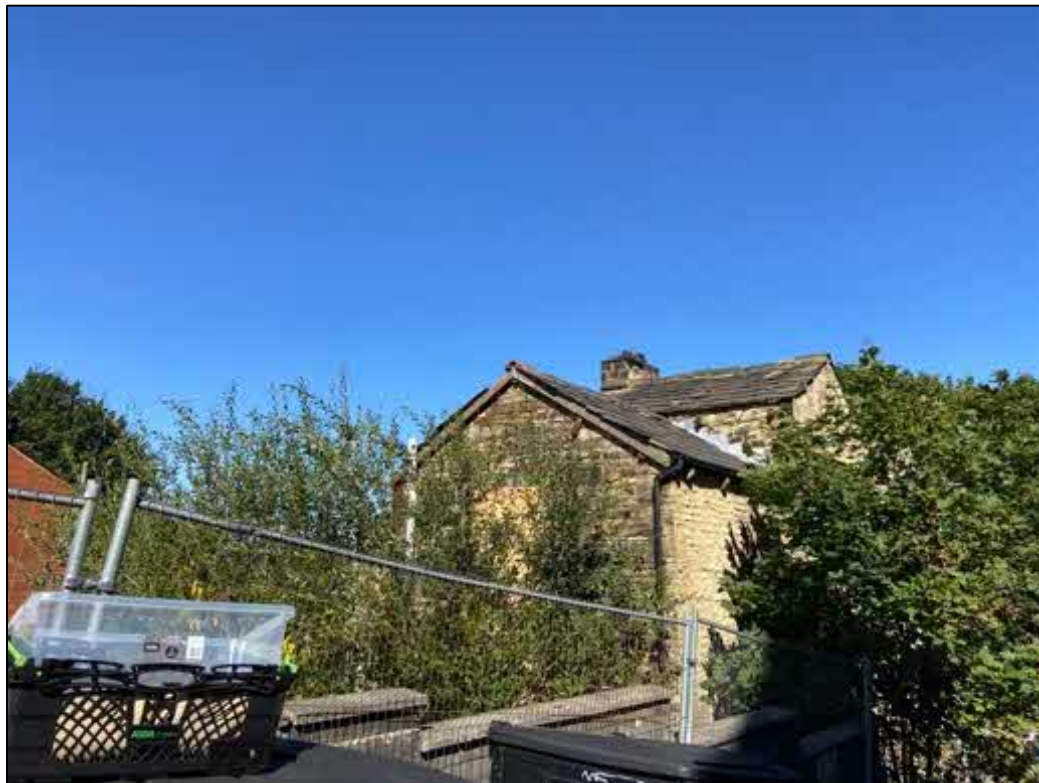
Fig 9: A further view of the rear of the building. The roof features several scattered tiles across the upper apex. The ridge lining is in fairly poor condition in places.

- 4.1 The results of the bat scoping survey suggest that the target building on site offers moderate bat roost potential. The building features several instances of ideal entry/exit points suitable for bat species. Several roof tiles were noted scattered and damaged atop the main section. Fascia linings found on the southern and rear faces are in fairly poor condition also. Large brick walls create ideal gaps between bricks that lead to wall cavities. Despite the site being within Burnley city centre, the site has direct links to adjacent tree lines and ideal foraging habitat. It was noted that street lighting is found directly outside of the target building at near fascia level.
- 4.2 No signs of bat usage were noted within the building on site.
- 4.3 Only one ancient bird nest was noted on the lower floor of the building near to the rear entrance.

- 5.1 The results of the bat scoping survey indicate that the target building offers moderate bat roost potential. No signs of activity were located during the survey.
- 5.2 Therefore, two further bat activity surveys are to be undertaken within the active bat season (May-September) to ascertain the presence or absence of bats within the building.
- 5.3 A single ancient bird nest was noted within the rear doorway of the building; therefore, **any removal/demolition required to facilitate the development should be done outside the breeding season. The scheme should monitor this and request advice if/when required.**

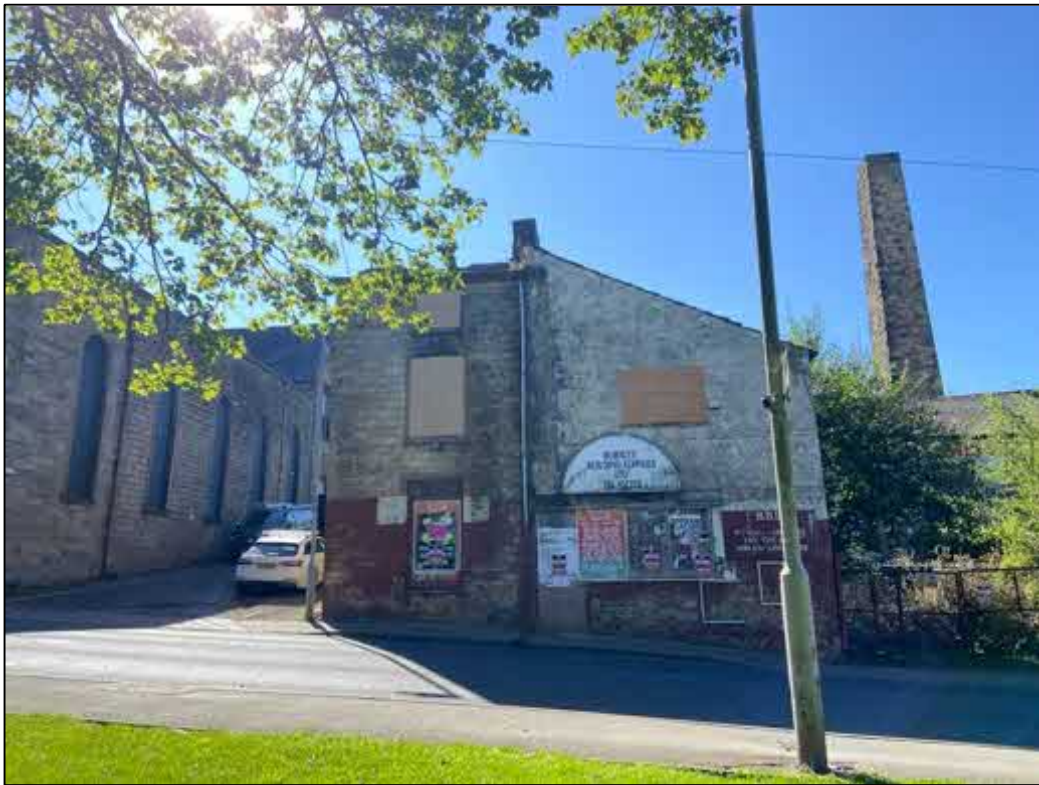
Fig 10: A front view of the subject building. The differing sections of the building can be seen. Extensive boarding across windows to deter vandalism was noted during the survey.

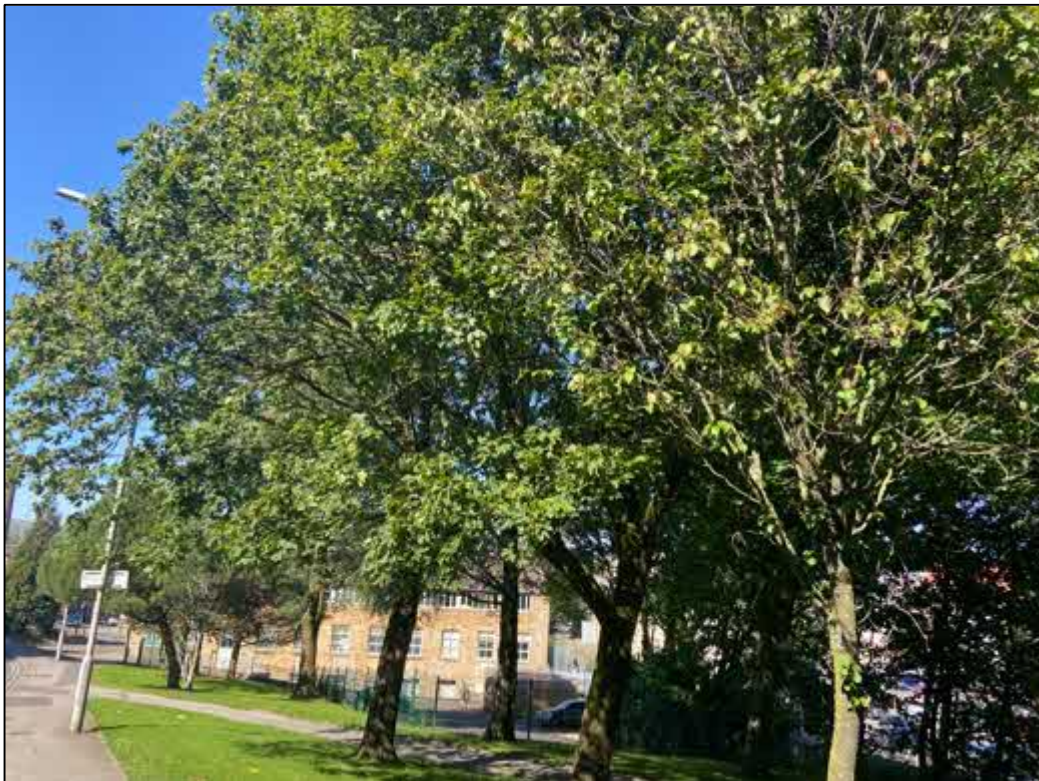
Fig 11: An amenity grassland patch features on the adjacent side of Hammerton street; this patch contains a cluster of mature trees ideal for potential bat foraging.
