BUILDING 2 - HAMMERTON STREET, BURNLEY, LANCASHIRE, BB11 1LG

We write to confirm the results of our structural inspection at the above property carried out on the 21st April 2015. The purpose of the survey was to establish the current structural condition of the building and if viable confirm the extent of works required to bring the building back into use.

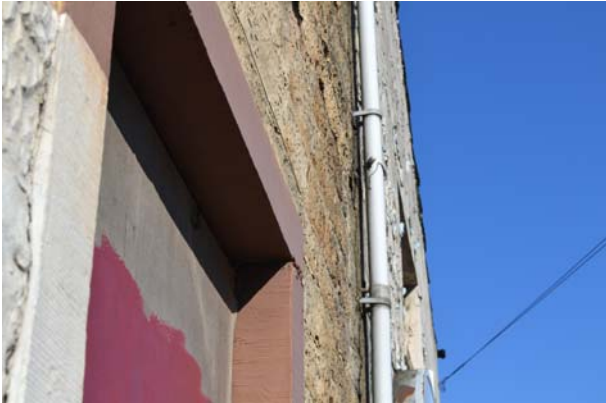
The front elevation appeared to be reasonably straight with only a slightly bulge at first floor level.

View on bulge to front elevation

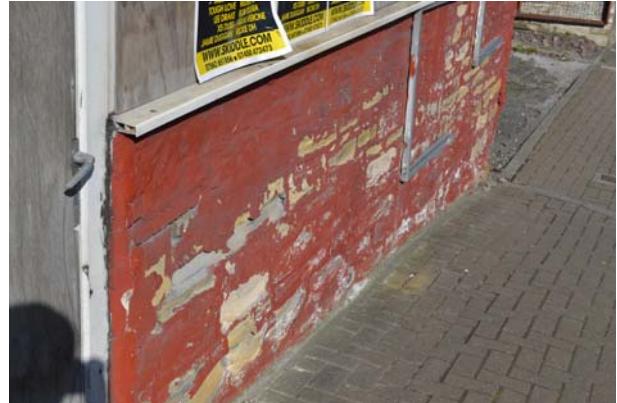
The wall had been painted and there was numerous areas of flaking paintwork revealing weathered stonework behind.

View on weathered stone to front elevation

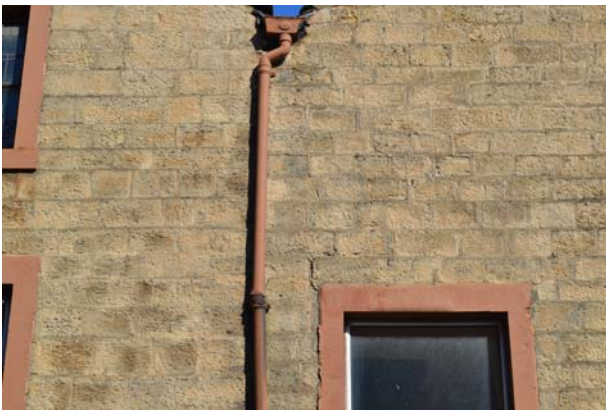
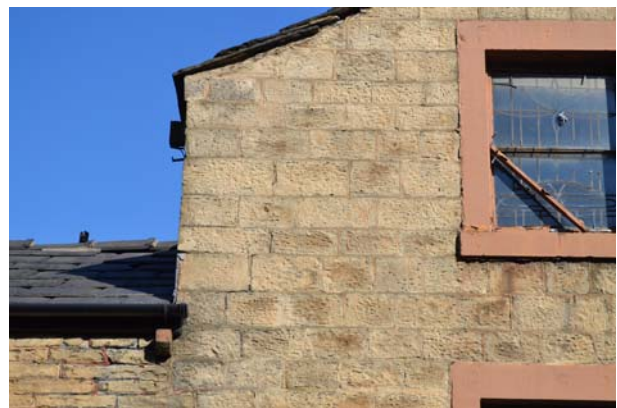
The side elevation appeared to be reasonably straight however there was a slight crack over a first floor window and to the top left hand eaves of the main building.

View on crack to left side elevation

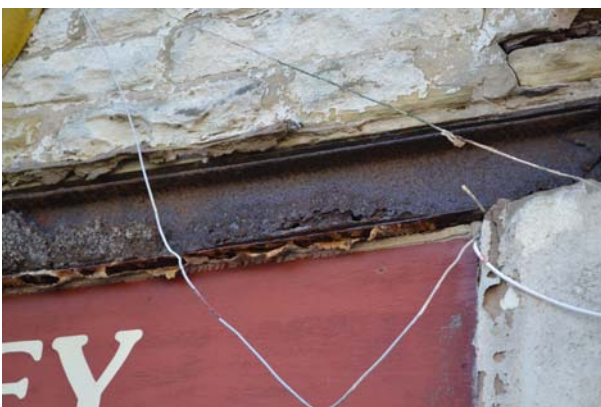
The steel lintels to the ground floor was in extremely poor condition and had suffered from excessive corrosion resulting in mass metal loss to the section.

View on defect to lintel to right side wall

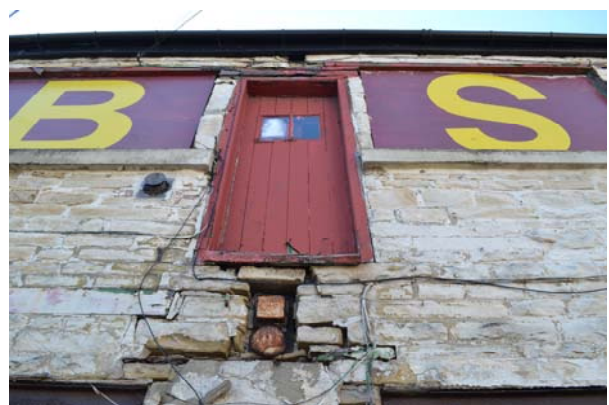
The side elevation appeared to be in a poor condition with numerous forms of wall construction, and a bulge at first floor level in the outward direction.

There was numerous areas of mortar loss to this elevation.

The timber lintels to the first floor was also in poor condition with evidence excessive decay.

View on defects to right side wall

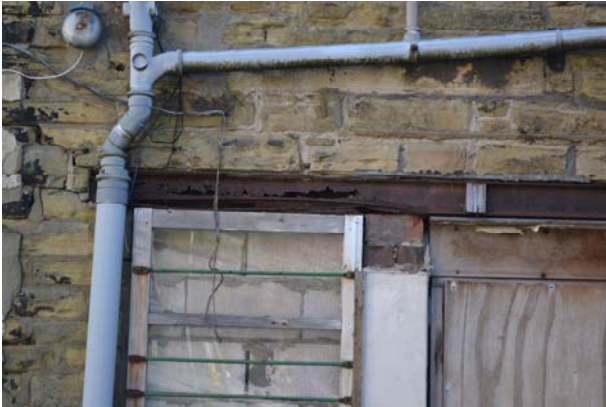
The steel lintel over the rear access door to the ground floor was in an extremely poor condition and had suffered from excessive corrosion resulting in mass metal loss to the section.

View on defect to lintel to rear wall

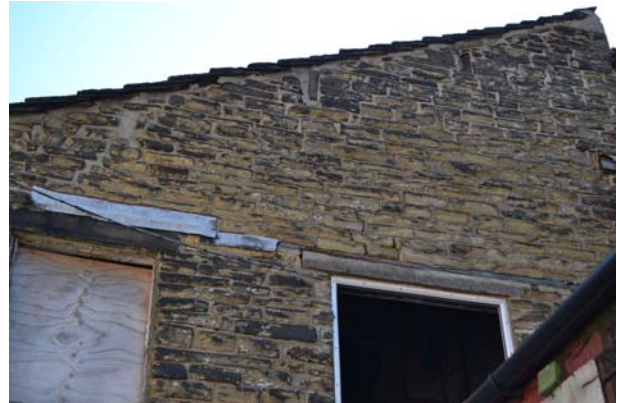
There was a number of cracks above the windows at first floor level and to the left hand side of the wall.

View on crack over first floor lintel

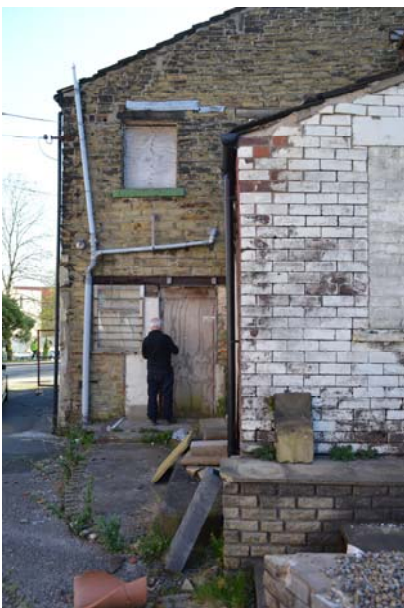
The right hand side wall to the rear extension was inclined outwards at the top.

View on inclination to wall

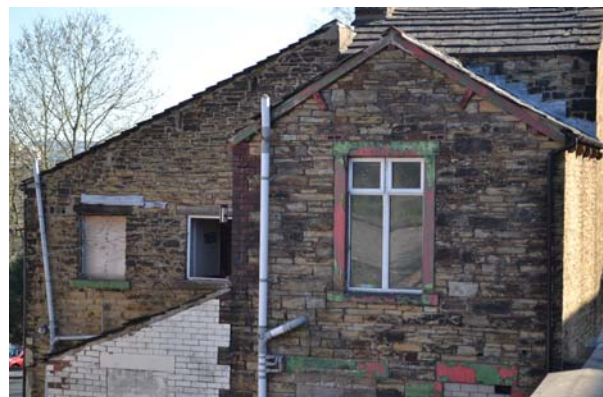
A number of original door and window openings to the rear elevation had been blocked up at some time in the past with brick or blockwork.

The rear elevation of the historic extension appeared to be relatively straight, however there was numerous areas of mortar deterioration.

View on defects to rear wall

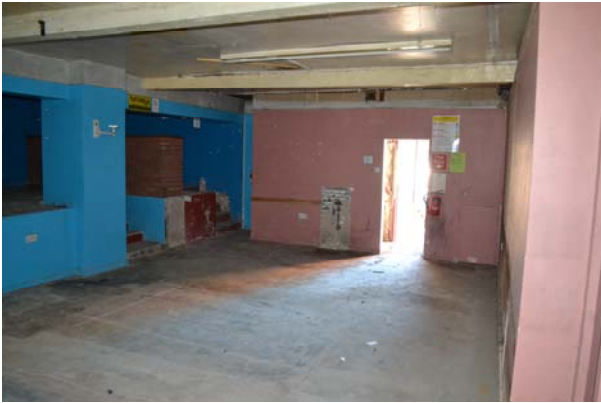
The lower ground floor appeared to be of a solid concrete construction with falls towards the side elevation with undulations throughout.

A number of internal structural alteration had previously been undertaken to create the open plan layout.

View on ground floor layout

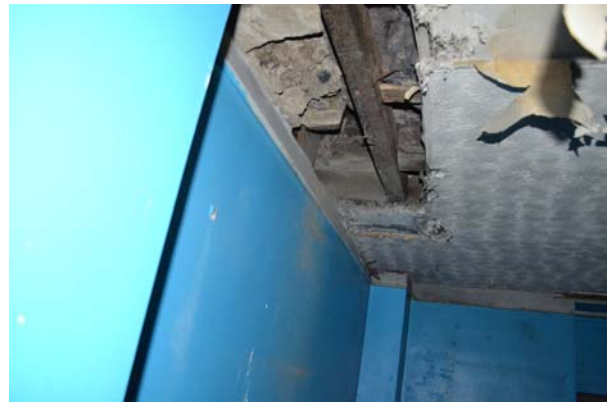
The chimney breast to ground floor level had previously been removed, and the section above was inadequately supported on the timber first floor joists.

View on lack of support to chimney structure

The building has clearly been subject to a number of poor quality structural alterations in the past, the nature of which has contributed to the deterioration of the building. In particular the lack of support to the chimney breast at ground floor ceiling.

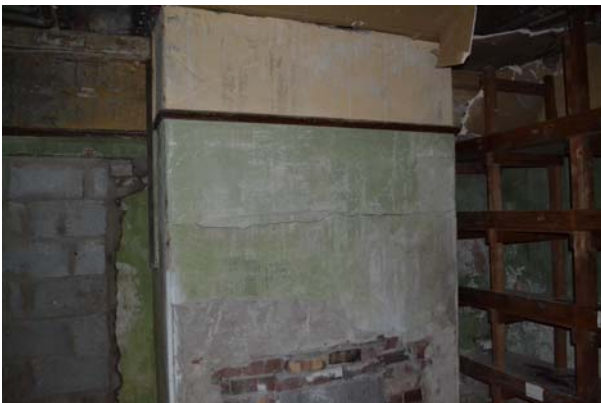
There was a number of defects to the wall construction to the rear room within the historic construction, consist of cracking to the brickwork / stonework.

There was also evidence of decay to the large timber beams and floor joists supporting the first floor above.

View on defects to ground floor room

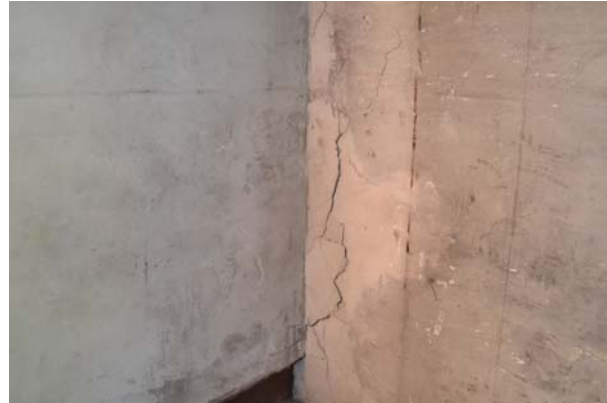
There was a vertical crack between the central spine wall and the front wall of the building which is representative of the defects observed externally.

View on crack to first floor spine wall

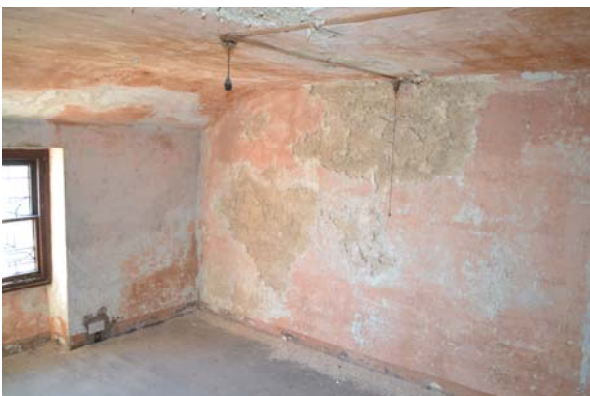
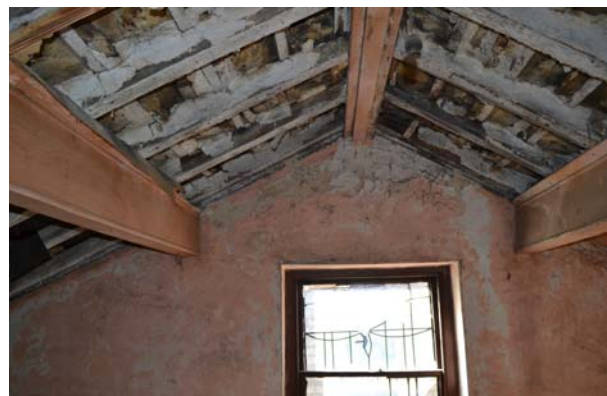
The walls to the second floor was generally in a poor condition with numerous areas of deteriorated plasterwork.

There was a vertical crack to the central spine wall in a similar location to the crack observed at first floor level.

The rafters to the main roof was exposed in a number of locations where clear gaps were evident in the stone slate finishes. The rafters also appeared to be suffering from timber decay to a varying degree of severity.

View on defects to second floor room
