Subsidence Investigation Report

Peter Scott and Christine Scott, The Old School, The Common, Mellis, Eye Suffolk IP23 8EE

Site Investigation and Drainage Report

Drainage Report

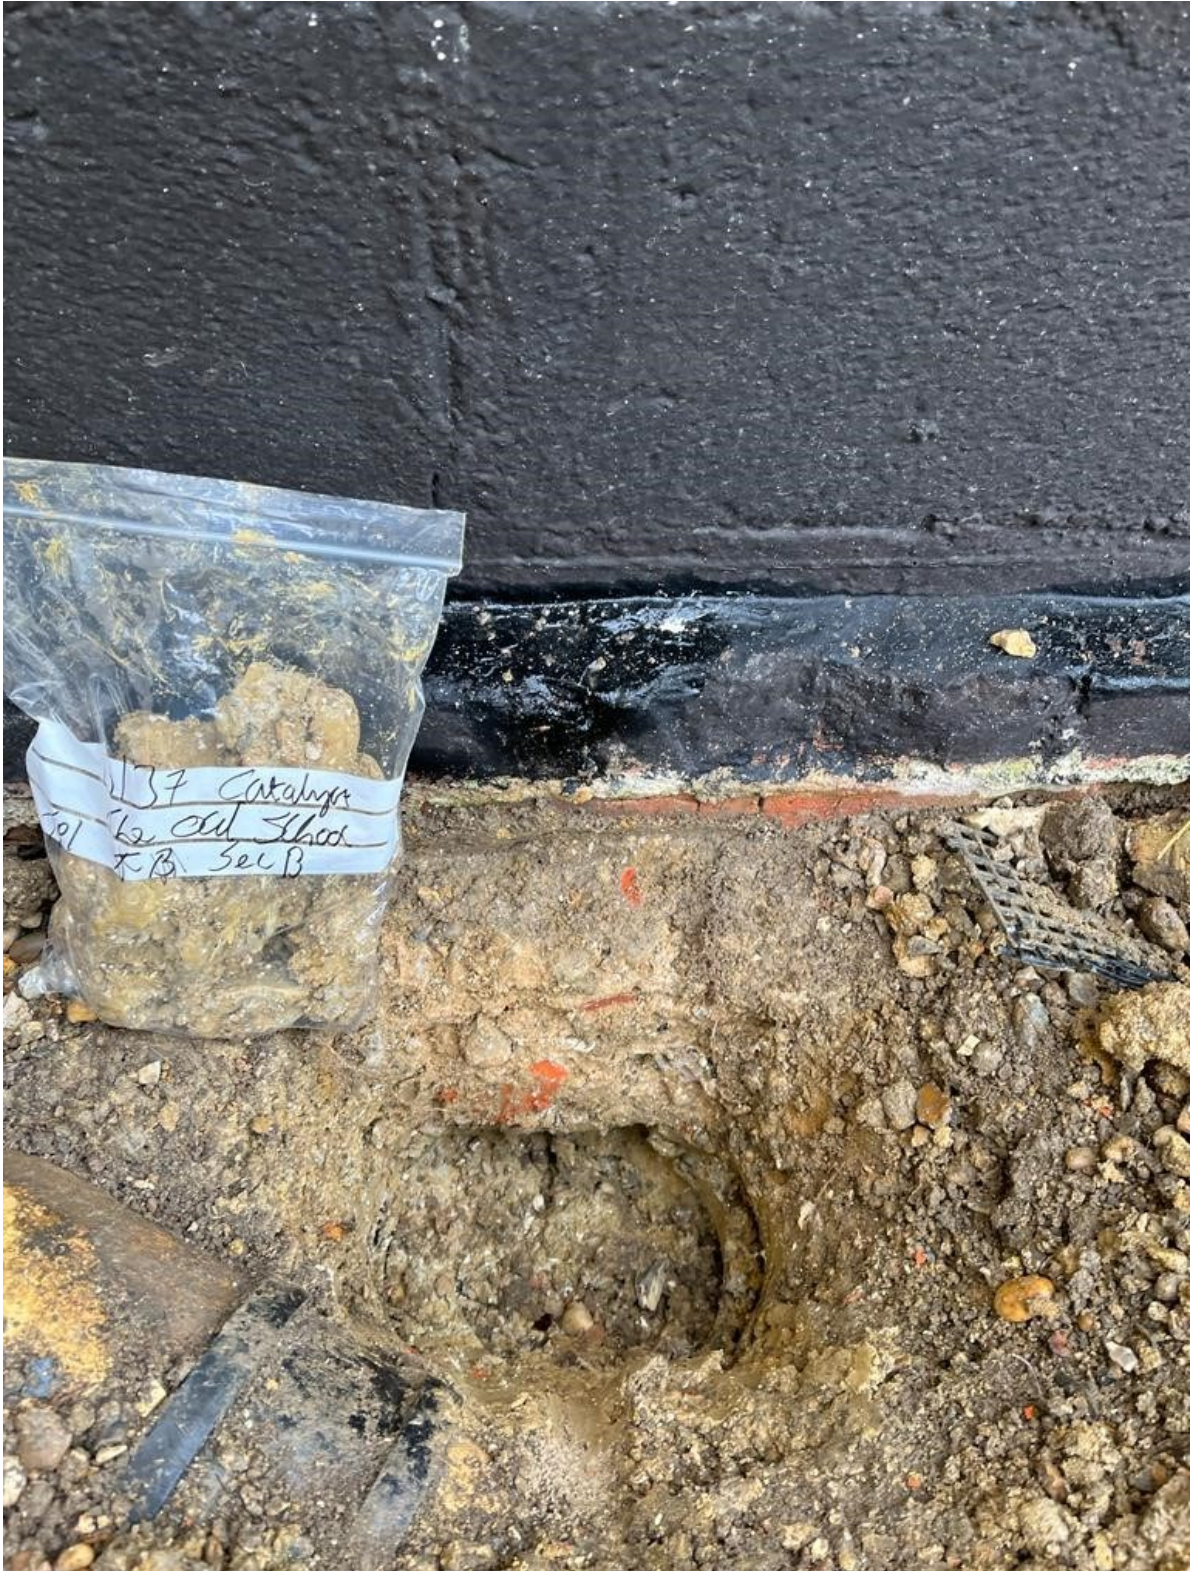
Photograph 1 - Trial Pit 1

Live roots noted beneath foundation level in stiff clay subsoil.

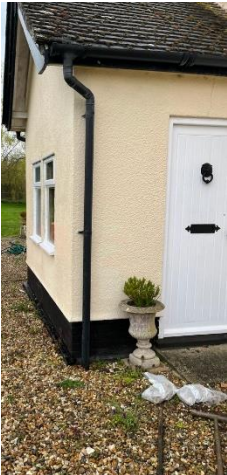
Condition: Satisfactory condition

Excavate and replace the rest bend of RWP1 & 2 with up to 1m pipework, perform further CCTV survey.

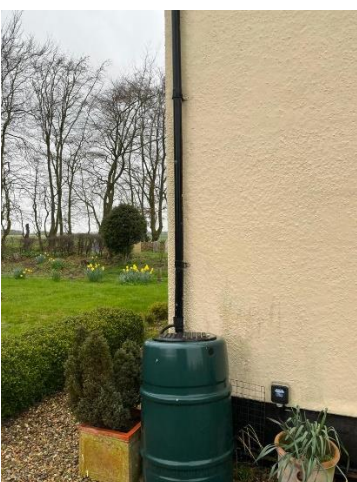
RWP2

Condition: Satisfactory condition

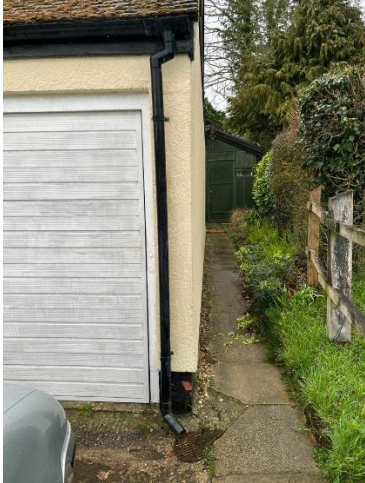
Condition: Satisfactory condition

Excavate and replace RWG1 with up to 1m pipework and further CCTV survey.

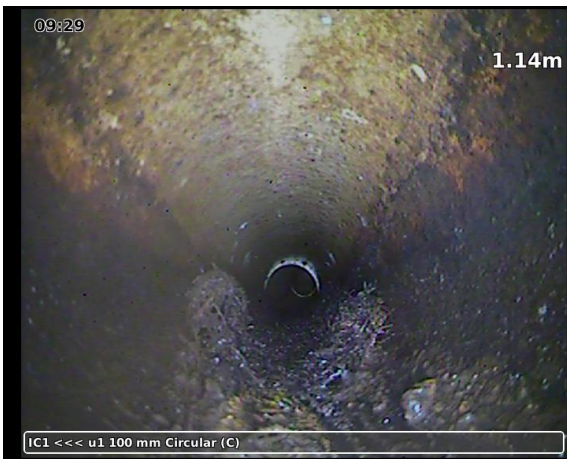
20230328-092631-snap0002.jpg, 00:02:58, 0.24 m
Fine settled deposits, 20% area loss

Repairs are also required to S1 and S2, however, it is likely internal excavations will be necessary to complete the repairs. We will assess this whilst on site conducting further investigations and provide recommendations.

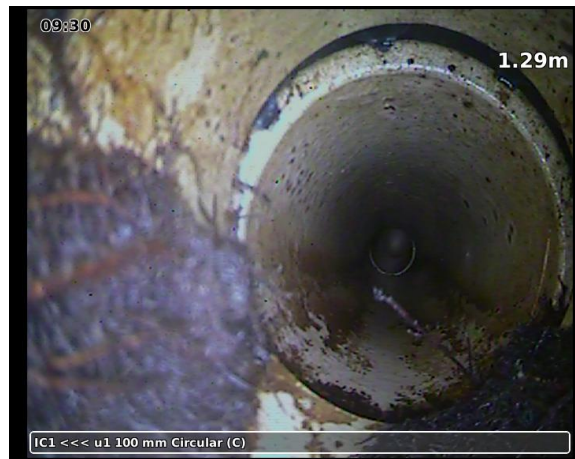
20230328-092631-snap0003.jpg, 00:03:27, 1.29 m
Large open joint

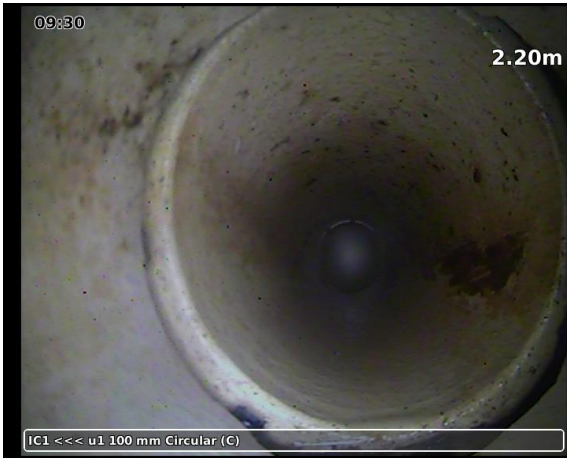
20230328-092631-snap0004.jpg, 00:03:51, 2.20 m
Medium open joint

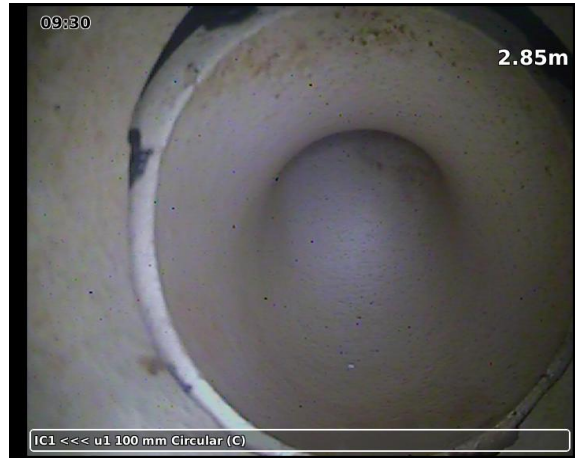
20230328-092631-snap0005.jpg, 00:04:02, 2.85 m
Medium open joint

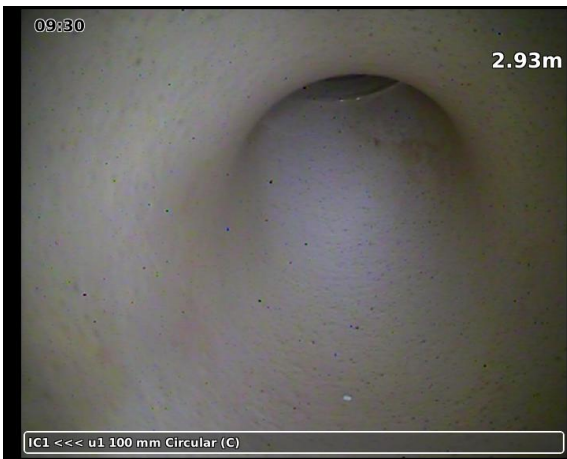
20230328-092631-snap0006.jpg, 00:04:07, 2.93 m
Line deviates up, full

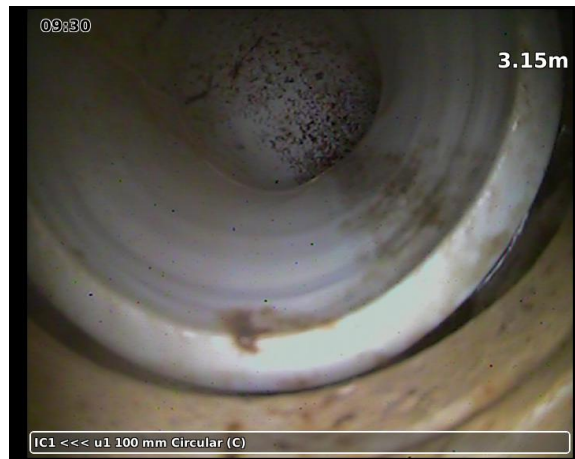
20230328-092631-snap0007.jpg, 00:04:21, 3.15 m
Medium open joint

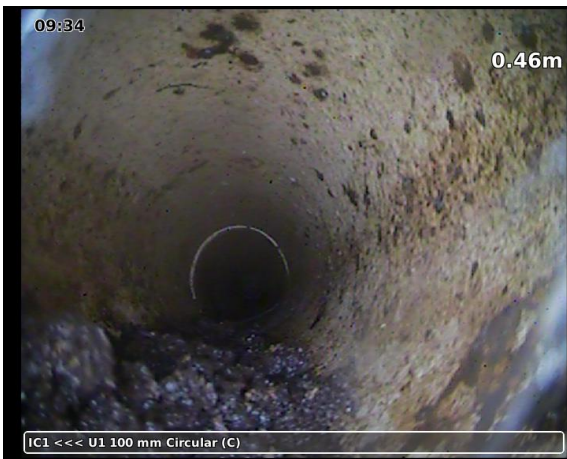
20230328-093329-snap0002.jpg, 00:00:29, 0.46 m
Fine settled deposits, 5% area loss

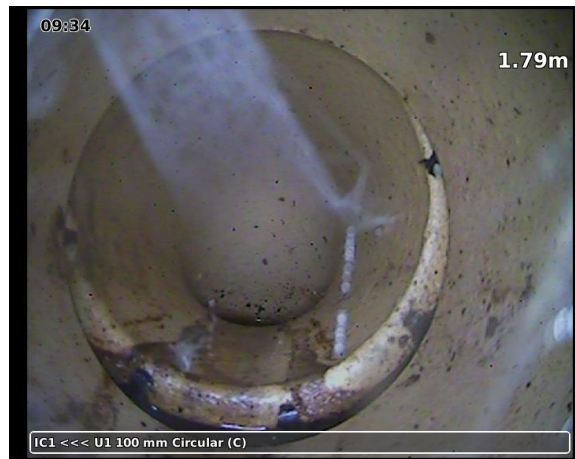
20230328-093329-snap0003.jpg, 00:00:54, 1.79 m
Medium open joint

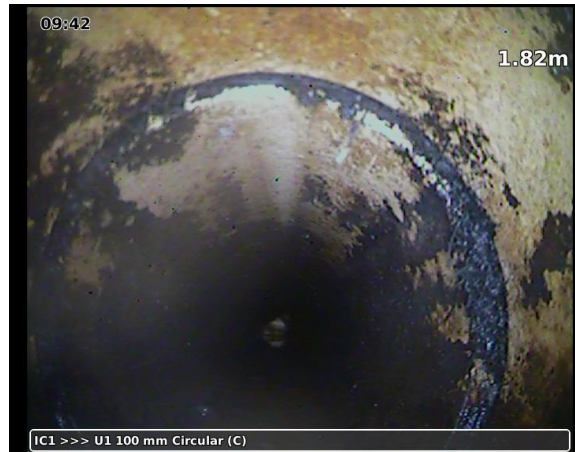
20230328-094135-snap0002.jpg, 00:00:32, 1.82 m
Roots

S3: Carry out high pressure water jetting / root cutting. Install 9m x 100mm structural liner.

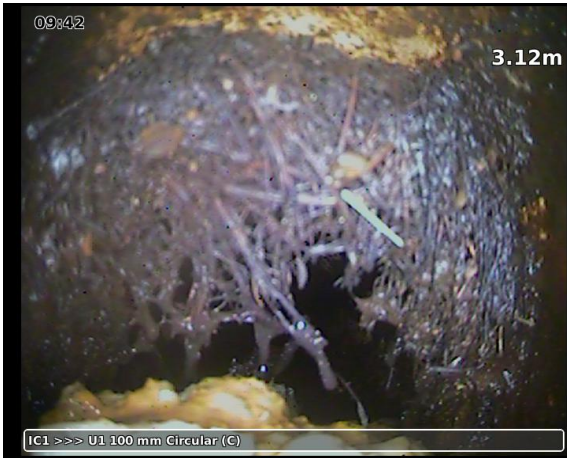
20230328-094135-snap0003.jpg, 00:00:47, 3.08 m
Roots

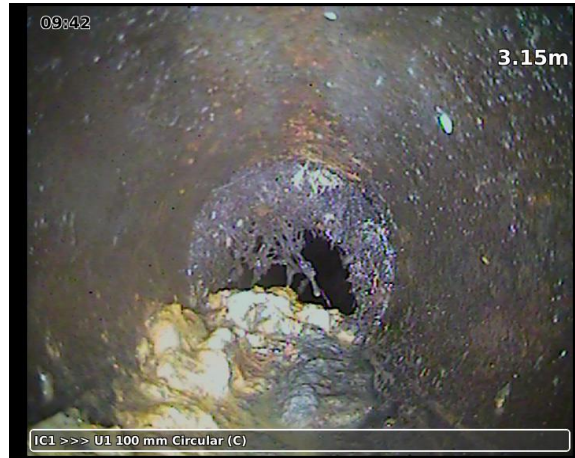
20230328-094135-snap0004.jpg, 00:01:02, 3.15 m
Fine settled deposits, 20% area loss

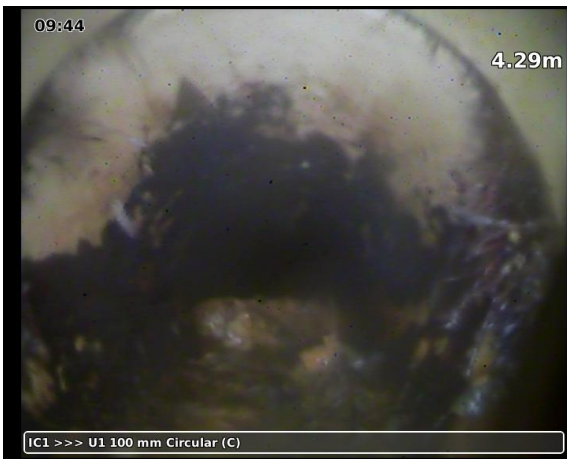
20230328-094135-snap0005.jpg, 00:02:32, 4.29 m
Roots

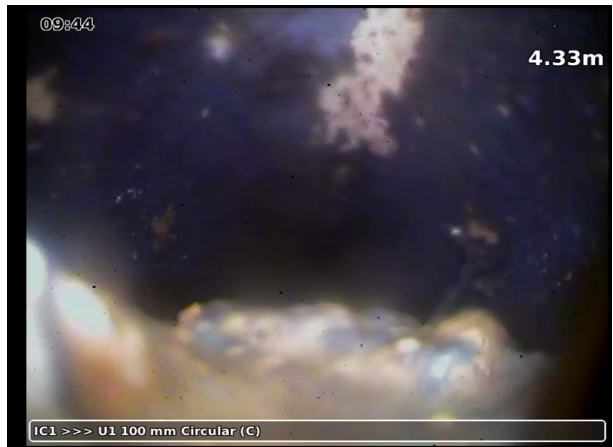
IC1X_25435ae2-dceb-4ab0-8dd4-7d4206f49c7d_20230403_1
00133_106.jpg, 00:02:37, 4.33 m
Fine settled deposits, 30% area loss

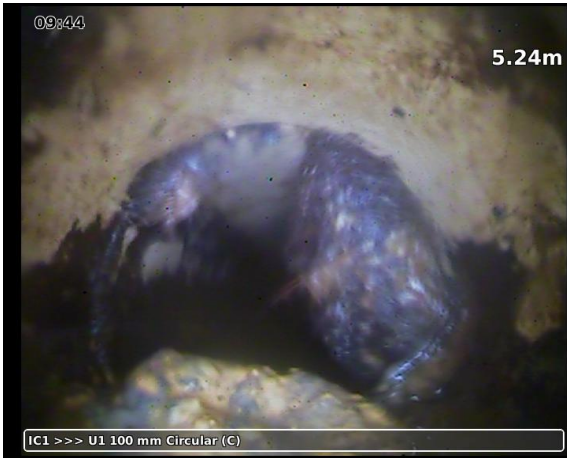
20230328-094135-snap0006.jpg, 00:02:46, 5.24 m
Roots

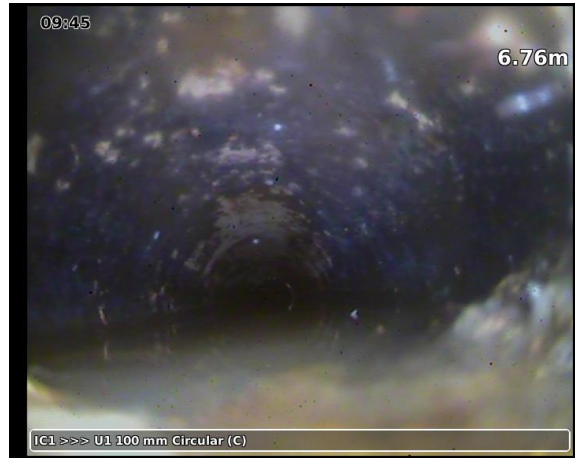
20230328-094135-snap0007.jpg, 00:03:37, 6.76 m
Water level, 25% of the height

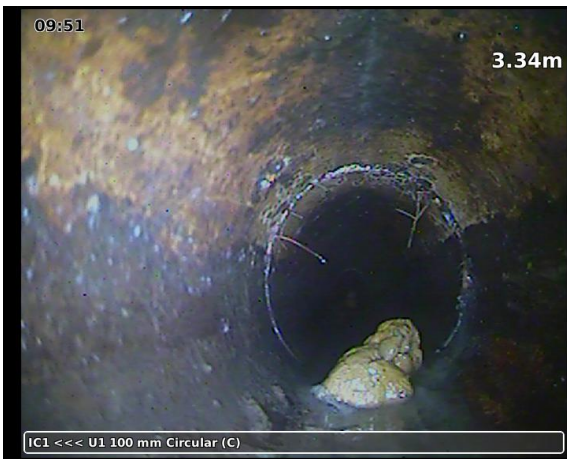
20230328-095032-snap0002.jpg, 00:00:34, 3.34 m
Roots

S4: Carry out high pressure water jetting / root cutting. Install structural patch liner at 3.34m.
