ARBORICULTURAL REPORT  
at  
54 Vicars Hill  
Lewisham  
London  
SE13 7JL

JCA Ref:  
18941/ChC

54 Vicars Hill, Lewisham, London, SE13 7JL.

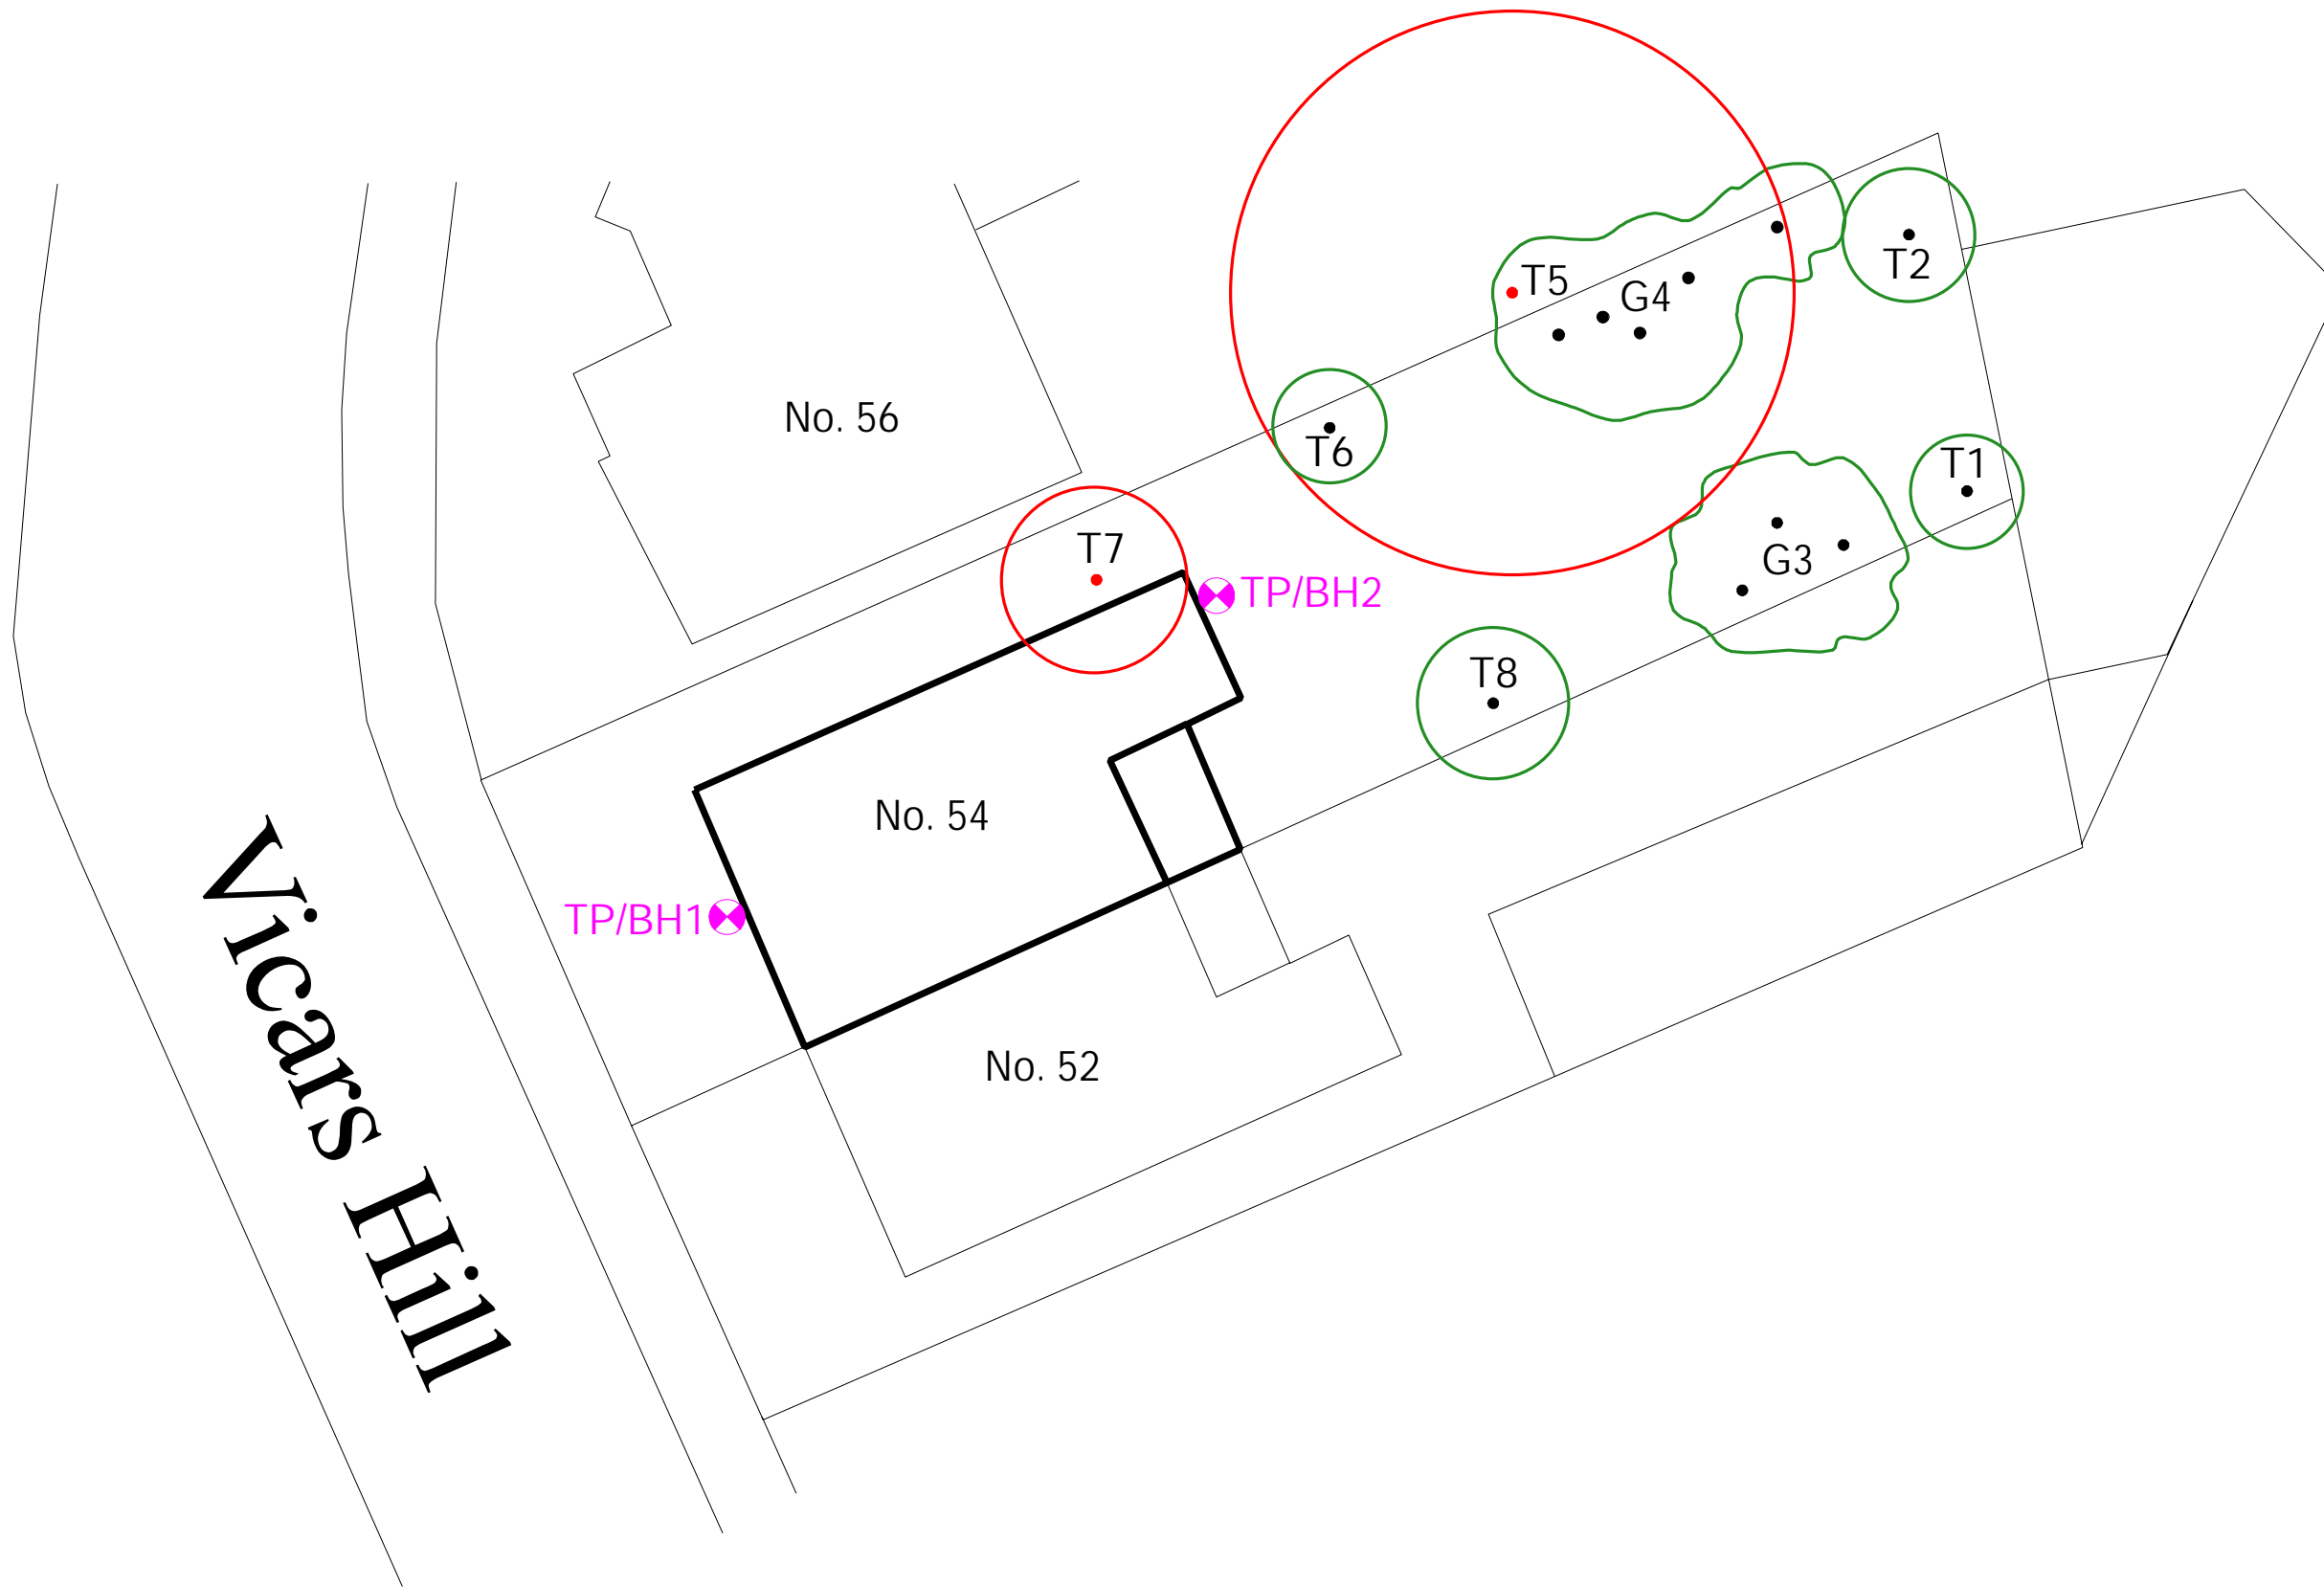
- 3.2.1 Please refer to the site plan at Appendix 2 for an indication of the trial pit/borehole locations.
- 3.2.2 Trial pit/borehole 1 revealed a concrete/brick corbel foundation at a maximum depth of 1100mm below ground level.
- 3.2.3 Trial pit/borehole 2 revealed a concrete/brick corbel foundation at a maximum depth of 400mm below ground level.
