CCTV REPORT FOR: 54 VICARS HILL
LONDON
SE13 7JL

Insured: Ms Quartano & Mr Bailey
Reference: DLG-SN-22-004841

Site Visit: 05-Oct-22
Report Date: 30-Nov-22

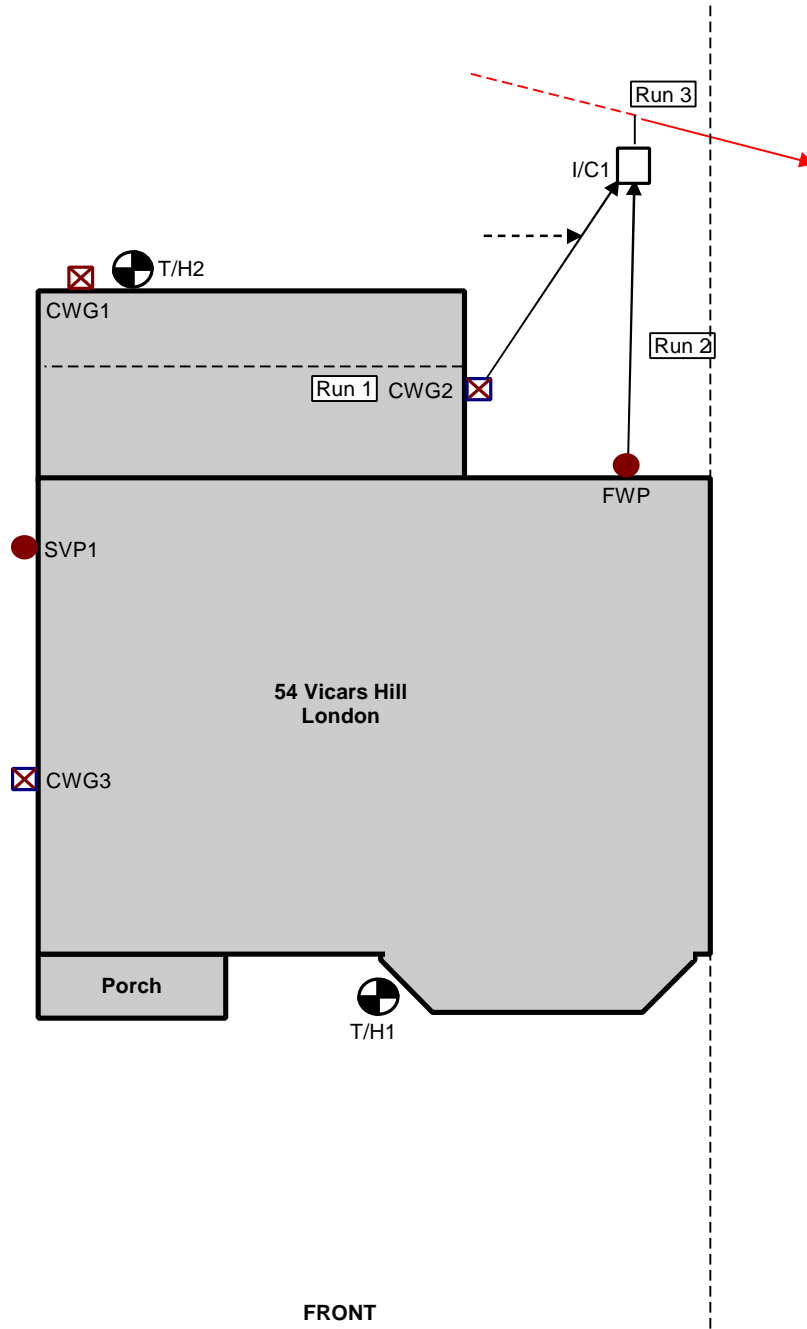
Metres	Faults / Defects	Remarks
0.00		At I/C1
0.60		Connection at 2 o'clock
1.70	Displaced Joint Medium	
2.30	Circumferential Crack 12 to 12 o'clock	
3.20	Circumferential Crack 1 to 9 o'clock	
3.80	Displaced Joint Medium	
4.00		At CWG2
		End of survey

Metres	Faults / Defects	Remarks
0.00		At I/C1
0.65	Displaced Joint Medium	
2.30	Displaced Joint Medium	
3.10	Circumferential Crack 9 to 4 o'clock	
3.90	Displaced Joint Medium	
5.50		Debris (Silt)
6.00		At FWP
		End of survey

Metres	Faults / Defects	Remarks
0.00		At I/C1
0.10		Connection onto shared line
1.00		Boundary
2.00	No Visible Defects	Past area of concern
		End of survey

Excavate and replace CWG, allowing for 1m pipe and junction at 0.6m.

Carry out high pressure water jetting to prepare pipework for lining. Install a structural liner from excavation downstream for 3m

Carry out high pressure water jetting to prepare pipework for lining. Install a structural liner from I/C1 upstream for 6m.

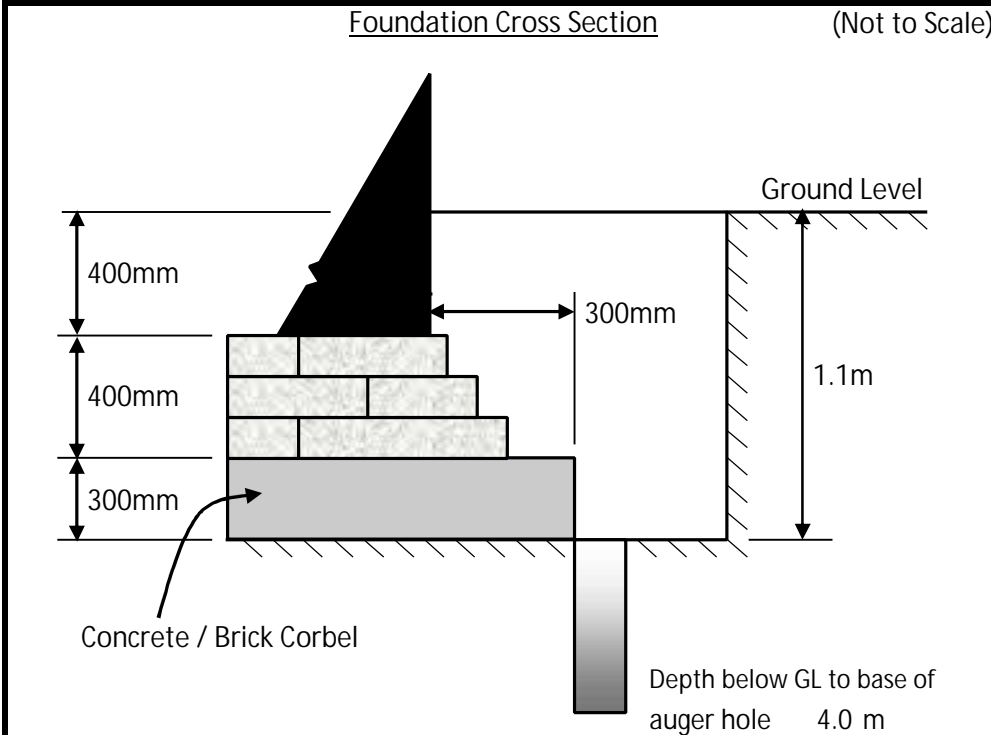
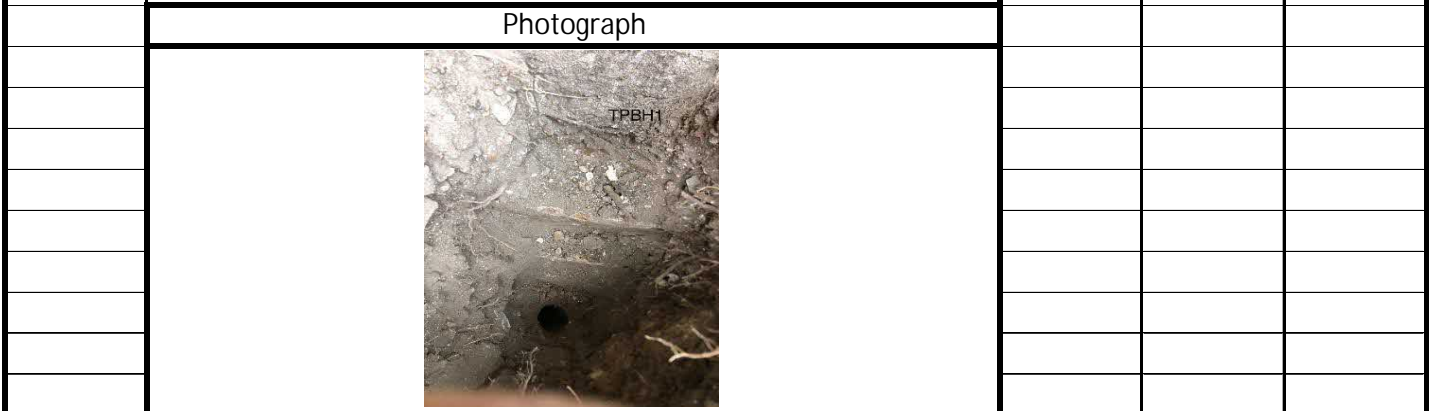
Location: Front bay T/H No. 1
 Ground Surface: Dry Weather: Dry Date: 05-Oct-22

From 1.1m

Down to 1.5m

up to 1mm diameter

Depth (m)	Soil Descriptions (NB: Field crew description only)	Test Type	Depth (m)	
			From	To
G.L.				
1.10	Stiff brown slightly sandy CLAY with occasional medium gravel	P.P. 4.0	1.100	
1.50	Stiff brown slightly sandy CLAY with rare medium gravel & root fibre	P.P. 4.0	1.500	
2.50	Stiff brown sandy CLAY with rare medium gravel	P.P. 3.0	2.000	
3.00	Stiff brown sandy CLAY	P.P. 3.0	2.500	
4.00	End of Borehole	P.P. 3.0	3.000	
		P.P. 3.0	3.500	
		P.P. 3.0	4.000

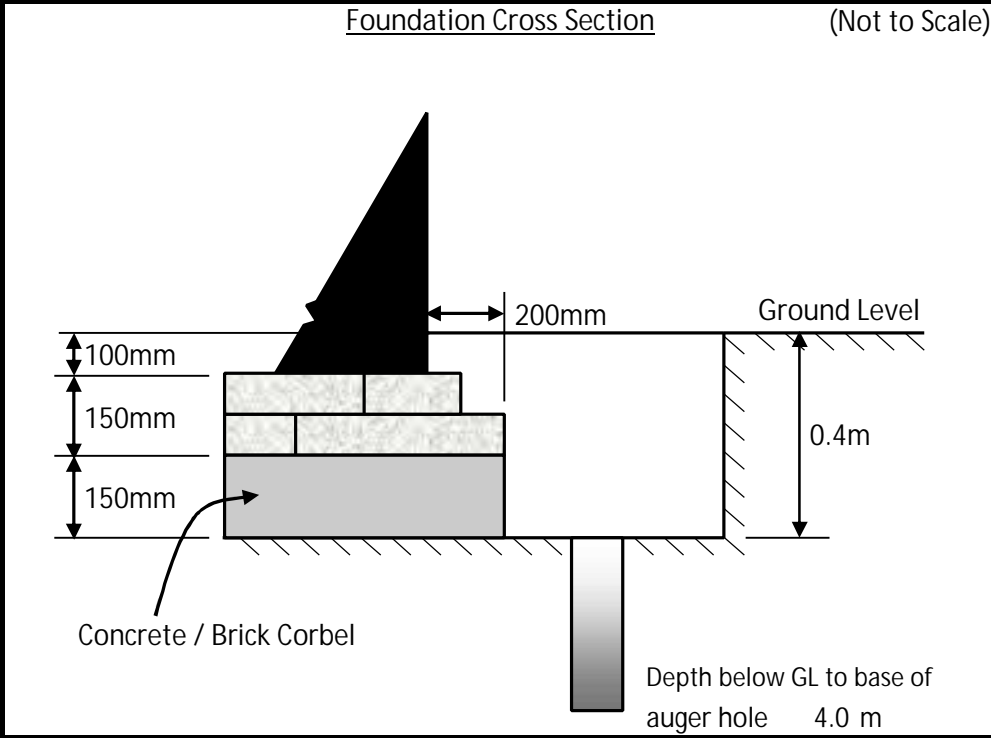
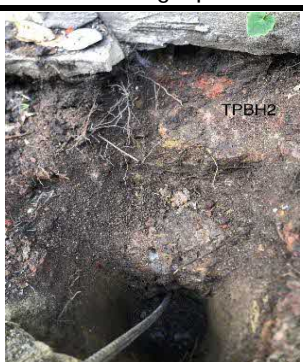
Location: Rear addition	T/H No. 2
Ground Surface: Dry	Weather: Dry
	Date: 05-Oct-22

Roots Depth & Diameter:
From 0.4m
Down to 0.8m
up to 1mm diameter
Water Depth Hit & Rise:
None observed on site
Reason for Termination :
Hole at instructed depth

Depth (m)	Soil Descriptions (NB: Field crew description only)	Test Type	Depth (m)	
			From	To
G.L.				
0.40	Soft brown CLAY with rare medium gravel	P.P. 1.5	0.400	
1.00	Firm brown slightly sandy CLAY	P.P. 2.5	1.000	
1.50	Firm brown slightly sandy CLAY with rare medium gravel	P.P. 3.0	1.500	
2.00	Firm brown slightly sandy CLAY	P.P. 3.0	2.000	
4.00	End of Borehole	P.P. 3.0	2.500	
		P.P. 3.0	3.000	
		P.P. 3.0	3.500	
		P.P. 3.0	4.000	
	<u>Photograph</u>

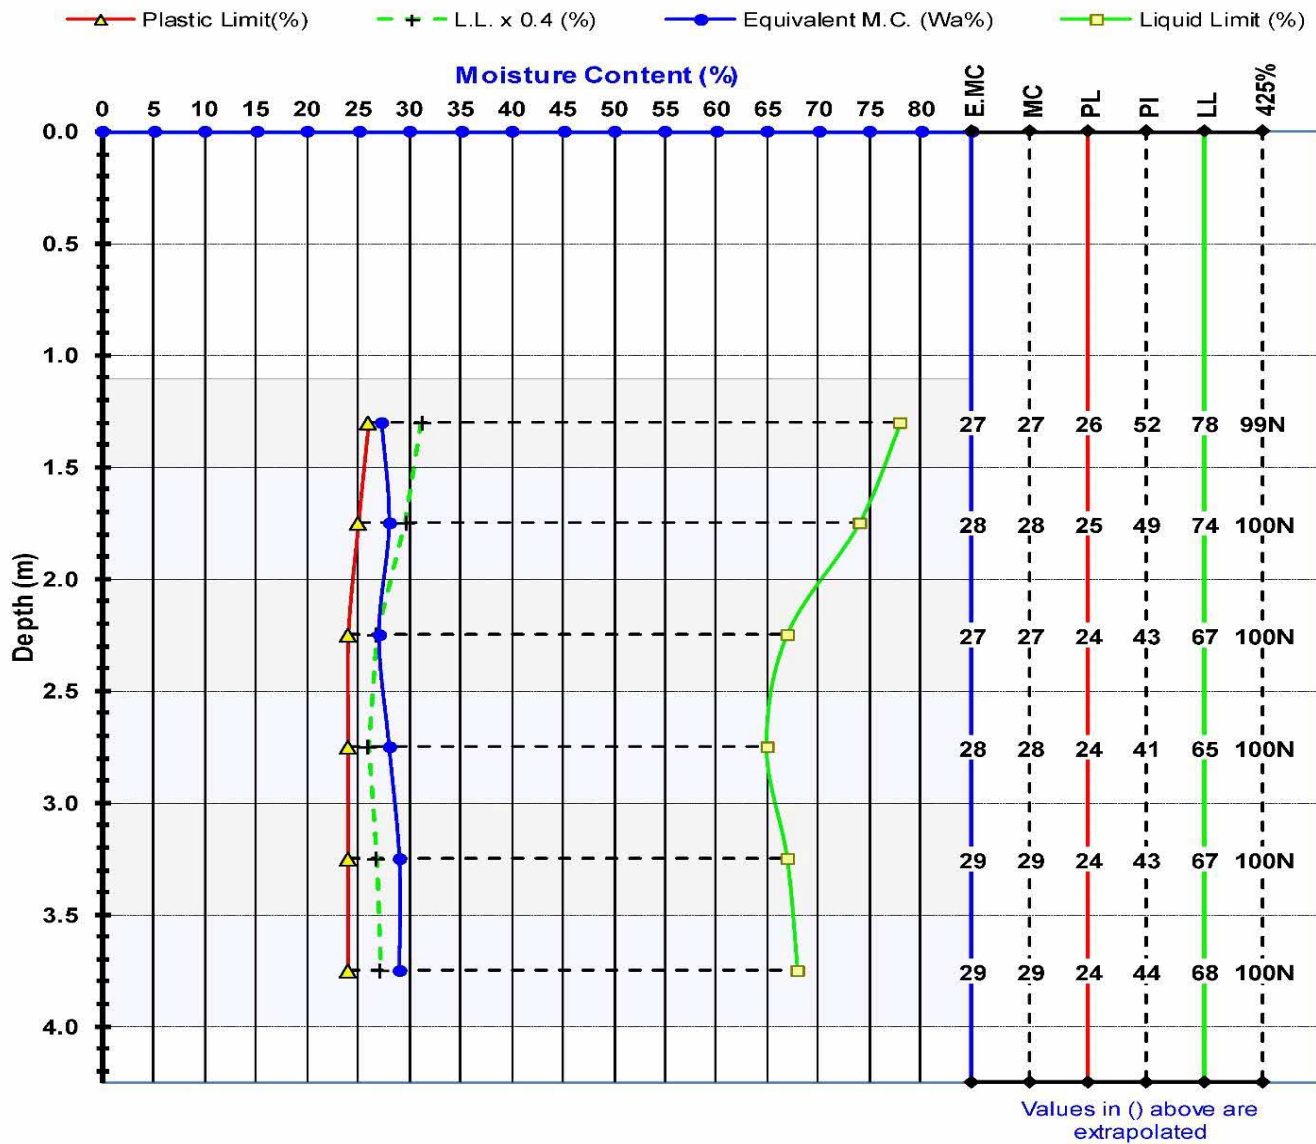
Depth T (m)	Depth B (m)	1 - Front LHS of bay Brief Soil Description	Plasticity (BS 5930)	Volume Change M.PI (BRE 240)
1.1	1.5	Stiff brown slightly sandy CLAY with occasional medium gravel	V. high CV	51% High
1.5	2	Stiff brown slightly sandy CLAY with rare medium gravel & root fibre	V. high CV	49% High
2	2.5	Stiff brown slightly sandy CLAY with rare medium gravel & root fibre	High CH	43% High
2.5	3	Stiff brown sandy CLAY with rare medium gravel	High CH	41% High
3	3.5	Stiff brown sandy CLAY	High CH	43% High
3.5	4	Stiff brown sandy CLAY	High CH	44% High

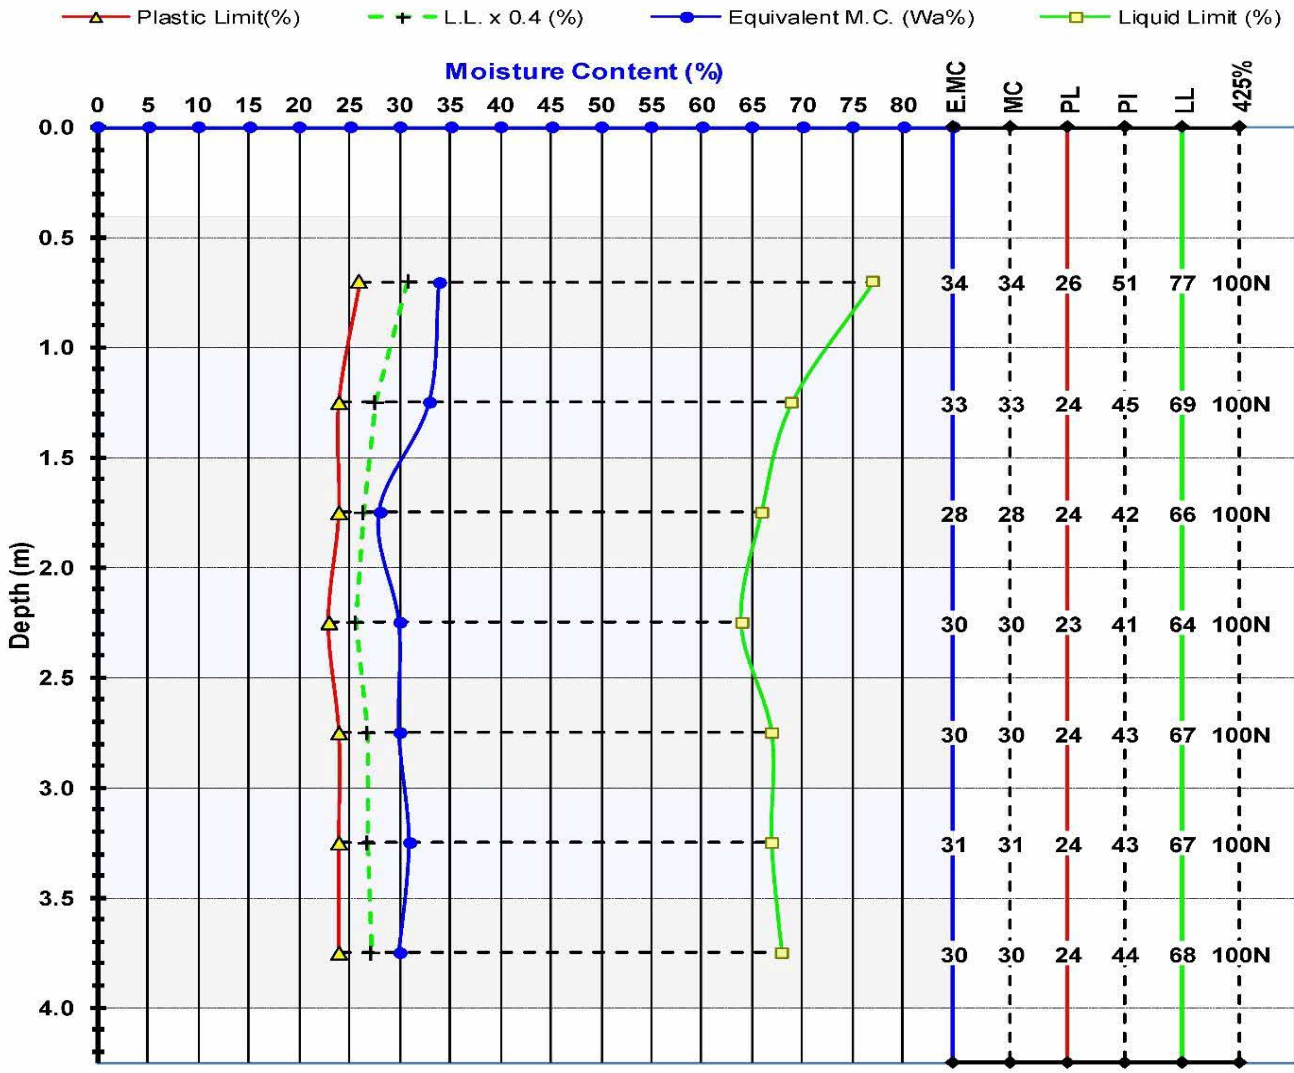
Depth T (m)	Depth B (m)	2 - Rear of addition	Plasticity (BS 5930)	Volume Change (BRE 240)	
		Brief Soil Description			
0.4	1	Soft brown CLAY with rare medium gravel	V. high CV	51%	High
1	1.5	Firm brown slightly sandy CLAY	High CH	45%	High
1.5	2	Firm brown slightly sandy CLAY with rare medium gravel	High CH	42%	High
2	2.5	Firm brown slightly sandy CLAY	High CH	41%	High
2.5	3	Firm brown slightly sandy CLAY	High CH	43%	High
3	3.5	Firm brown slightly sandy CLAY	High CH	43%	High
3.5	4	Firm brown slightly sandy CLAY	High CH	44%	High
