**Re: 7 Blenheim Road, Deal, CT14 7AJ**

Further to your instruction to inspect the above property and report on the two chimney stacks on the south elevation, I report as follows.

12946 – 7 Blenheim Road, Deal  
Record photographs  
6<sup>th</sup> July 2023

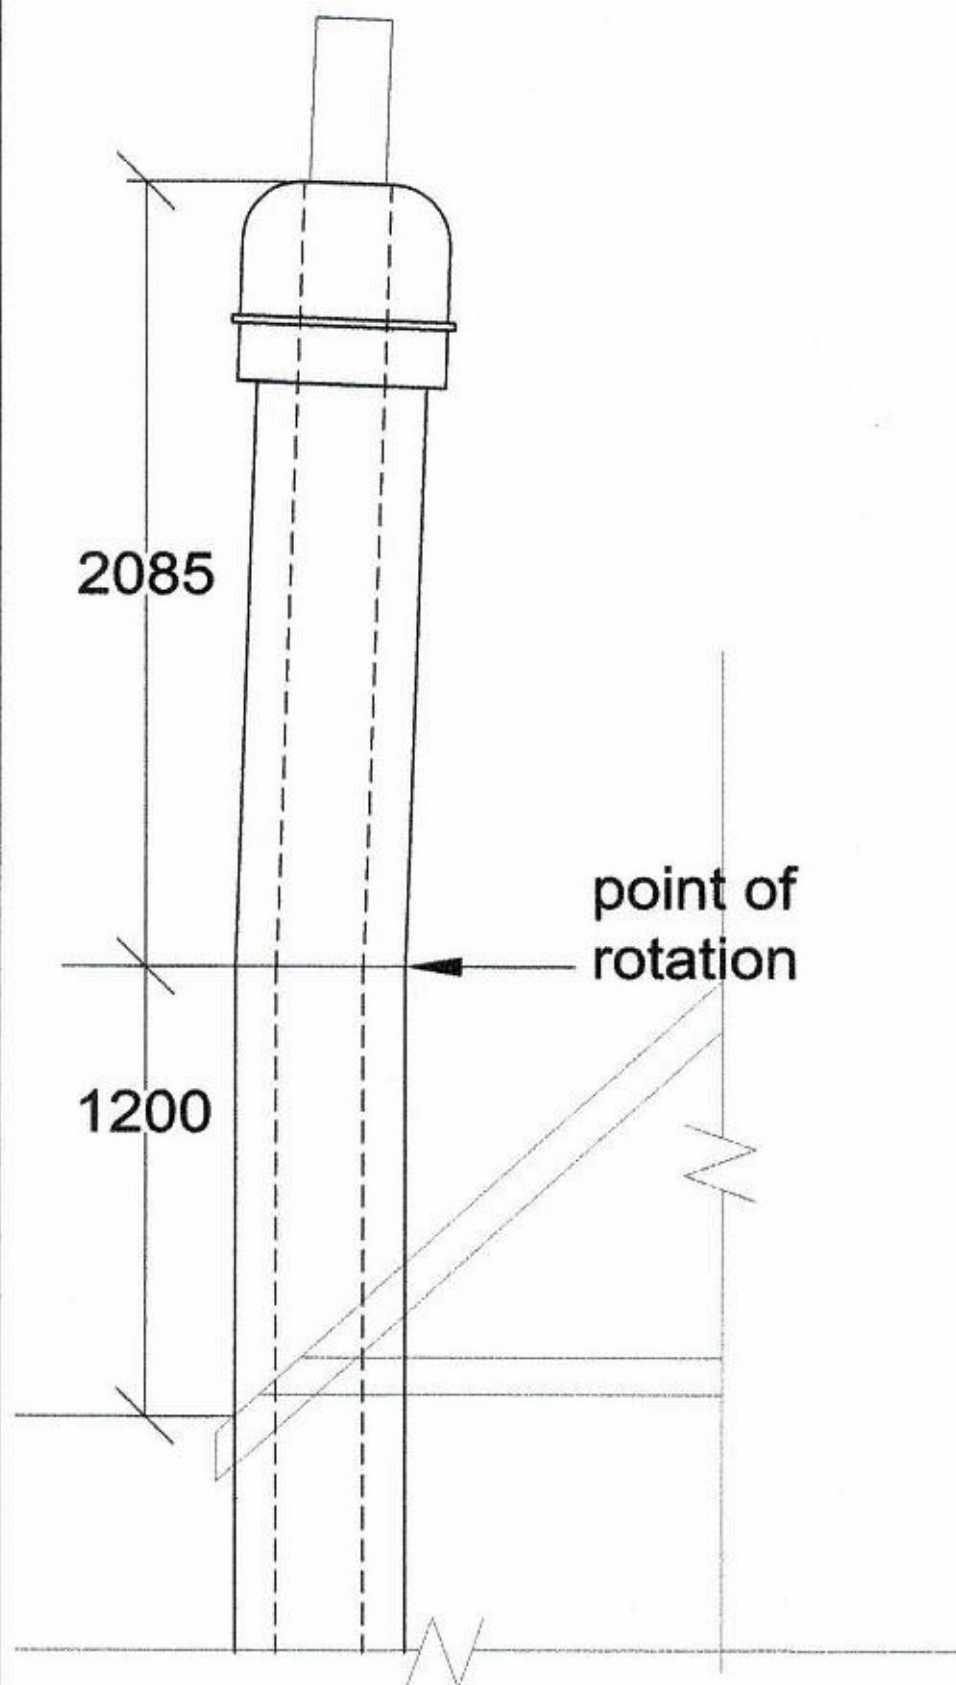
REAR CHIMNEY

The render has been removed from the outer and front faces of the stack to a metre above eaves level (photograph 7, 8 & 10). Where the render has been removed it was observed that ferrous nails had been driven into the mortar bed joints at between 100mm and 150mm pitch to key the render to the stack (photograph 9). There is an inward rotation of the top 2 metres of the stack of 15mm/600mm (photograph 7 & 13). There is a fracture of the brickwork to the front face for the 5 courses below the oversailing courses (photographs 11 & 12). It was not possible to inspect the internal faces of the flues.

It is recommended that the stack be carefully taken down to the point of rotation and the stack below this level inspected. Subject to the lower part of the stack being serviceable, the stack can be rebuilt from this level using sound bricks from the stack the shortfall being made up with similar bricks. The mortar joints of the outer and front cheeks should be raked out to receive the render.

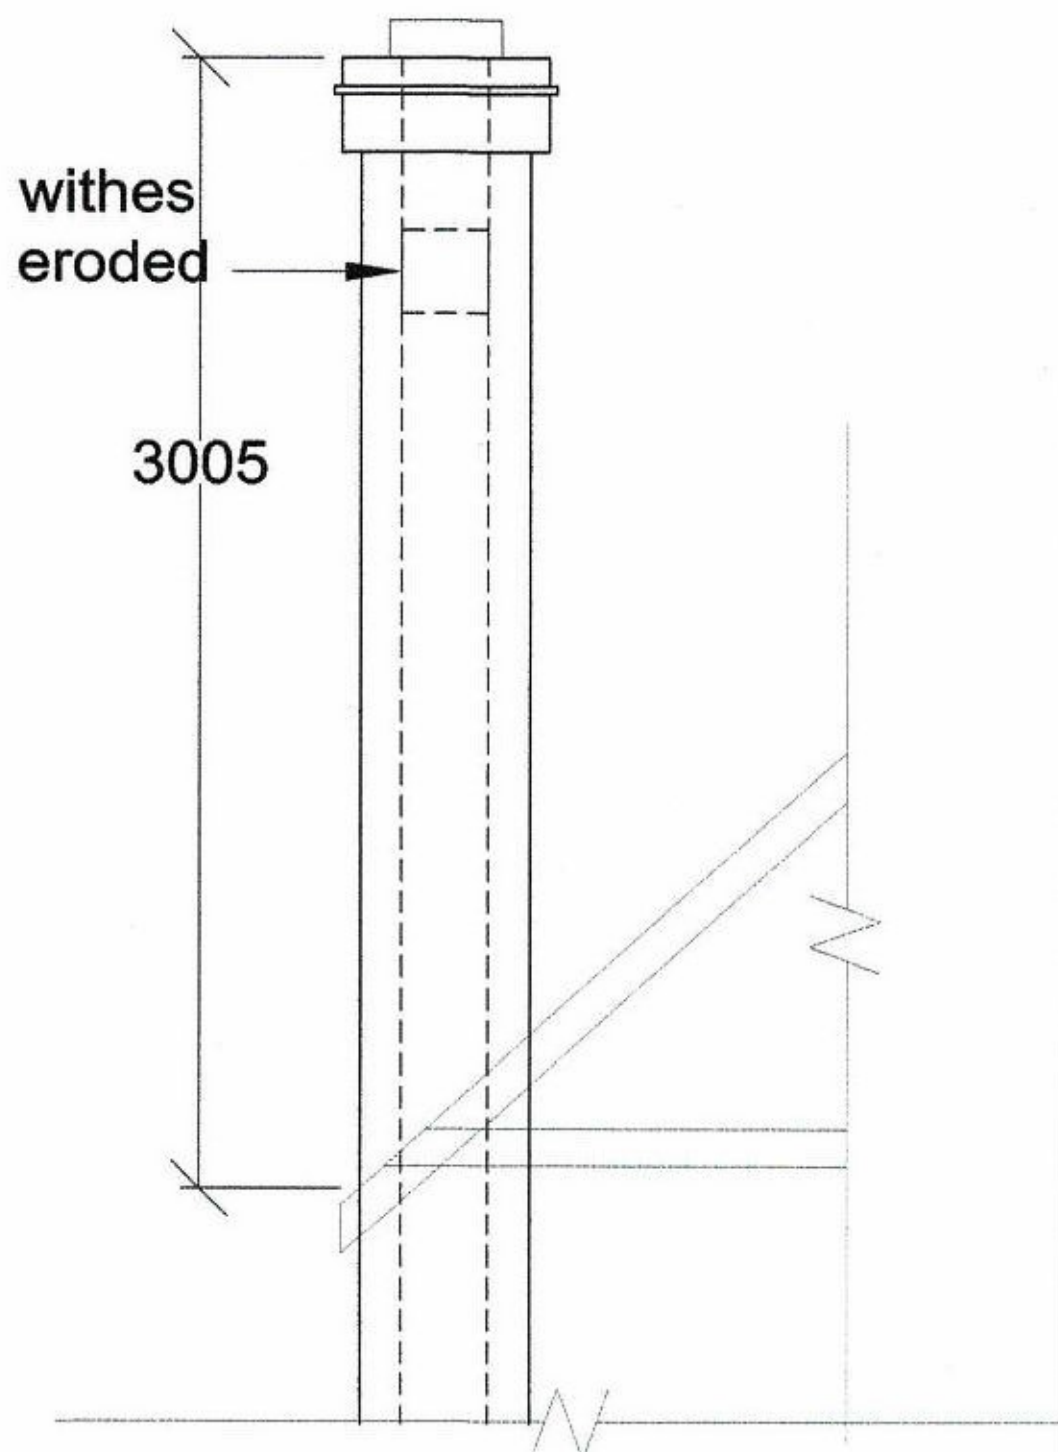
FRONT CHIMNEY

The render has been removed from the outer face of the stack above eaves level and from the front face to 1200mm above eaves level. Where the render has been removed it was observed that ferrous nails had been driven into the mortar bed joints at between 100mm and 150mm pitch to key the render to the stack (photograph 2). There is extensive fracturing of the bricks for the top 10 courses below the oversailing courses (photographs 4 & 5). It was possible to inspect the internal faces of brickwork to the two front flues (photograph 6). The flues are not parged, the withes between all three flues are eroded some 12 courses below the top of the stack. The fracturing of the brickwork and erosion of the withes has weakened the stack to the extent that it could fail

It is recommended that the stack be carefully taken down to below where the withes are eroded and the stack below this level inspected. Subject to the lower part of the stack being serviceable, the stack can be rebuilt from this level using sound bricks from the stack the shortfall being made up with similar bricks. The mortar joints of the outer and front cheeks should be raked out to receive the render.

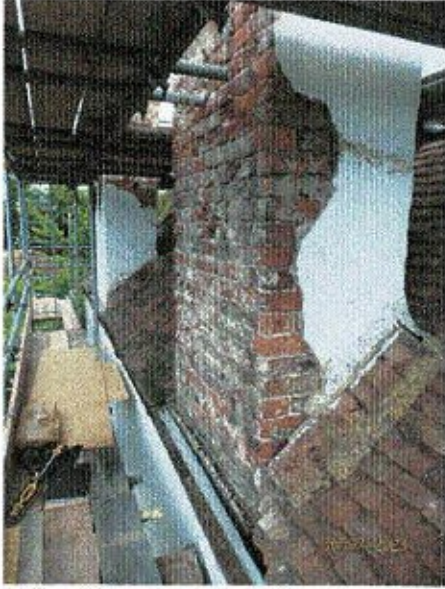
Photo 1

The property is a three storey dwelling that faces east onto Blenheim Road dating from circa 1820. There are two chimneys on the south façade (photograph 1), the front chimney having three flues, the rear chimney having four flues.
