Wellow Wood Cottage, Wellow Wood Road, West Wellow, Romsey.

Initial thoughts.

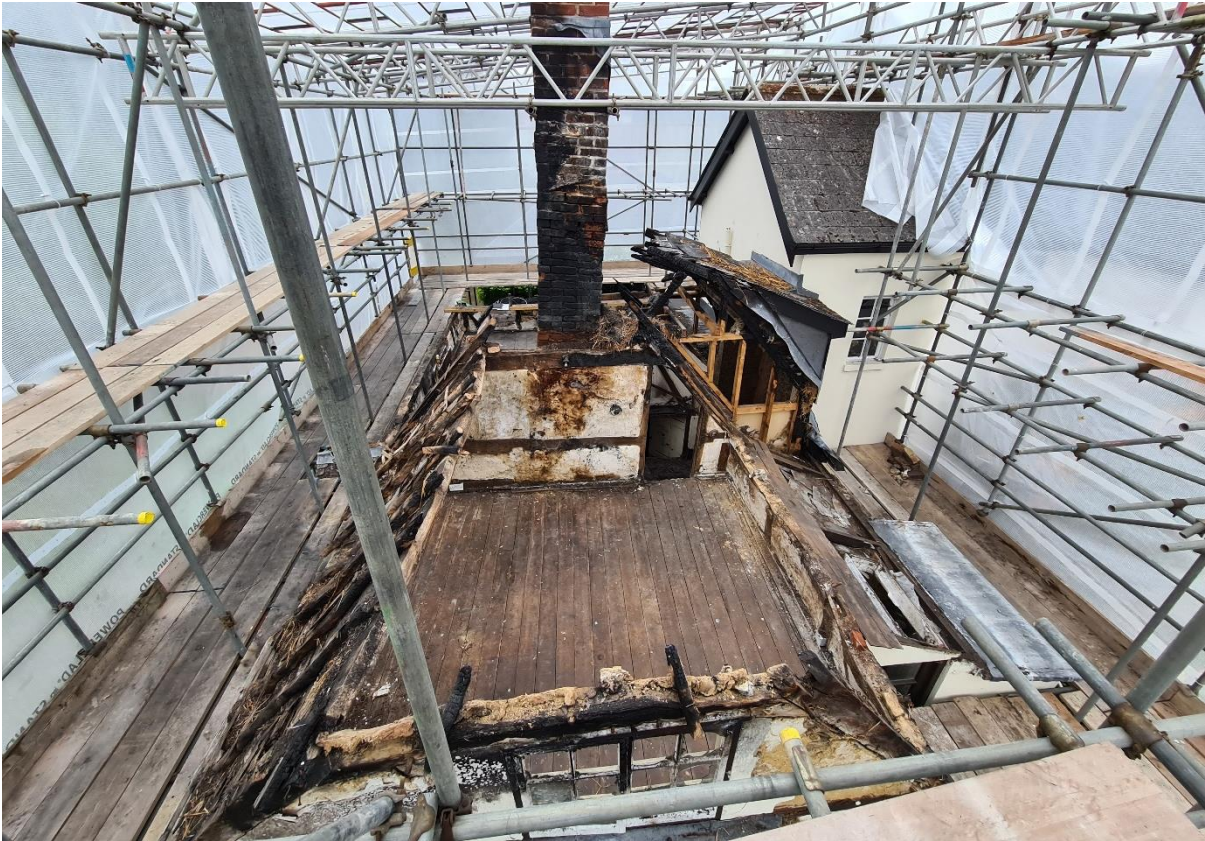
The building has lost almost all of the historic roof framing above wall plate level with only a handful of rafters and some of the purlin plus two trusses – adjacent to the stack and on the east gable. The wall frames are largely intact but with a few areas of fire damage and some scorching. While the floor boarding has some damage, the floor framing is untouched by the fire, although the large amounts of water used to extinguish the fire have caused a large amount of mould to bloom on the timbers, particularly areas of sapwood.

View from above showing extent of fire damage to frame.

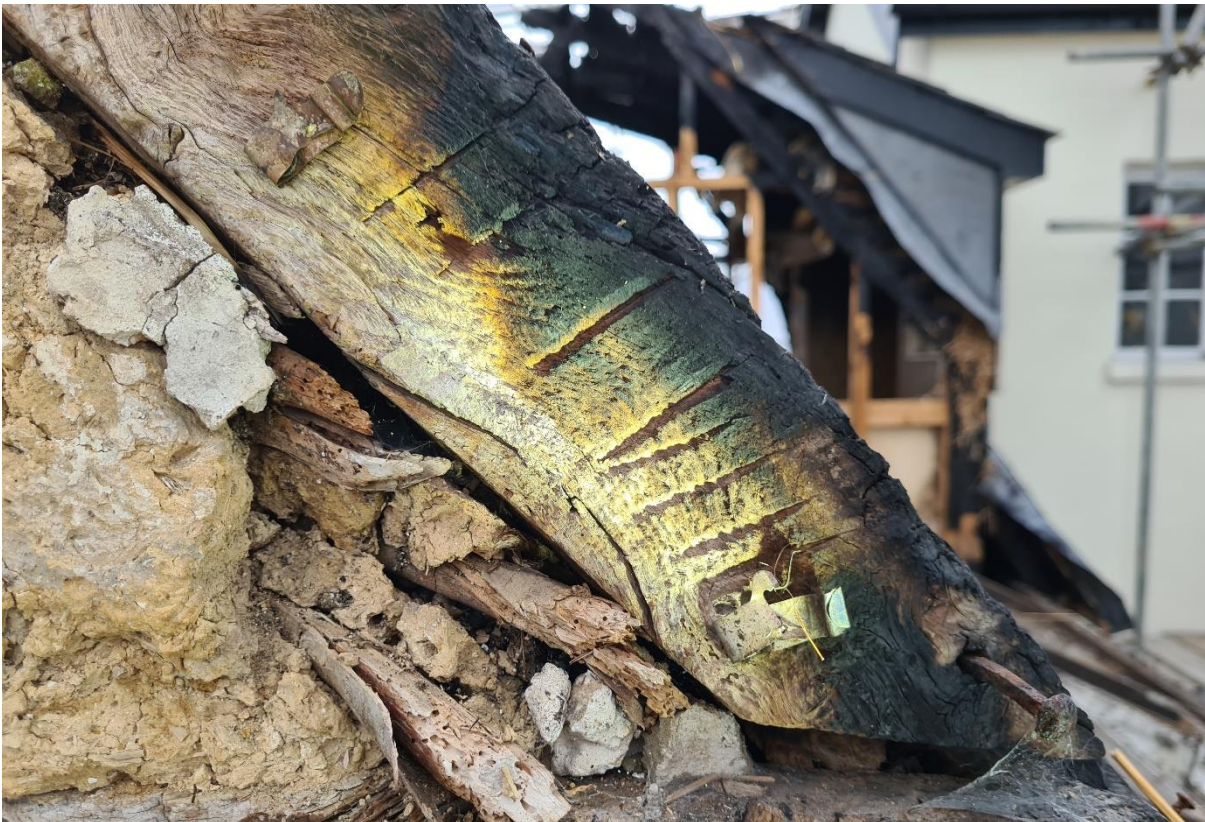
Carpenter's numerals visible at foot of principal on NE corner.

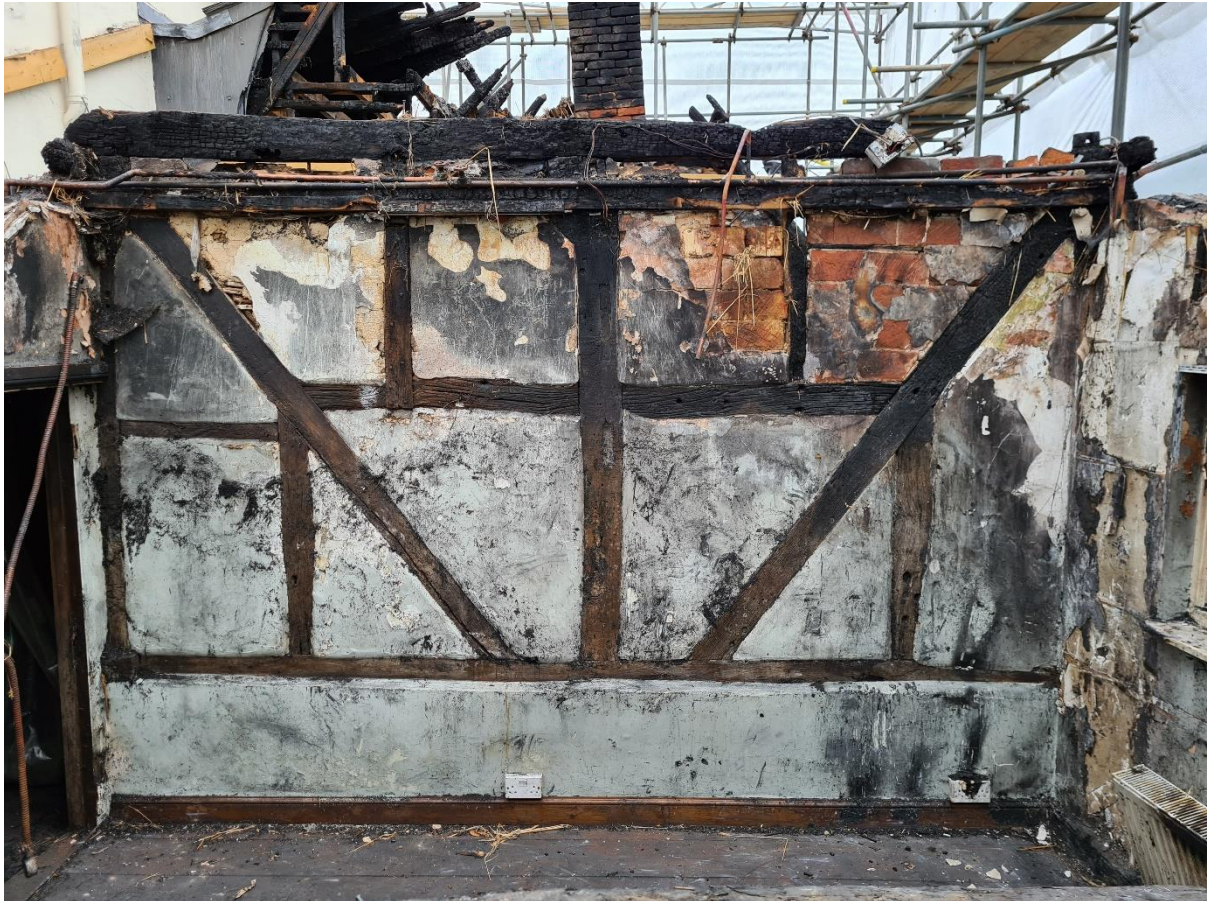
West gable – note tie beam – it will need to be scarfed for just over half it's length as well as an external face patch.

The tie beam to the west gable has lost maybe 55% of its length to fire damage but it can easily be repaired with a new section scarfed into it, albeit the remaining 45% will likely require a face patch to the outside as well. Once this, and the lighter damage to the studs below (including the oddly positioned (reused?) jowl post) have been repaired then a new truss can be built comprising of a pair of truncated principals and a collar. The remaining truss to the east gable should serve as a pattern for this new frame and ideally would have tapered principals and a curved collar as well as a pair of studs to the tie beam – evidenced by the mortices in the upper face of the tie.

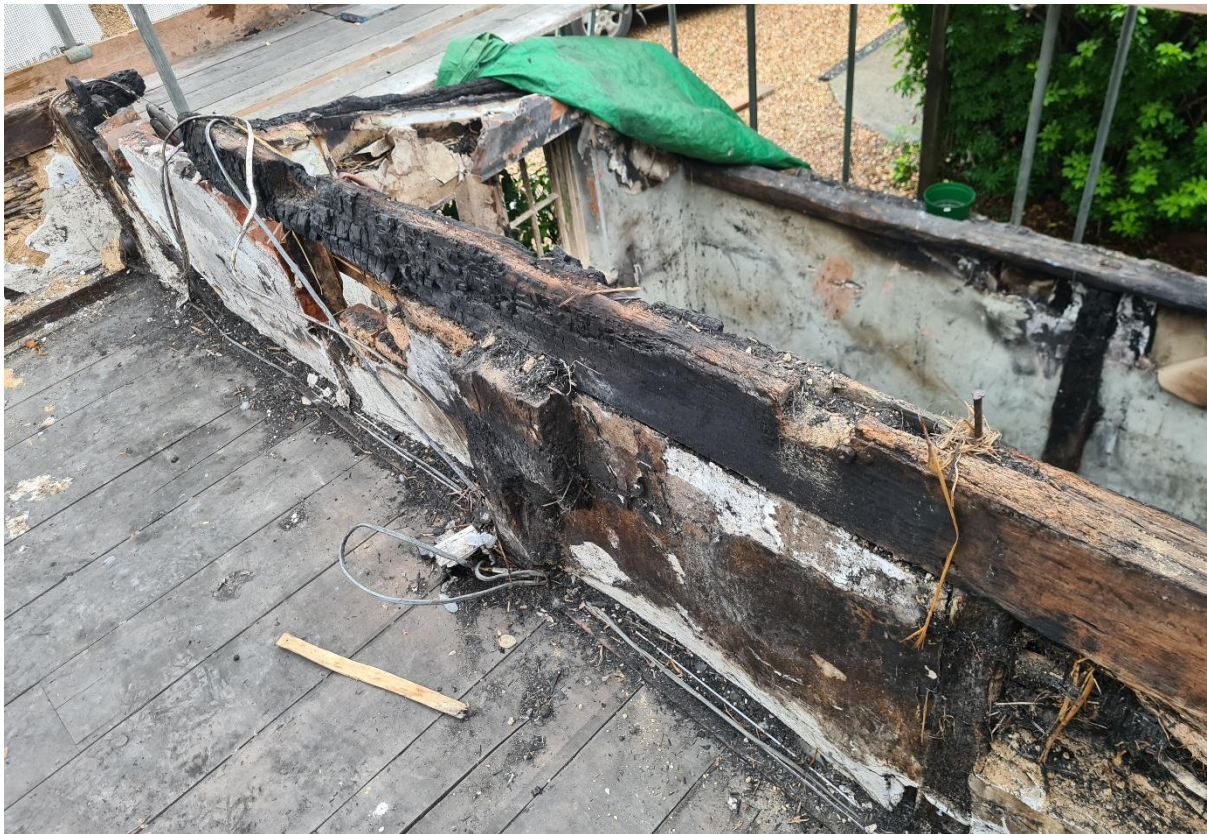
Internal view of west gable tie beam. From just to the right of the central post it is basically sound, albeit scorched.

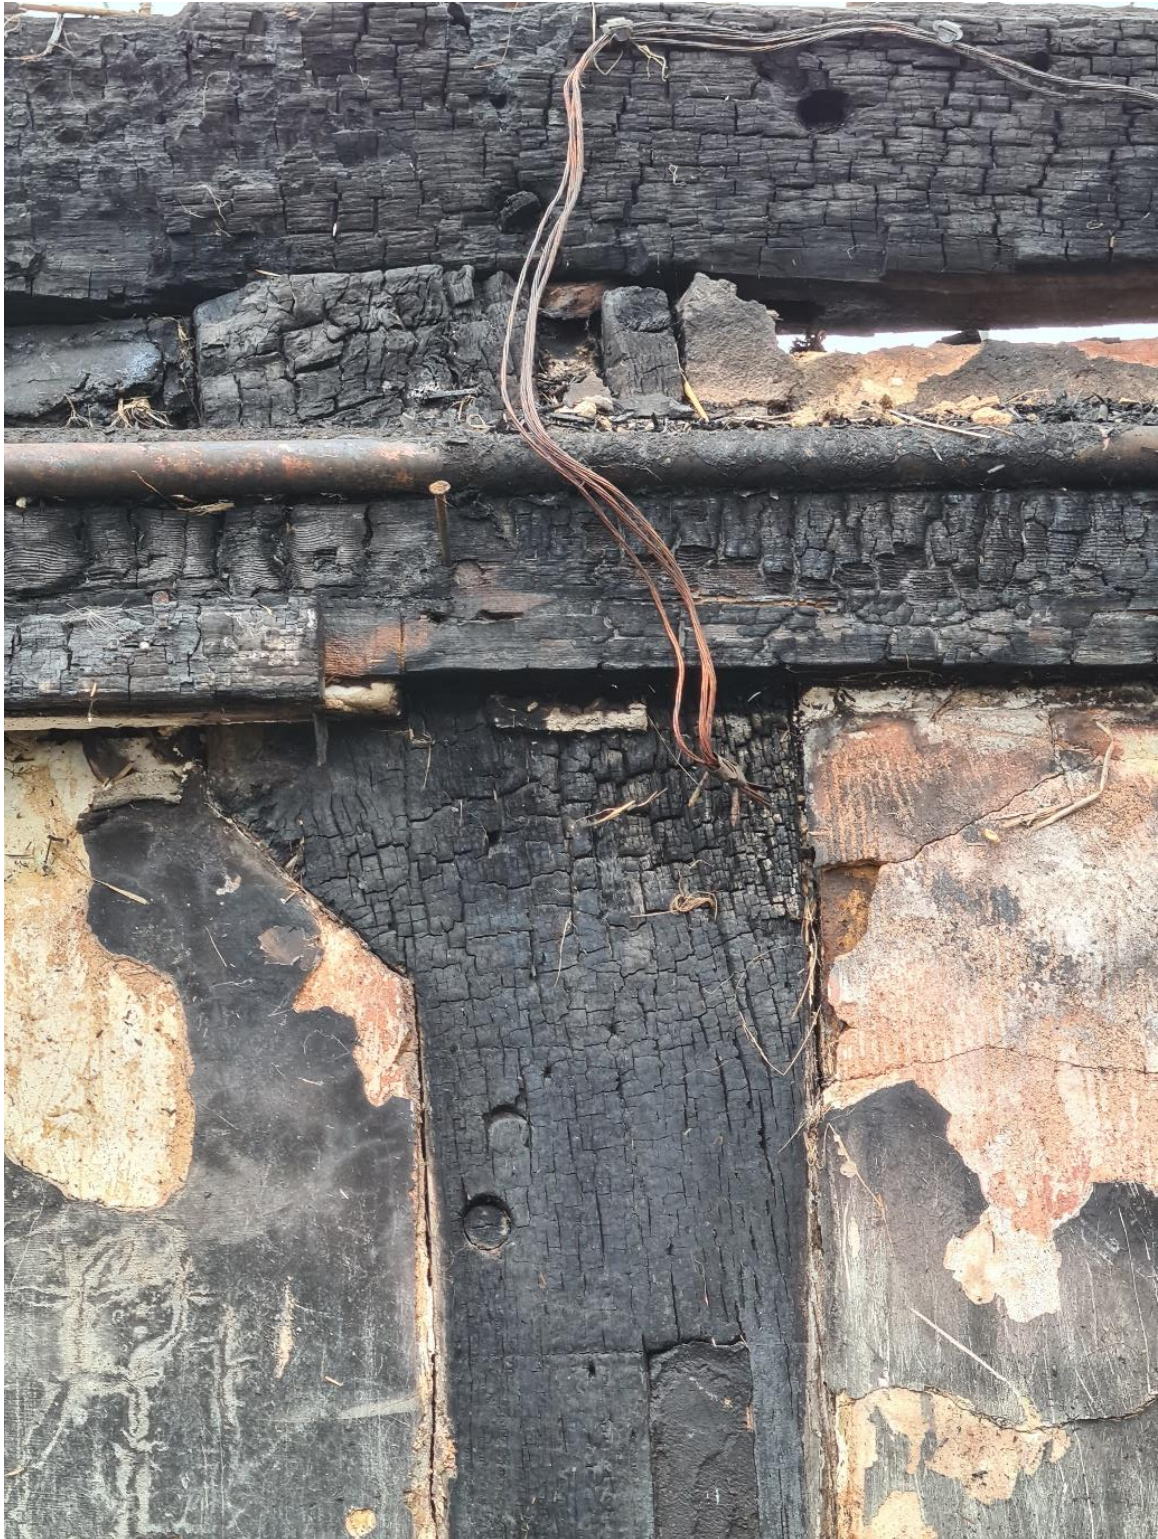
Jowl post re-used within west gable. Note tenon for wall plate (at top, to the right of cabling) proving it was used elsewhere prior to this frame, also void mortices below. The peg within the gable tie beam is NOT associated with this connection – there is no tenon there.

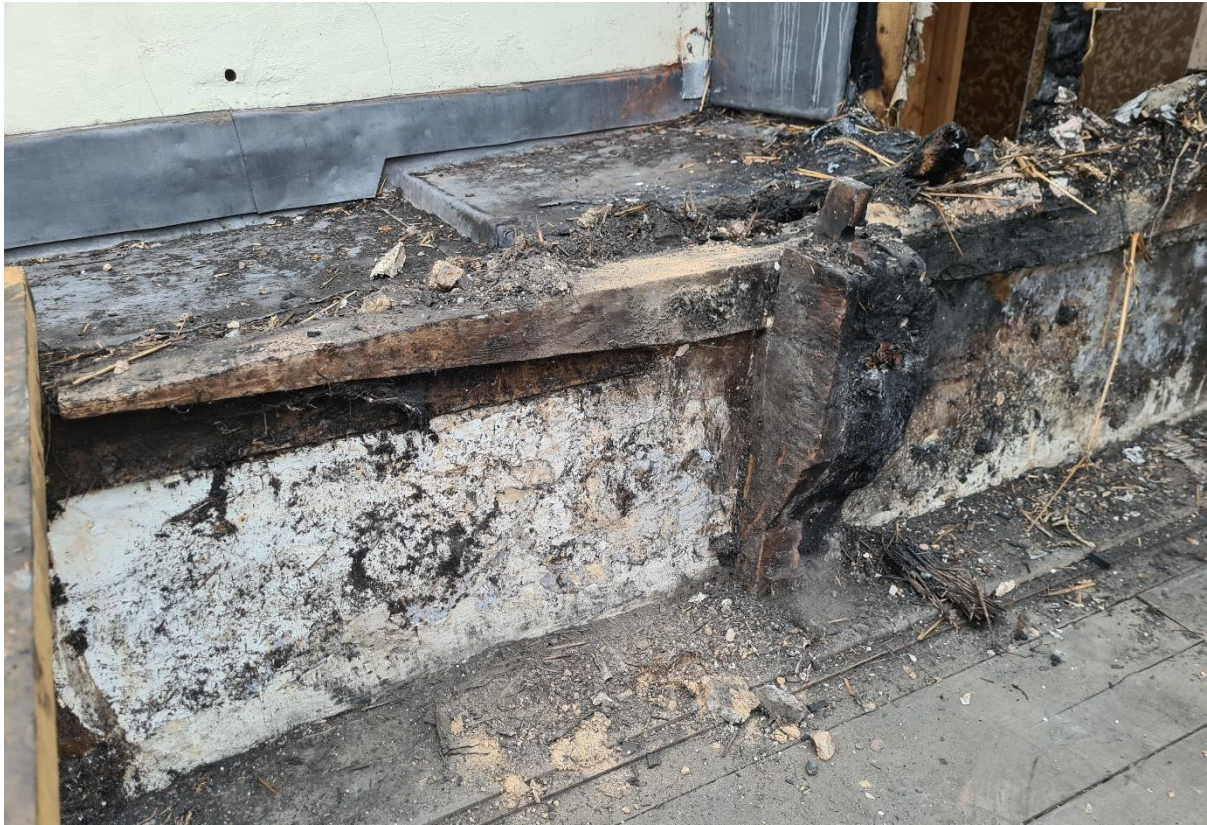
The post has a jowl – a flared section of timber at the top of the post which is used to form a tenon (also mostly intact) and joint into the underside of a tie beam. **If** there was a tie beam here, then the first floor is most likely a later insertion. The wall plate directly above this post has also been repaired (late 19th/early 20th century?) which has sadly removed the lap-dovetail joinery for any tie beam, so we’ll never know for certain, but this does give hints at the former layout and use of the building as well as possibly suggesting an earlier construction date. The only other detail that could have corroborated this is a truss on top of the *possible* tie beam which in turn would have given the opportunity for the purlins to be scarfed at this point – exactly as we see in the truss to the east of this position. If any photographs survive showing the purlins within this bedroom, we might expect to see splinting, or metalwork to fix them together once the possible truss was removed.

Jowl post in north wall – note teazle tenon remnants, suggesting there was originally a tie beam here. Also note the patch repair to the wall plate – removing any evidence of a lap-dovetail joint for the tie beam.

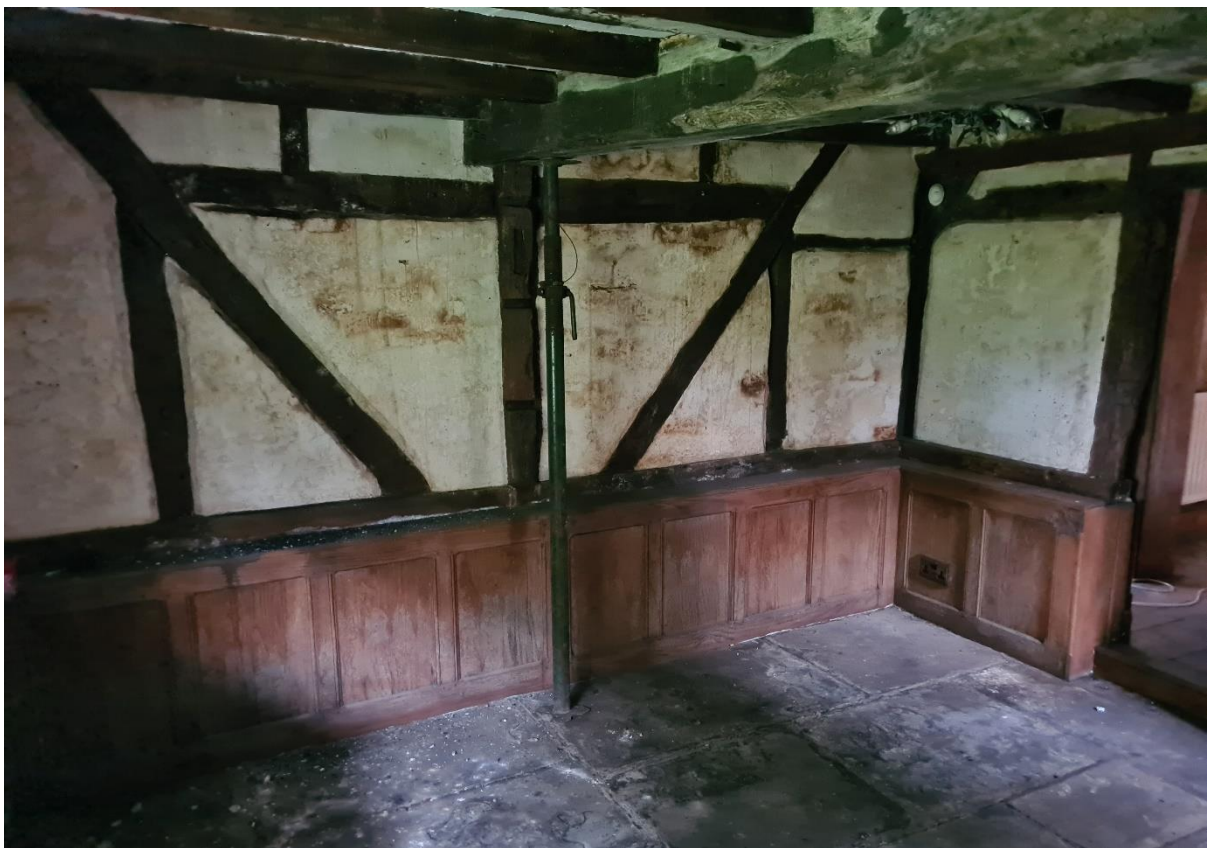
Interior of ground floor room, west end. Note low-level paneling – this should be opened up to check the moisture content and condition of sole plate and bottoms of studs/posts. This will also allow air flow to the area and speed up drying out of the building fabric.

This area of the front elevation has been rebuilt at some point (late 20th/early 21st century) to a good standard but as noted earlier, it may have swept away the upper section of a jowled post (presumably the lower half was removed by the window?). For some reason, these two rooms have had low-level paneling installed – it may be to mask something considered ugly, or in poor condition but even if entirely innocent it will currently be retaining moisture and reducing airflow so at the very least, I would suggest some degree of opening up for both ventilation and further inspection.

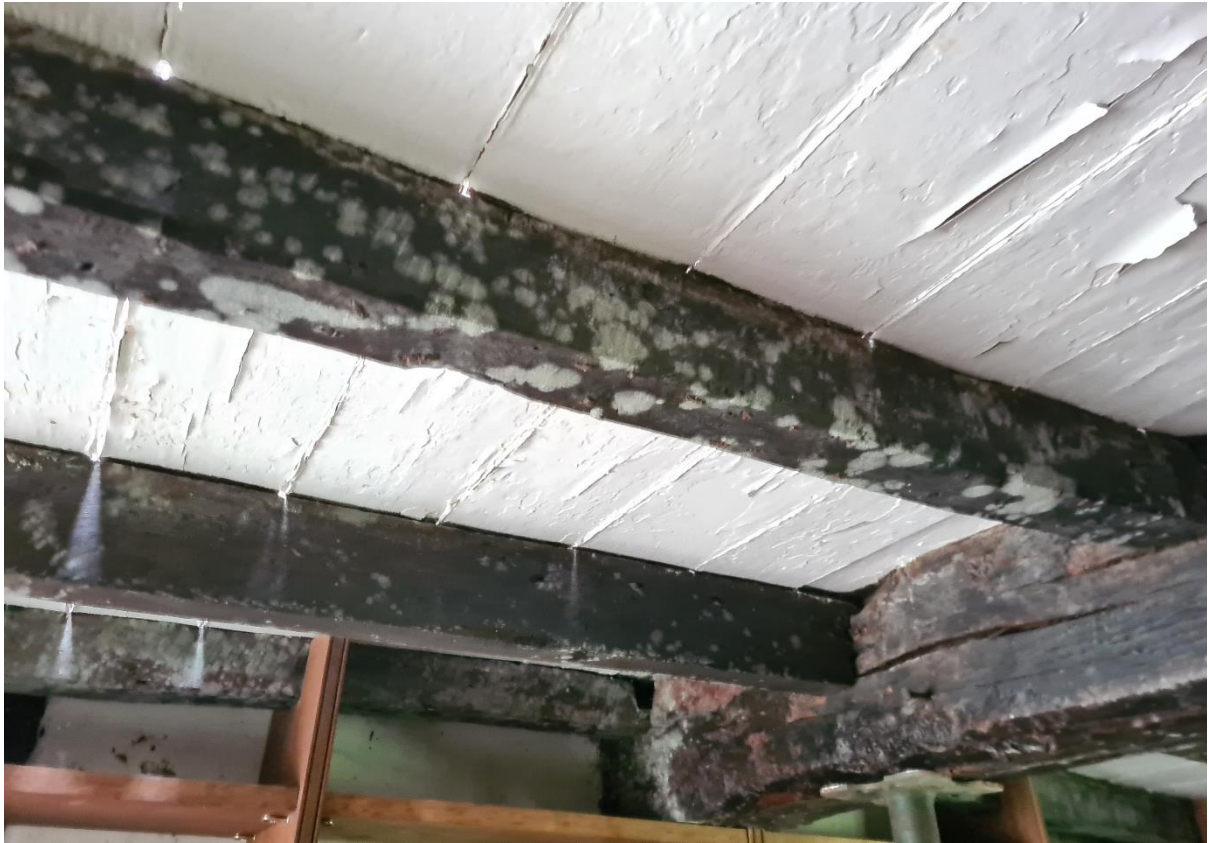
Within the two ground floor rooms the floor framing is basically intact, certainly there is no obvious damage from the fire, although as previously noted, the large amounts of water used to extinguish the fire and the high moisture content of all surrounding building fabric have created a fantastic ecosystem for various moulds to flourish. If these moisture levels persist, then fungal spores will eventually settle, and the small-section timbers of the joists could easily and quickly lose their capability. Every effort must now be made to bring down the moisture levels – ironically, I noted the outlet of the dehumidifier was laying on the floor and discharging water into the concrete floor and a masonry wall (I rectified this by repositioning it to discharge into the toilet).

Mould is flourishing on the floor framing due to the rise in moisture levels putting out the fire. It is particularly worse on components with a higher sapwood content making them very much more susceptible to further decay.

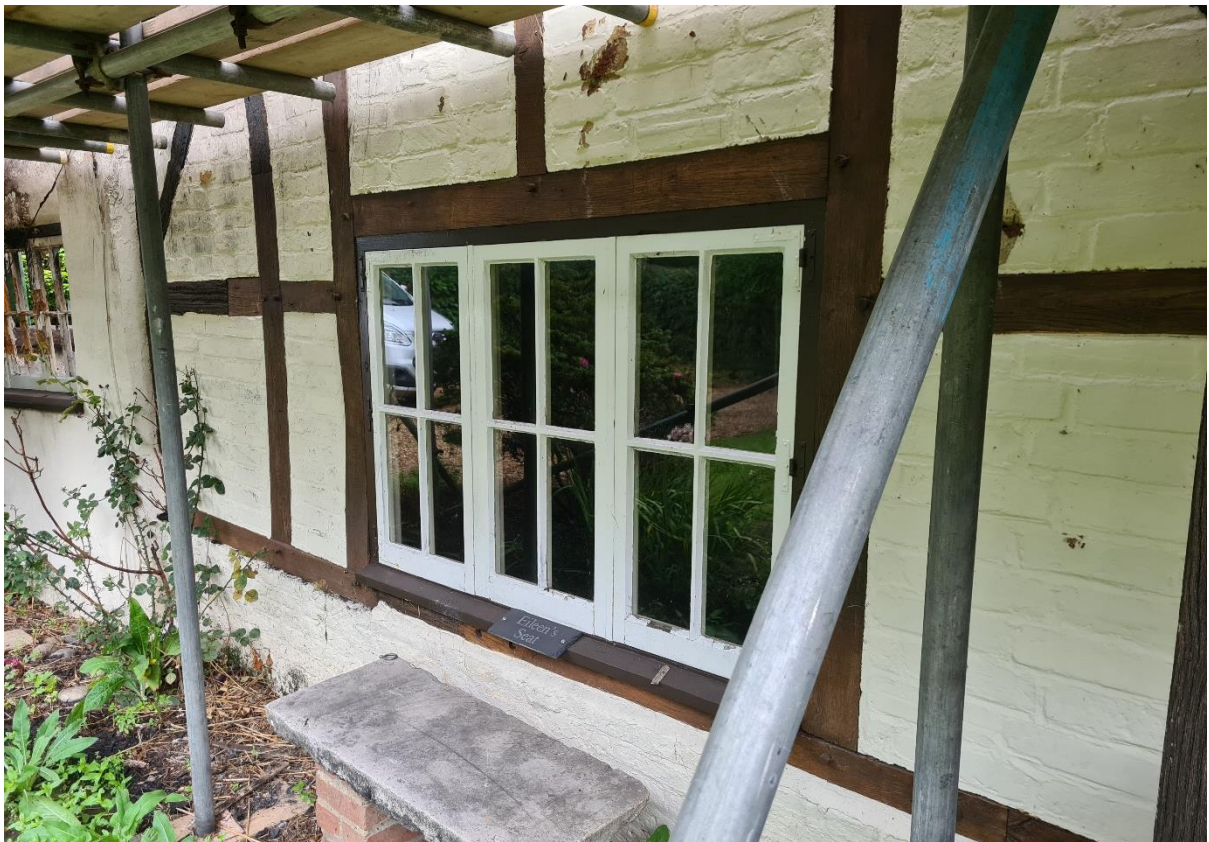
It is evident that some years prior to the fire the frame had been repaired to a high standard, although these repairs *perhaps* gave rise to the loss of a storey post on the south wall. This missing post would have confirmed that the frame was of three bays – possibly with two bays forming an “open hall” but the only remaining evidence for this is the post in the north wall.

Exterior view at southwest corner of frame. This area of framing has been rebuilt to a good standard, although historically there would have been a jowled storey post in the middle of the window. I suspect that the current window replaces a Victorian window which cut through the post making restoration of the post seem pointless to previous occupants.
