quinquennial inspection
church of st. peter and st paul • osbournby

pcc of south lafford • diocese of lincoln

date of inspection: 23 june 2022

PETER ROGAN
+ ASSOCIATES LIMITED
ARCHITECTS +
HISTORIC
BUILDINGS •
CONSULTANTS
46 • ST. MARY'S GATE
NOTTINGHAM

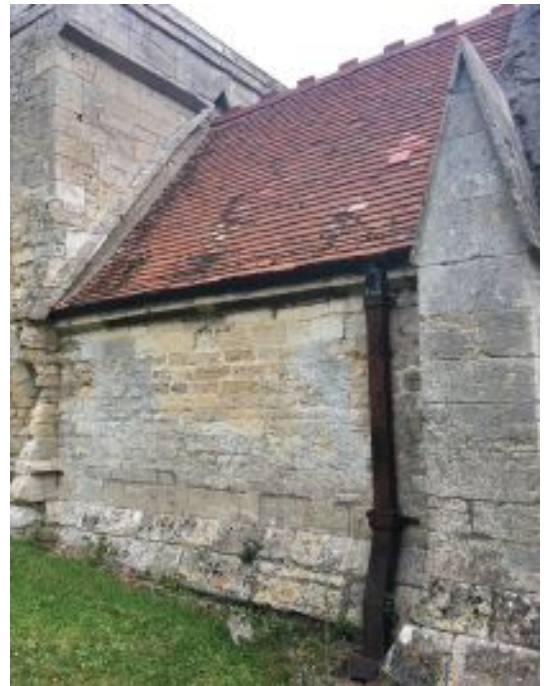
Above: RWP1 - south porch west side. Below: Base of RWP2 and RWP3 with plastic branch pipes.

- [M] Periodically check and clear.
- [B] Refurbish/repaint

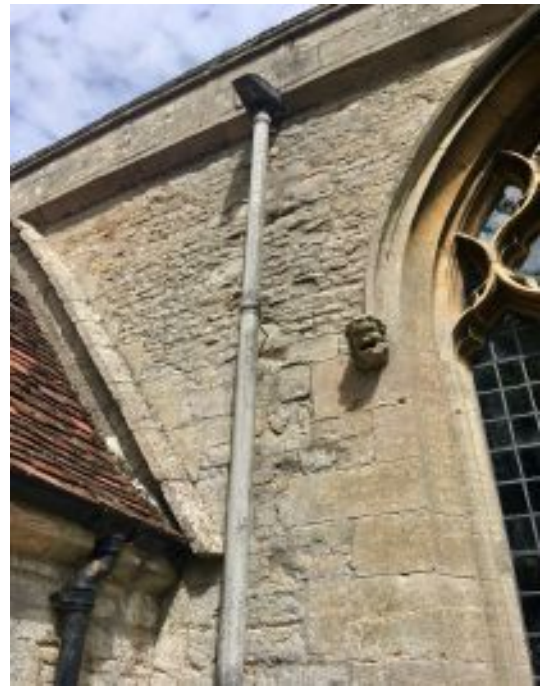
*Above: RWP3 - south aisle downpipe east of the porch.
Below: Base of RWP4. Bottom: RWP5 - south aisle south elevation eastern downpipe.*

[B] *Install gully/drainage.*

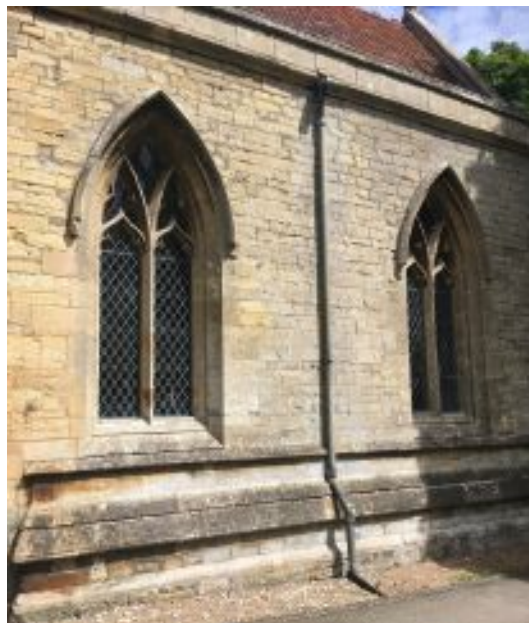
North aisle, north elevation, east end: Evidence of overflow from the joints at the top of the pipe to the base of the swan neck causing staining on the downpipe and also the downpipe stops at high level above the plinth of the wall causing water discharge onto the stonework and onto the ground with no gulley or below ground rainwater management, although some plastic guttering now placed under the outlet.

Above: RWP6 - chancel south elevation. Below: RWP7 - chancel north elevation. Bottom: RWP8 - north aisle, north elevation, east end.

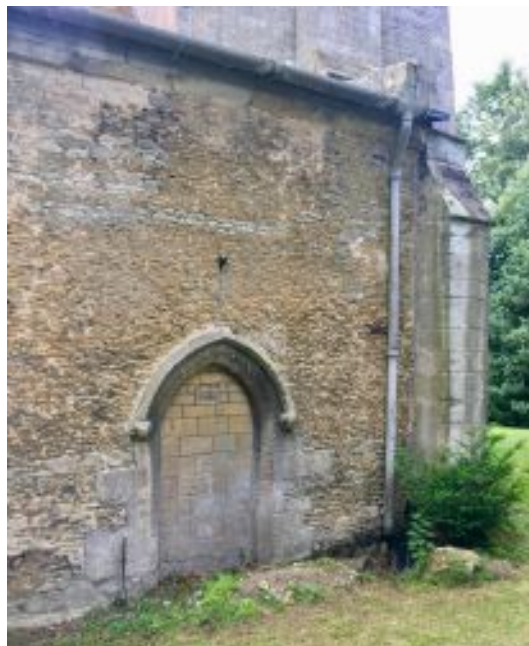
Above: RWP9 - north aisle, north elevation, west end. Below: Chancel south elevation. Bottom: Lantern attached to the southeast buttress of the chancel.

[B] Replace asbestos downpipe with cast iron or aluminium.

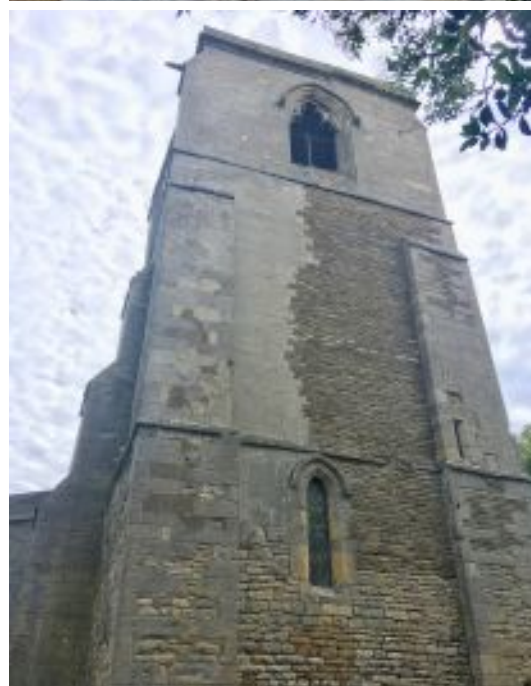
There is evidence of some cracking through the northern buttress, partially disguised by the render but running vertically through the middle of the buttress. The window stonework is as described in the window

Above: Tower north elevation lower stage. Below: View of the tower north and west elevation at belfry level seen from the drone. Bottom: Tower west elevation lower stage.

section but with some cracking evident running in the stonework, which looks somewhat fresh and running through cement pointing leading from the base of the window corner on the north side down through the stonework below, almost running down to ground level. Above the window some cracking from the window arch running through the plinth into the base of the tower stage above through the ashlar work, possibly in part caused by some poor bonding of stonework. The crack then seems to peter out. The southern buttress contains some old weathered stones but the stonework has generally been pointed up in a cementitious mortar and appears to be satisfactory for the moment. The old ferramenta to the window would benefit from repainting and has caused damage to the lintel stonework but the damage now is probably less significant than the interest value in the old ferramenta. To the second stage the stonework around the slit window to the stair would benefit from pointing up and one or two stones above the lintel are rather weathered and might benefit from consolidation or replacement. To the northern buttress some of the face stones have been masked with a mortar fill abutting old render but not blending well with it and a couple of the corner stones on the southern aris, 2 courses up from the stringcourse to the base of the lowermost stage, have spalled leaving a gap. The stringcourse stonework to the top of the lowermost stage is cracked and split in places with some missing sections, notably to all the corners of the buttresses and through the southern half of the main walling area. To the southern buttress on the second stage some open joints, which would benefit from pointing up in lime mortar and a little bit of damage to the top offset. To the belfry stage there is some old distortion around the head of the window, fairly significant and displacement of tracery. Running up into the stonework above there is some distinct misalignment of the stringcourse detail to the base of the old parapet. The parapet itself has been truncated and capped with a lead covering. All movement in the tower is very significant but appears to be historic and it appears as if the northern side of the tower has slumped and distorted in the past. At present however, the top stage of the tower looks to be in a satisfactory condition and all movement historic – note that birds are entering through the mesh in the window. The tower underwent major repairs in the 1960s when much of the renewed masonry visible on the west face is presumed to have been installed - all generally remains as recorded in 2017.

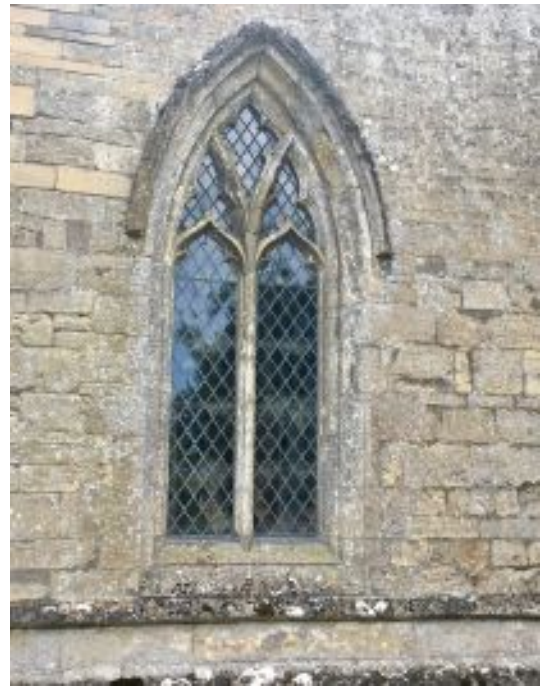
Open joints to the top of the cusp head of the middle window but generally all stonework is in a reasonable condition. A few quarries appear to have been replaced, possibly due to vandalism. Lead weathering to the

Above: W3 - chancel north elevation central window. Below: W4 - chancel north elevation west end. Bottom: W5 - north aisle east elevation.

base of all cills and some old distortion in the cills, which is disguised by the lead weathering but is historic. All remains as seen in 2017.

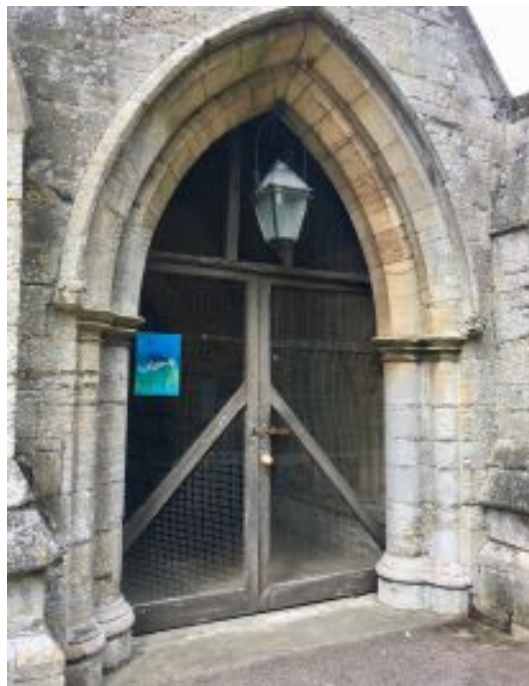
The hinges from the inside may benefit from cleaning down and painting and the hinge pins oiling. The loop handle has some wear to the spindle but not significant and the door generally is an important feature and generally satisfactory for the moment. The door stonework has some old damage to the western jamb mid-height.

Above: D1 - porch outer mesh doors. Below: D2 - porch inner door.

[M] Periodically oil hinges to aid use of doors.

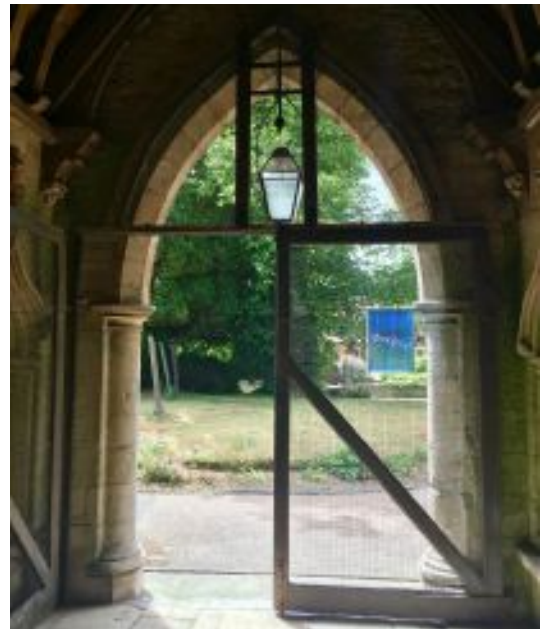
The stone seat is starting to break-up/delaminate in places, especially where abutting the north wall within the porch and some repair desirable. Otherwise the wall is generally

Above: Porch south wall and entrance gates. Below: Porch north wall and arched entrance to the south aisle. Bottom: Porch west wall.

in a good condition, although some bits of the pointing at eye level are dropping out and slight repointing is desirable. Some green mould bloom, particularly towards the northern end of the wall around some of the ogee arches - as noted in 2017.

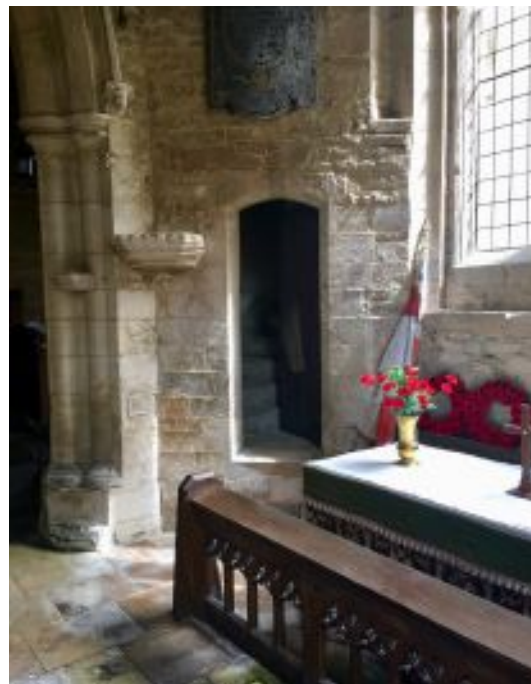
The columns have a slight southward lean in some cases but appears long-standing. Some algal growth around

Above: Spiral stair entrance at the east end of the south aisle. Below: South aisle east wall and east window. Bottom: South aisle north wall arcade.

the base of the columns. Arcade stonework generally looks to be in a good condition. The walling above is of narrow bands of squared rubble walling, some old signs of streaking, which is probably historic and then the top wall plate has been replaced with concrete with the main roof beams bearing onto the wall tops and all appears to be satisfactory at present.

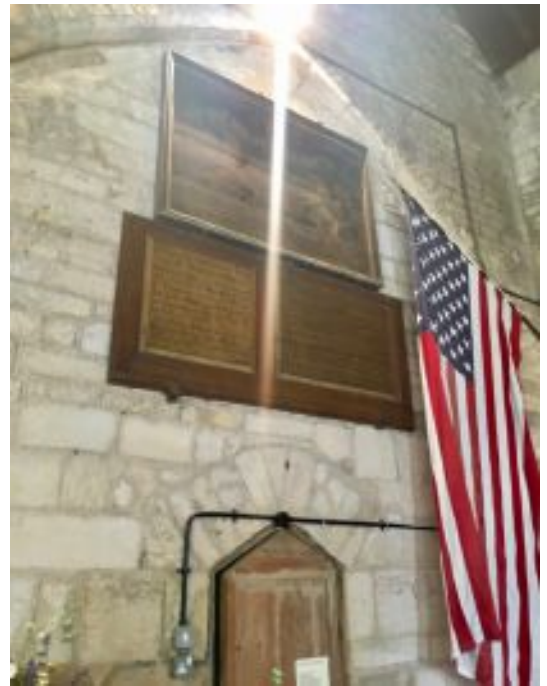
Above the infill the stonework is generally coursed rubble, there are cracks above the tower arch, the middle extending upward and also to the south side at a quarter distance across the entire face to the southern corner. The north side has some cobwebs but no obvious major cracks but some fine cracks may exist. The upper pointing is whiteish in colour and the wall steps in at the level below the roof purlins where above this the stonework is much rougher and partially patched with various mortars and renders. It would be helpful to point up and fill the cracks to allow monitoring of any ongoing movement; it is presumed that the infilling of the arch occurred to help strengthen the tower and the most recent tower repairs were carried out in the

Above: Nave west wall. Below: Nave looking west. Bottom:

1960s in a major project. Around the top of the wall there is streaking from old water ingress. All generally as recorded in 2017.

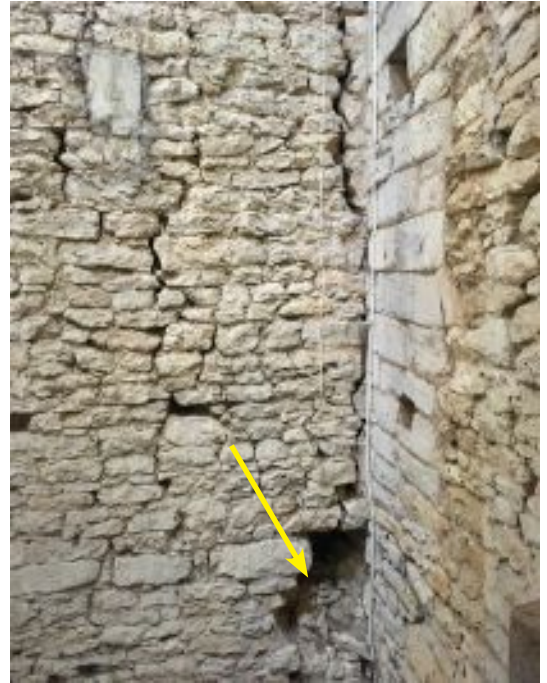
Above: South corner of the belfry/intermediate chamber with larger void visible. Below: Cracking to the belfry/intermediate walling.
