# RETIREMENT VILLAGES

# VISUAL APPRAISAL SURVEY

PENLEE HOUSE,  
ROSELAND COURT, TREGONY  
CORNWALL

JULY 2023 | PROJECT REF: 22323

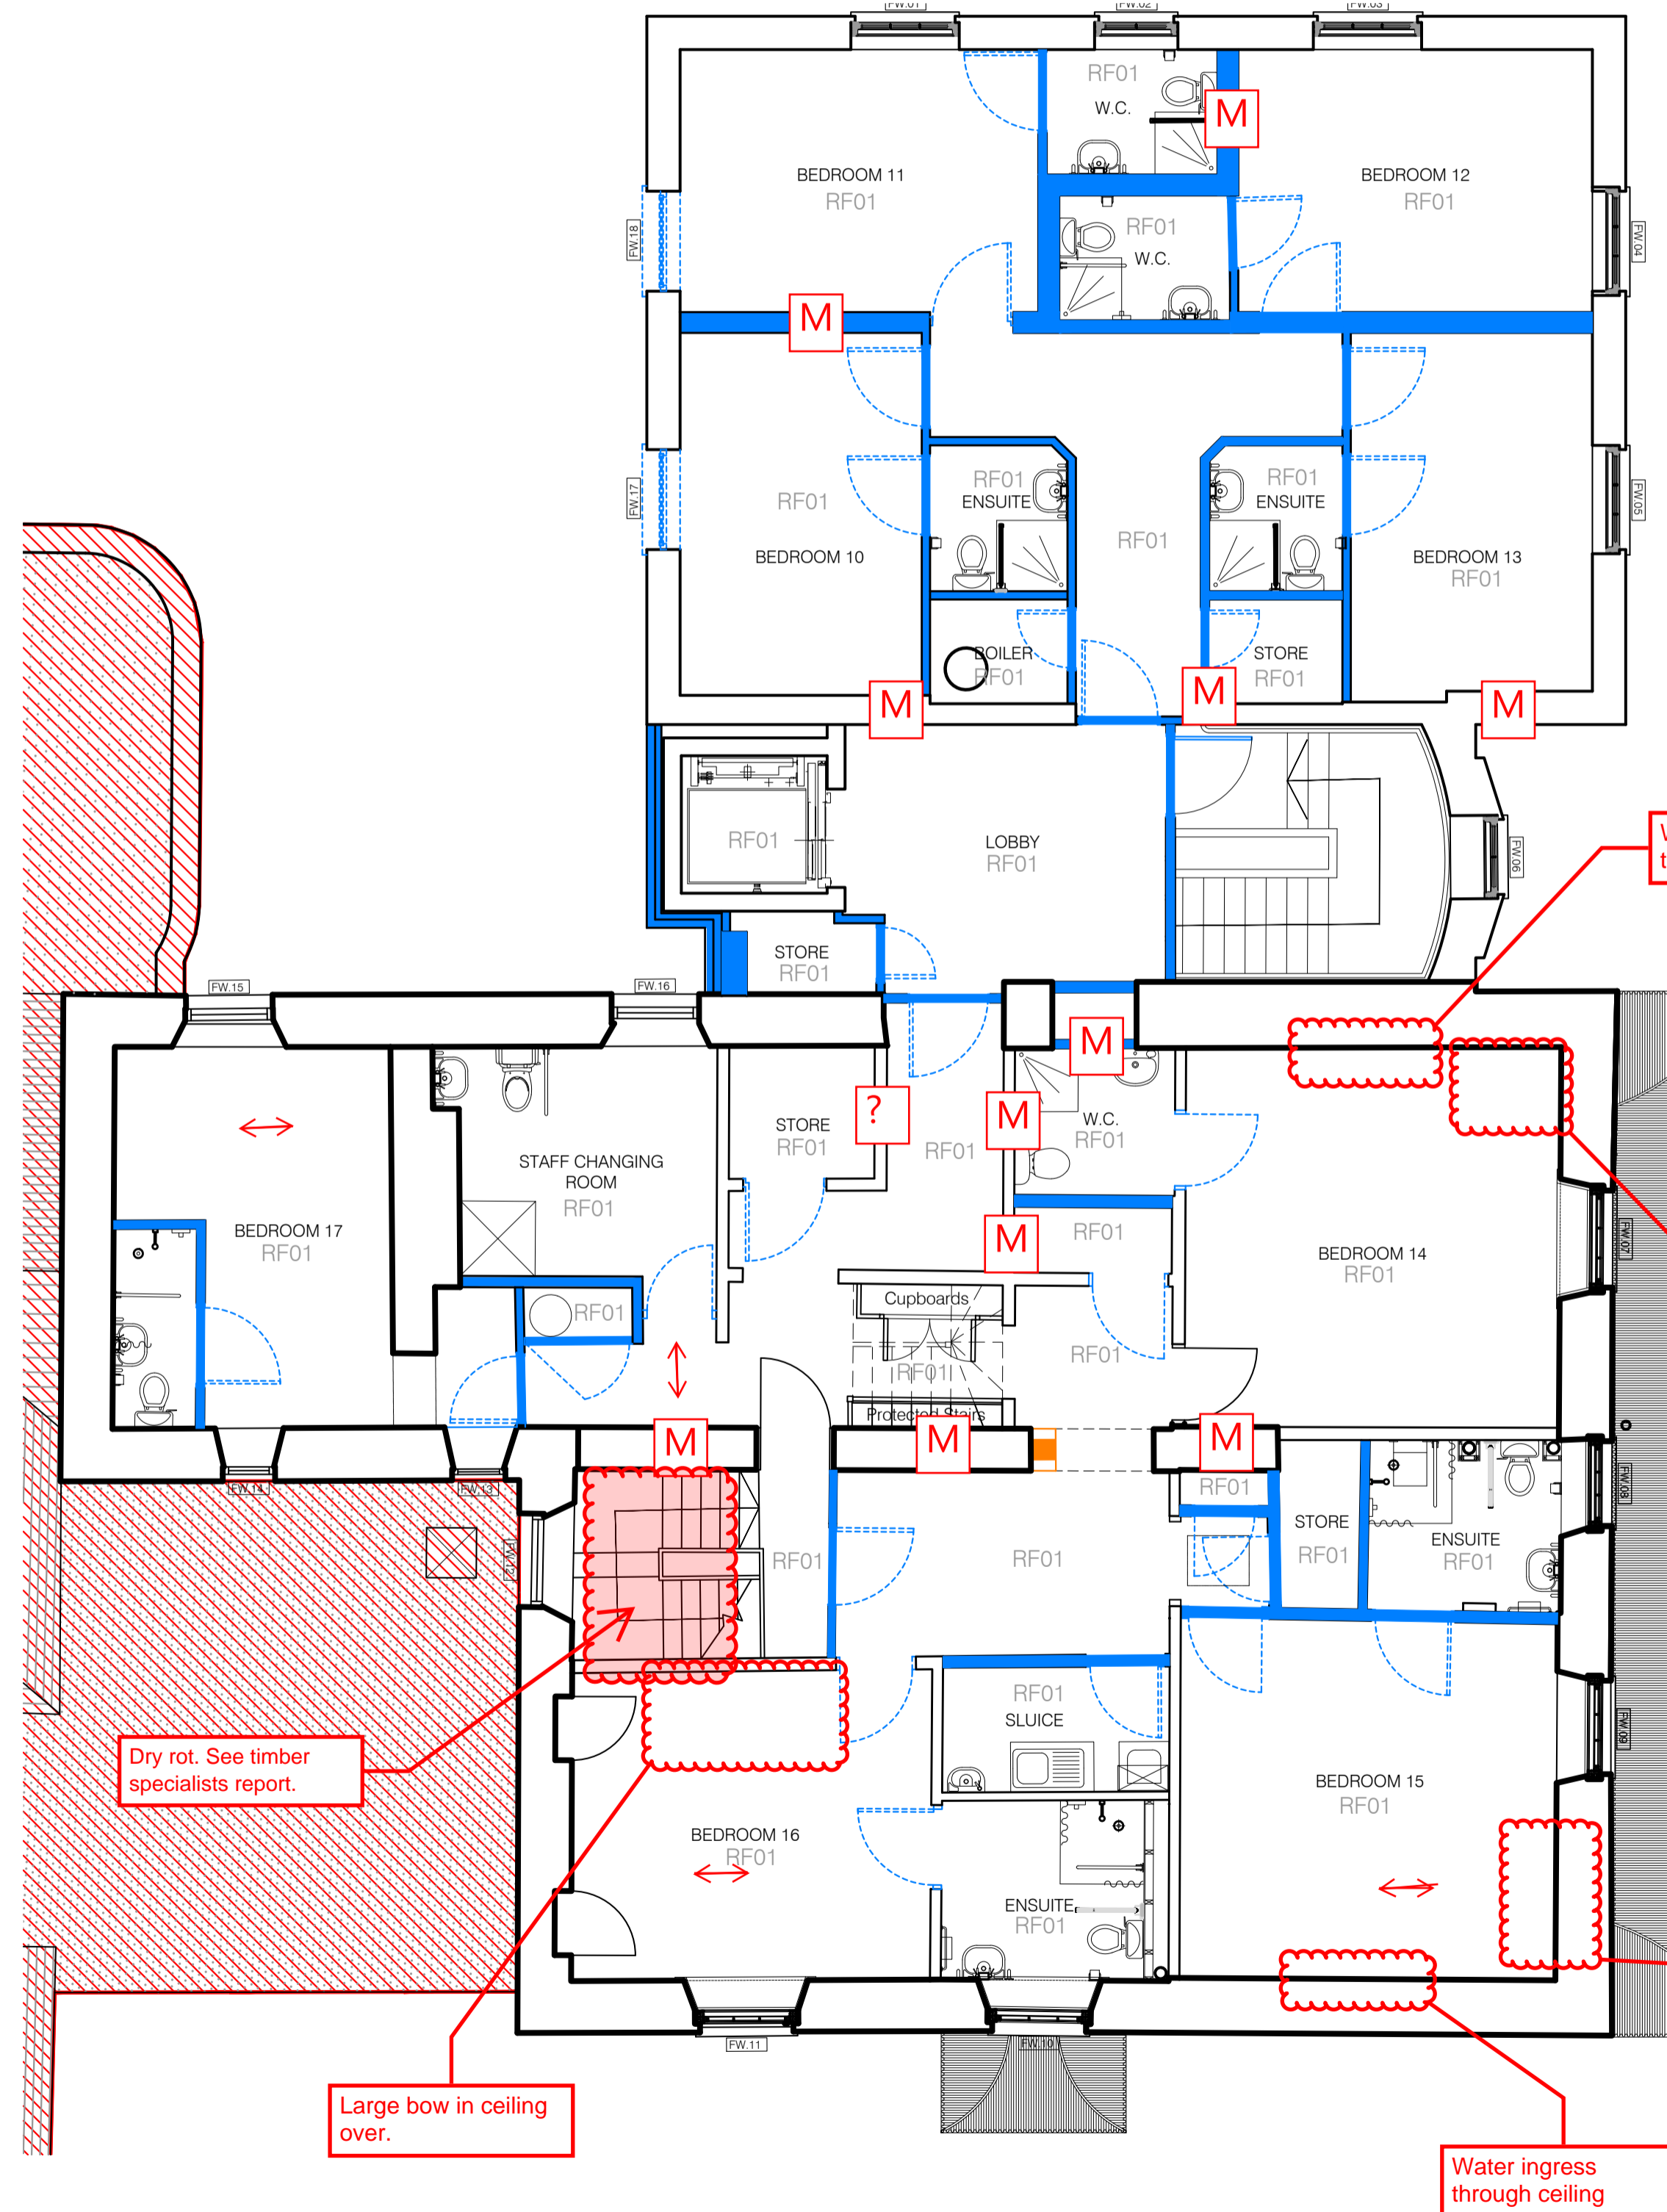
Dry rot. See timber specialists report.

joists previously repaired

Joists heavily decayed. Bearing lost.

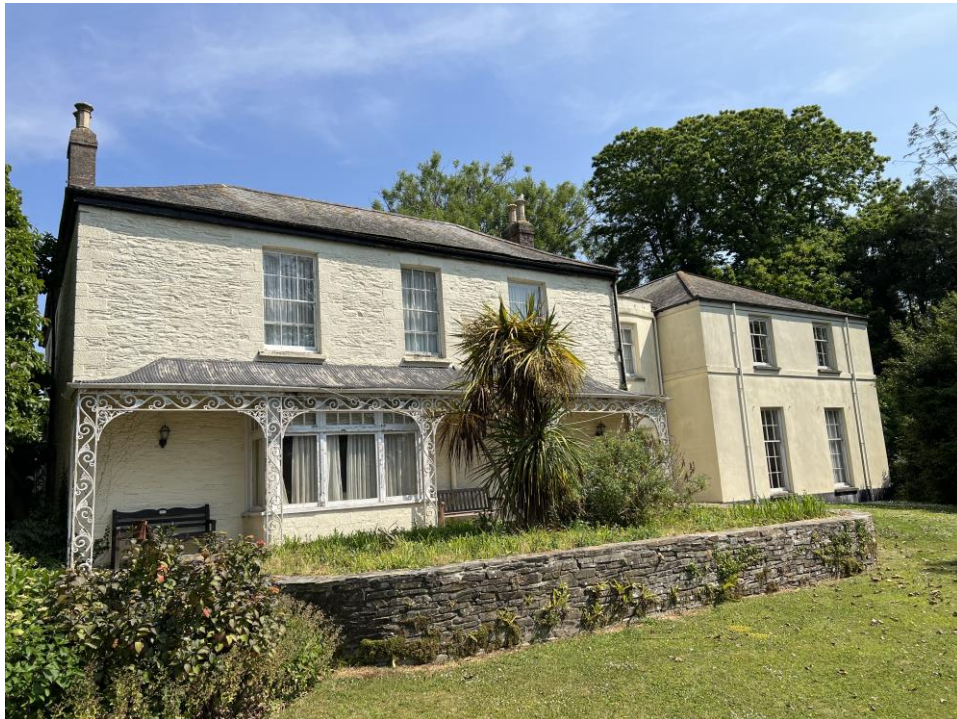
- .1 The stonework to the original elevation is altered random altered shale with granite quoins and lintels. All the stonework is painted (fig 1).
- .2 An external metal canopy is present for the full length of the original elevation. The paint is peeling from the metal sections, and there is some corrosion particularly to the roof members. However, there is little loss of section. The metal should be cleaned, and the previous paint removed. A new anti-corrosion paint system should then be applied before applying the decorative finishes. The bases of the uprights are not visible and so should be exposed (fig 6). A general allowance should be made for possible repairs.

Fig 1 South elevation

- .3 The shallow stone arches appear to have performed adequately to date. However, an allowance should be made for repointing of these arches where required in order to preserve their stability.

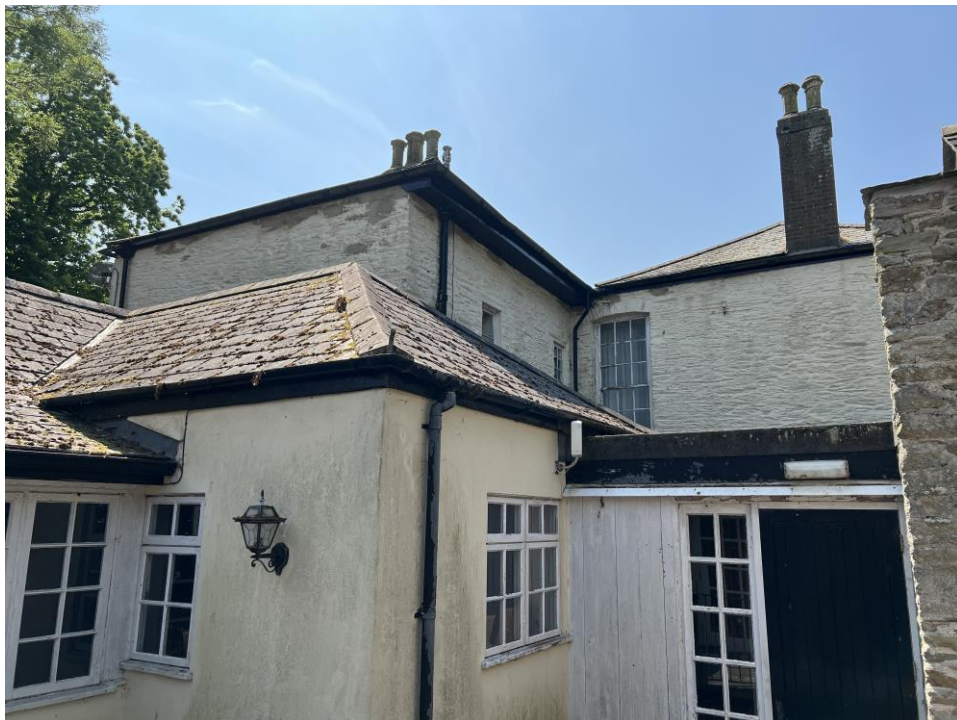
- .1 This elevation is partially obscured by the adjacent single-storey buildings (see sketch and fig 2). The single window opening in the original building is formed with a shallow stone arch formed from vertical shale stone rather than granite. As this form of construction relies fully on the stone-to-stone bearing, the arch should be inspected and repointed where necessary.
- .2 The rear elevation of the modern extension is free from visible defects. Sub-floor vents are also visible.

Fig 2 North elevation

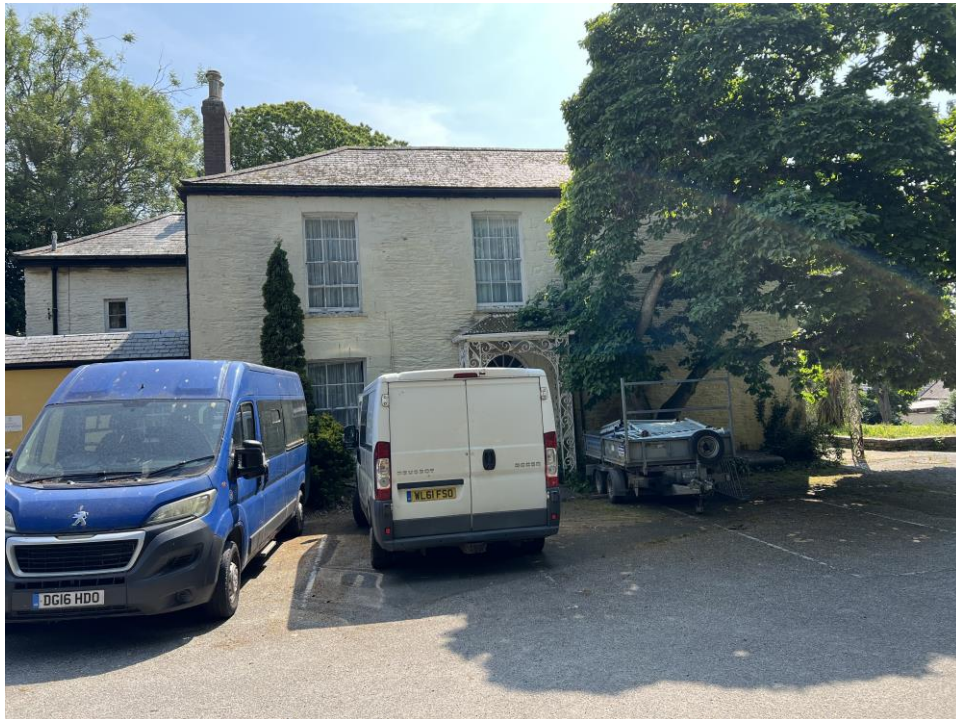
- .1 A large tree is present alongside this elevation (fig 3). We would suggest that this is commented on by the consultant arboriculturist as this will have the potential to affect the foundations to the building and the adjacent basement walls.

Fig 3 West elevation

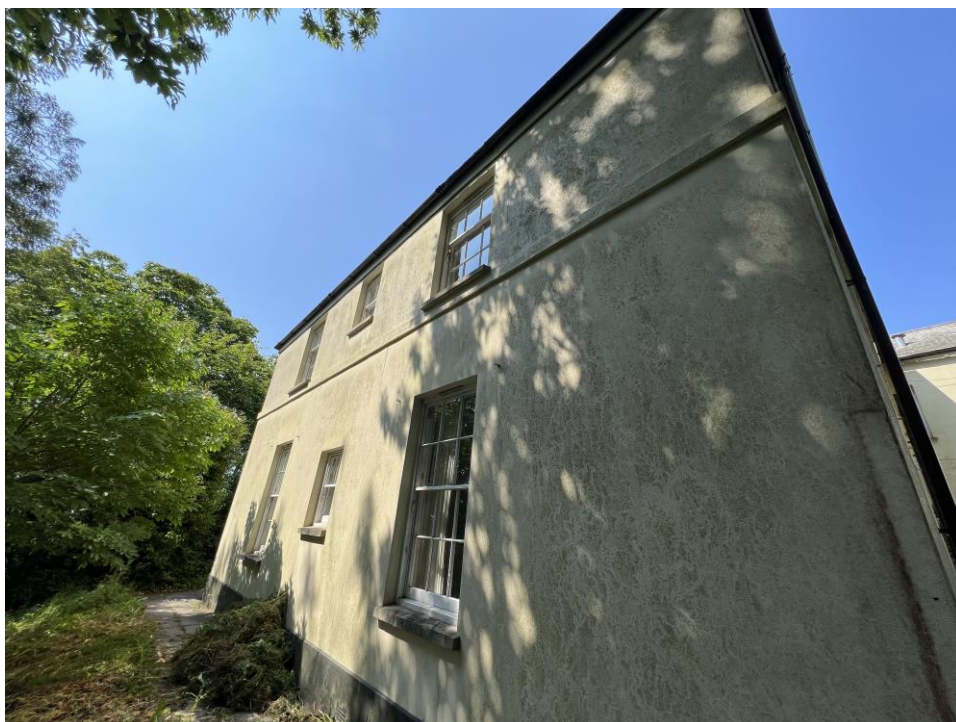
Fig 4 East elevation (1 of 2)

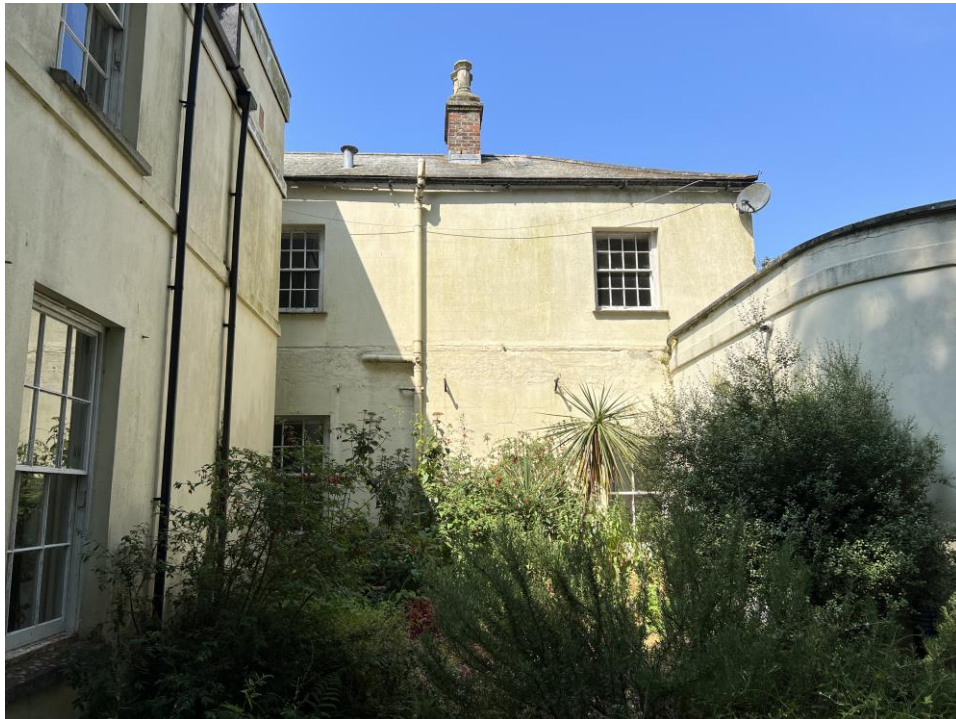
Fig 5 East elevation (2 of 2)

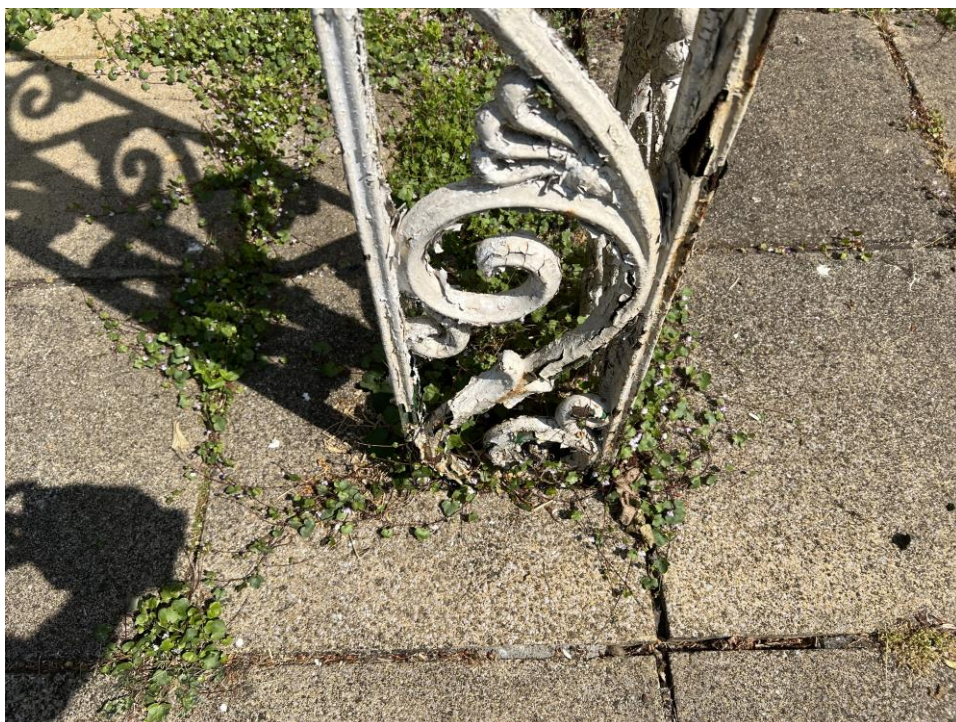
Fig 6 Typical base of lattice column to canopy

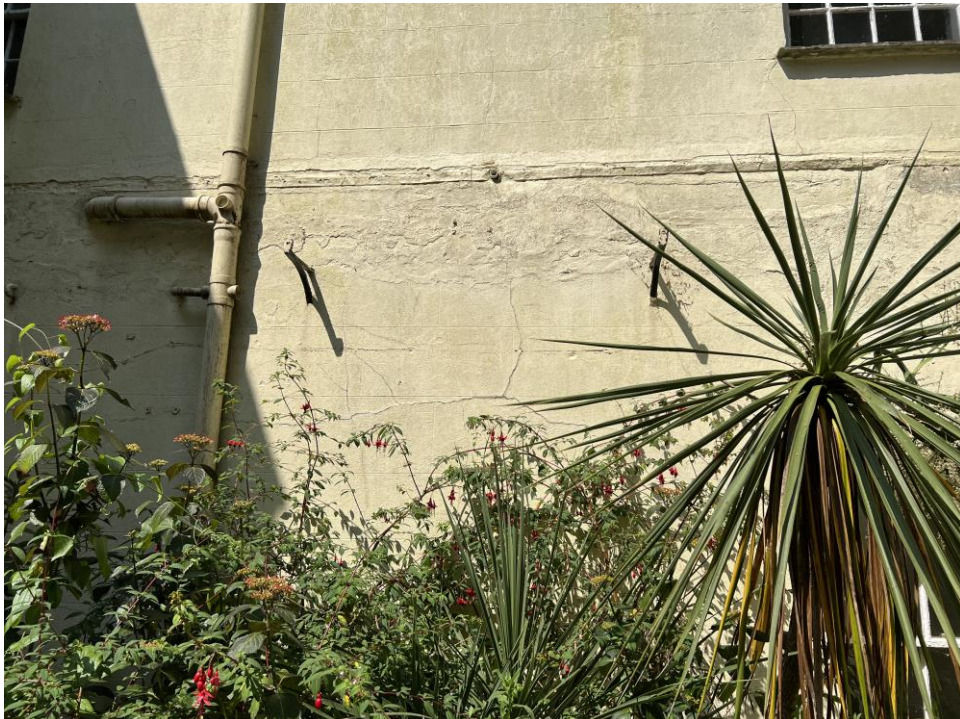
- .1 The east extension of the modern extension has several sub-floor vents indicating that the ground floor is of suspended construction.
- .2 There is cracking to the render in the exposed section of the east elevation of the original building. The cause of this is unclear. The render should be removed to see if the cracking penetrates the stonework beneath. At this stage, a provisional allowance should be made for localized Helifix type repairs and possible underpinning for this length of wall.

Fig 7 Cracking to east elevation of original building

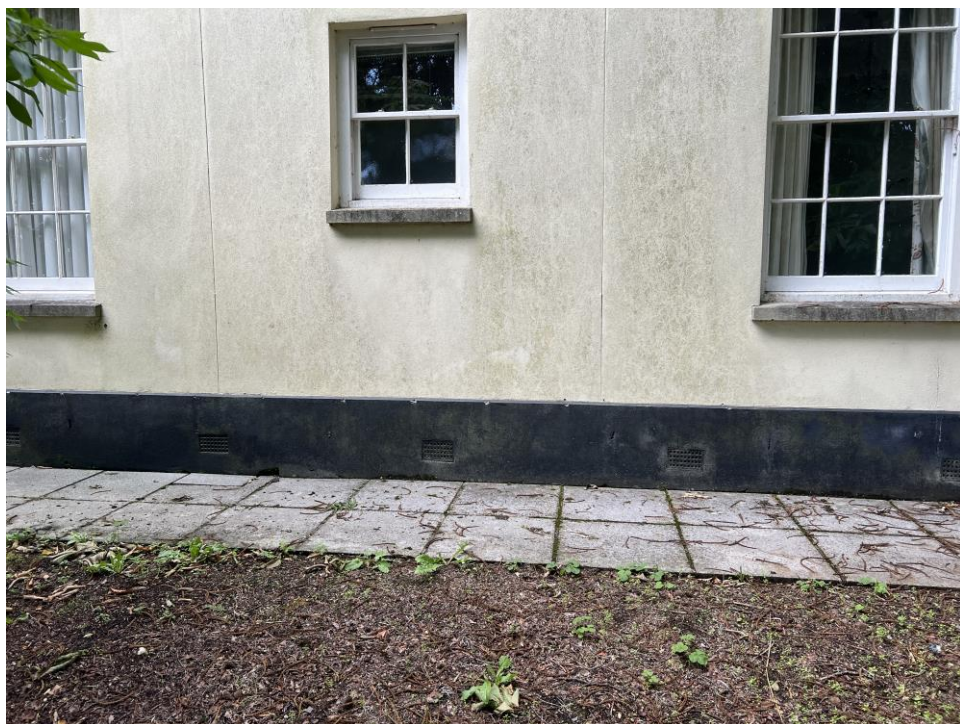
Fig 8 Sub-floor vents in modern extension.

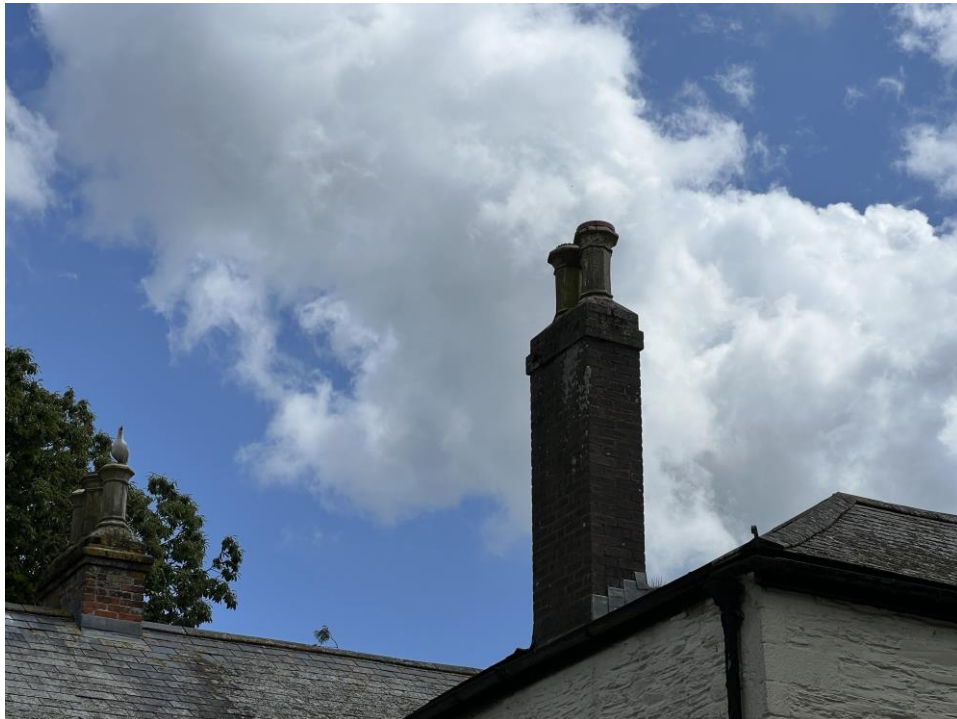
- 
- .3 There are loose and damaged slates on the roof pitch to the original building. These should be made good.
  - .4 The chimneys visible in this elevation are formed in brick and have been repointed in the past. However, as there are visible leaks within the building at several chimney locations, we would recommend that these are inspected once a scaffold is erected, and allowance made for repairs and repointing (see 2.2.3.6).

Fig 9 Typical chimney

- .6 The chimneys to the original building are relatively slender. They also incorporate tall chimney pots. As such, consideration should be given to the provision of metal chimney stays connecting the chimneys to the adjacent roof structure. The chimneys have been repointed in the past. However, in light of their slenderness these should be inspected once the building is scaffolded. A general allowance should be made for possible repointing and isolated repairs.

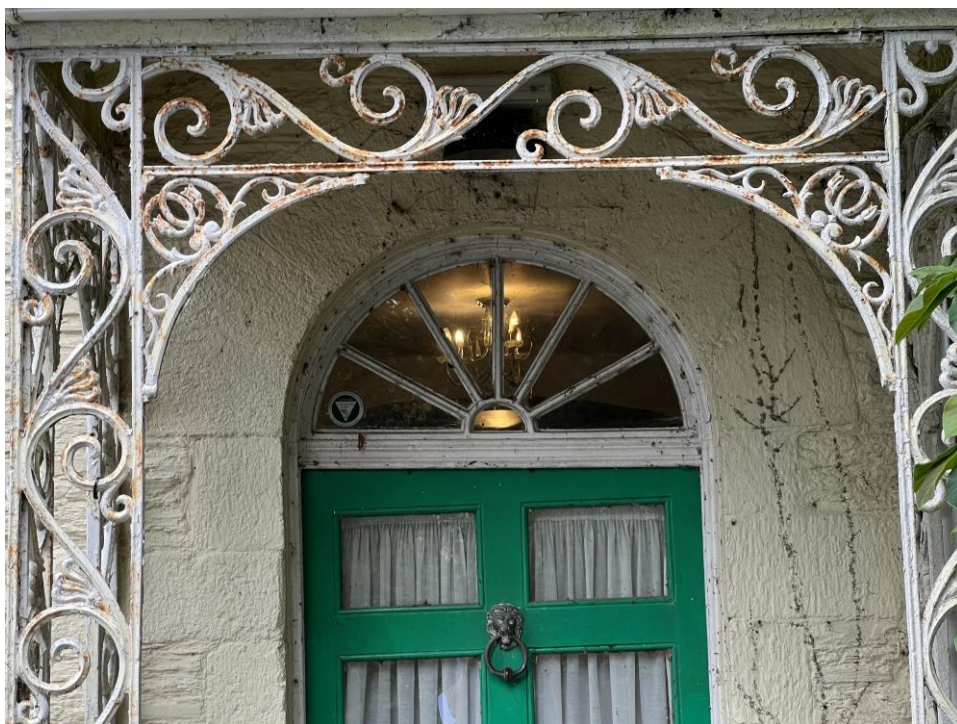
- .4 The doorway in the elevation exhibits a significant drop from north to south. There is no recent cracking around this door and so the movement is considered to be historic. However, the adjacent drainage should be inspected, and allowance made for its possible repair. The comments made above in relation to the tree should also be reviewed.

Fig 10 Distortion in doorway to west elevation.

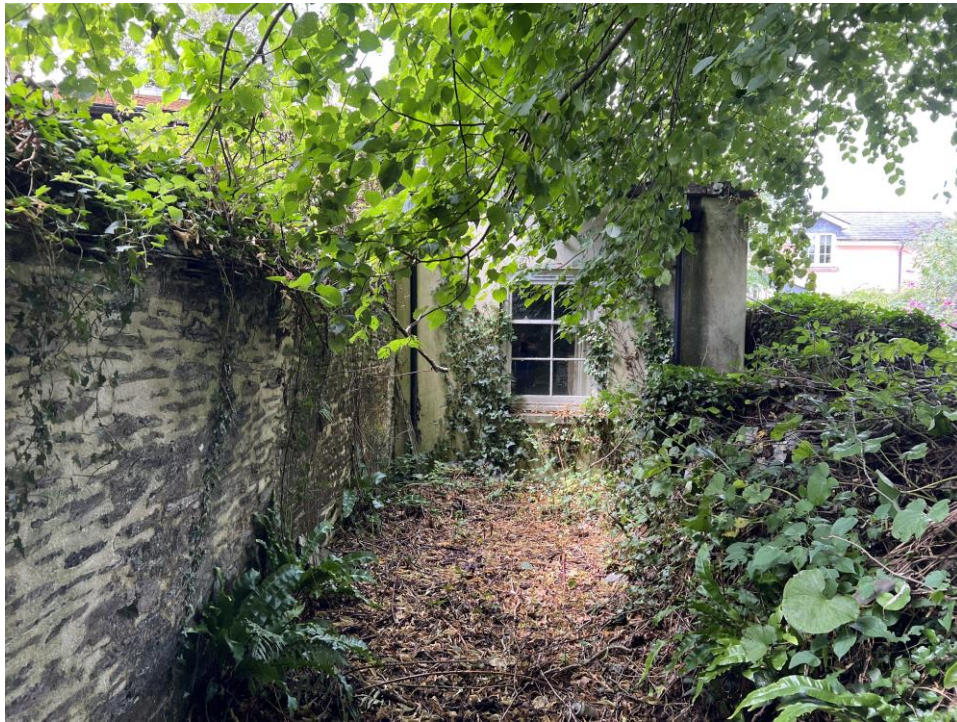
- .9 We note that the external garden wall indicated on the layout intersects the kitchen, RG27, which is to be demolished. The end of the garden wall is currently restrained by the building and so additional restraint will be required in the form of a return wall or pier to preserve the stability of the boundary wall.

Fig 11 External garden wall and intersection with single storey building to north of house.

- All new and retained timber should be treated against decay and wood-boring beetle attack.
- The stability of the external garden wall should be considered once the existing single-storey buildings are demolished. Additional work will be required as outlined in 2.2.1.9.

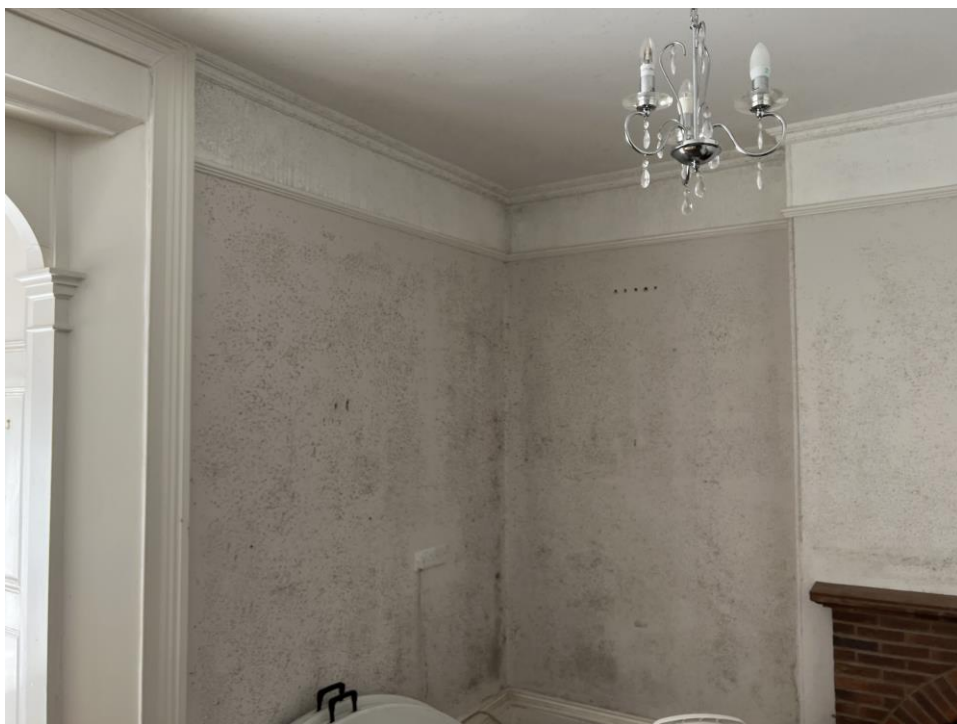
- 
- .4 There is cracking to the ceiling in Bedroom 6. There is also mould growth on the inside faces of the external walls. There is also some distortion to the timber lintel over the bay window. This should be commented on by the timber treatment surveyor.

Fig 12 Mould growth in bedroom 6

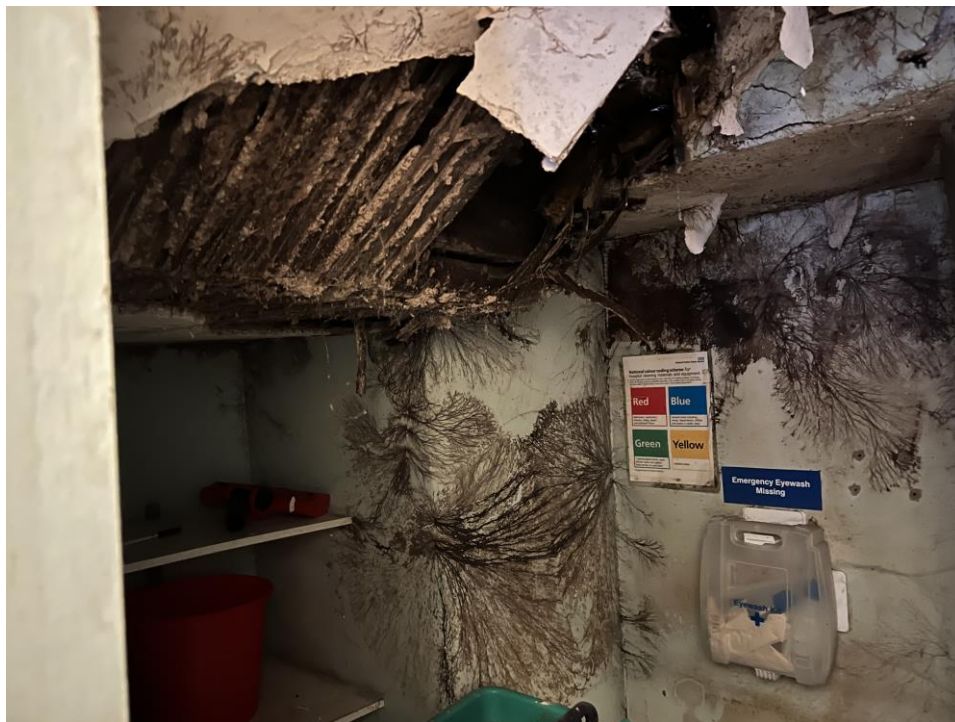
- .5 There is extensive damp and mould growth in bedroom 7 against the northern wall.
  - .6 The staircase within the original building is heavily affected by dry rot. This is extensive and the stairs have been closed off for safety reasons. The extent of the dry rot is being established by the timber surveyor. We are aware that there will be a zone beyond the known extent of the dry rot where all timber will need to be removed and all masonry will need to be treated to prevent a reoccurrence. Reference should be made to the SMT Associates report in this respect.

Fig 13 Dry rot under main staircase in original building.

- 
- The extent of the dry rot identified within the original building should be established. As described in section 2.2.1.6, the extent of the timber to be cut out will be greater than the visible extent of the outbreak in order to prevent a reoccurrence.

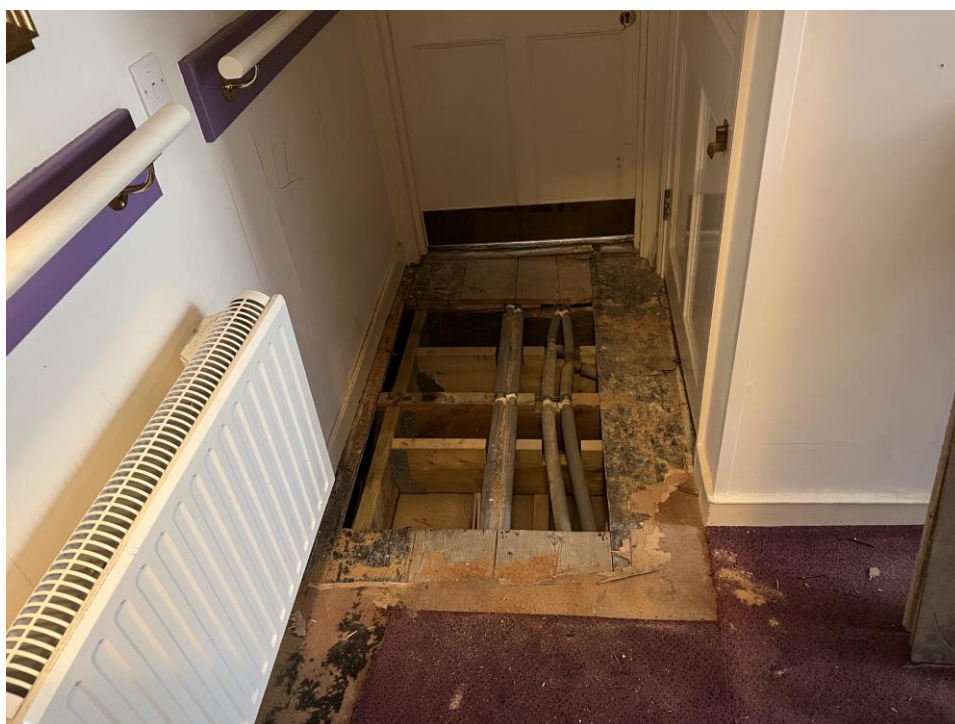
There is a significant drop in the floor level around location 4. The joists in this area were found to have been supplemented with new joists. However, these are then trimmed out at the face of the wall and supported back on the original joists (fig 14).

Fig 14 Trimmed first floor joists in location 4

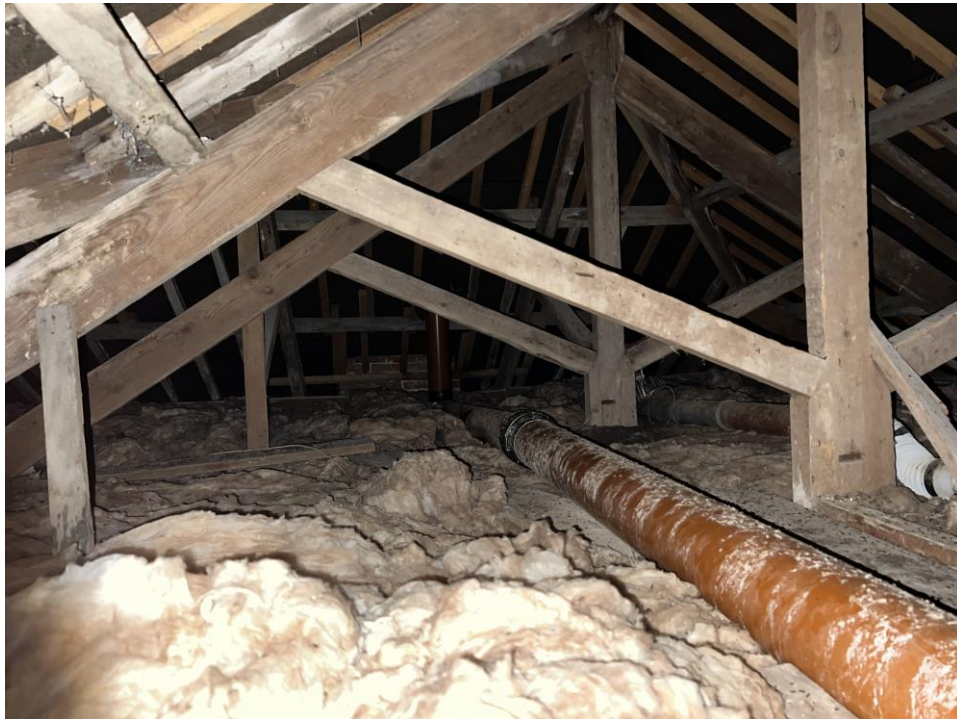
- .2 The roof structure is formed in traditional cut-timber roof trusses spanning across the full width of the building. These support timber purlins and common rafters. The roof covering has been replaced in the past as there is a formal sarking felt. The common rafters also appear to be a later addition.

Fig 15 Typical roof structure

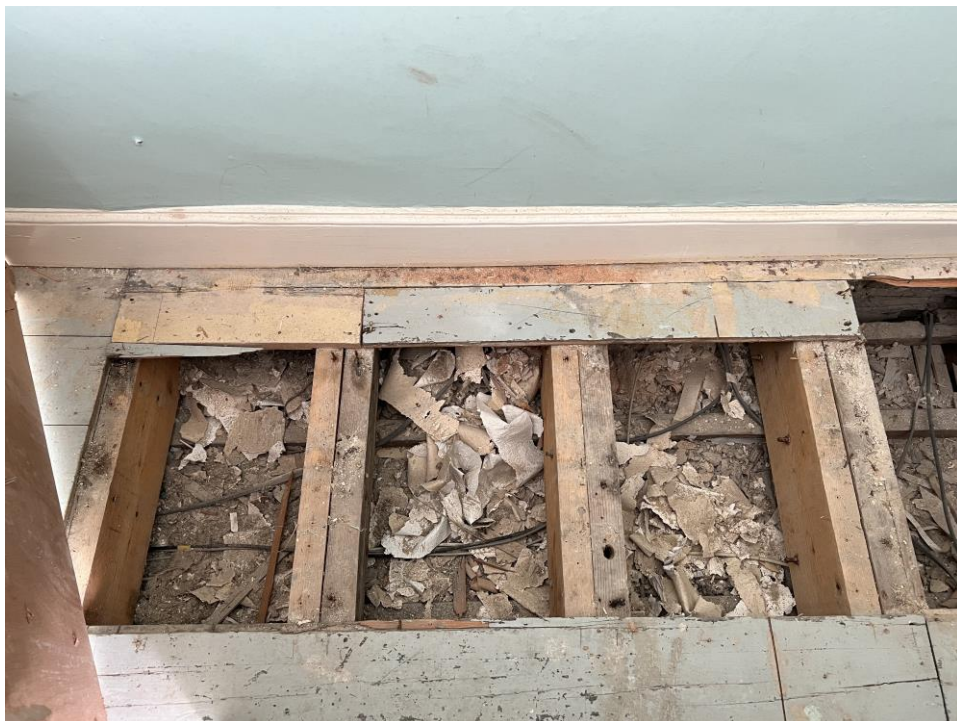
In several of these locations, the joists were seen to have been repaired in the past following extensive decay. The repairs appear to have been

carried out in a rather ad-hoc manner and we suspect that the various splices will not be able to be confirmed as adequate by calculation. These will therefore have to be upgraded as part of the proposed works.

Fig 16 Previously repaired first floor joists.

- The first-floor joists have been subject to widespread repair in the past. Since then, further decay has occurred. The increased loading required to meet modern acoustic requirements means that the joists will need to be upgraded significantly. An allowance should be made for the doubling up of the existing joists and for the replacement of, say, 50% of the existing joists if found to be decayed.

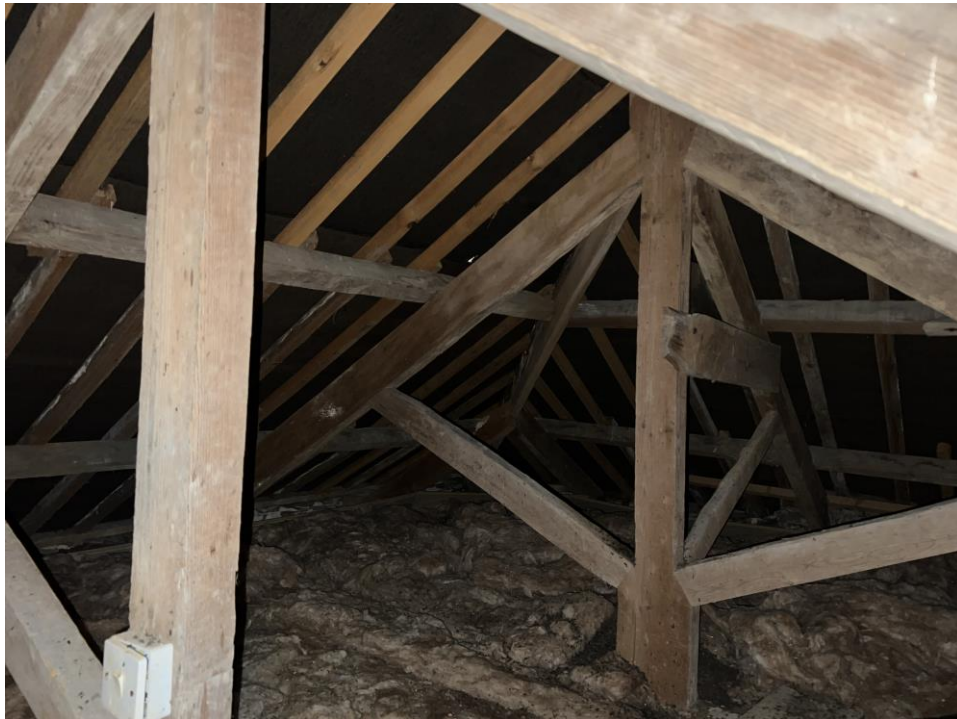
Fig 17 Typical roof structure showing hip end.

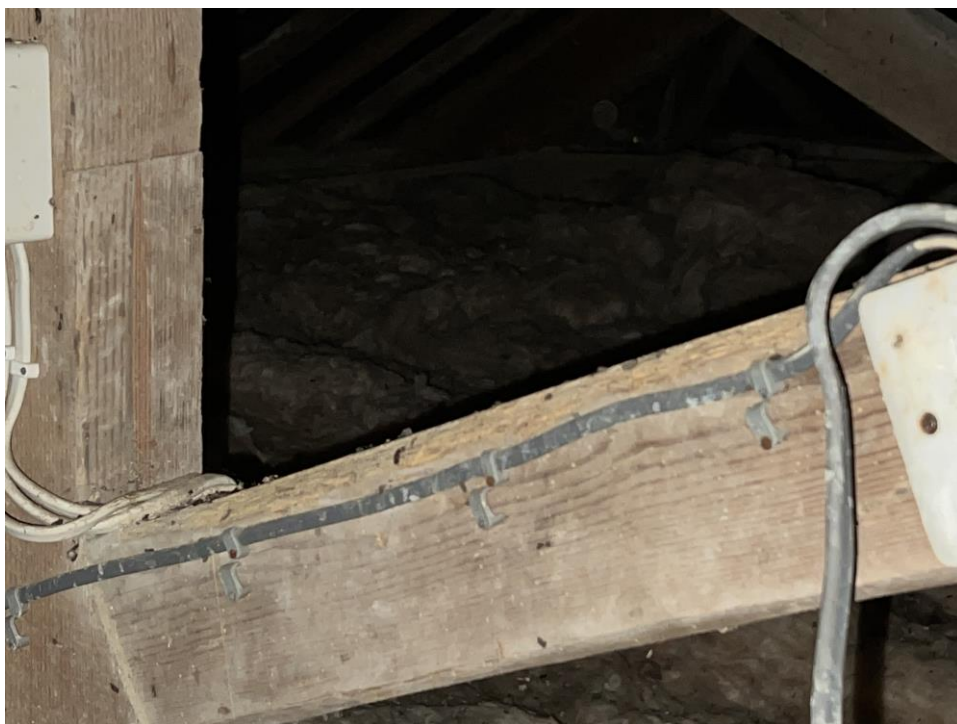
- .3 Our inspection revealed that the trusses close to the access hatch are affected by woodboring beetle attack. These should be commented on by the timber treatment specialist. At this stage, allowance should be made for possible repairs to the trusses where the infestation is advanced. All new and existing roof timbers must be treated against decay and wood-boring beetle attack.

Fig 18 Wood-boring beetle attack to truss member adjacent to roof hatch.

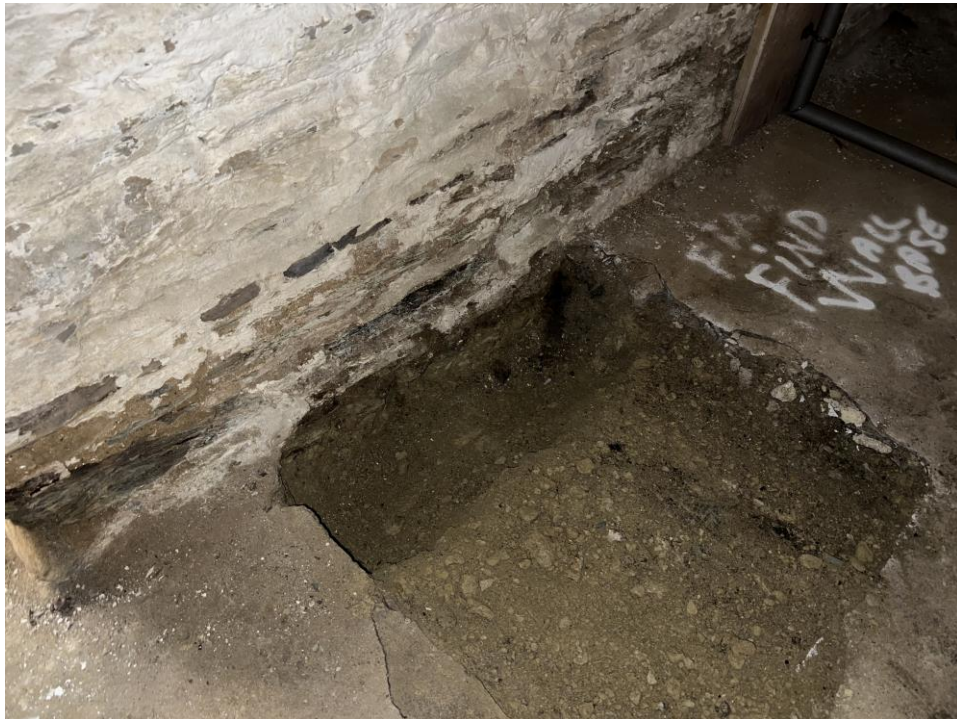
- .2 The walls to the basement are formed in random shale stonework. A trial excavation alongside one wall revealed its founding level to be only fractionally below the existing floor level. The floor itself was seen to be merely a thin layer of sand/cement overlying the weathered shale rockhead below (fig 19).

Fig 19 Excavation to underside of basement wall.

- The basement is very damp. We understand that it is to be dry lined as part of the work. If this requires the installation of a new floor slab, with modern construction thicknesses, then underpinning of the existing walls will be required as the founding level is only fractionally below the existing screed level.

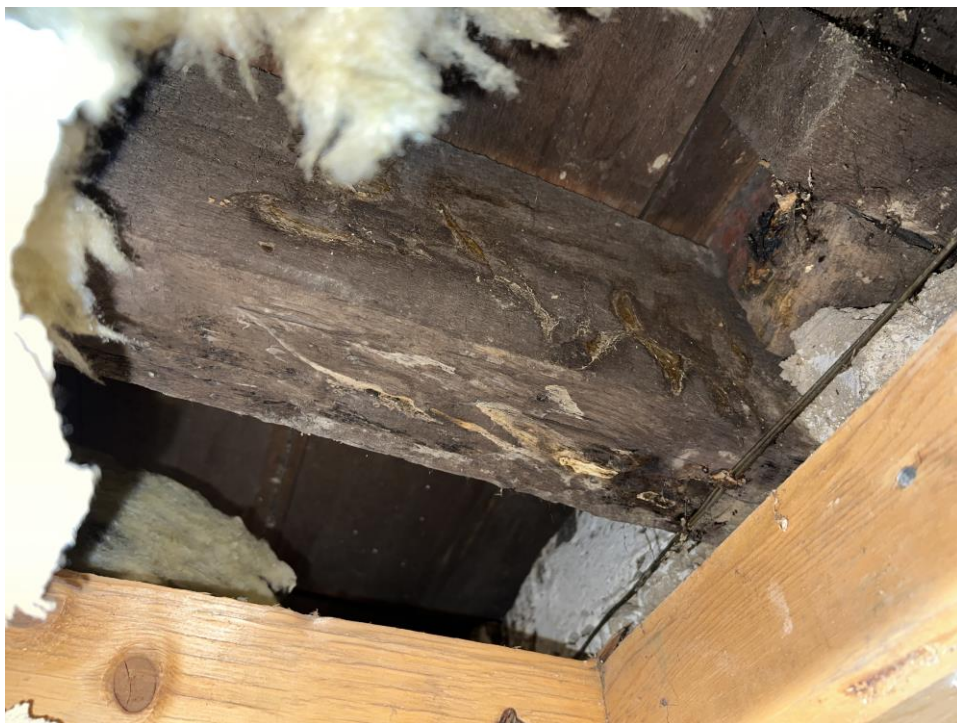
- .3 Four holes were made through the basement ceiling to inspect the ground floor joists above (figs 20). These were found to be 140-150x75mm joists at 440-590mm centres. Some of the joists have previously decayed and have then been repaired in the past with new sections having been spliced in.

Fig 20 Ground floor joists exposed in basement.

- The external stonework walls are damp and there is decay to all the timber elements in contact or embedded within the masonry.
- The ground floor joists are in a poor condition where present over the basement. The existing ceilings should be removed to allow a full inspection. Until then, allowance should be made for the strengthening of the floor and for the possible replacement of 75% of the existing joists.
