82 Highburgh Road, Glasgow G12 9EN

We propose replacing the existing sash and case window with newly manufactured timber sash and case windows that will be manufactured in a like for like formation. Horn detail would be lifted from the existing windows to preserve the established style.

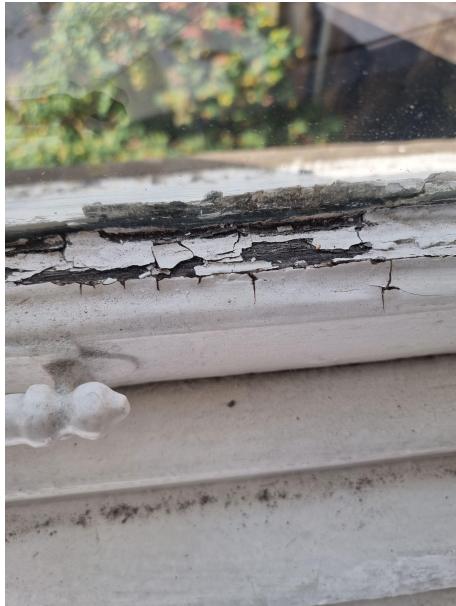
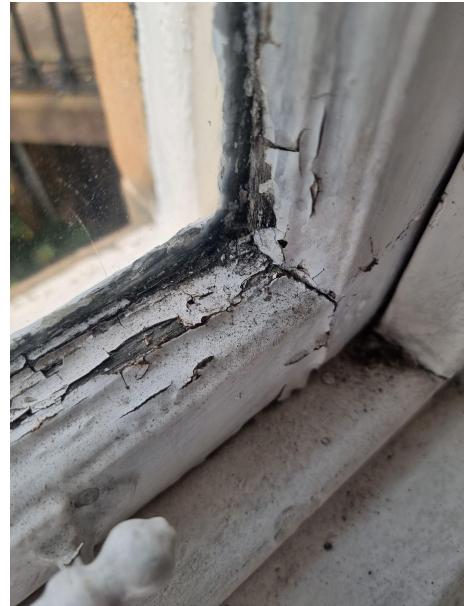
Paint has come away from the windows which is allowing water to enter the woodwork resulting in further rotting.

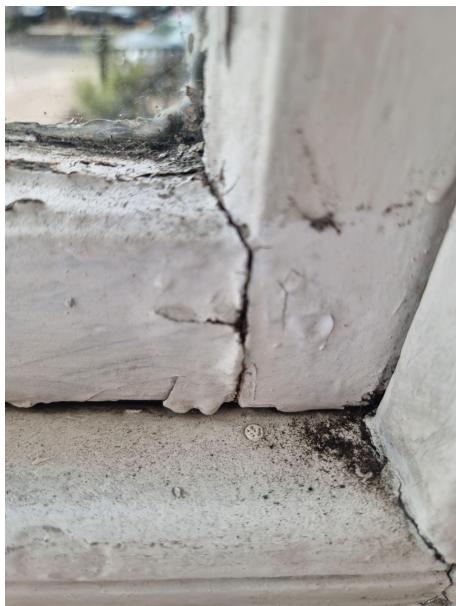
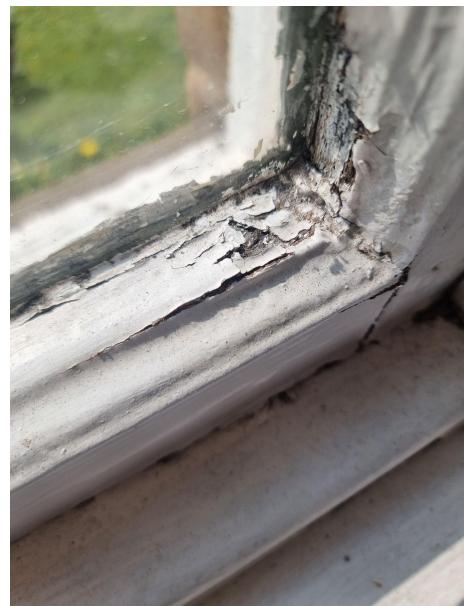
Photos show that the timber joints are failing and the sash woodwork is rotting.

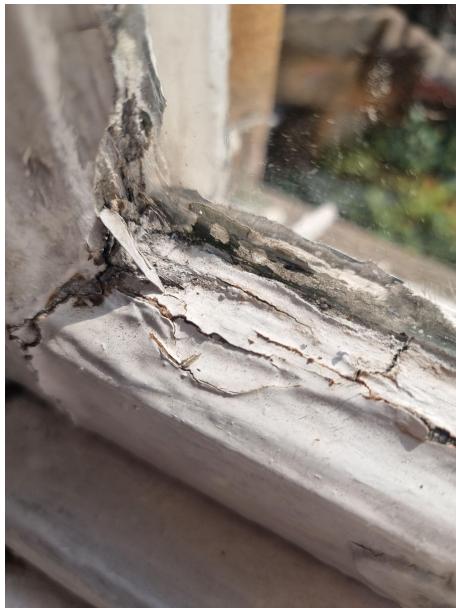
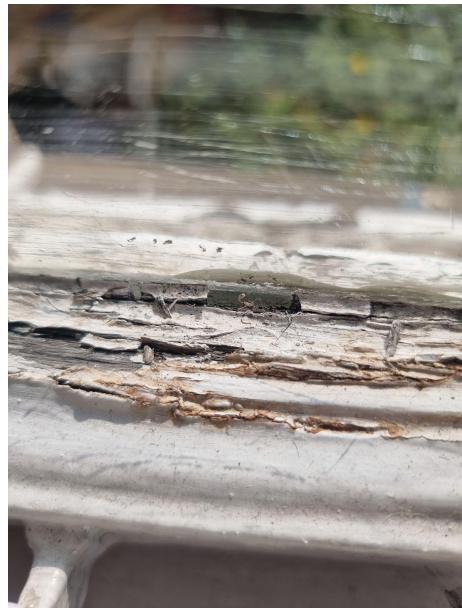
Photos show rotting bottom rails and broken seals.

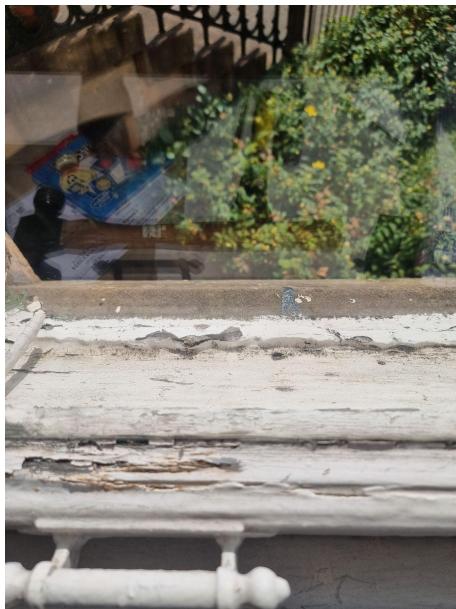
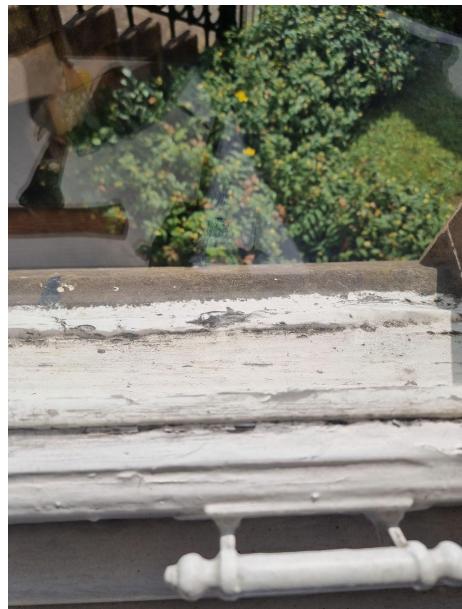
Photos show rotting bottom rail and sills to the windows.

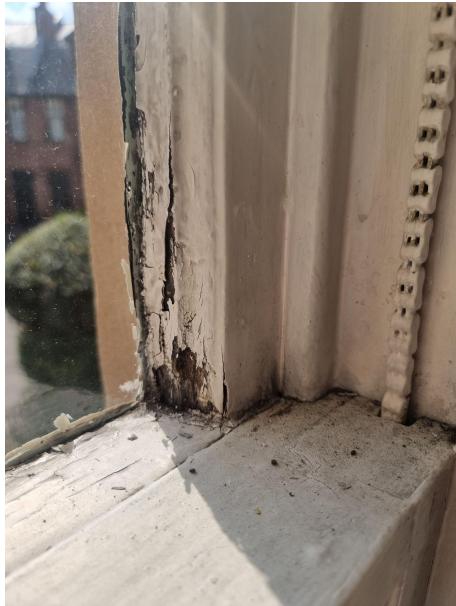
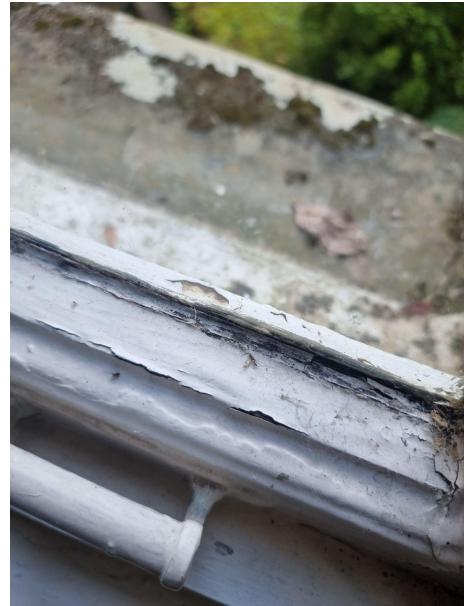
Photos show that the sashes and seals around the panes have failed, allowing water to enter the woodwork and causing rot and decay.

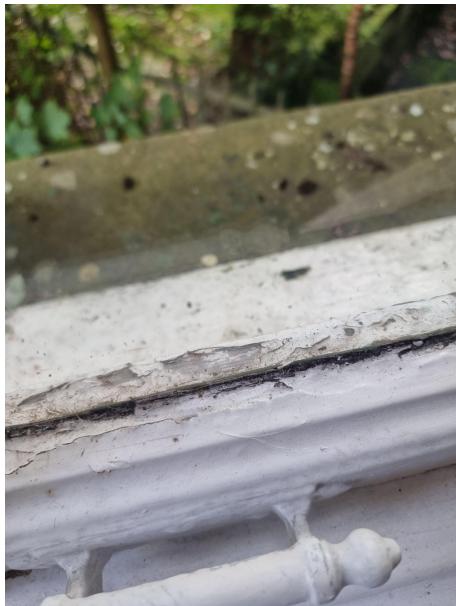
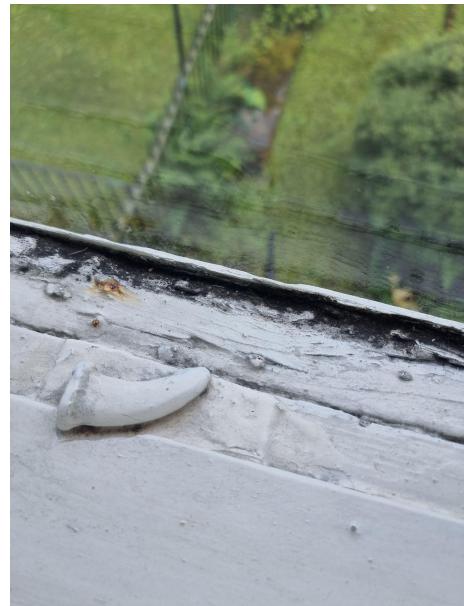
First photo shows the outside of the bottom rail is rotting and the second photo shows that the seals at the midrail have deteriorated and are allowing water to enter the woodwork and causing further rot and decay.

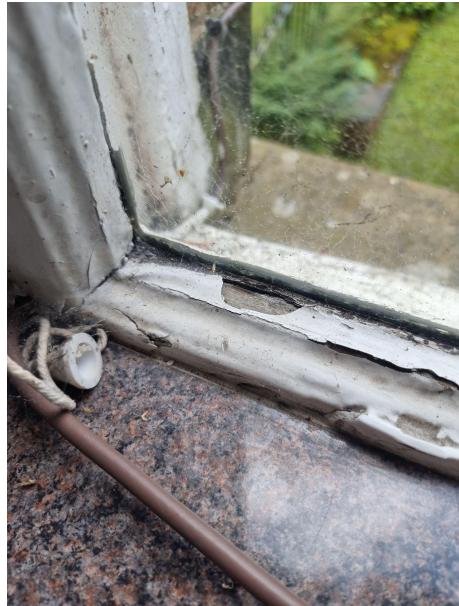
Bottom rail is showing signs of water damage and rot.

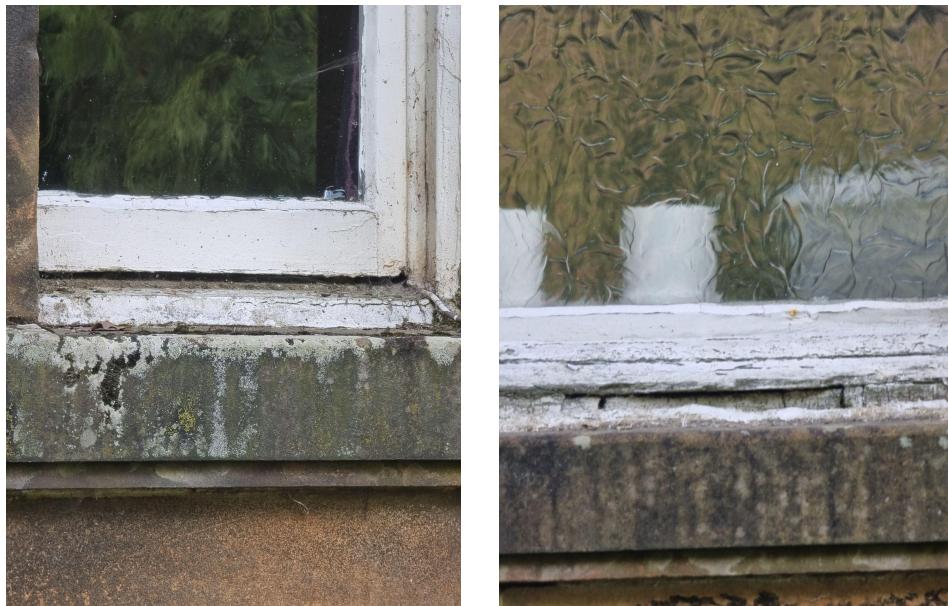
First photo shows a large gap between the bottom rail of the window and the sill which is allowing wind and water to enter the property. Both photos also show that the sills are rotting and deteriorating in sections.

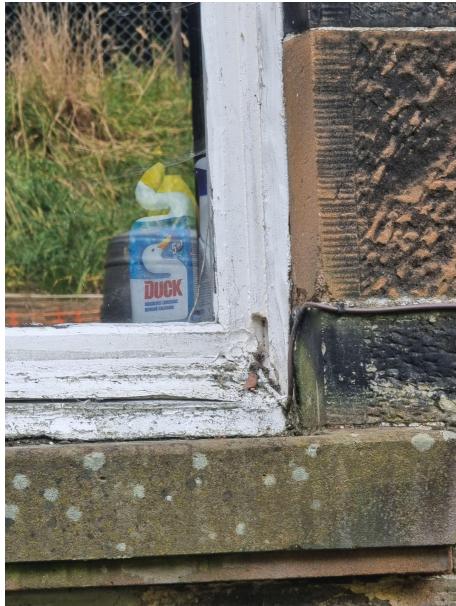
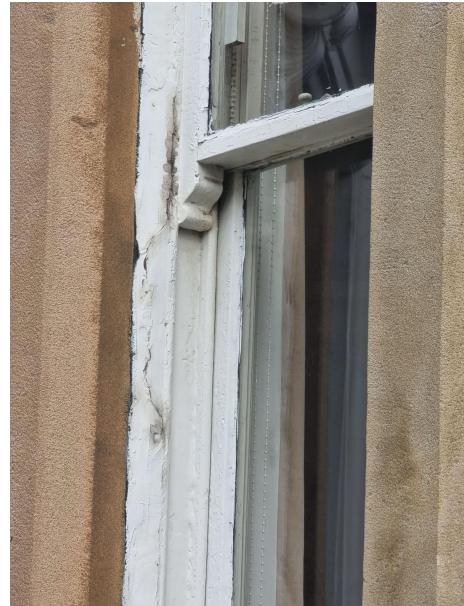
First photo shows missing sections of mastic and the casement bottom rail and sill are warped due to water damage. The second photo again shows broken mastic and signs of rotting within the casement.

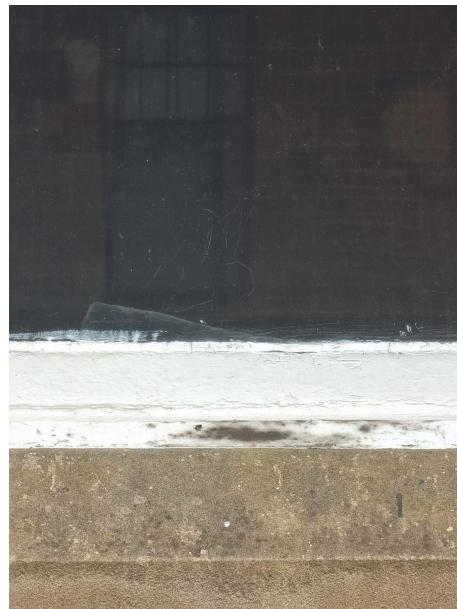
Signs of damp and rotting behind the mastic under the window.
