## BS5837:2012 TREE SURVEY / Arboricultural Impact Assessment

Customer No: MBHDE05  
Document No: 800815ver3  
29/09/2023

Site Address:  
FS330 – Witney Service Station, Welch Way,  
Witney, Oxfordshire. OX 28 6JL

800815ver3,  
Based on Survey 25<sup>th</sup> Sept 2022

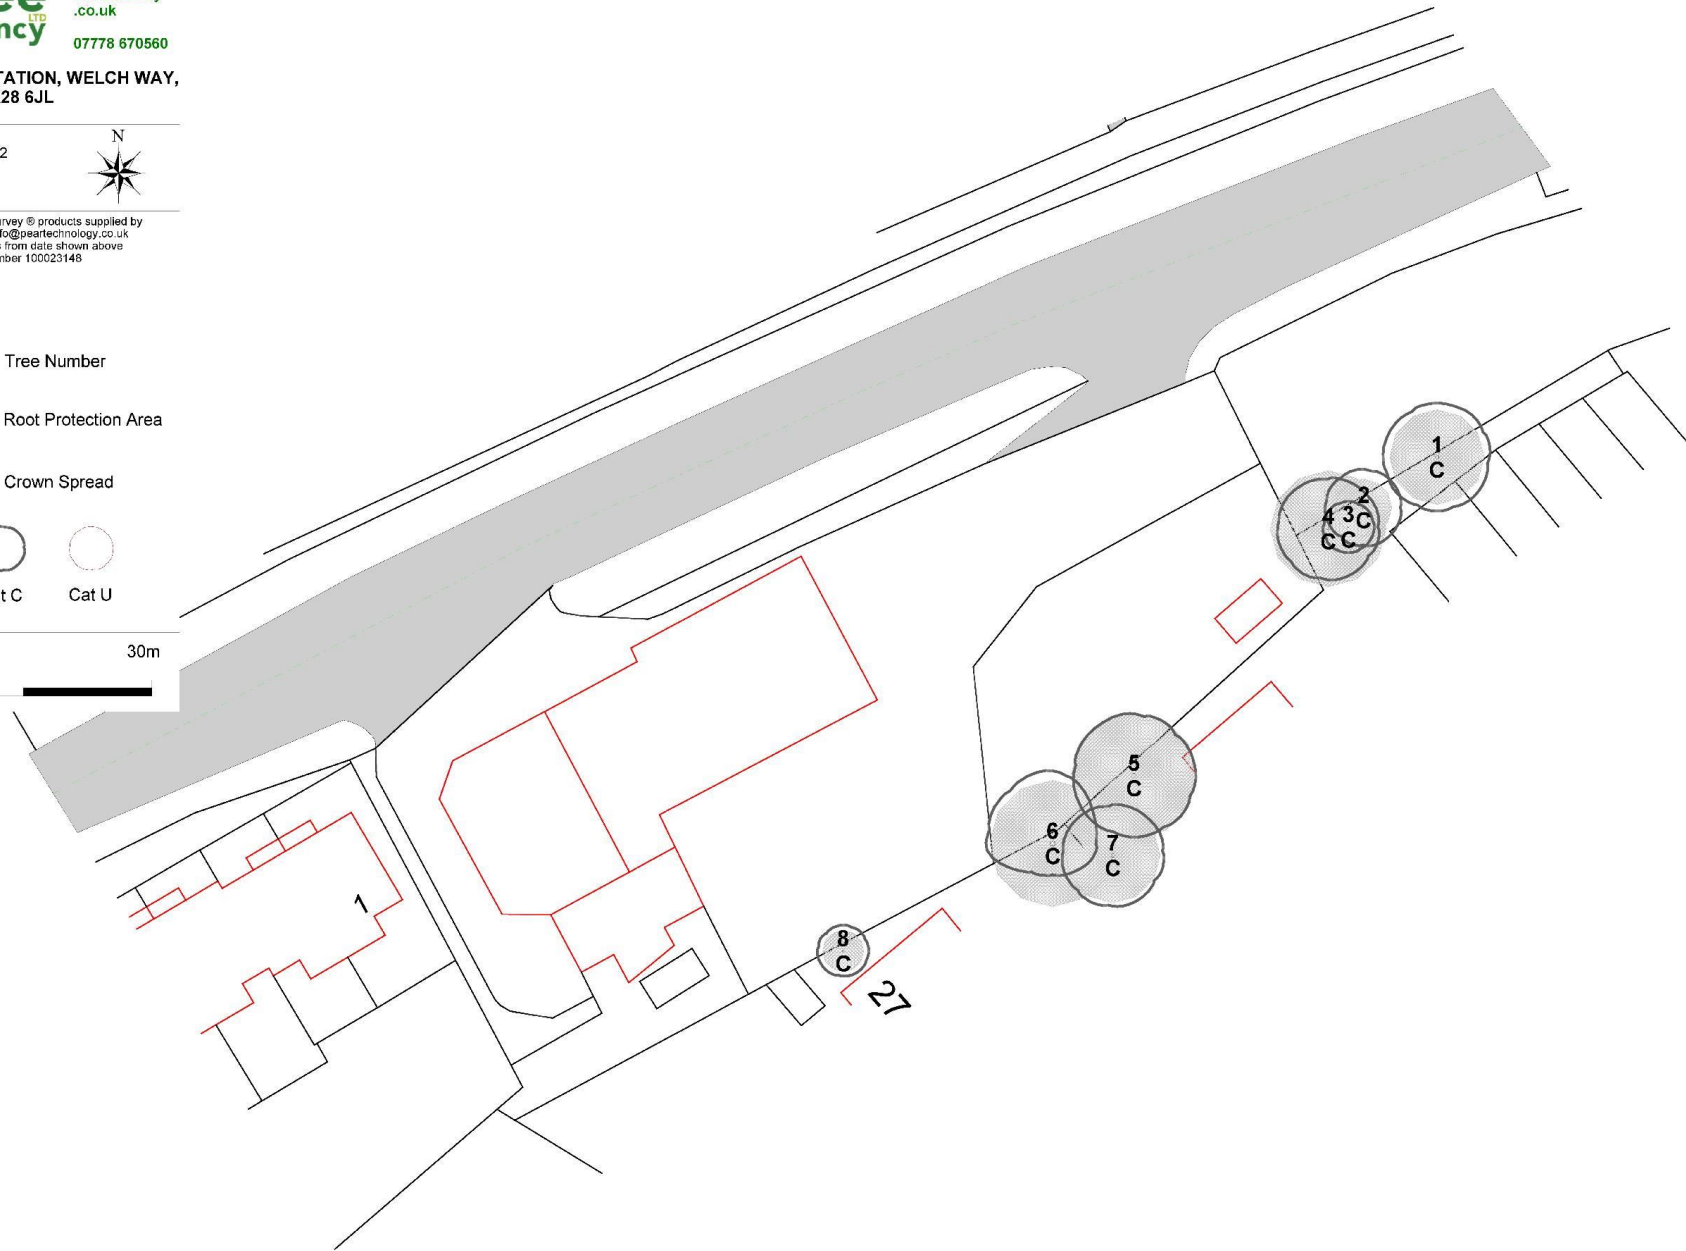
Tree Constraints

The Crowns of the trees (Category C) overhang the site, and the Root Protection Areas as determined according to BS5837:2012 are also present into the site.

T4 Willow, is just the other side of the rear boundary, and is assumed to be in the ownership of whoever owns the alleyway to the rear of the houses in Bartlett Close. The survey shows that the crowns and also the Root Protection Area are present in the Service Station Land.

T5 Box Elder, and T6 Sycamore are in the rear gardens of houses in Bartlett Close. The crowns and Root Protection Areas are present in the Service Station Site.

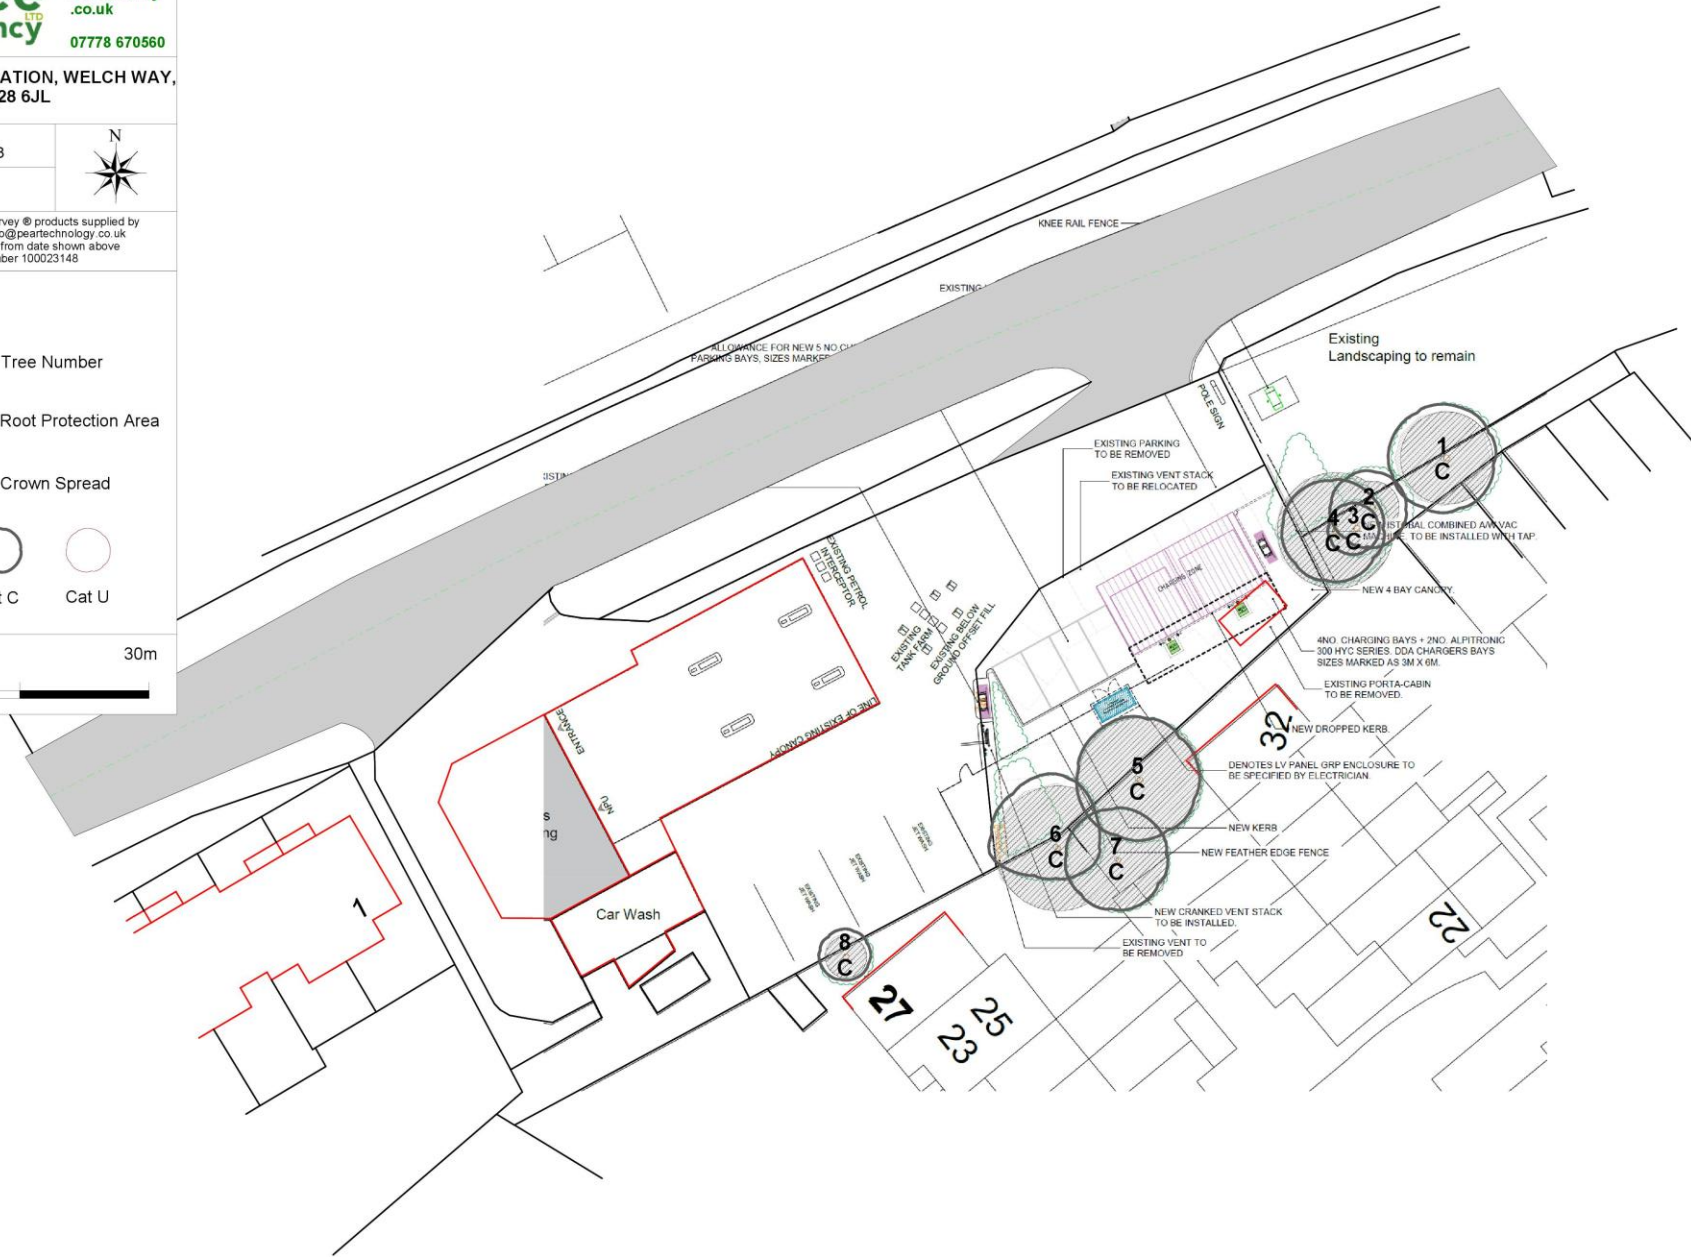
Design Overlay

There are no Conflict Areas now adjustments have been made in 13664 - Witney - P02 - 330 Proposed Site Layout - Rev D.pdf

The Cranked Vent Stack removal is expected to involve excavation within the RPA of T6, with the likelihood of damage to roots within the RPA.

The recommendation is therefore that the stack be left as much in situ, with severing outside the RPA and reduction in height to just below ground level.

The proposed design as in the document 13664 - Witney - P02 - 330 Proposed Site Layout - Rev D.pdf is acceptable with just the minor caveat re leaving the vent pipes in situ as much as practical.
