Wellow Wood Cottage, Wellow Wood Road, West Wellow, Romsey.

Initial thoughts.

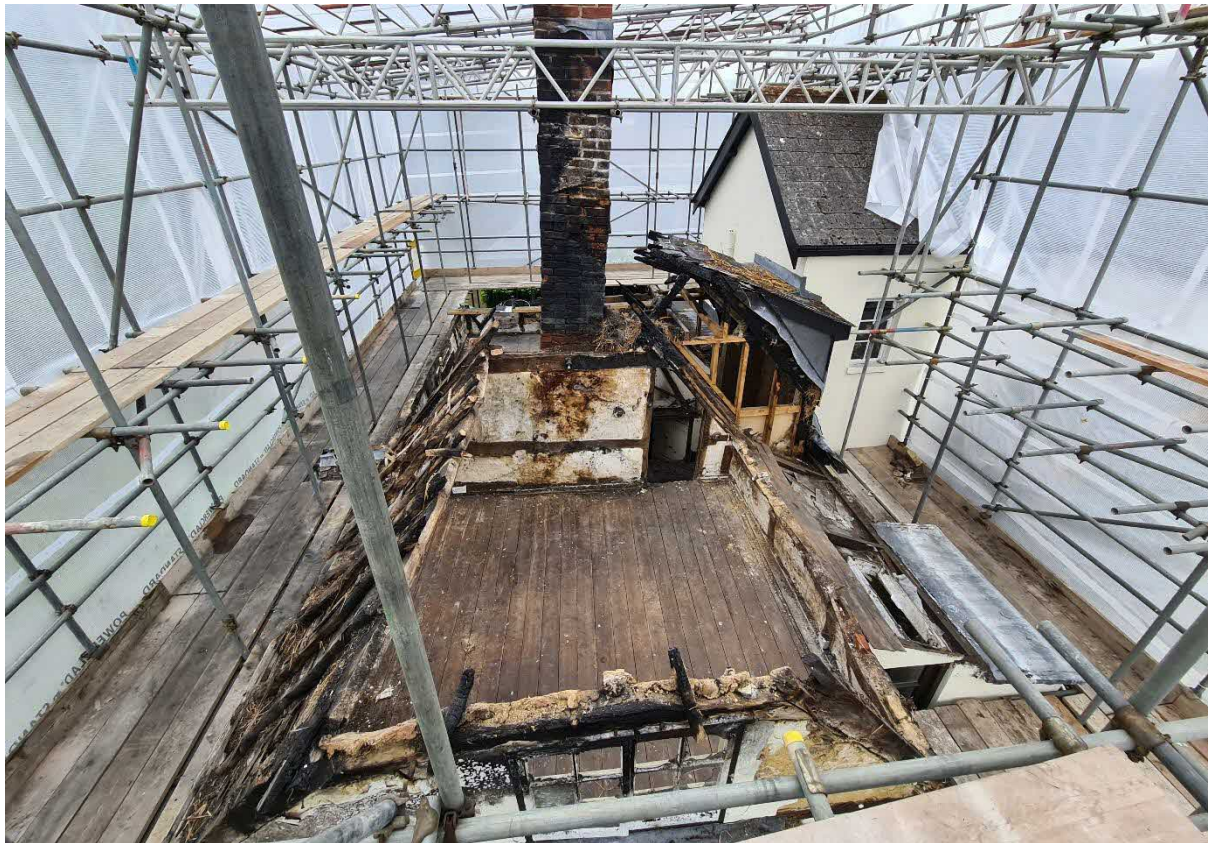
The building has lost almost all of the historic roof framing above wall plate level with only a handful of rafters and some of the purlin plus two trusses – adjacent to the stack and on the east gable. The wall frames are largely intact but with a few areas of fire damage and some scorching. While the floor boarding has some damage, the floor framing is untouched by the fire, although the large amounts of water used to extinguish the fire have caused a large amount of mould to bloom on the timbers, particularly areas of sapwood.

View from above showing extent of fire damage to frame.

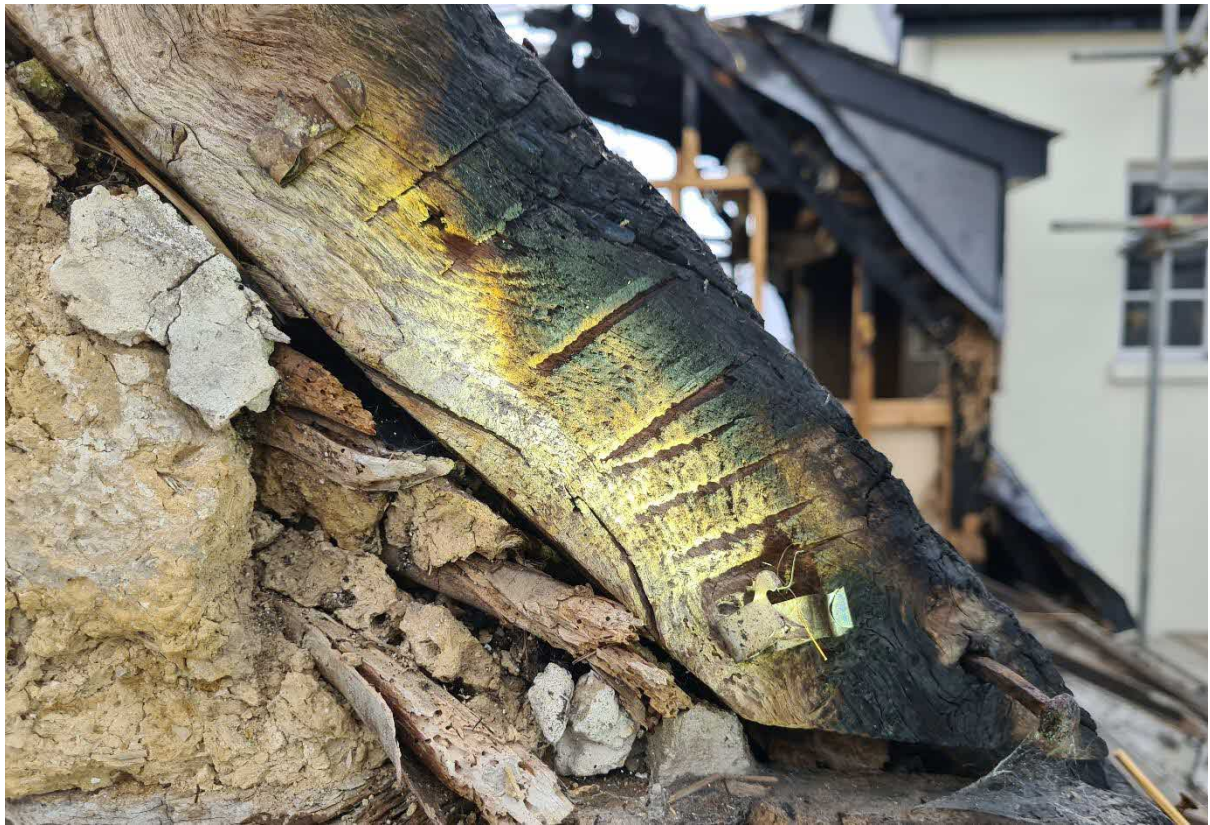
Carpenter's numerals visible at foot of principal on NE corner.

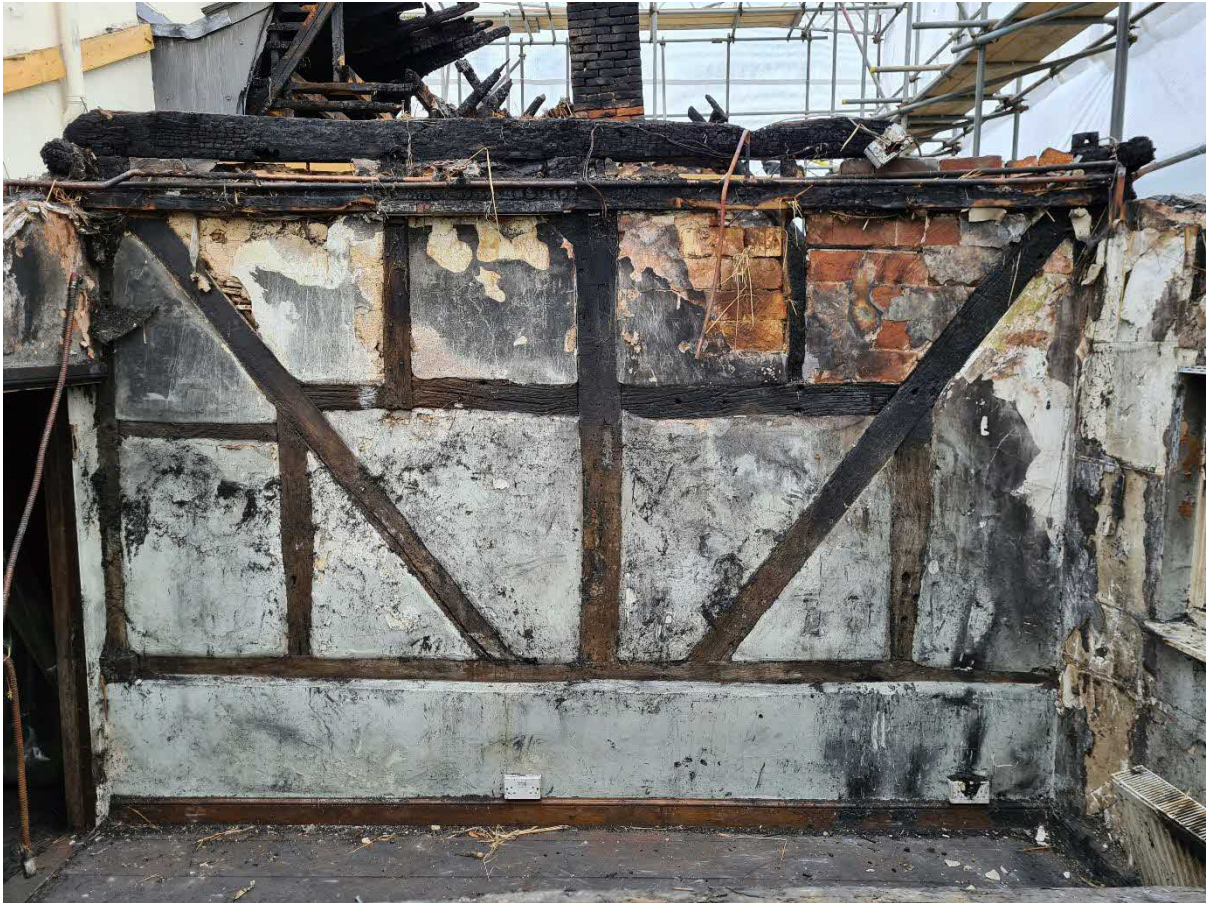
West gable – note tie beam – it will need to be scarfed for just over half it's length as well as an external face patch.

The tie beam to the west gable has lost maybe 55% of its length to fire damage but it can easily be repaired with a new section scarfed into it, albeit the remaining 45% will likely require a face patch to the outside as well. Once this, and the lighter damage to the studs below (including the oddly positioned (reused?) jowl post) have been repaired then a new truss can be built comprising of a pair of truncated principals and a collar. The remaining truss to the east gable should serve as a pattern for this new frame and ideally would have tapered principals and a curved collar as well as a pair of studs to the tie beam – evidenced by the mortices in the upper face of the tie.

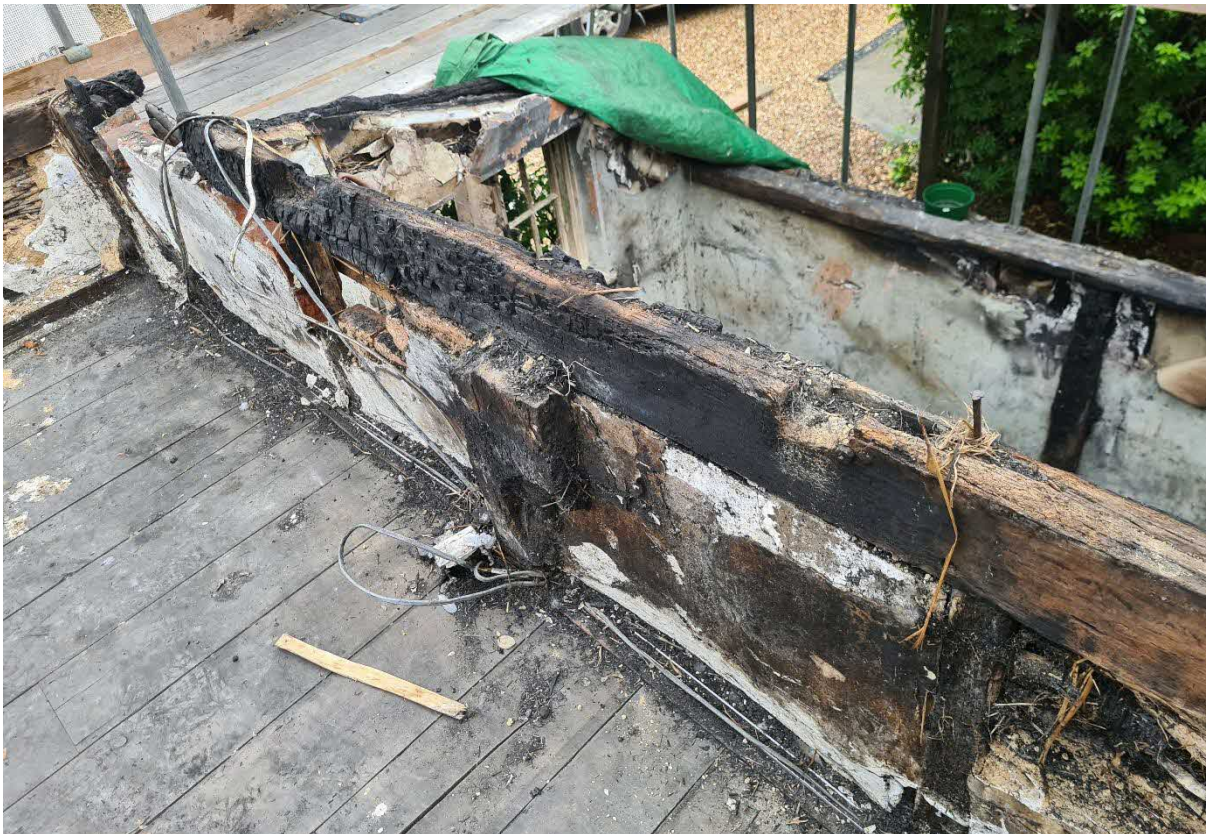
Internal view of west gable tie beam. From just to the right of the central post it is basically sound, albeit scorched.

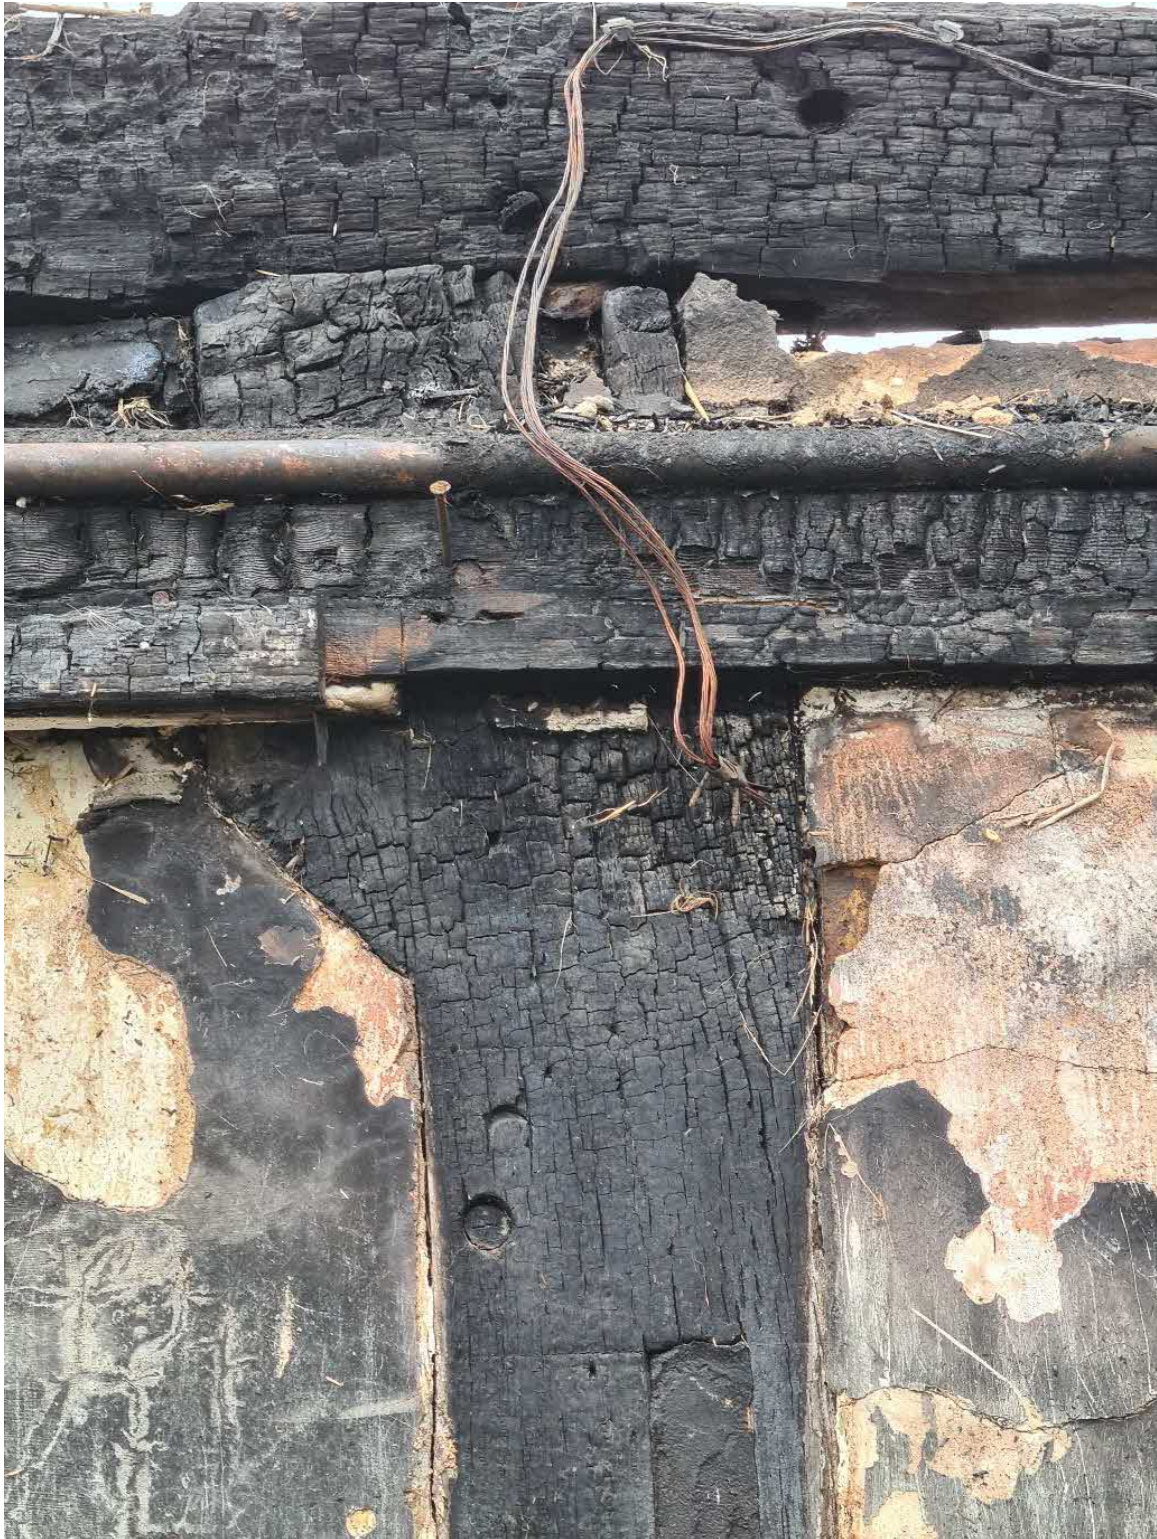
Jowl post re-used within west gable. Note tenon for wall plate (at top, to the right of cabling) proving it was used elsewhere prior to this frame, also void mortices below. The peg within the gable tie beam is NOT associated with this connection – there is no tenon there.

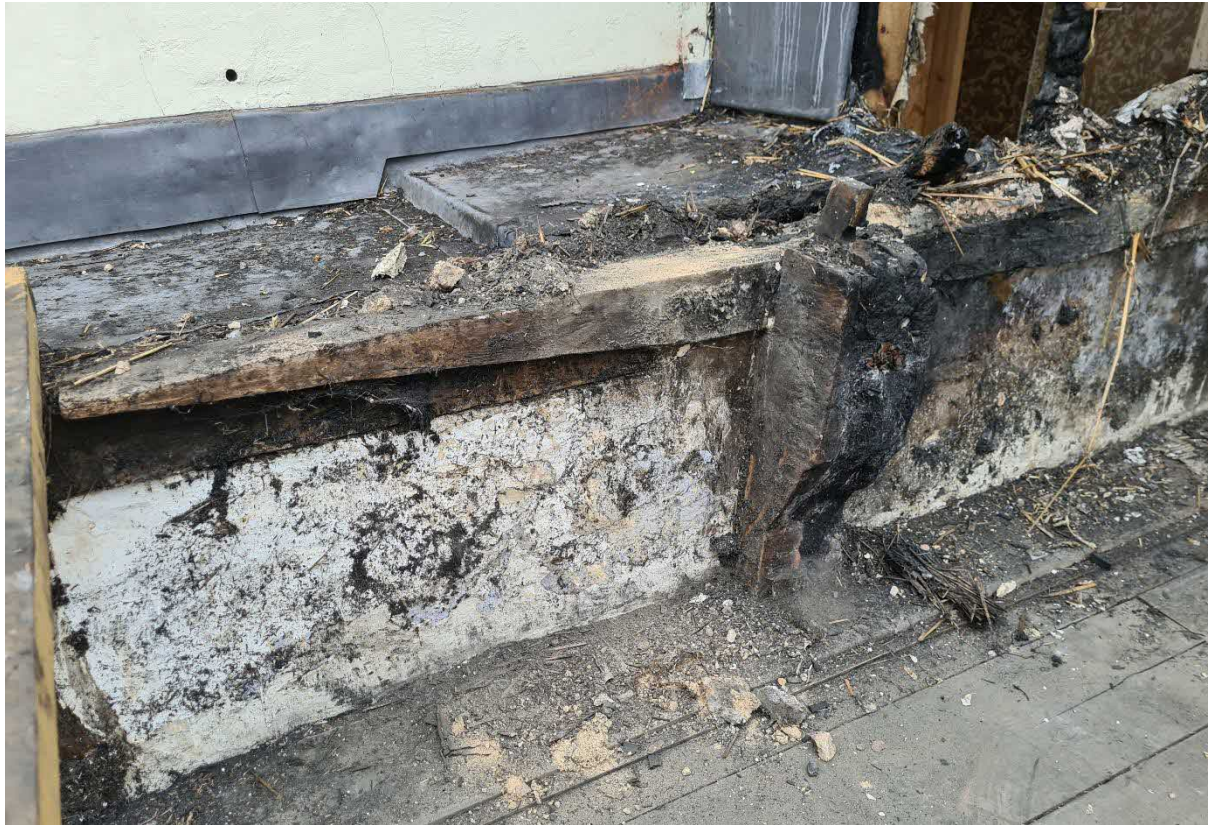
The post has a jowl – a flared section of timber at the top of the post which is used to form a tenon (also mostly intact) and joint into the underside of a tie beam. If there was a tie beam here, then the first floor is most likely a later insertion. The wall plate directly above this post has also been repaired (late 19th/early 20th century?) which has sadly removed the lap-dovetail joinery for any tie beam, so we'll never know for certain, but this does give hints at the former layout and use of the building as well as possibly suggesting an earlier construction date. The only other detail that could have corroborated this is a truss on top of the possible tie beam which in turn would have given the opportunity for the purlins to be scarfed at this point – exactly as we see in the truss to the east of this position. If any photographs survive showing the purlins within this bedroom, we might expect to see splinting, or metalwork to fix them together once the possible truss was removed.

Jowl post in north wall – note teazle tenon remnants, suggesting there was originally a tie beam here. Also note the patch repair to the wall plate – removing any evidence of a lap-dovetail joint for the tie beam.

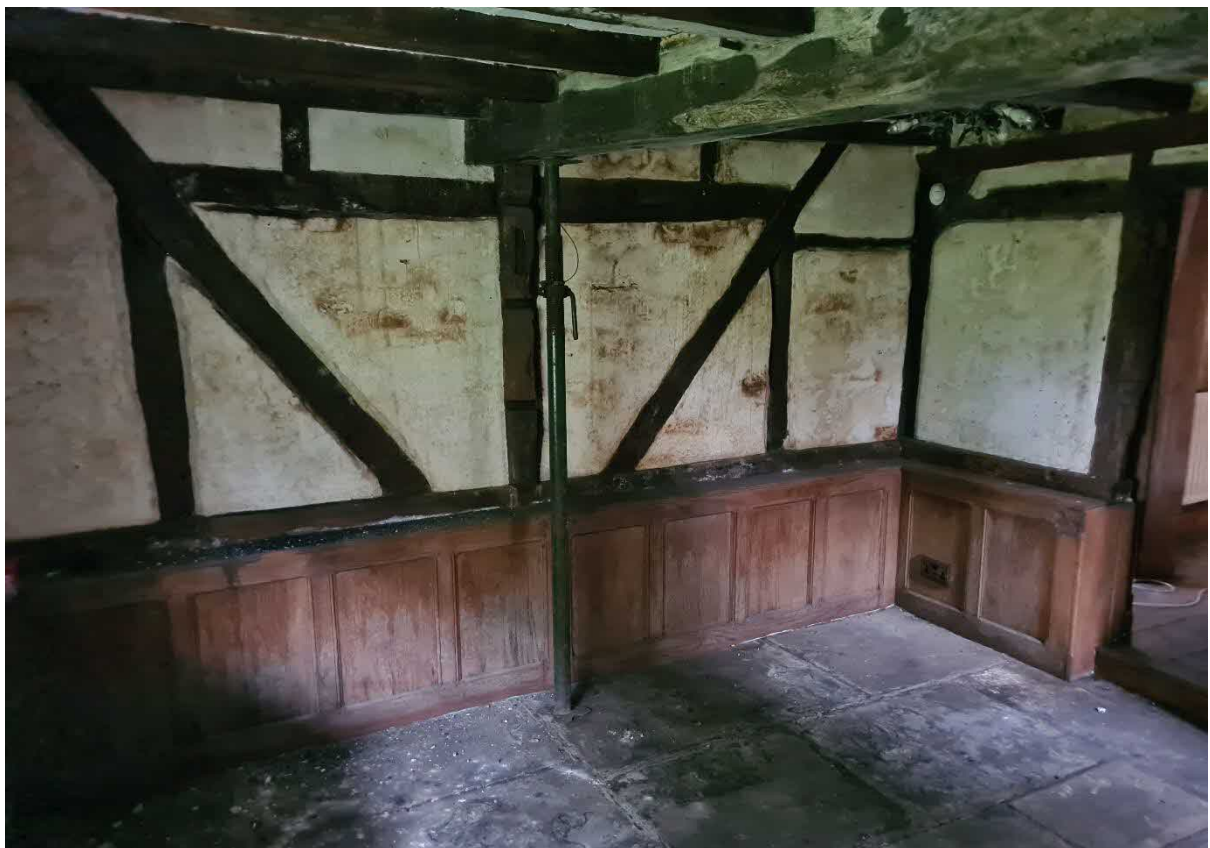
Interior of ground floor room, west end. Note low-level paneling – this should be opened up to check the moisture content and condition of sole plate and bottoms of studs/posts. This will also allow air flow to the area and speed up drying out of the building fabric.

This area of the front elevation has been rebuilt at some point (late 20th/early 21st century) to a good standard but as noted earlier, it may have swept away the upper section of a jowled post (presumably the lower half was removed by the window?). For some reason, these two rooms have had low-level paneling installed – it may be to mask something considered ugly, or in poor condition but even if entirely innocent it will currently be retaining moisture and reducing airflow so at the very least, I would suggest some degree of opening up for both ventilation and further inspection.

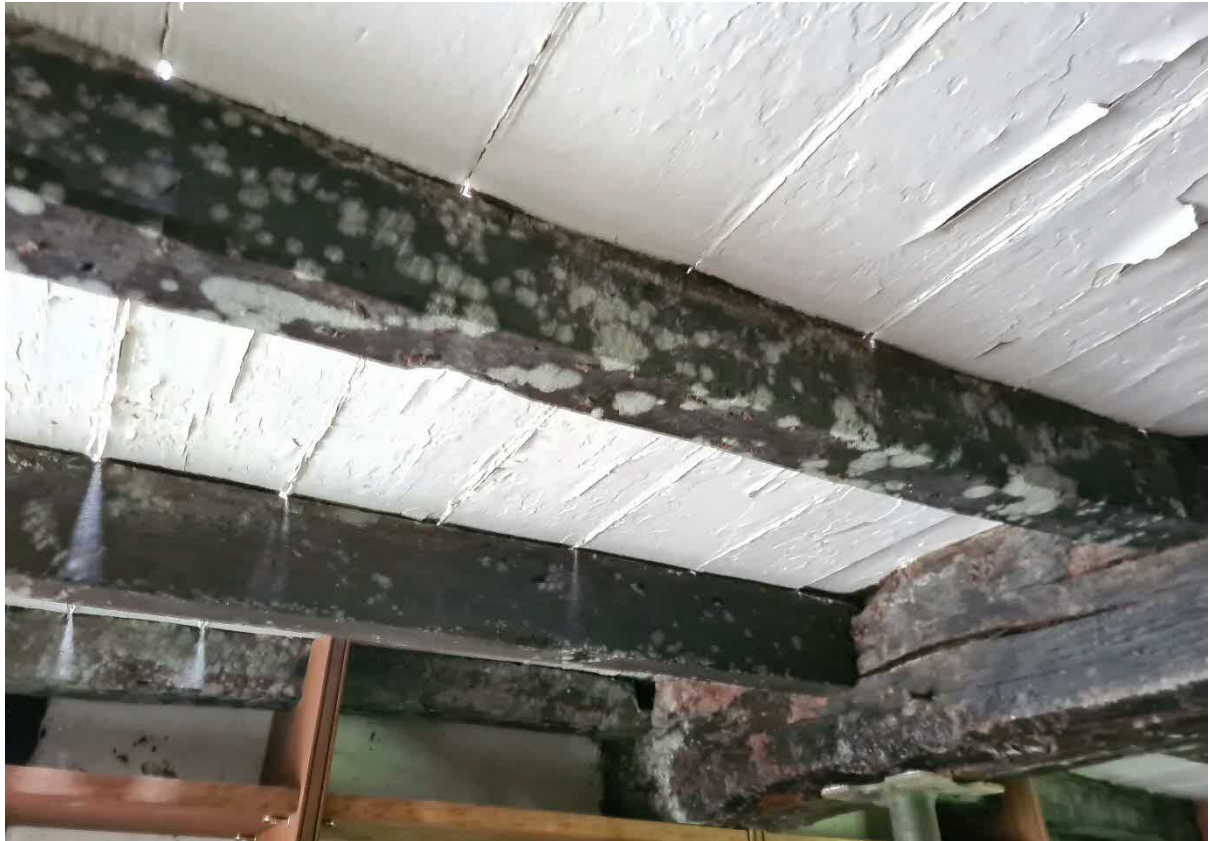
Within the two ground floor rooms the floor framing is basically intact, certainly there is no obvious damage from the fire, although as previously noted, the large amounts of water used to extinguish the fire and the high moisture content of all surrounding building fabric have created a fantastic ecosystem for various moulds to flourish. If these moisture levels persist, then fungal spores will eventually settle, and the small-section timbers of the joists could easily and quickly lose their capability. Every effort must now be made to bring down the moisture levels – ironically, I noted the outlet of the dehumidifier was laying on the floor and discharging water into the concrete floor and a masonry wall (I rectified this by repositioning it to discharge into the toilet).

Mould is flourishing on the floor framing due to the rise in moisture levels putting out the fire. It is particularly worse on components with a higher sapwood content making them very much more susceptible to further decay.

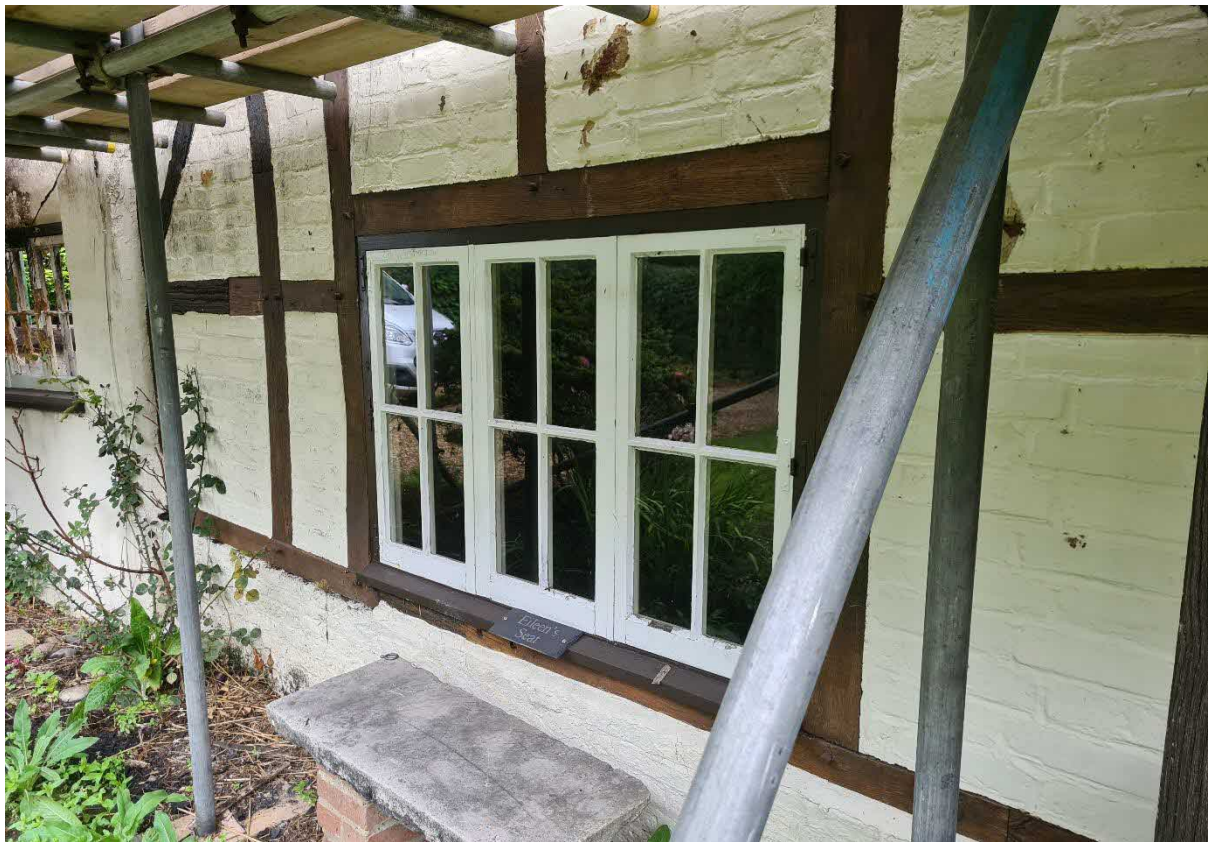
Exterior view at southwest corner of frame. This area of framing has been rebuilt to a good standard, although historically there would have been a jowled storey post in the middle of the window. I suspect that the current window replaces a Victorian window which cut through the post making restoration of the post seem pointless to previous occupants.
