## Fern House, Reepham, Norfolk

### Structural Appraisal Report

**Ref:** 230833/D Hubbard

**Date:** 11 October 2023

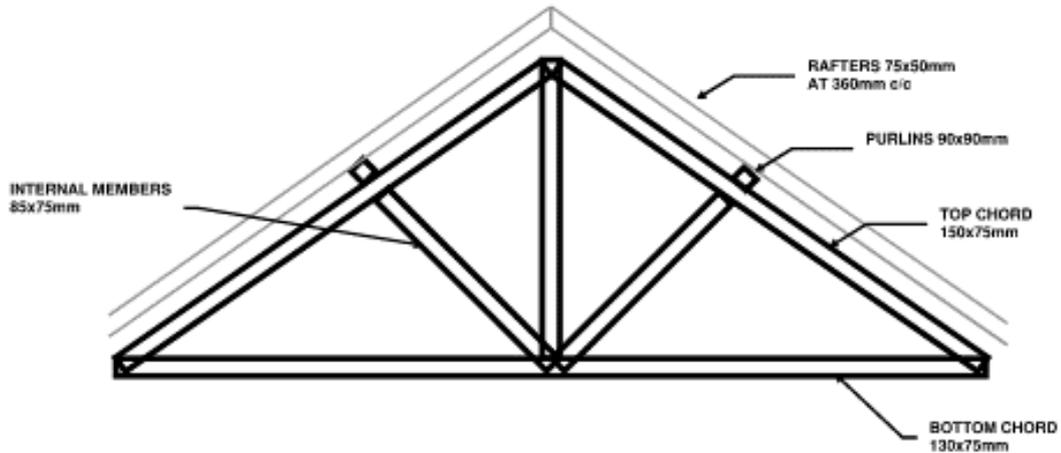
Figure 2 - Coach House existing roof structure

- 3.11 When viewed externally the roof structure appears to be in generally good condition with no obvious deflection of the ridges or significant distortion evident. Internally there is no apparent deterioration of the timber roof structure however deflection of the purlins is clearly visible. The sizes of the roof members were recorded during the inspection and are included on the sketch in Figure 2 below.

- 5.15 Visible deflection of the duo pitched roof above the main area of the Coach House was noted during the visual inspection. Calculations have been carried out to assess the capacity of the existing roof members which have been found to be inadequate for the proposed insulated roof build-up. It is therefore proposed to replace the existing roof structure to facilitate the introduction of insulation.

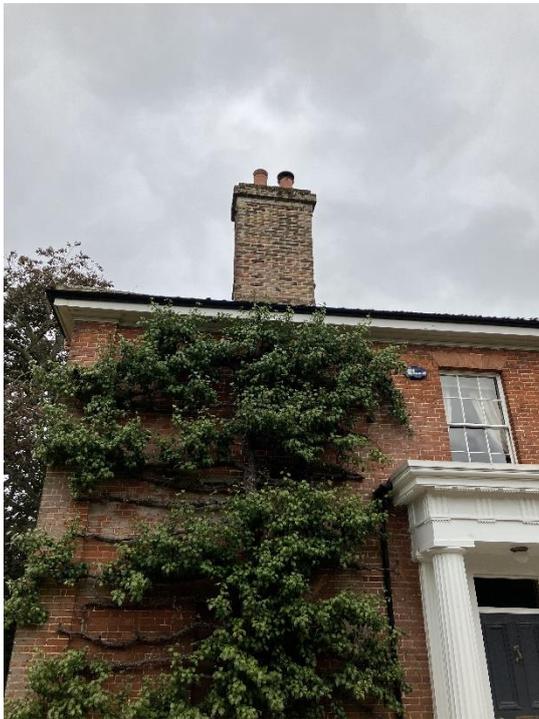
- 3.4 The external masonry load bearing walls appear to be in generally sound condition and no significant deterioration of the mortar joints was observed. The North and West elevations have been rendered and it was therefore not possible to observe the condition of the brickwork. Two climbing trees are present on the Eastern elevation and areas of staining / efflorescence could be observed behind the tree closest to the South-East corner.

Photograph 1 – View of chimney adjacent to Southeast corner of Main House. Efflorescence / staining of brickwork visible on brickwork behind tree.

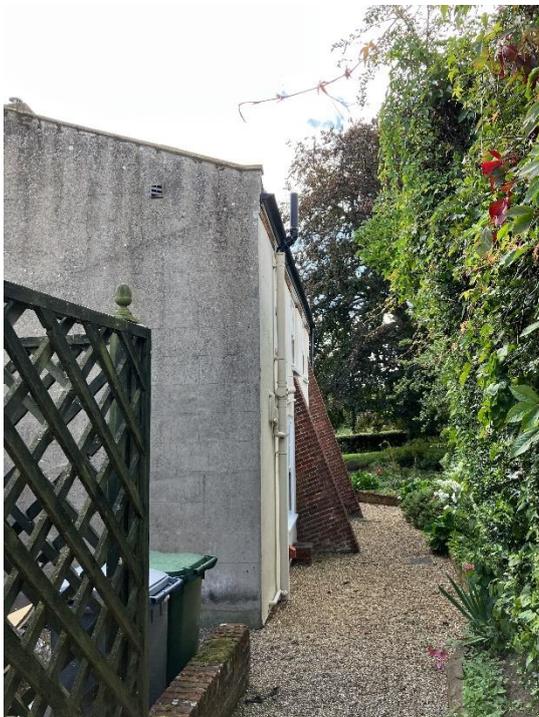
- 3.5 Two buttresses are present on the West elevation, these appear to be in reasonable condition with minor staining of the brickwork at low level.
- 3.6 Previous repairs / areas of repointing as well as localised spalling of a handful of bricks were noted on the East elevation of the service wing. An area of staining / algal growth was also noted above the ground floor windows.

Photograph 2 – View of buttresses to Main House West elevation. Minor staining of brickwork at base of buttresses.

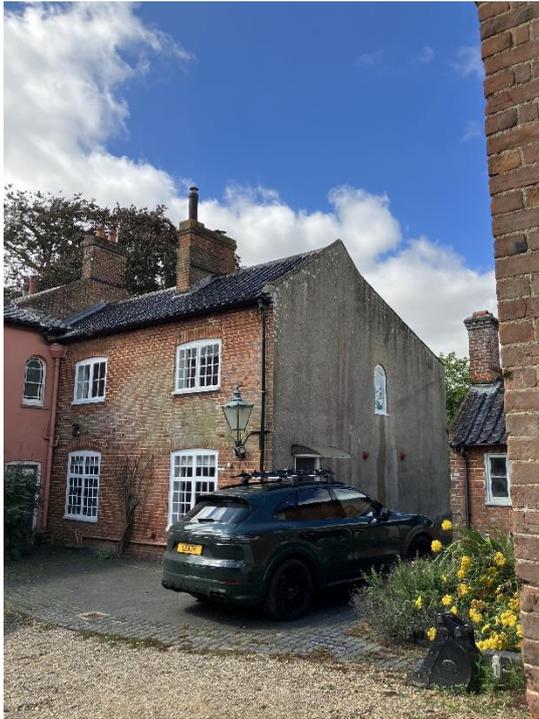
Photograph 3 - East Elevation of Main House Service Wing. Staining of brickwork between ground / first floor windows and previous repairs to brickwork. Localised spanned bricks.

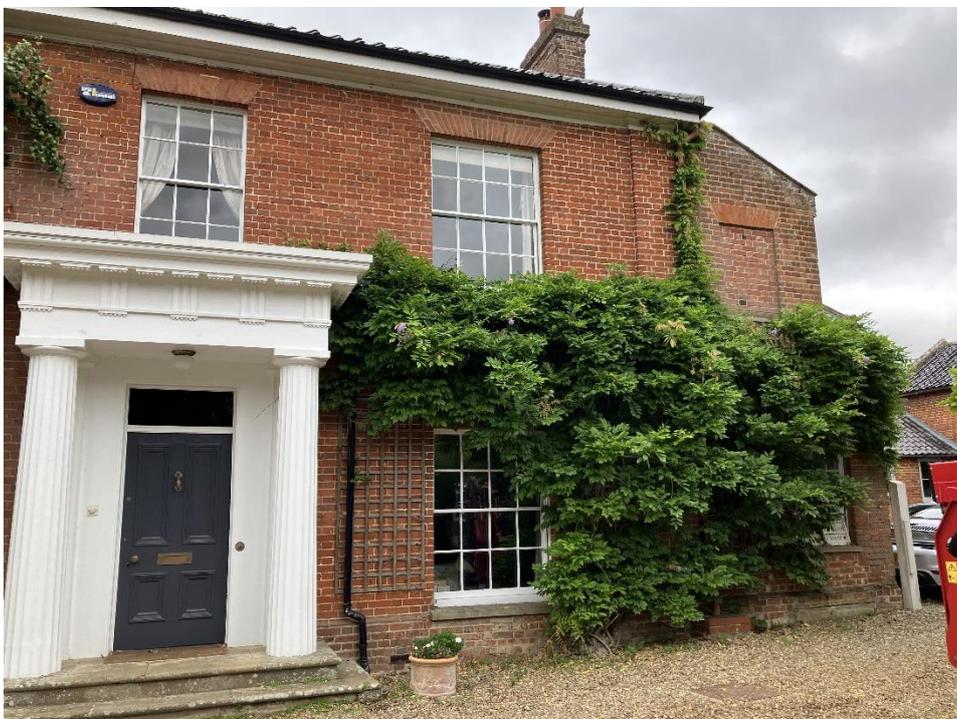
- 3.7 Efflorescence of the high-level brickwork is present on the Eastern elevation of the lean-to, and it appears that previous repairs have been undertaken to the low-level brickwork. Repointing of the brickwork below the eaves level was also noted on the North elevation.

Photograph 4 - Main House Lean-to East Elevation. Efflorescence of brickwork at high level and brickwork repairs under ground floor window. Historic window opening infilled at first floor.

- 5.7 It is not envisaged that any significant intervention is required to the existing external walls which are generally in good condition. Minor repairs and localised areas of repointing are likely to be required to the lean-to section which abuts the North elevation. Repairs to the existing fabric are to be carried out using traditional methods and materials.

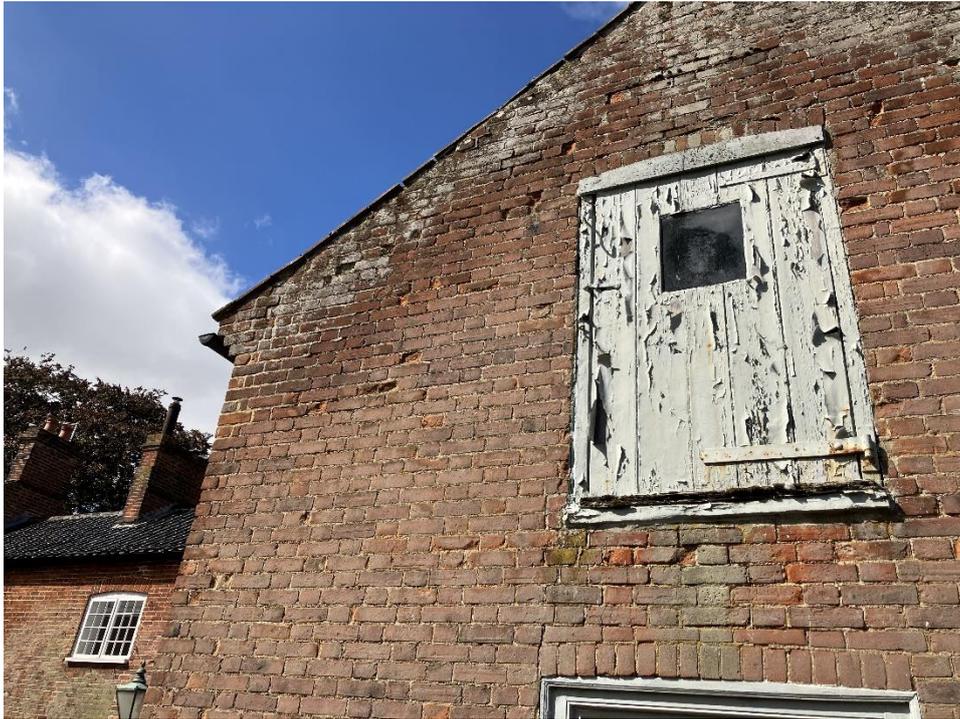
- 3.12 Several areas of mortar loss and / or localised spalling of the brickwork are present on the external elevations. Efflorescence is also present at high level on both gable elevations where the brickwork appears to be in relatively poor condition.

Photograph 5 – Coach House East Elevation. Efflorescence of brickwork at high level and localised spalling of brickwork.

- e-pointing
  - Localised replacement of significantly spalled bricks
  - Installation of helical bed joint reinforcement across cracks
  - Re-bedding of the upper courses of brickwork on both gable elevations

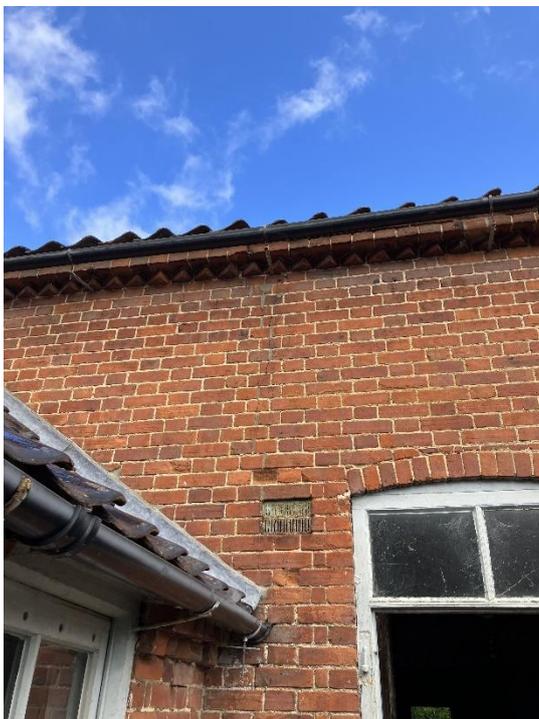
- 3.13 A vertical crack on the South elevation appears to have been previously repaired but has re-opened at some stage. There is also evidence that cracks above the double doors have been filled previously.

Photograph 6 – Vertical crack on Coach House South Elevation.

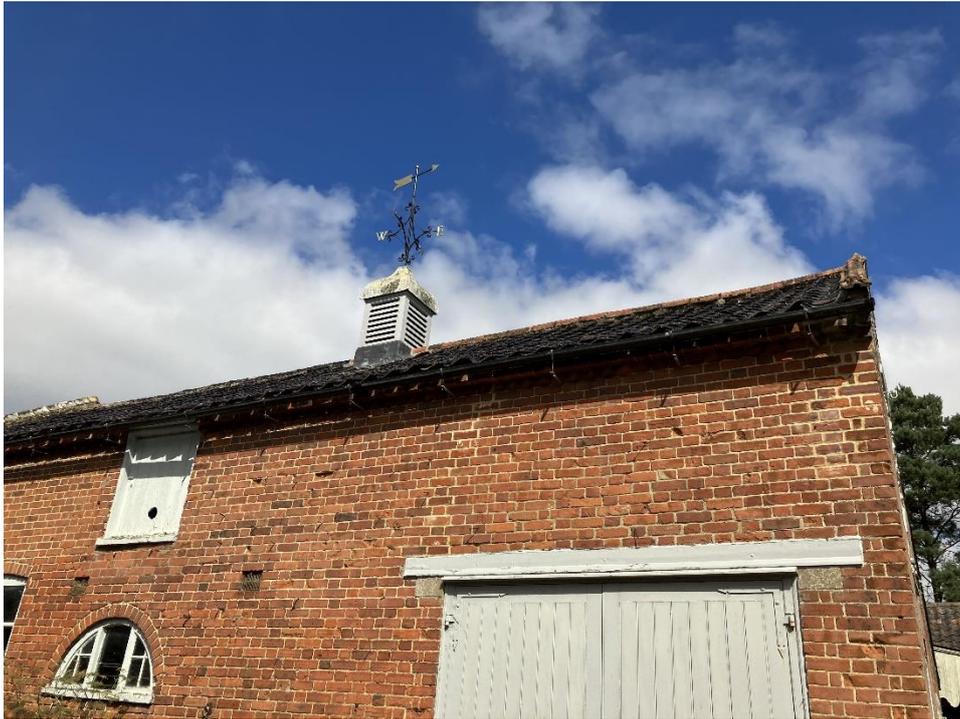
Photograph 7 – Previous repairs to Coach House South Elevation. Minor distortion of brickwork bed joints over double door opening.

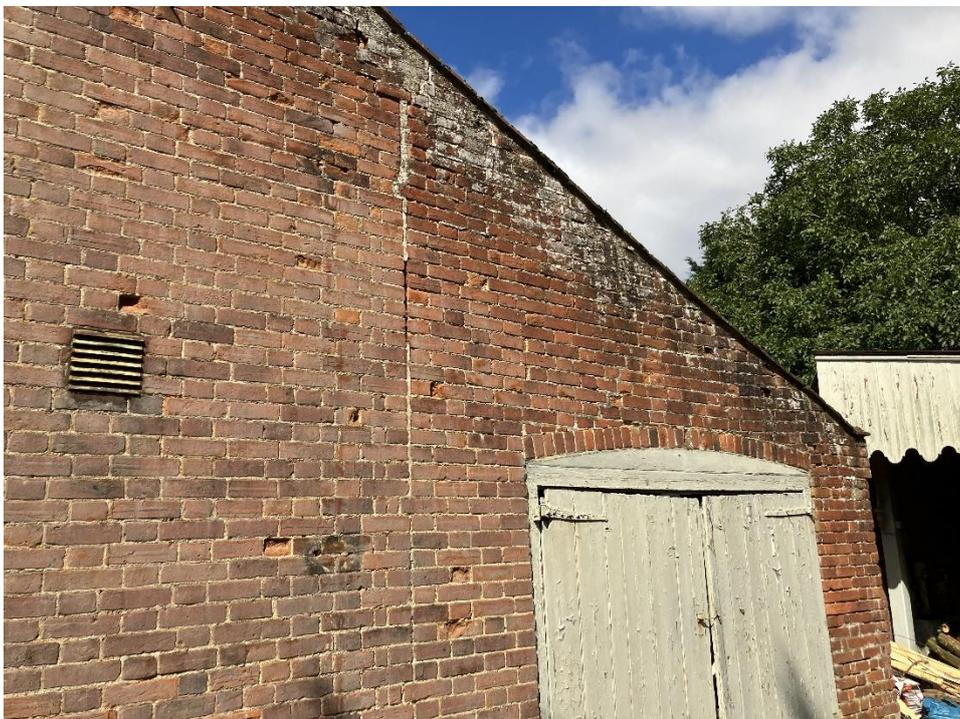
- 3.14 There is a vertical joint on the East elevation between the one and two storey sections of the building, most of the mortar filling the joint has fallen out leaving an open vertical joint.

Photograph 8 – Vertical joint in Coach House East Elevation.

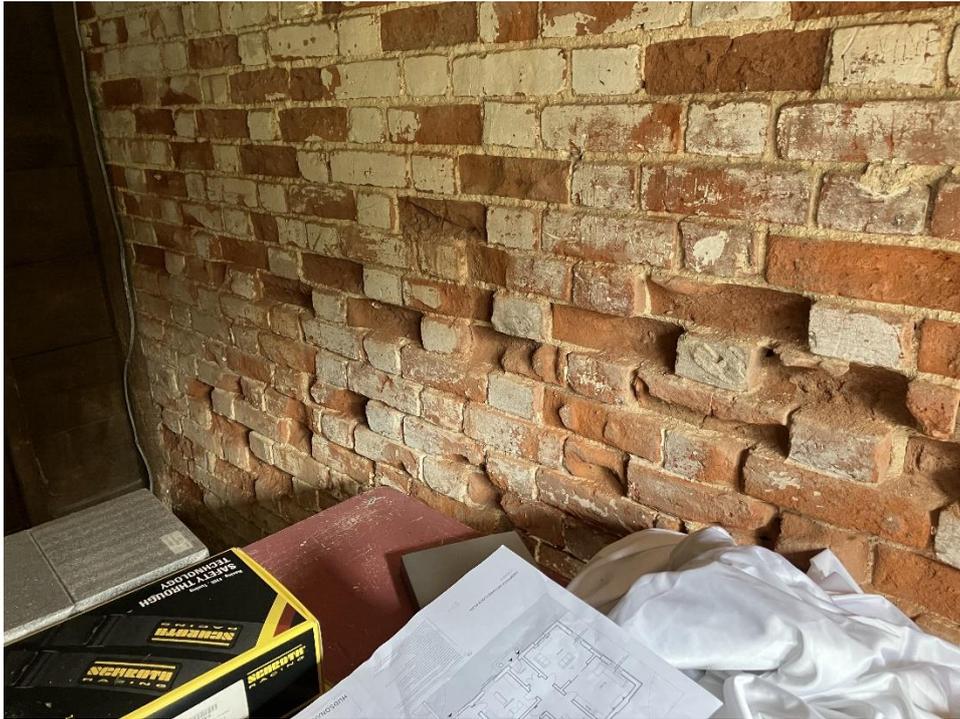
- 3.15 Internally substantial deterioration of the brickwork has occurred in some localised areas with significant spalling of the bricks.
- 3.16 Slight diagonal cracking of the wall between the car parking area and the stables is visible from on both sides of the wall.

Photograph 9 – Coach House storage area brickwork deterioration.

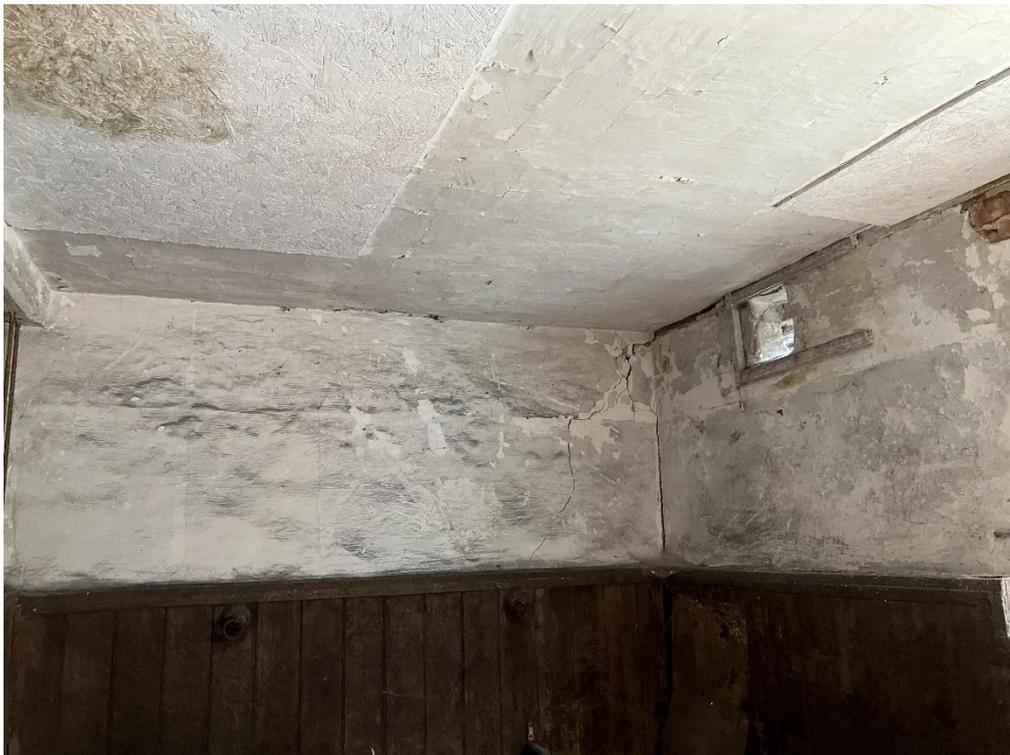
Photograph 10 – Cracking in corner of stable area. Crack extends through the wall and is visible in the adjacent garage.

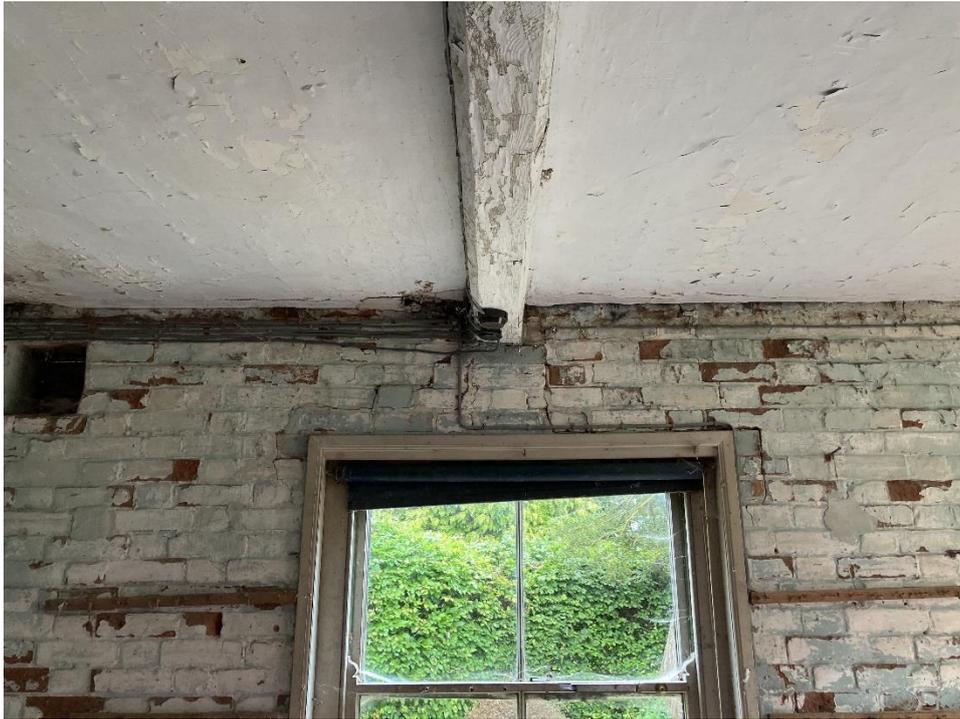
- 3.17 The window to the garage area does not appear to have a lintel over and slight diagonal cracking is present emanating from both corners of the window opening.

Photograph 11 – Diagonal cracking over brickwork over Coach House garage window opening. It appears that no lintel has been provided above the window.

- Installation of a lintel above the existing window opening on the South Elevation
- 5.14 The existing first floor structure consists of 60x120mm floor joists spanning between downstand beams which measure approximately 160x250mm. Calculations have been carried out to assess the existing floor structure which has been found to be inadequate for the proposed use. It is therefore proposed to replace the existing first floor structure with a new timber floor which meets modern design standards. It is proposed to retain the existing downstand beams as non-load bearing elements to retain the existing fabric and to maintain the existing aesthetics.

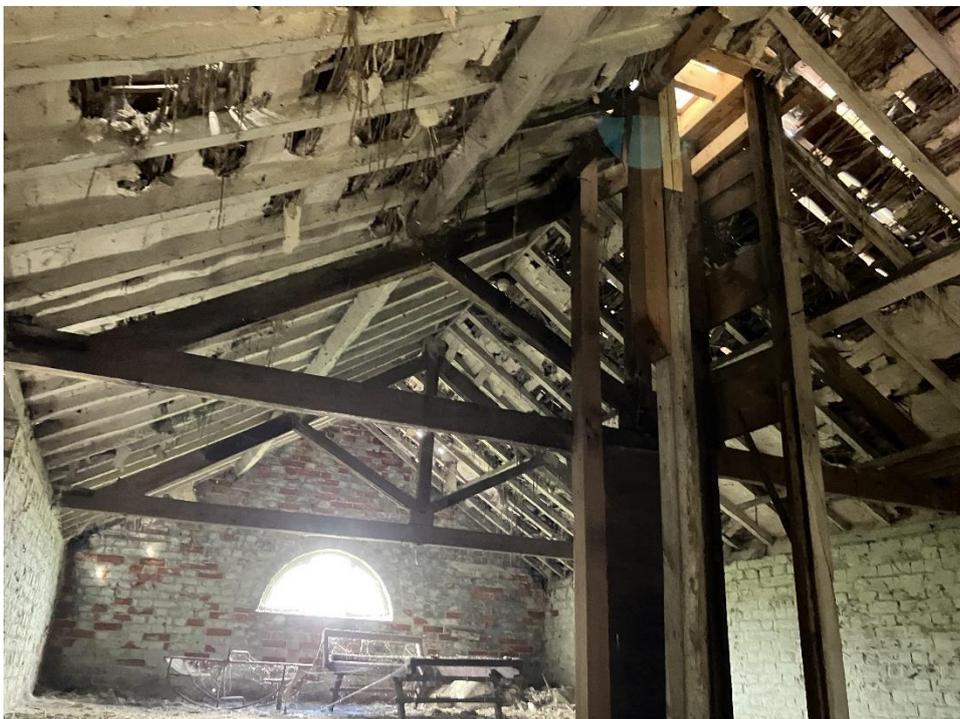
Photograph 12 – Timber roof structure to Coach House.

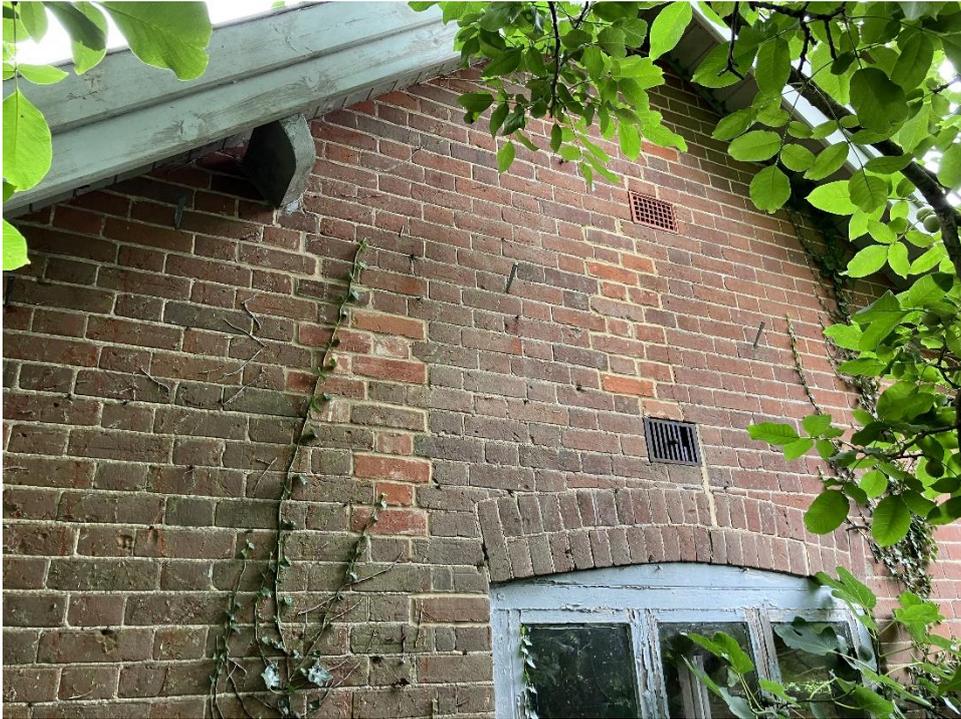
- 3.18 When viewed externally the roof structure appears to be in generally reasonable condition with no obvious deflection of the ridges or significant distortion evident.
- 3.19 Previous repairs to the gable elevation including a crack to the arch lintel over the window opening were noted during the inspection.

Photograph 13 – Previous repairs to Garage Gable Elevation

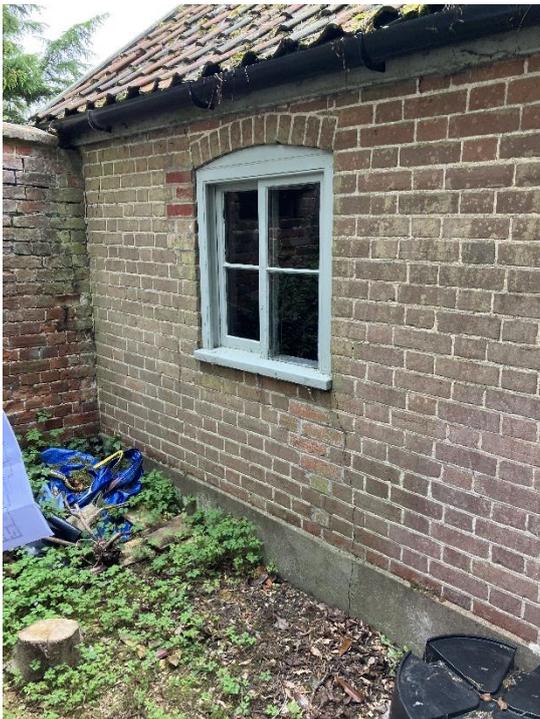
3.20 There is a slight diagonal crack extending either side of the window opening on the rear elevation, some bricks adjacent to the window have also been replaced previously. The adjacent freestanding external wall has issues with staining of the brickwork, mortar loss and localised areas of spalling.

Photograph 14 – Cracking and previous brickwork repairs to Garage rear elevation.

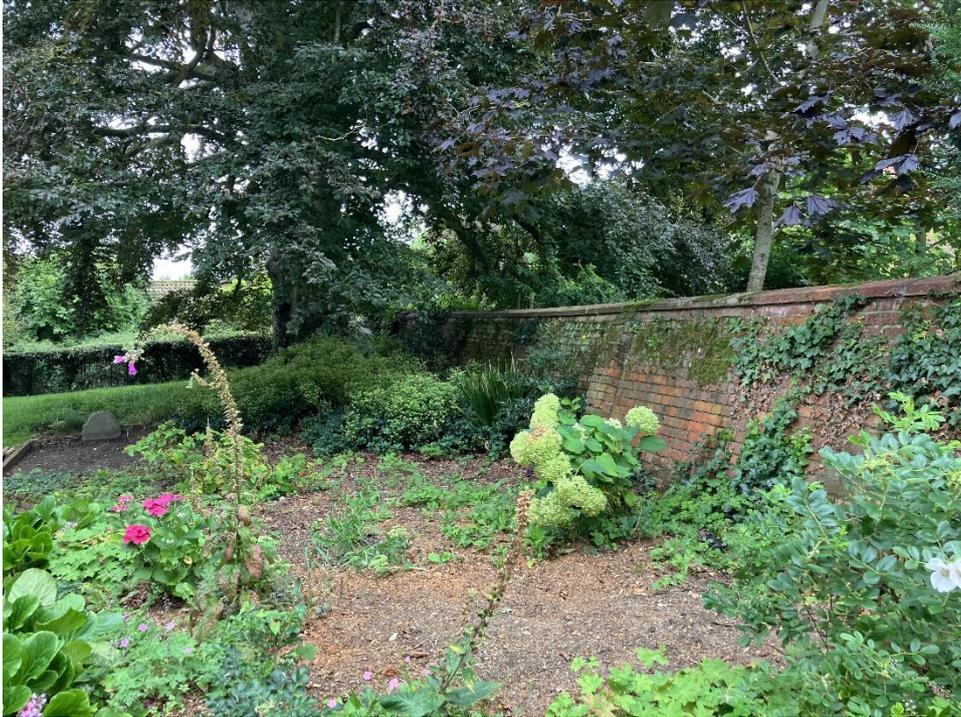
- 3.9 Assess to the roof spaces was not provided during the inspection.
- 3.10 The existing boundary wall to the West of the house was observed to be leaning. Widespread vegetation growth was also noted as well as mortar loss in some areas.

Photograph 15 – Garden wall along Western site boundary

- 5.8 Remedial works are likely to be required to repair and stabilise the existing boundary wall. This is likely to comprise of the careful removal of vegetation and localised areas of re-pointing. Additional buttresses may be introduced to prevent further leaning of the boundary wall.
