Observations

Enclosed: Site inspection photographs numbers 1 to 8

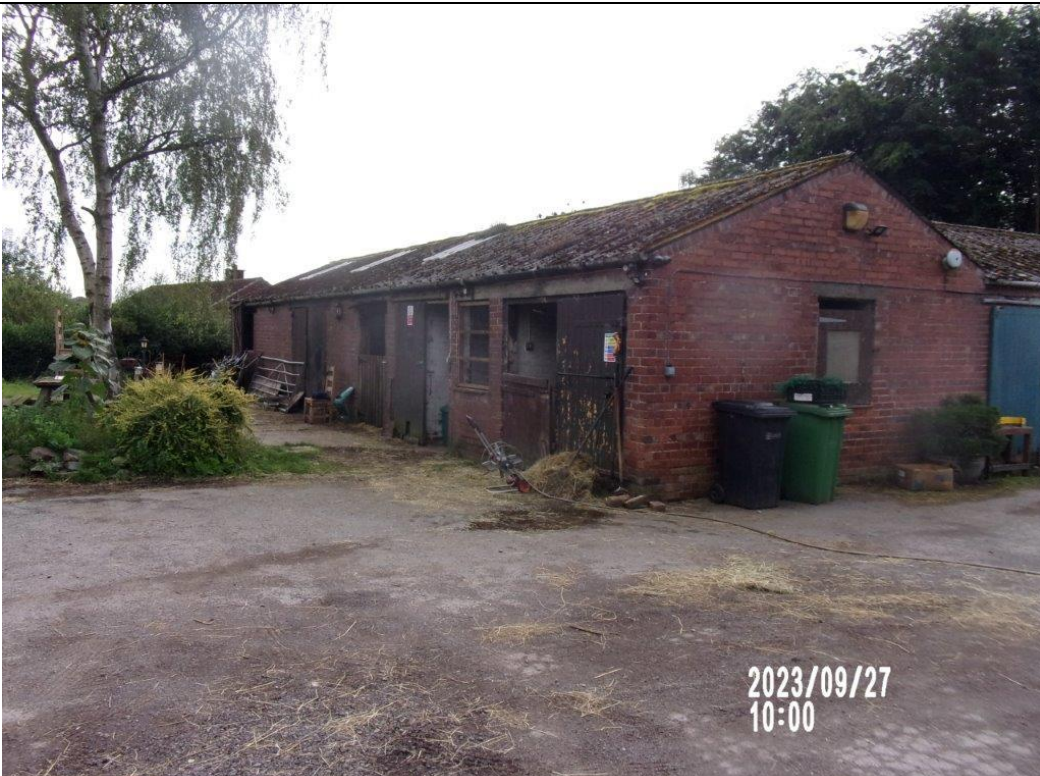
PHOTO NO: 1

North elevation

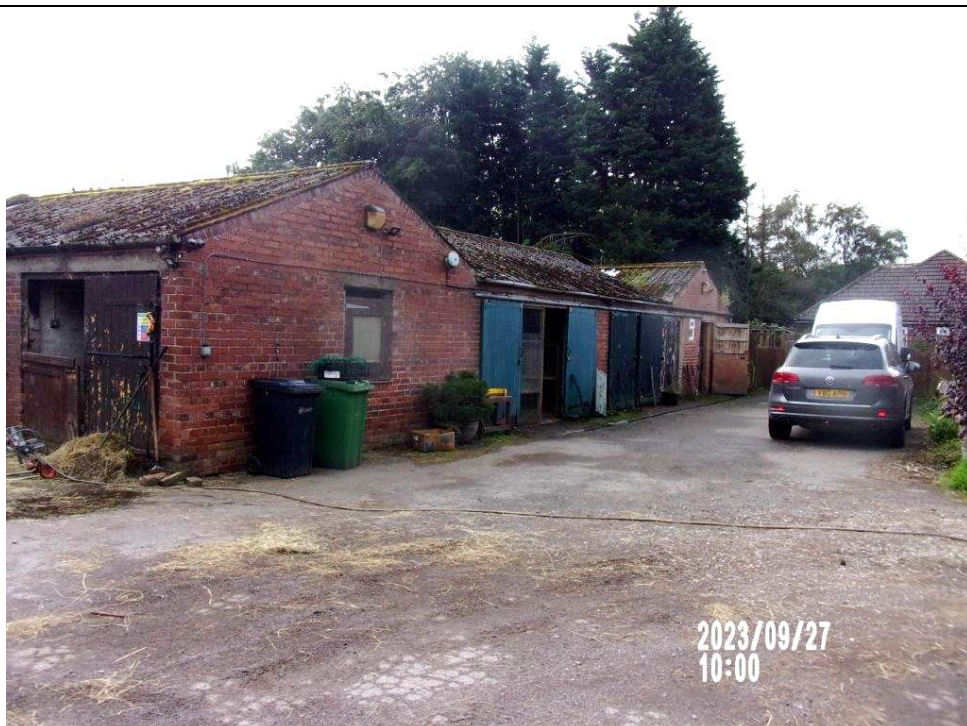
PHOTO NO: 2

West elevation

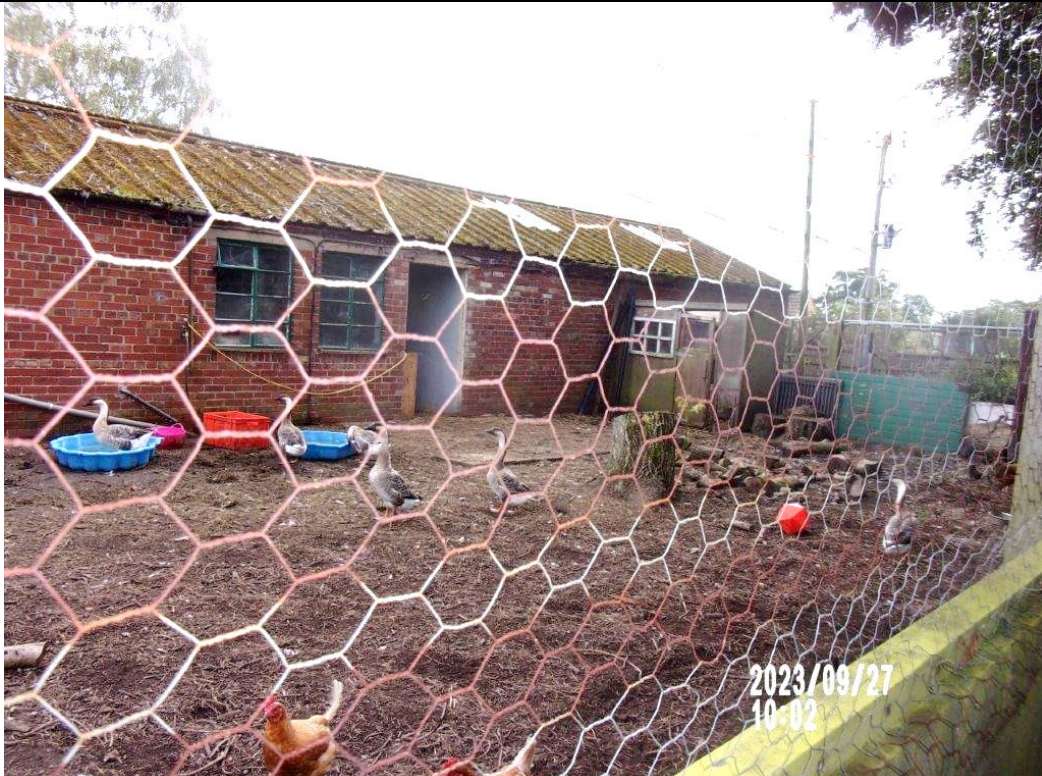
PHOTO NO: 3

South elevation

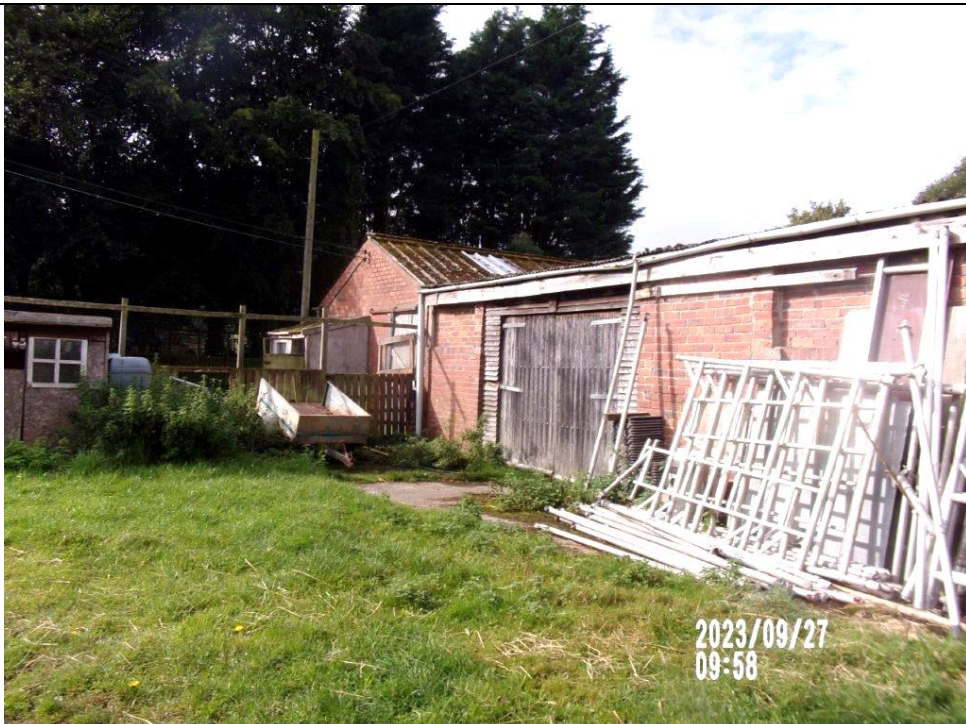
PHOTO NO: 4

East elevation - part

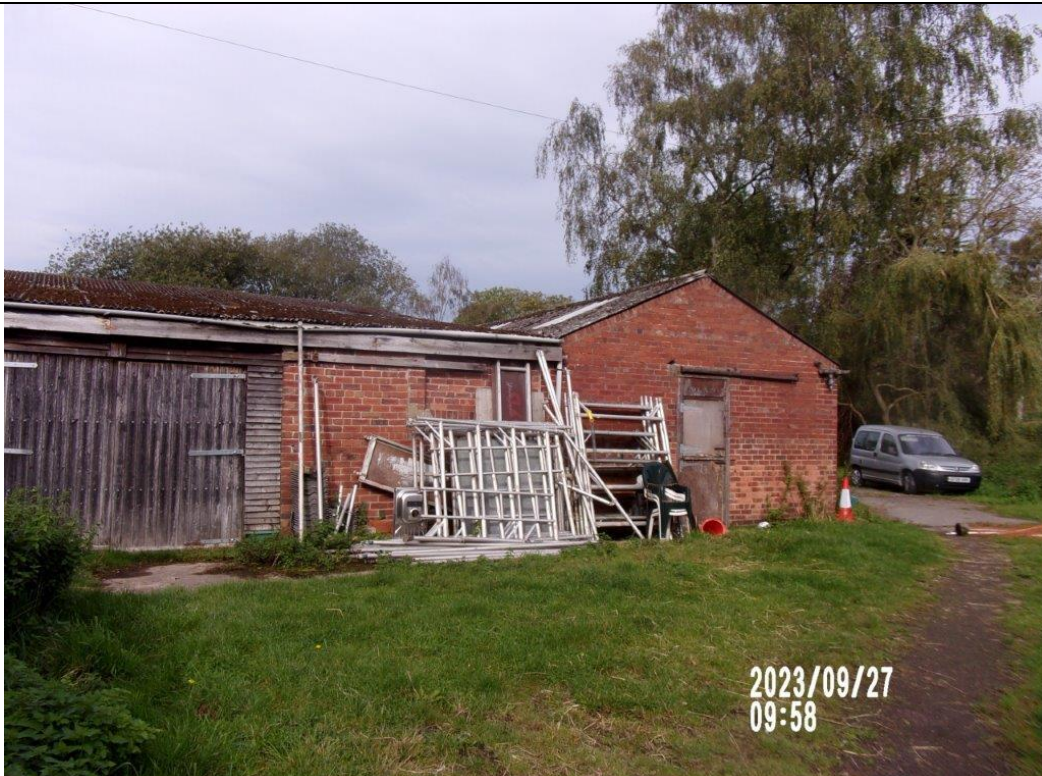
PHOTO NO: 5

East elevation – part

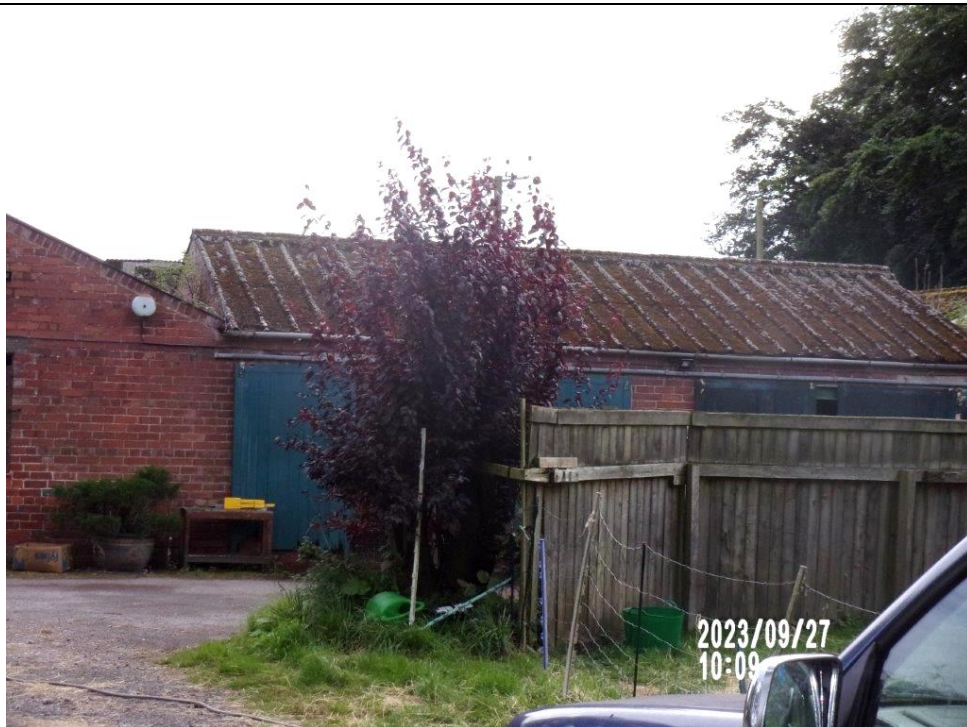
PHOTO NO: 6

West elevation

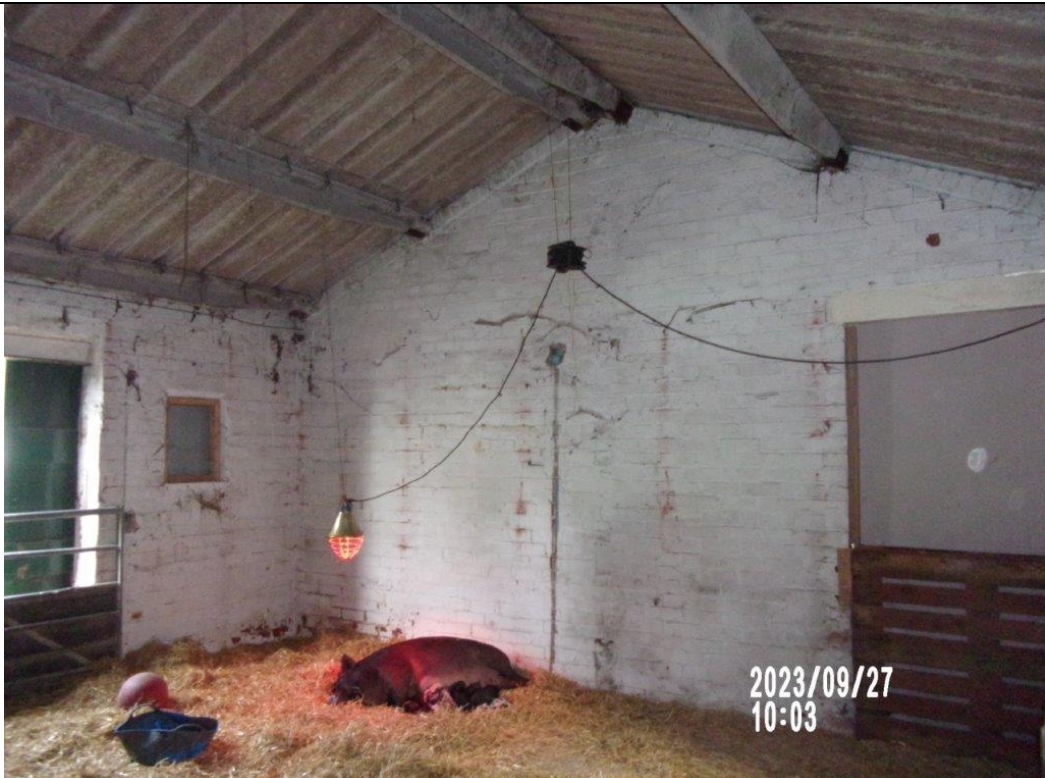
PHOTO NO: 7

Internal view – typical

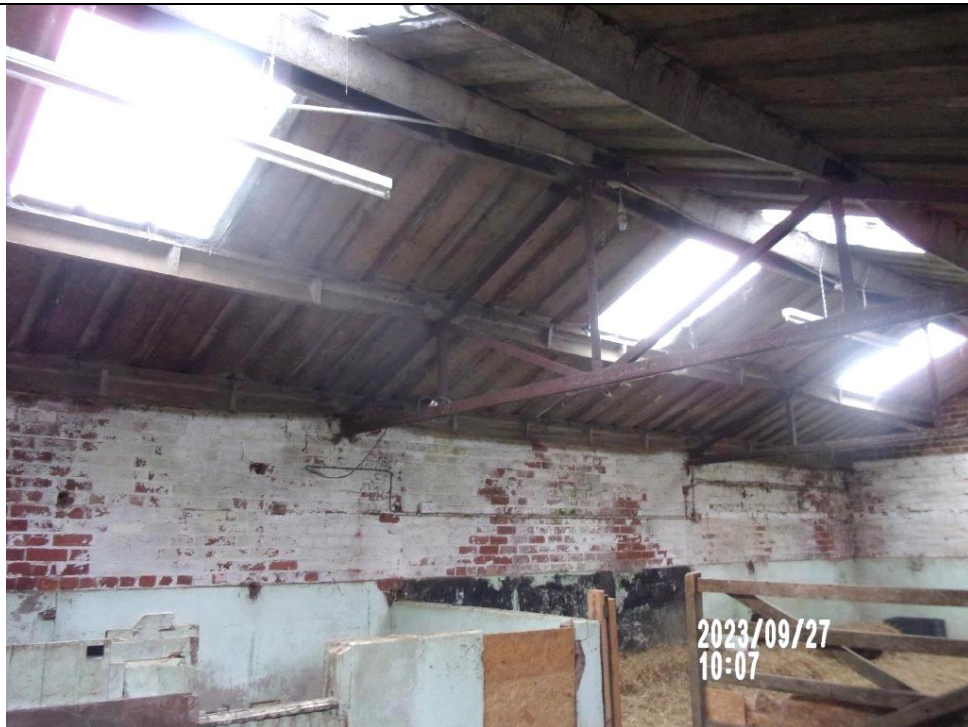
PHOTO NO: 8

Internal view - typical
