Listed Building App. ref. DC/23/0779 Manston Hall, Whepstead IP29 4TN

SURVEY OF FRAME AND PROPOSED REPAIRS, in accordance with Condition 3 of App. ref. DC/23/0779 Manston Hall, Whepstead IP29 4TN

Assessment of Condition of Extant fabric relative to Sole-Plate Repair

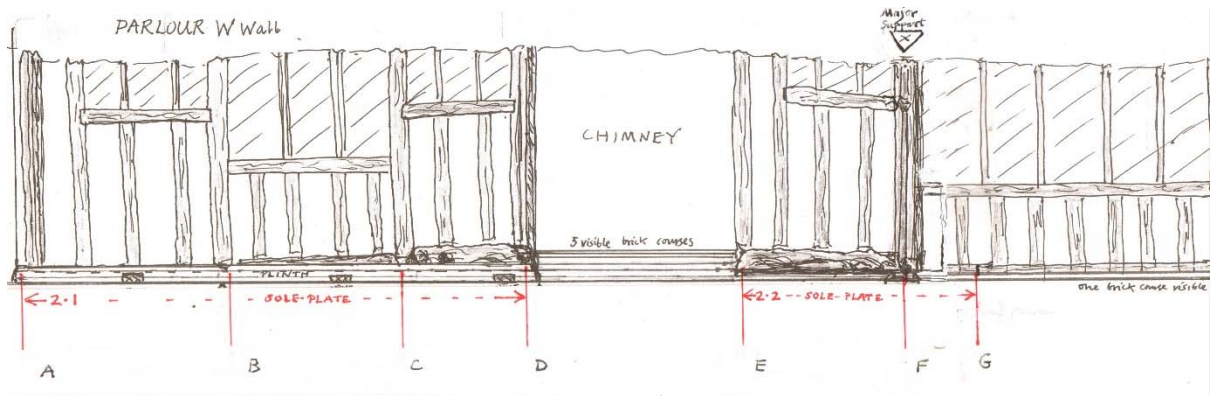
f-2

The Parlour sole-plate, which has rotated by about 45° slopes markedly from south to north. From **A** to **B** it disappears behind the wall-like plinth. From **C** to **D** there is a thicker projecting section on the exterior. [see: f-1 plan iia, f-2, f-3, f-4, f-5, f-6]

On the exterior a substantial **repair**, using scarfed-in sections of *green-oak*, is required. [see **F-3, F-4**]. The aim remains, for as much as possible of the **existing fabric**, to be retained depending on its condition and fitness for purpose.

A-D Sole-plate [Original 16th C – *interior measurement*] timber **230 x 150 mm** internal length **4140mm**. Insert *Green Oak repairs* using *Halved Joints*.

A-C Sole-plate [Original 16th C – *exterior evidence*] Will need **major repair** to sections currently below parapet of brick plinth - from timber **230 x 150mm**, length **3400 mm**.

C-D Sole-plate [Original 16th C – *exterior evidence*] Here the **retention** of, all *visible extant timber* is intended but *scarfed in repair* will be needed behind raised brick plinth– nominal original dimensions. **230 x 180 mm** length **1200 mm**

A-D Studs approx. size of original timbers **150 x 100mm** to use for sections needing *scarfed in repairs*, at the base. These repairs will be *proportionate* and use simple **halved joints** fixed with **hidden stainless steel fixings**.

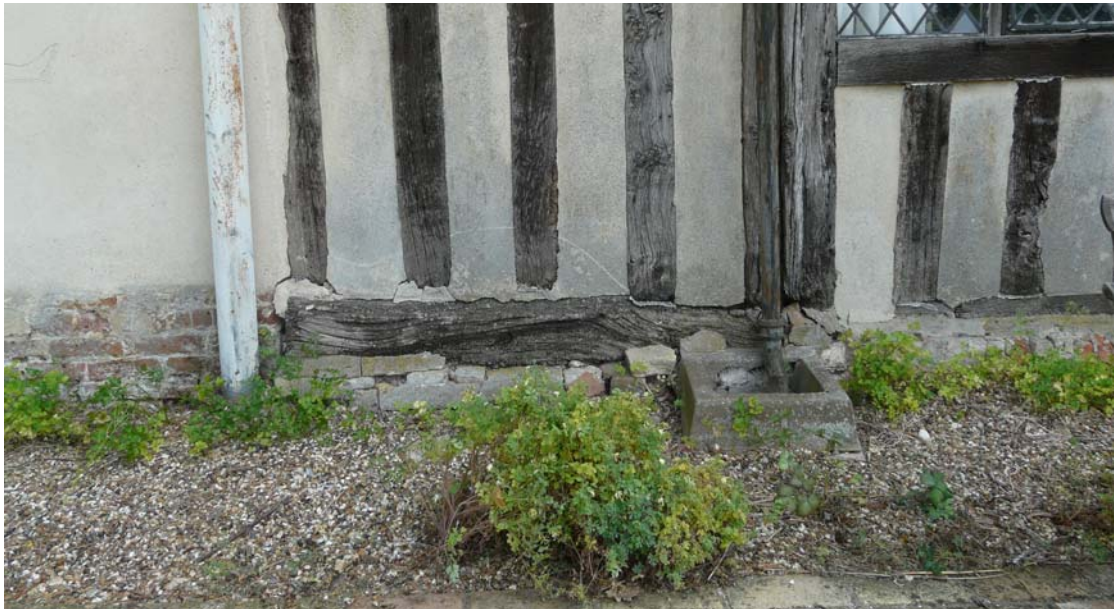
f-7 **E-F-G**

Interior evidence suggests less rotation of the original sole-plate than in the Parlour. But there is a substantial length from **E-F** which, standing proud of the stud wall, has deteriorated especially at the base. (see: f-2, f-7) This impacts on the **stability** of the *major upright support* for the cross beam in the Hall – at **F**.

This **sole-plate** carries the *load* of the *major upright support \x/* at **F** and given the condition of the **sole-plate** beneath this, a substantial length needs to be **replaced**.

E-G - Sole-plate [*interior evidence*] timber nominally **230 x 150 mm length 1800mm**

E-F(G)- Sole-plate [*exterior evidence*] timber nominally **230 x 180 mm length 1800mm.**

E-F – Post *Major Upright Support \x/* at **F** – of nominal section **290 x 290mm** will need *scarfed in repair* to base, using *vertical halved joints*; fixing by being *tenoned* to the new **soleplate**. n.b. *retain/recreate* carved detail to front.

E- F - **Studs** - of nominal section **150 x 100mm**. Up to **x 3** need *scarfed in* proportionate *repairs* to base, again using *vertical halved joints*, fixed by *tenons* or *hidden stainless steel fixings*, as appropriate to the new sole-plate.

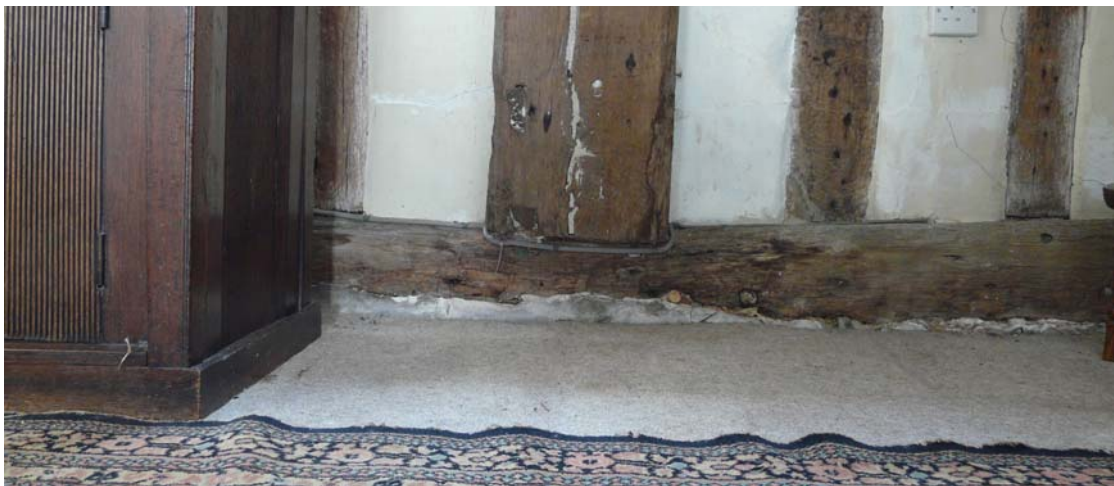
f-8 **F**

Exterior evidence reveals **decay** caused by damp and **voids** suggesting rodent activity. Downward pressure exerted by the weight of *major upright support* – **F** is apparent inside. [see: f-8]

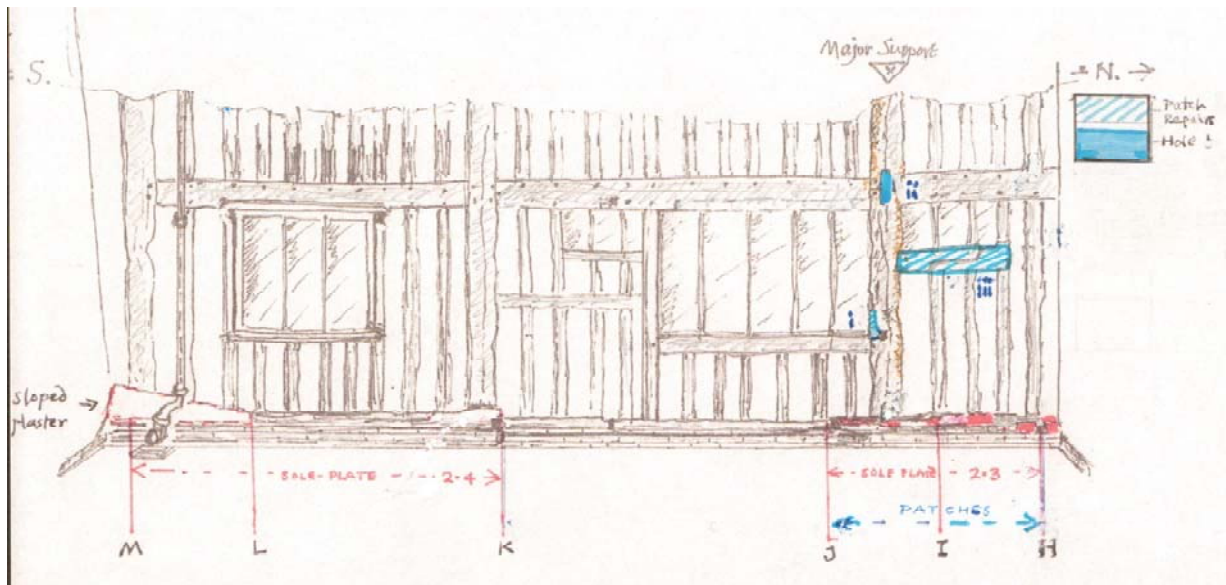
f-9

At the North End, H-J both on the **interior** and **exterior**, there are considerable losses and concrete filled holes in the **sole-plate**, particularly from H-I. Here, penetration by water running off the roofs meeting at the angle where the 18th/19thC wing joins [see: f-1 plan iia], and holes in the timber frame (evidently made to support a lean-to structure) explain the *poor/decayed condition* of the extant fabric.

Replacement of the whole **sole-plate H-J** is necessary.

H-J sole-plate - Fit *new, Green Oak sole-plate* using *Halved joints*. Will need **new** length of **1200mm** of nominal section **120 x 180 mm** timber.

Up to x 4 **Studs** of nominal section **150 x 100mm** will need scarfed-in *repair* to base and all to be joined using *vertical halved joints*, fixed by *tenons* or *hidden stainless steel fixings*, as appropriate, to the new sole-plate. [f-9, f-10, f-11, f-12, f-13].

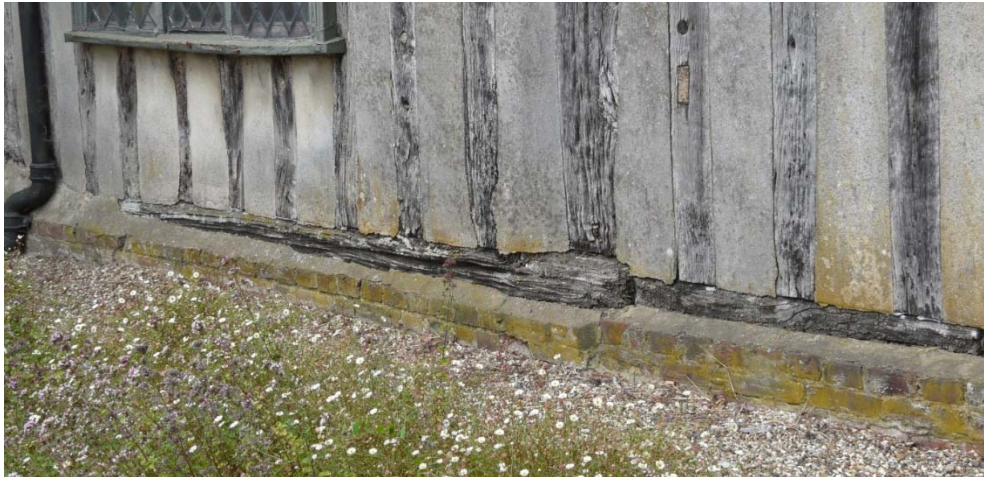
f-15 **K**

Internally - the original **sole-plate** survives about **170 mm** from the floor to full length. However, of this only about **50-60mm** is visible at the top – the rest hidden by skirting. Also internally, the last section of infill before the southernmost support of the 16th C. house shows *plaster affected by damp*.

Externally - the wall leans out, at the base. As on the west façade, the original **sole-plate** must have rotated

This *external render* will be **removed** and a **new** section of **sole-plate** will be **inserted** and **jointed**, as appropriate, while using *hidden stainless steel fixings* to the timbers above. [**f-15, f-16**]

Sole-plate here, of nominal section **150 x 200 mm**. The *South end* of the East façade, runs for **3700mm** from **K-M**. [**f-9, f-10, f-15, f-16**]

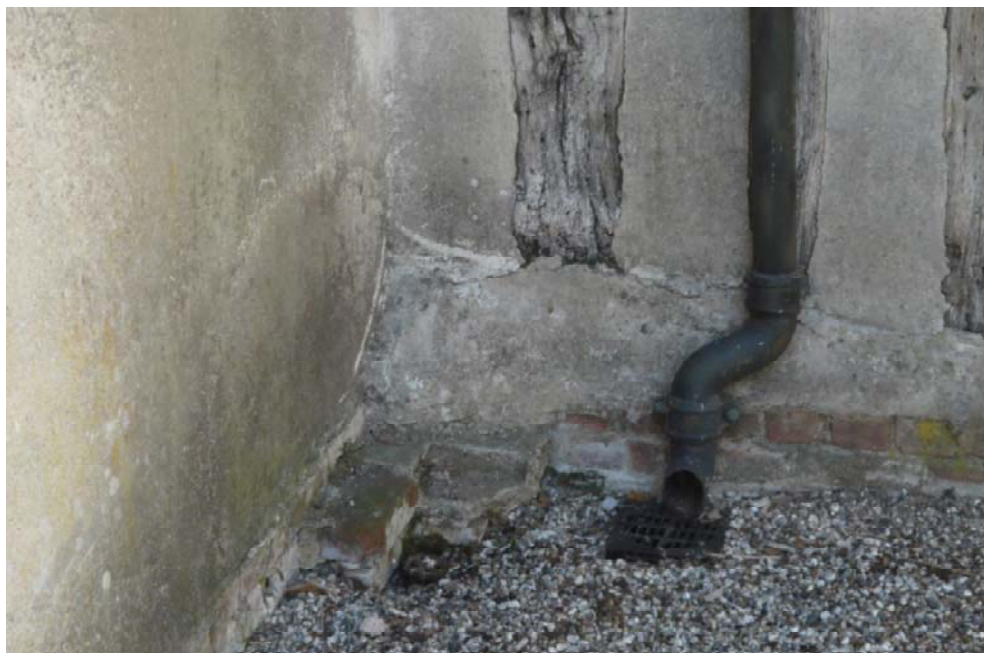
f-16

L-M is the location where no *exterior sole-plate* remains visible. All is covered by sloped *render*. [see: **f-16**] *hidden stainless steel fixings* to the new sole-plate

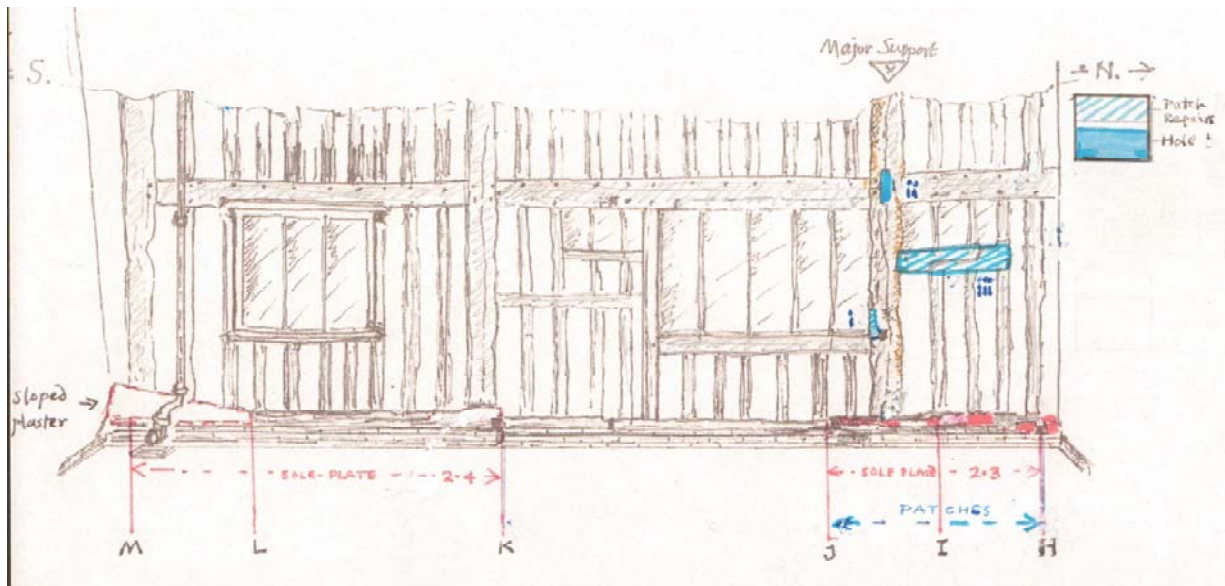
f-9

The blue line, marked at the northern end of this elevation, [see f-1 plan iia] shows the location of some failing 'surface' repairs on the frame. [see: f-12, f-13] Also, the Major upright support (marked \x/) is similarly affected.

Replace/part replace x 3 'nailed on' **patch repairs** [see diagram: f-9.- N.B. the details marked with **blue** roman numerals **i** to **iii**].

All **repairs** will be formed from precisely cut *air-dried oak*, **30mm – 50mm** thick, and cutting out only enough from the retained fabric to form a flat plane to fix the patch. These patches will be fixed with *marine adhesive (Sikaflex 291i)* and *stainless steel screws*, pelleted over with *oak pellets*.

i] *Irregular upright and small* – location: lower right hand side/corner of *5 light Hall window* [size: **35mm x 35mm** and approx. **190mm** high [see: f-9, f-10].

ii] Replace x 2 **patches** with *New Cill front to small high window*, at North end of Hall. Replace whole external *cill* to match that extant on West side of Hall, W. [f-9, f-10, f-12]. *Original complete size 120mm w x 1110mm h x 100 mm depth of studs* [Extant dimensions: In two parts: - to South, possibly *original but damaged and cut down 110mm x 830mm*: - to North, nailed on, crude old repair, **100mm x 280 mm**]

iii] Insert, using *air-dried oak*, 1 **vertical block** - to **protect junction** of **wall-plates & Major upright support \x/** - location: at N. end Hall E. façade. -size: **75 mm w x 220mm h x 50mm d.** [see: f-9, f-13]
