CHURCH OF ST CHARLES BORROMEIO,
HAMPTON ROAD,
HAMPTON ON THE HILL,
WARWICK,
CV35 8QR.

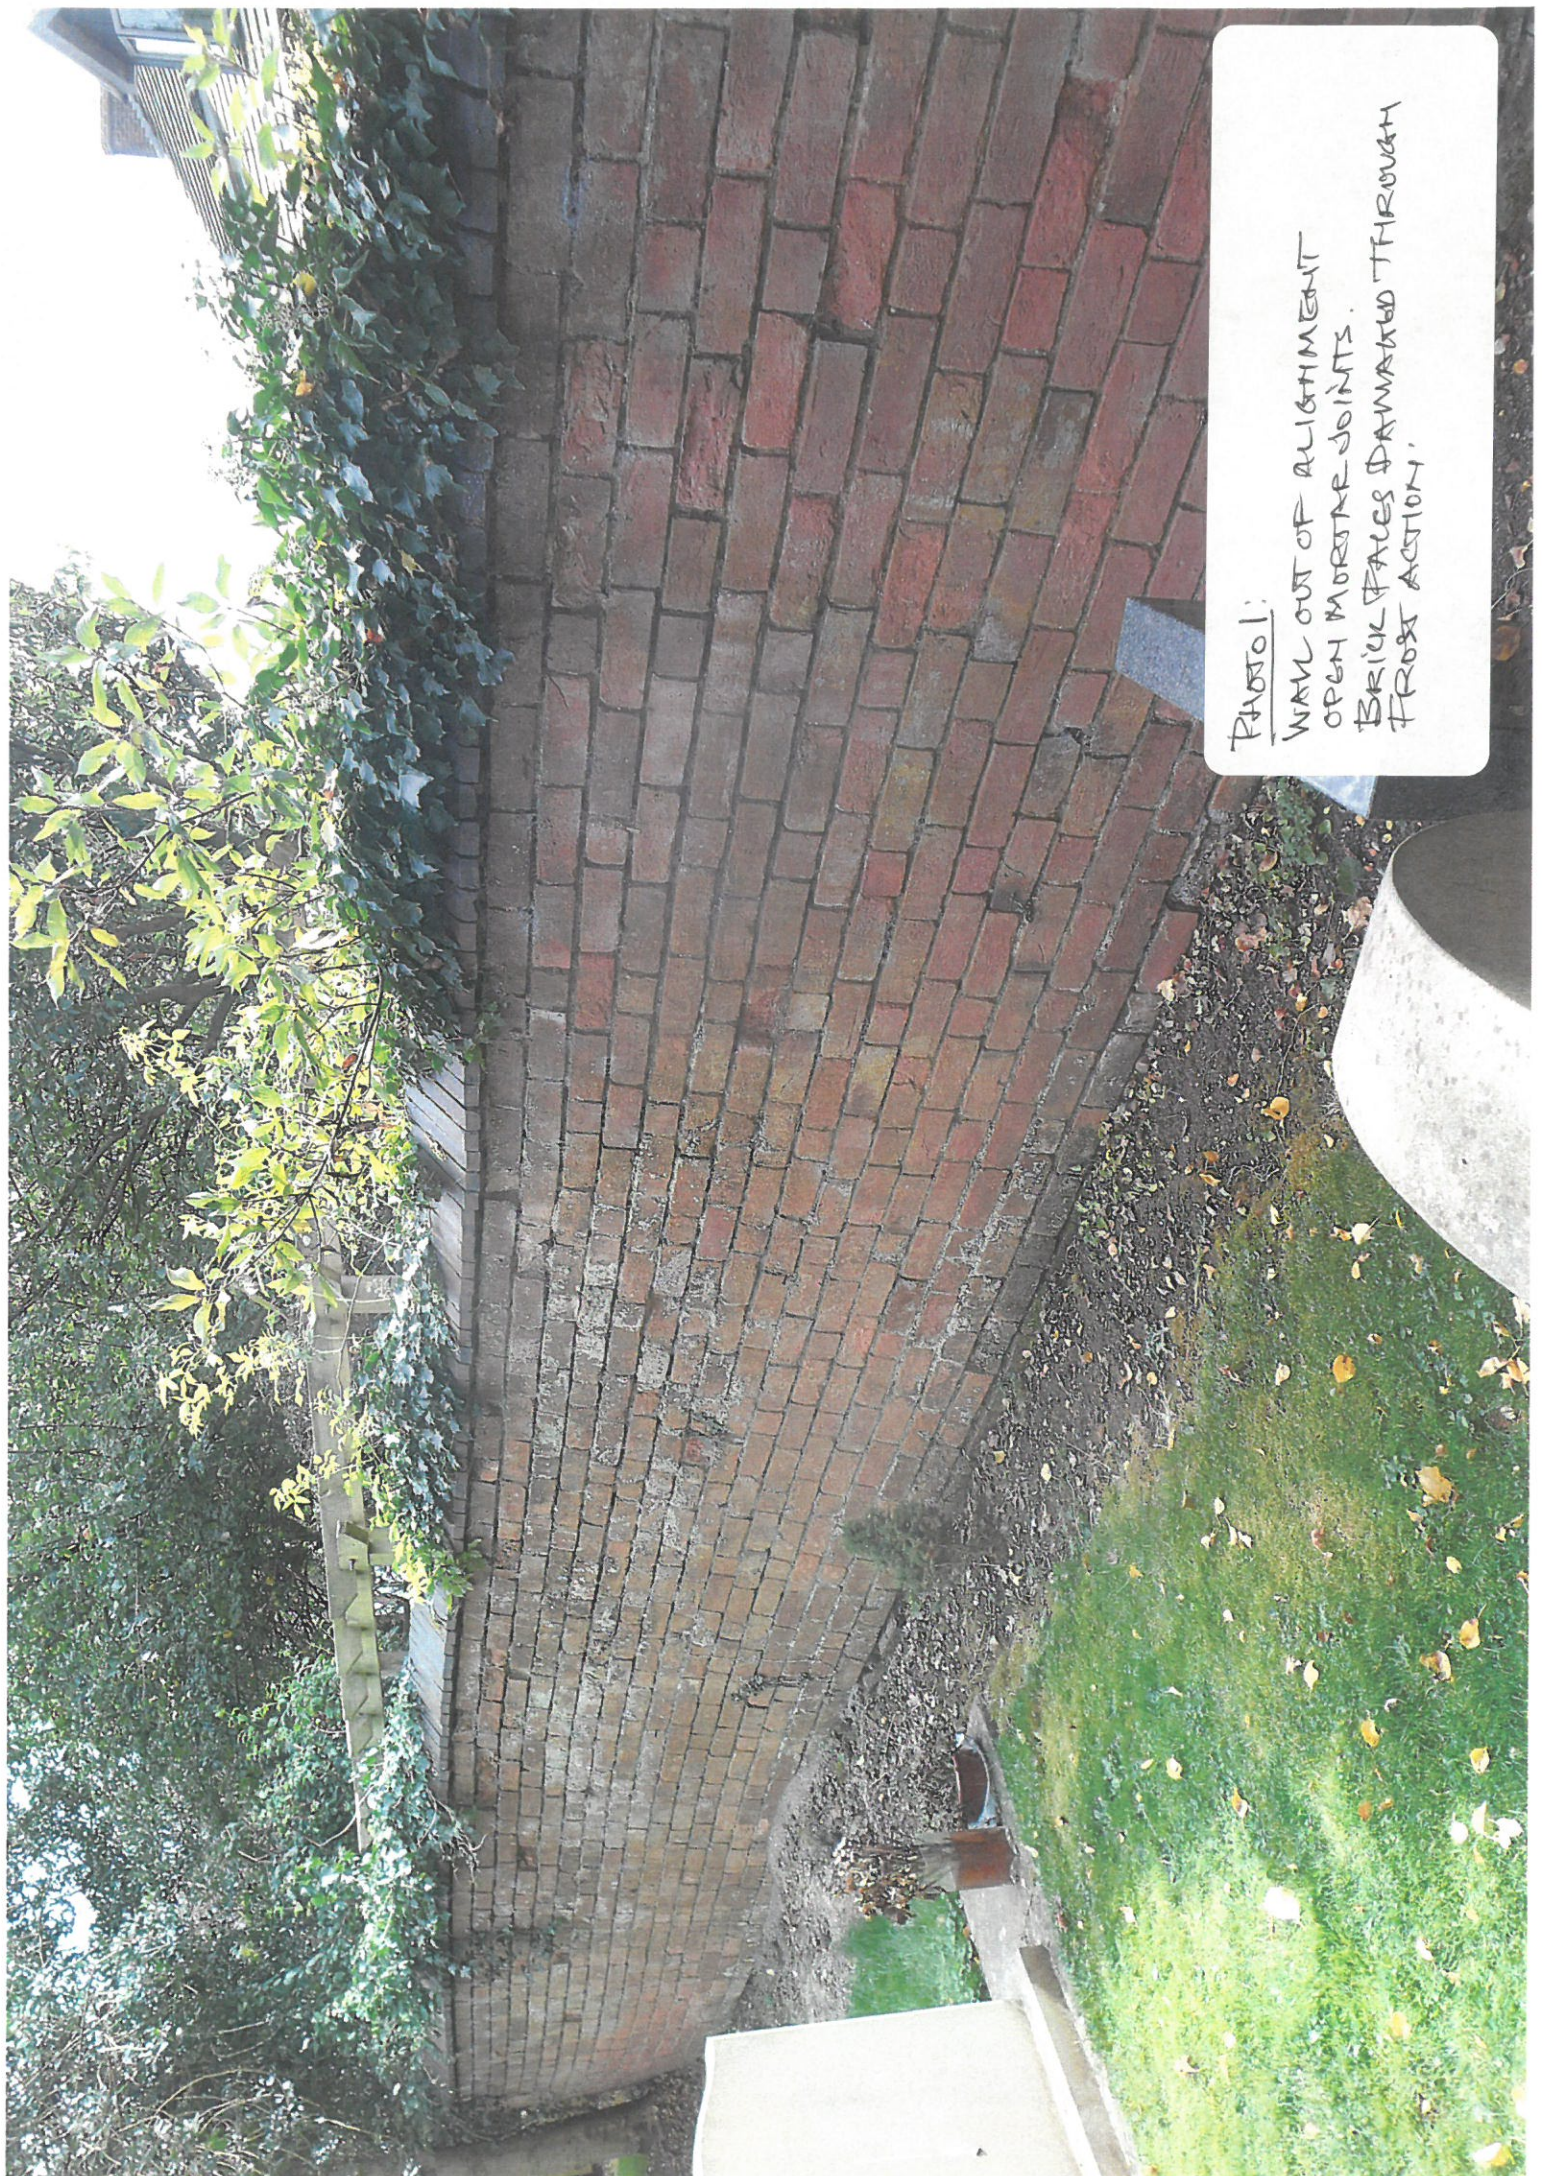
PHOTO 1:

WALL OUT OF ALIGNMENT
OPEN MORTAR JOINTS.
BRICK FACES DAMAGED THROUGH
FROST ACTION.
