PROPOSED EXTENSION - PHOTOGRAPHIC RECORD OF EXISTING EXTENSION

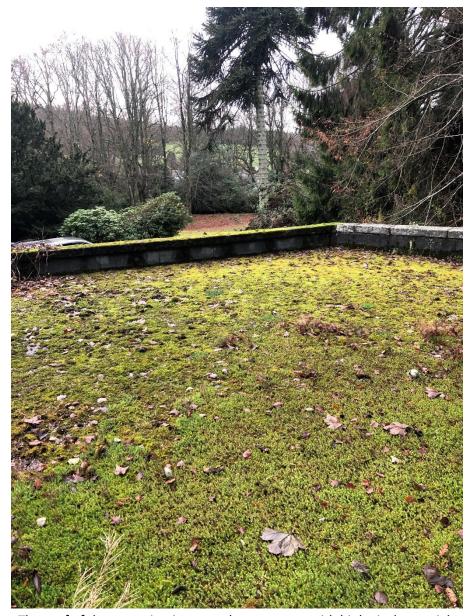
The roof of the extension is currently overgrown with biological materials

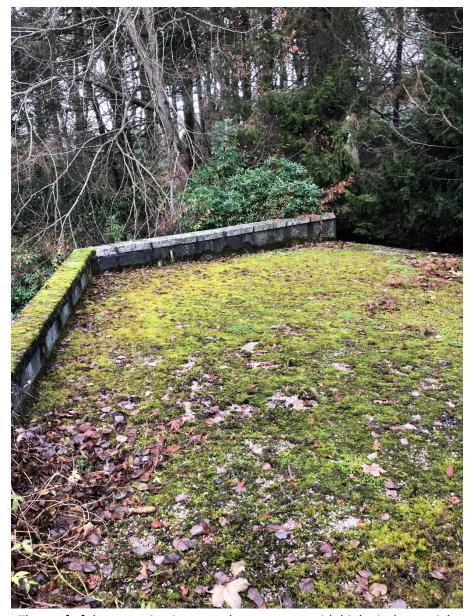
The roof of the extension is currently overgrown with biological materials

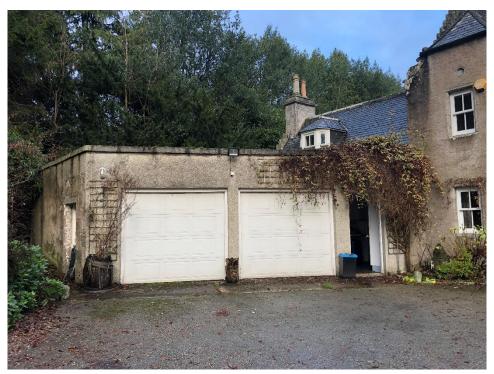
Front (south) Elevation with 20th Century garage doors and pass door added

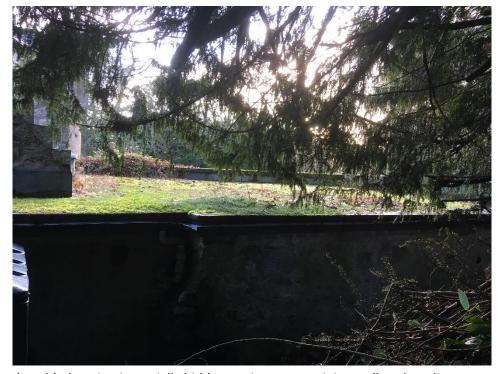
Rear (north) elevation is partially hidden, acting as a retaining wall to the adjacent ground

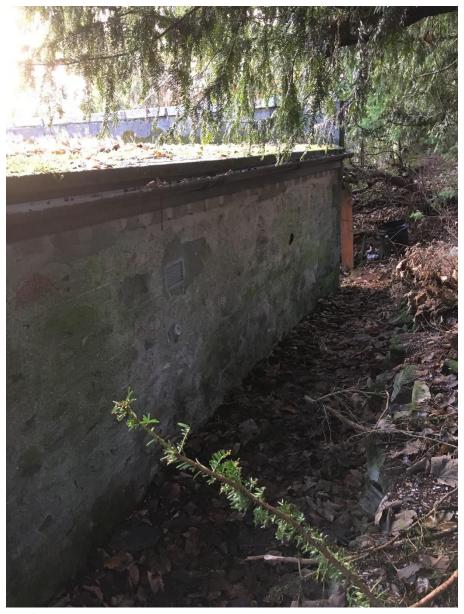
Rear (north) elevation is partially hidden, acting as a retaining wall to the adjacent ground

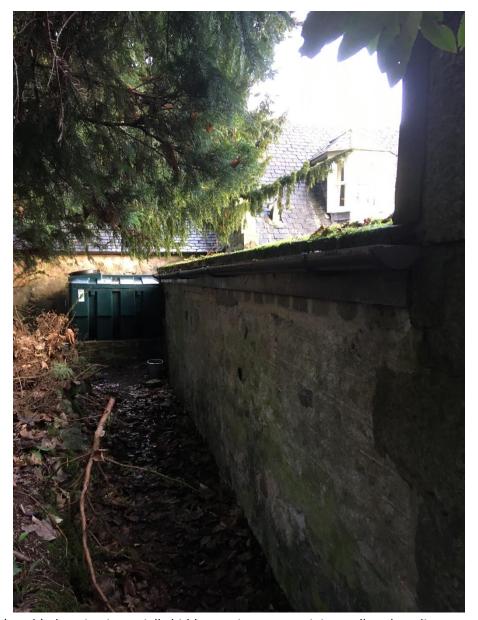
Rear (north) elevation is partially hidden, acting as a retaining wall to the adjacent ground

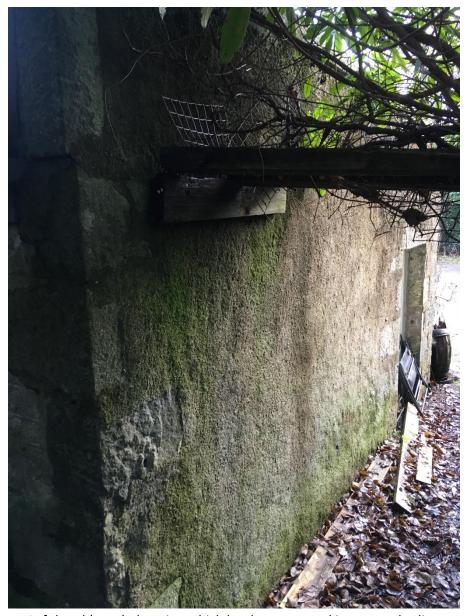
Left hand (west) elevation which has been covered in cement harling

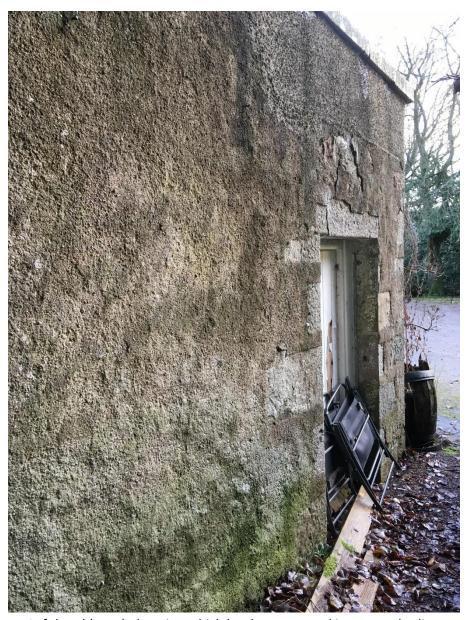
Left hand (west) elevation which has been covered in cement harling

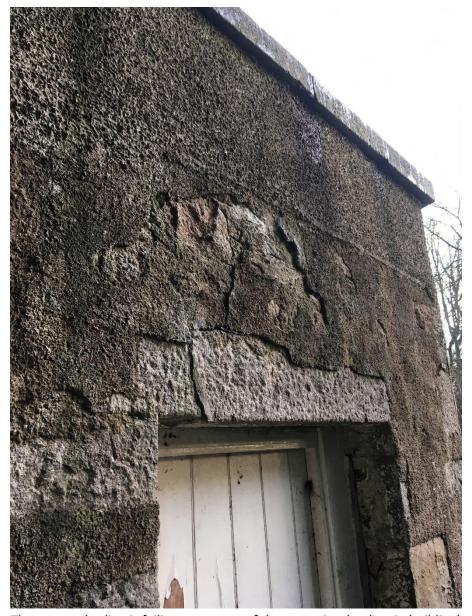
The cement harling is failing over parts of the extension (and main building)

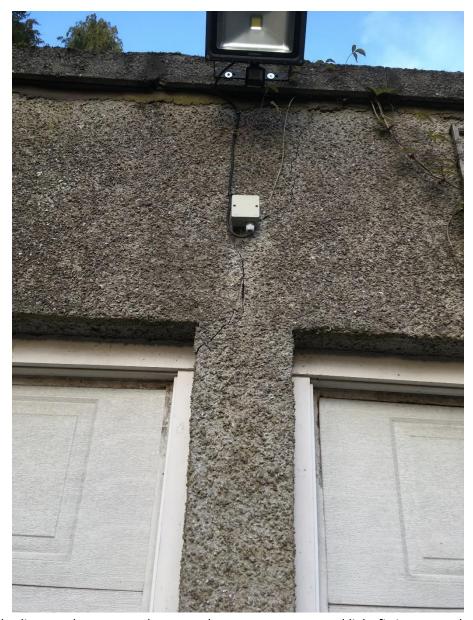
Cement harling, modern garage doors, modern concrete cope and light fitting to south elevation

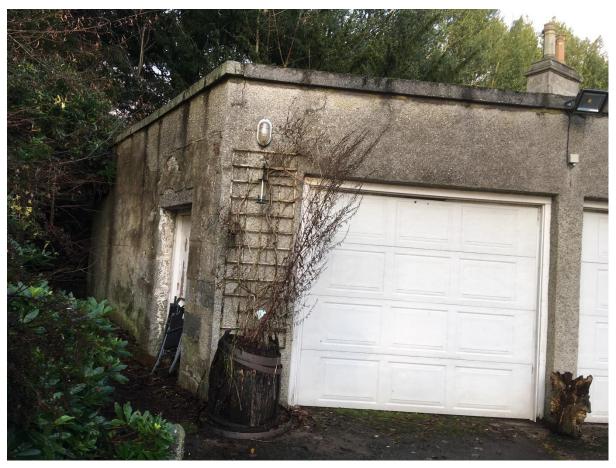
South and west elevations showing the garage door, modern access door, cement render and concrete cope

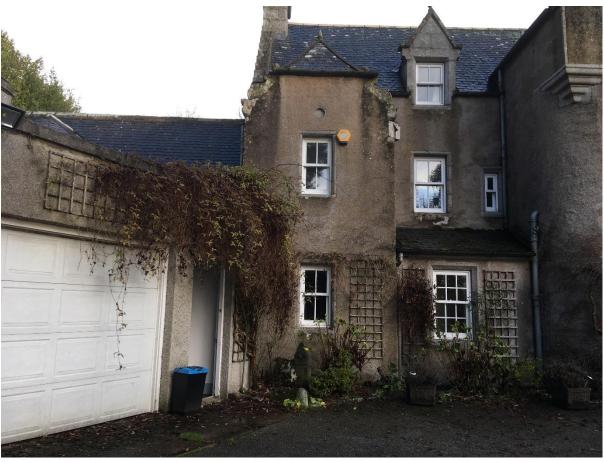
The south elevation of the extension connects back to the northernmost jerkin headed gable

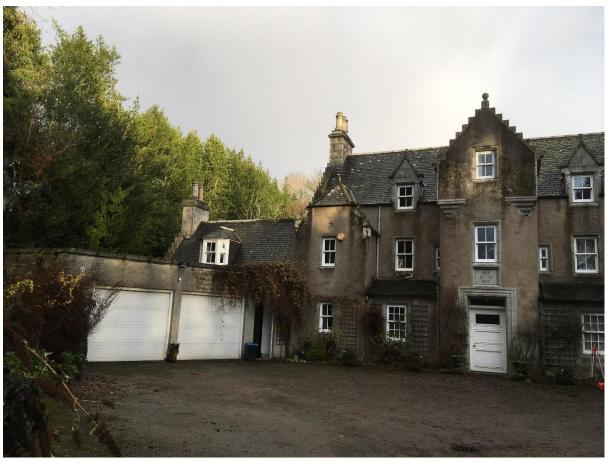
The extension shown in a wider context against main house
