Design Statement

to accompany LBA Application
23/02487/LBA

Application summary: This statement has been prepared to support the application for the installation of replacement windows and double glazed units to 12a Cleveden Crescent Lane, Glasgow. The existing Mews property lies within a conservation area so a sensitive approach to repair and replacement is proposed; with details matching existing where possible, removal of non-original security bars proposed and general upgrading of glazing to bring the property up to better energy efficiency standards whilst retaining the historic character of the property.

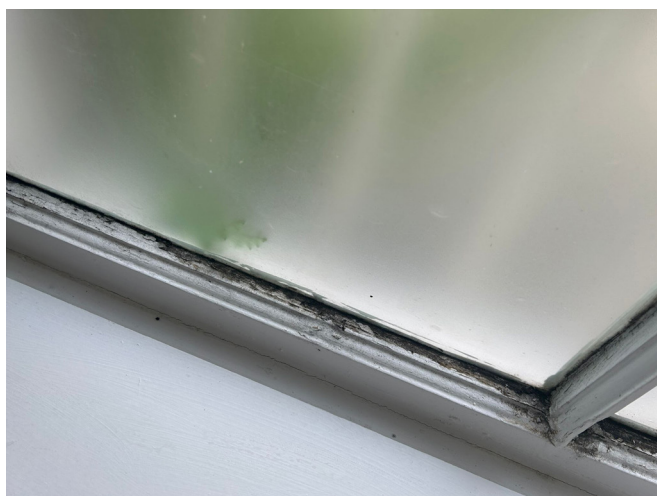
Reasoning: On inspection of the existing windows it is clear that not only do they not meet modern standards of energy efficiency, but the windows themselves are in disrepair, with rot and degradation visible throughout. On W1 and W2 the wooden sashes themselves are slightly rotten and require full replacement. The proposed replacements are to match existing style and detail. The replacements will have frosted glass as per existing, as there is a bathroom behind. The security bars are to be removed and any damage to existing stonework repaired, as they are unsightly and not in keeping with the original detail.

W1: Image from inside showing poor condition

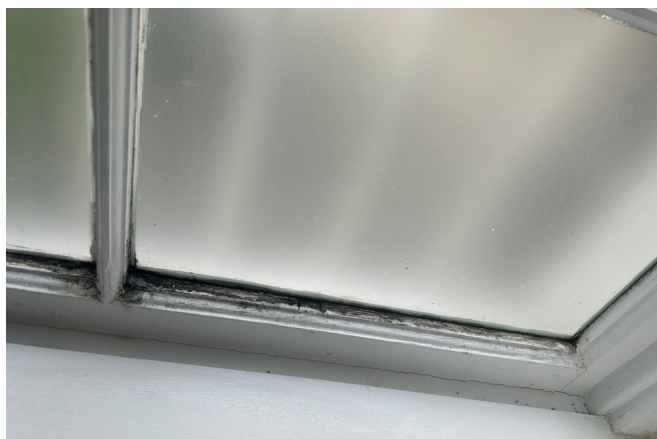
W2: Image from inside showing poor condition

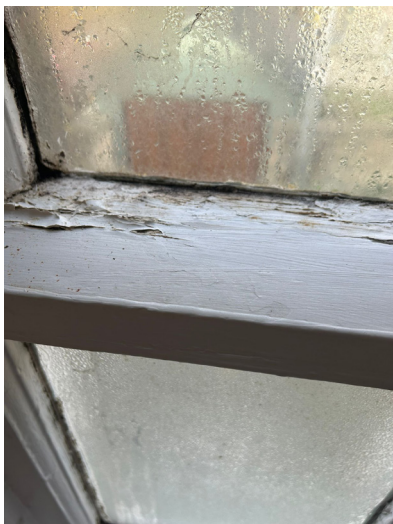
W4: Image showing poor condition

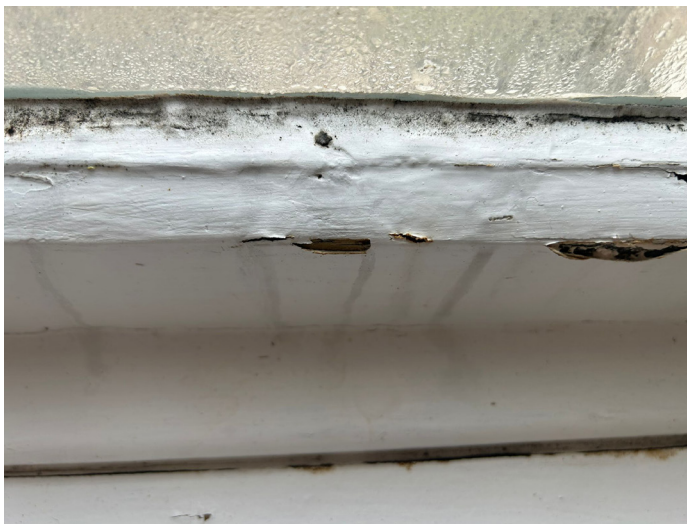
W5: Poor condition of timber, mould and condensation

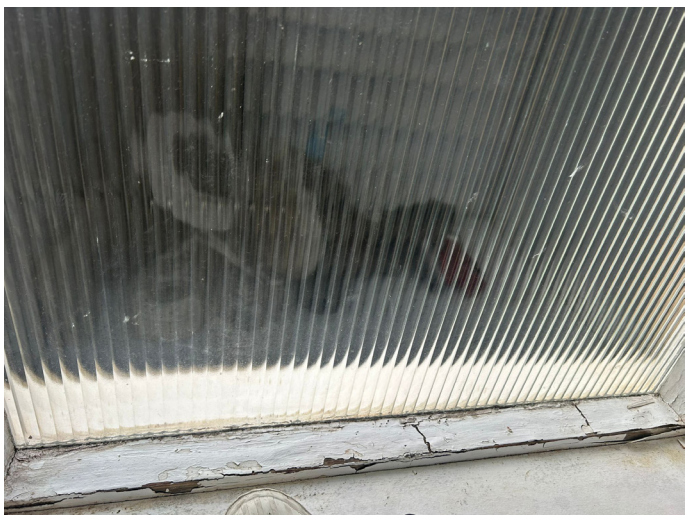
The windows to the rear of the property show similar signs of poor refurbishment or replacement, water ingress, rotting timber and mould:

W6: Poor condition and non-original glazing

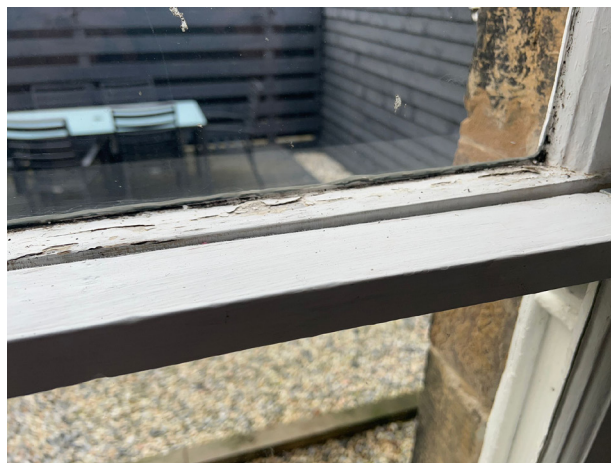
W7: Poor condition of sash and visible mould

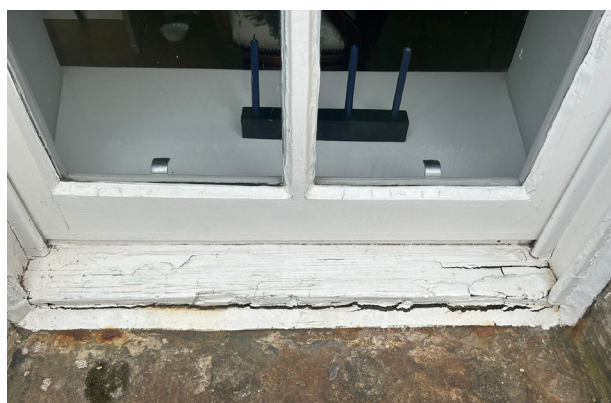
W10: Poor condition from exterior
