MJC Tree Services Limited

19th May 2023

Re: Ash Trees at Land off Chatfield Road, Niton, Isle of Wight, PO38 2DR.

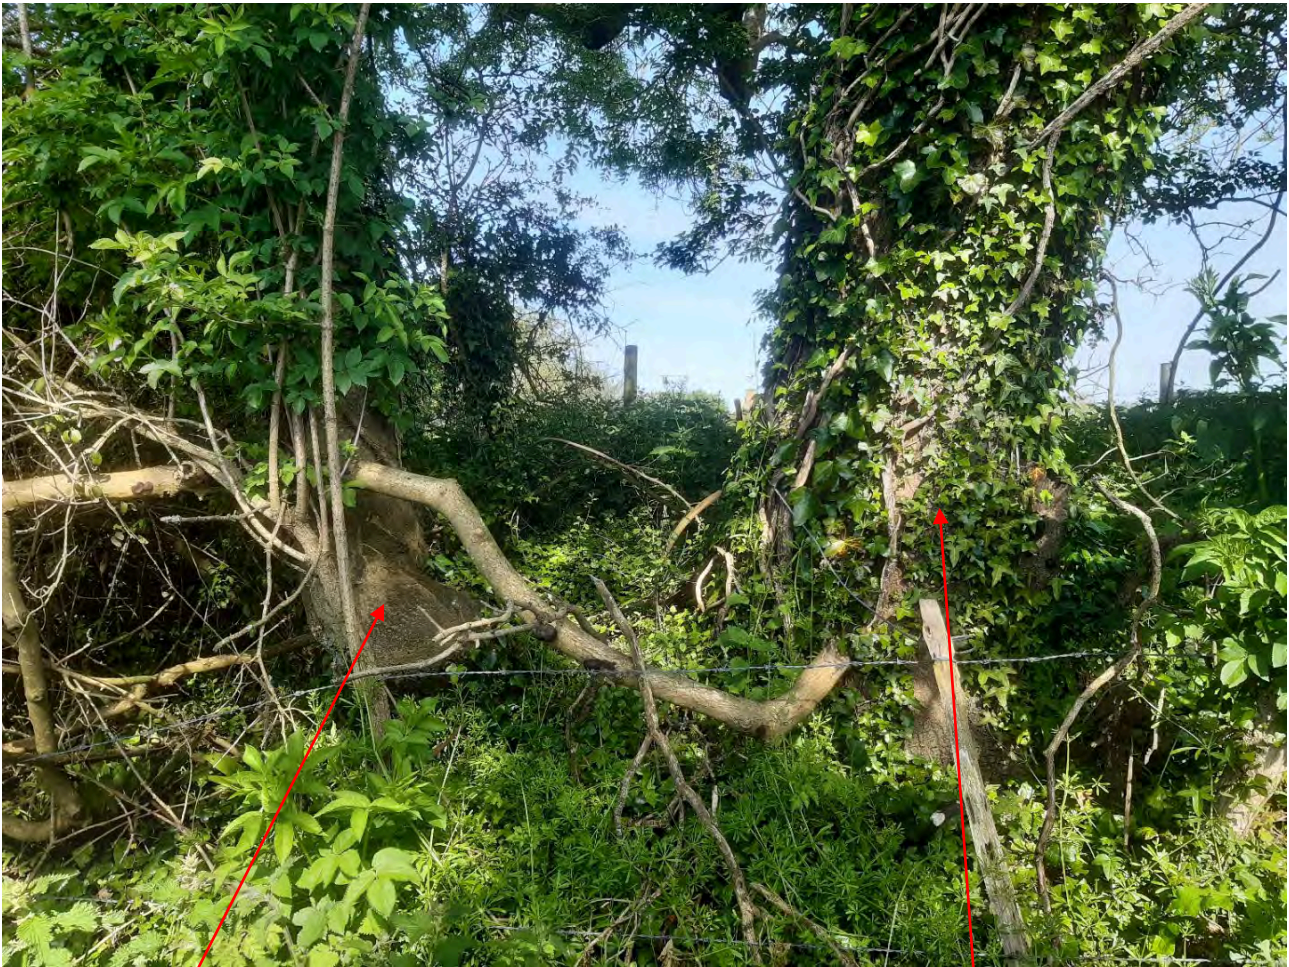
On closer inspection of the two trees, it became clear there are in fact three trees, with a smaller and heavily asymmetric Ash tree located to the south west of tree no. T1, see Figure 1 of Appendix 2 of this letter. This additional tree is of very little value in arboricultural planning terms, and would not be sustainable as an independent tree given its crown asymmetry and significant lean away from tree no. T1. Therefore, I do not consider that the non-inclusion of this tree in the tree report used as part of the planning application bundle for the site is significant planning issue.

Figure 01 – Additional tree not recorded in the Tree Location Plan

Additional Ash tree to the south west of tree no. T1.

Ash tree no. T1.

The additional Ash tree to the south west of tree no. T1 is also showing clear symptoms of Ash Die Back and the comments made above in respect of this fungal pathogen can also be applied to this tree. The necessary removal of tree nos. T1 and T2 will leave this additional tree exposed and semi-prostrate, and it is almost inevitable that this tree would fall towards the south west shortly after the removal of tree nos. T1 and T2. Therefore, this additional tree should also be removed on the grounds of health and safety at the same time as tree nos. T1 and T2 are removed.

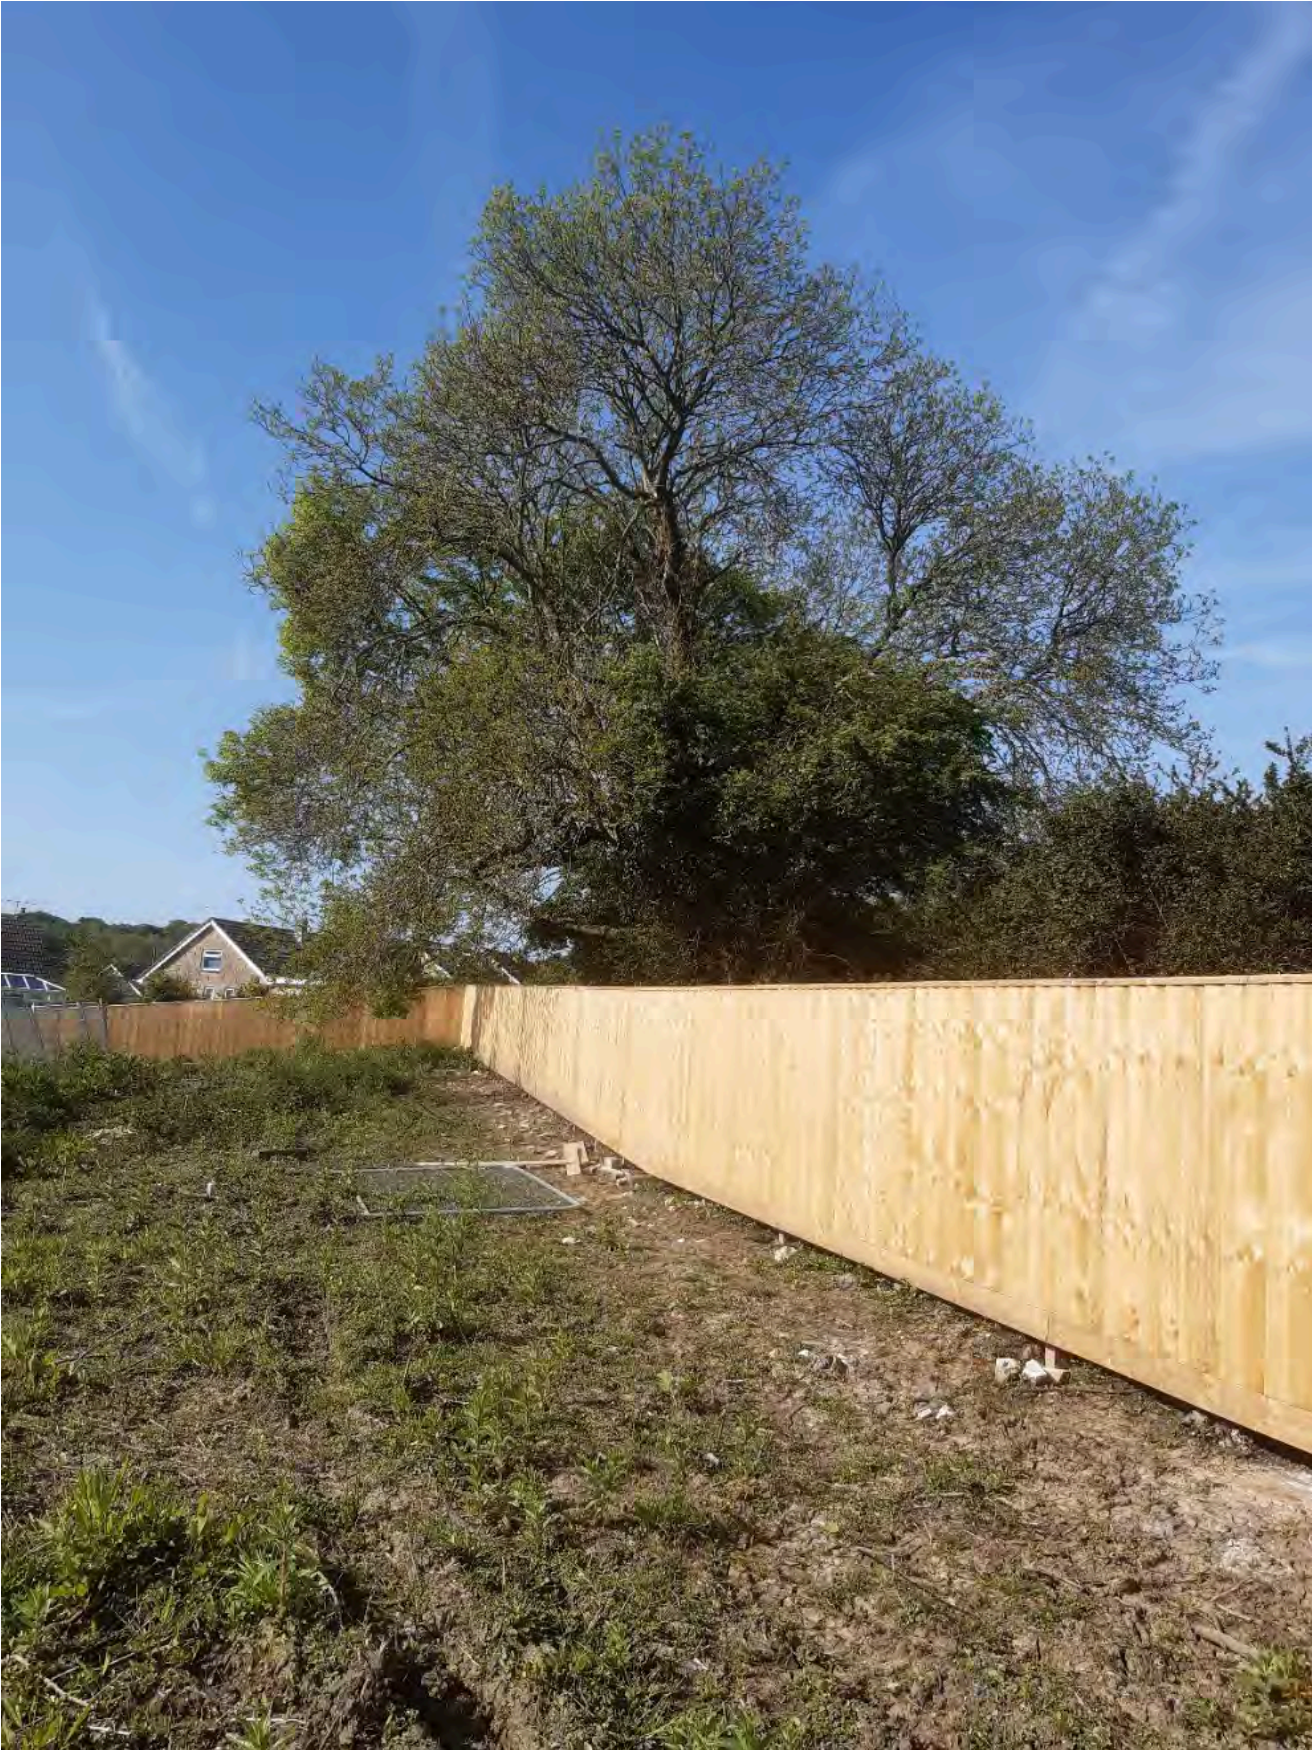
Tree no. T2 is illustrated in Figures 02 and 03 of Appendix 2 of this letter. In comparison to tree no. T1, the crown of tree no. T2 is very thin. There is extensive peripheral crown dieback, and the leaves that are being produced are smaller than I would normally expect. I believe these symptoms are strongly indicative of Ash Die Back caused by the fungus *Hymenoscyphus fraxineus*. This exotic fungal pathogen is invariably fatal for the Common Ash, although the length of time taken for an individual tree to succumb varies widely. Of more significance is the fact the timber of an infected tree becomes significantly more brittle, even in the early stages of infection, and this leaves the tree more prone to branch, and even trunk, failure <https://www.forestryengland.uk/westonbirt/chalara/FAQS> & <https://rfs.org.uk/wp-content/uploads/2022/06/Managing-ash-dieback-Vol-2.pdf>. This increased risk of branch failure can pose significant risks of harm to persons and/or property in certain circumstances.

Figure 02 – Tree no. T2 viewed from the north east.

In the original context of the site, i.e. as an agricultural grass field, the risk of harm posed by the increased risk of branch failure in tree no. T2 would not pose a significant risk of harm to persons and/or property as there would only a low chance that any person or property would be under the tree if and when it failed. However, as the site has now been developed for residential use, the tree is now within falling distance of a dwelling and its crown overhangs a domestic garden, and there is a much higher chance that a person or property will be under the tree and vulnerable to damage or injury if and when the tree fails. Therefore, tree no. T2 poses a significant, and I believe unacceptable, risk of harm to persons and/or property, and it should be removed on the grounds of health and safety.

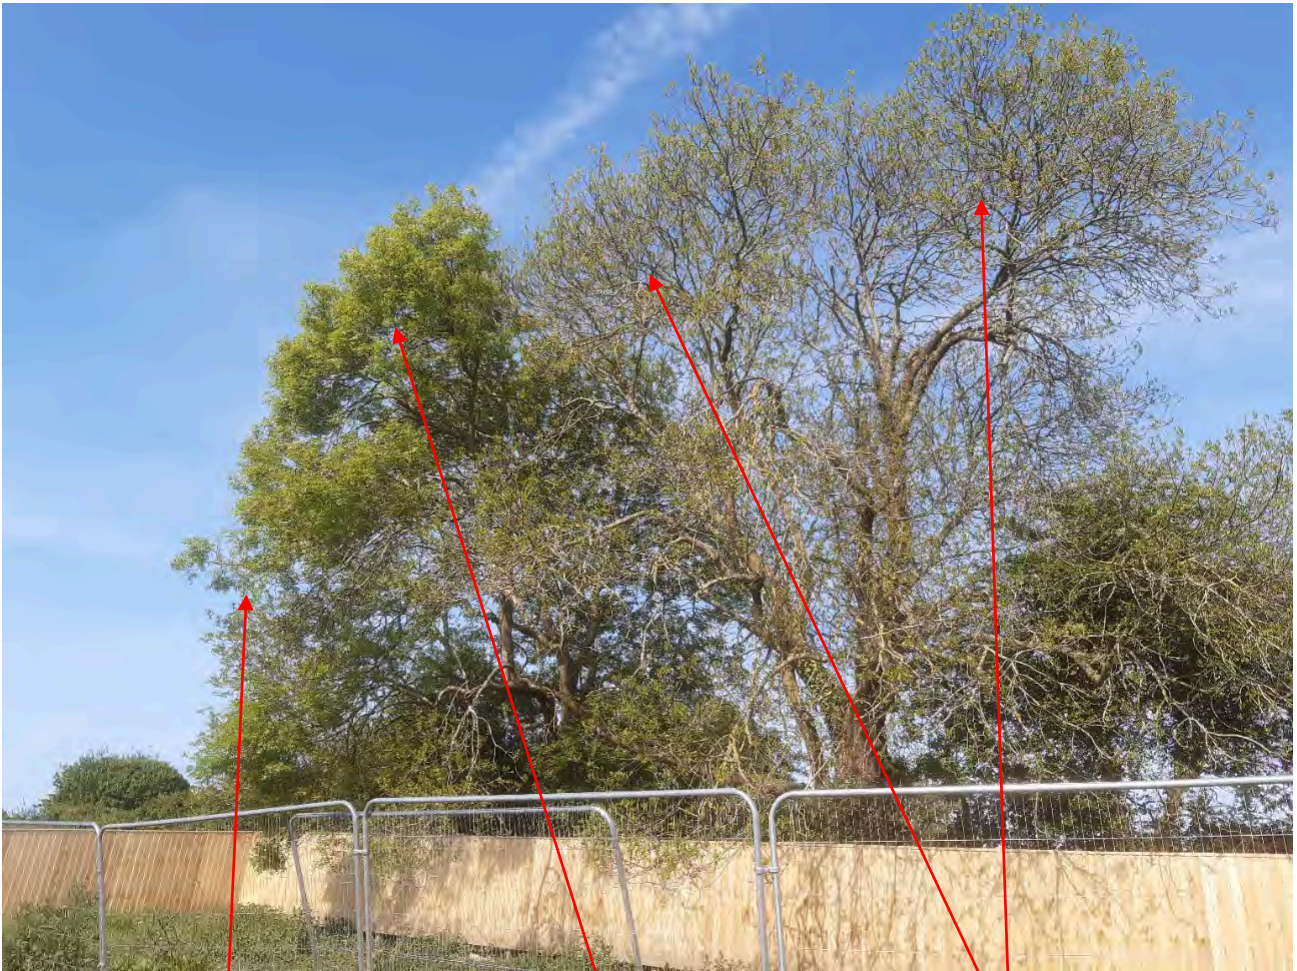
In comparison to tree no. T2, the crown of tree no. T1 seems full and healthy, see Figure 03 of Appendix 2 of this letter. However, the crown of tree no. T1 is asymmetric as a result of competition for light and space with tree no. T2, and the crowns of both trees form a single, unified and mutually interdependent structure in aerodynamic terms. The necessary removal of tree no. T2 will expose tree no. T1 to new and increased wind loads that it had previously been protected from by the companion shelter of tree no. T2. This increased exposure will increase the risk of branch, trunk or root plate failure, and this will increase the risk of harm posed by T1 to persons and/or property.

Figure 03 – Tree no. T2 viewed from the south east.

Thinning crown of additional Ash tree to the south west of tree no. T1.

Full and seemingly healthy crown of Ash tree no. T1.

Very thin and dying back crown of Ash tree no. T2.

In summary, the Ash tree nos. T1 and T2, and the additional Ash tree to the south west of tree no. T1, should all be felled on the grounds of health and safety, and their retention would pose an unacceptable risk of harm to persons and property.

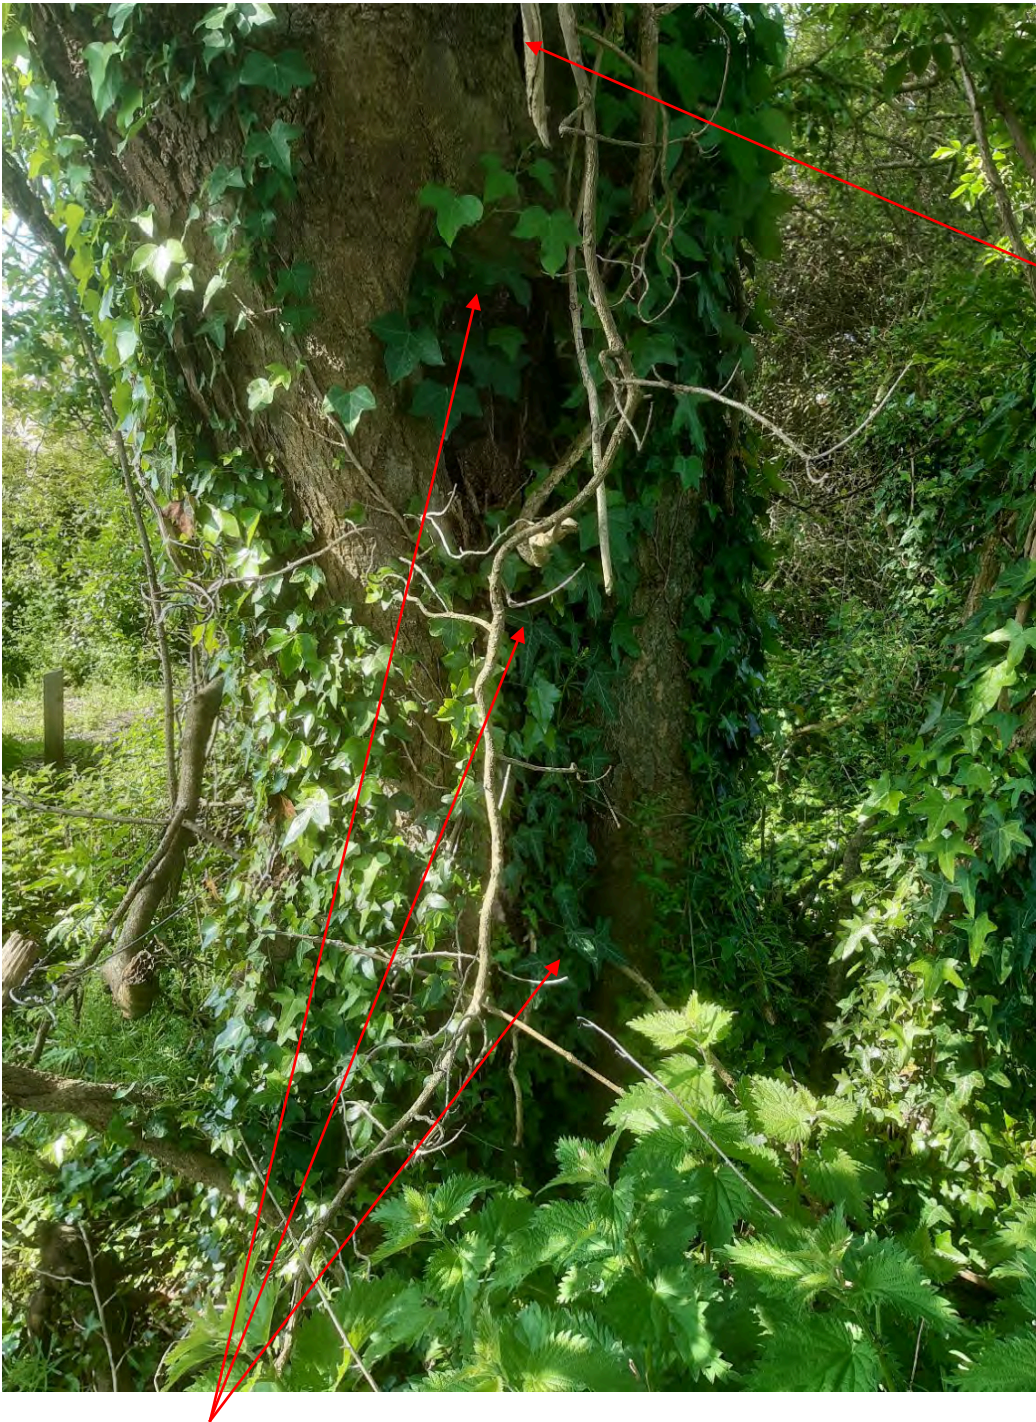
The trunk and branch bole of tree no. T1 is significantly decayed, see Figure 04 of Appendix 2 of this letter. This decay is compromising the structural integrity of the trunk and branch bole, and the branch attachments around the branch bole. This decay is currently sufficient to raise significant health and safety concerns given the proximity of the tree to a dwelling and garden, and this decay will only worsen over time as Ash trees have little resistance to internal decay (Lonsdale 1999). The necessary removal of tree no. T2 will leave tree no. T1 exposed to new and increased windloads, and this will increase the risk of branch and/or trunk failure to a seriously high level. Therefore, tree no. T1 should be removed on the grounds of health and safety at the same time as tree no. T2 removed.

Figure 04 – Decayed trunk and branch bole of tree no. T1.

Decay and cavitation extending upwards into the branch bole with openings at past branch removal wounds that have rotted out.

Extensive trunk decay and cavity formation visible through large, open and longitudinal bark wound.
