## GeoEnvironmental Desk Study

Egmont Street

Mossley

**Report No. A5333/23**

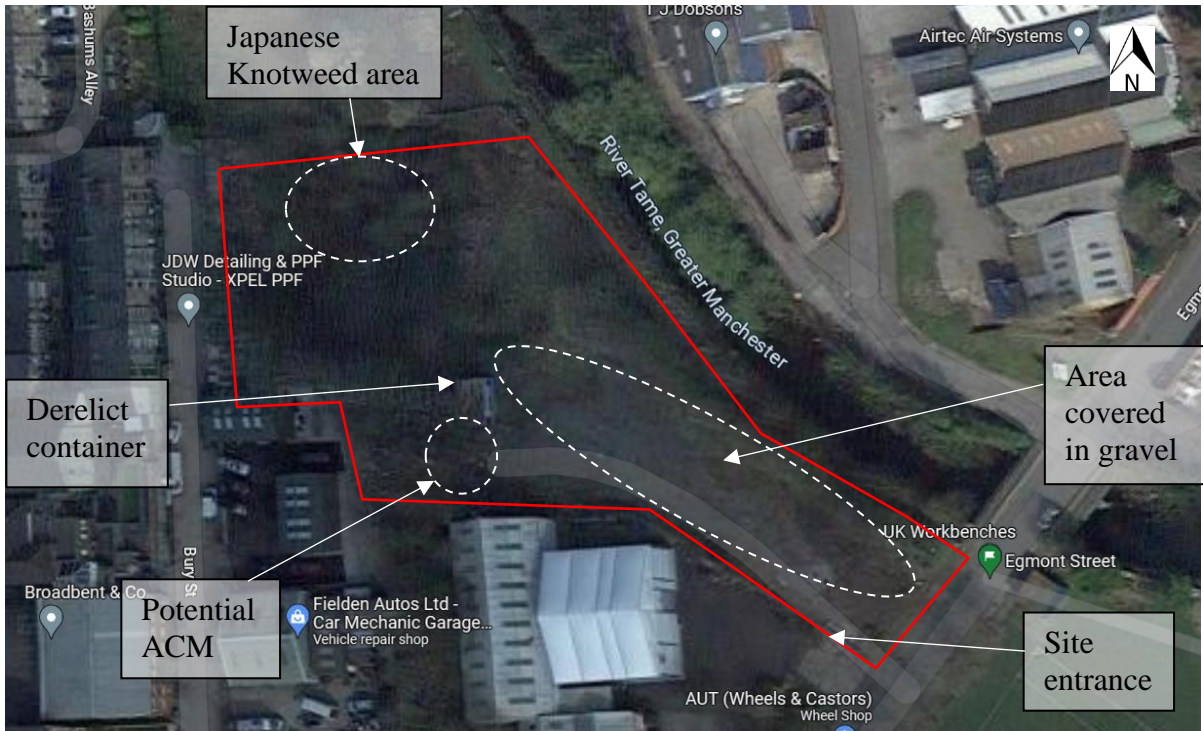
**Figure 3 Site Features Plan**

- 4.6 Japanese Knotweed and Himalayan Balsam (both invasive plants) have been identified in northern part of the site, in the area of the rough vegetation.

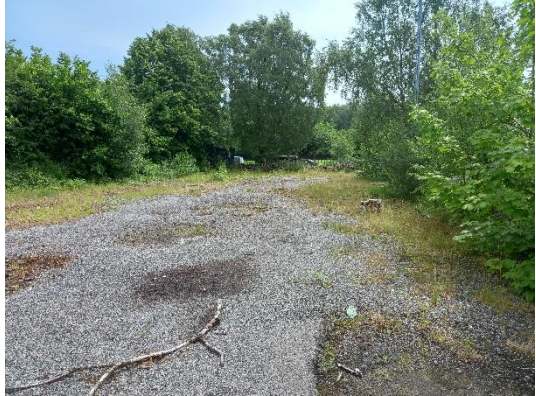
<p><b>Plate 5 View across the site, looking S</b></p>	<p><b>Plate 6 View for the warehouse with ACM cladding, looking NW</b></p>

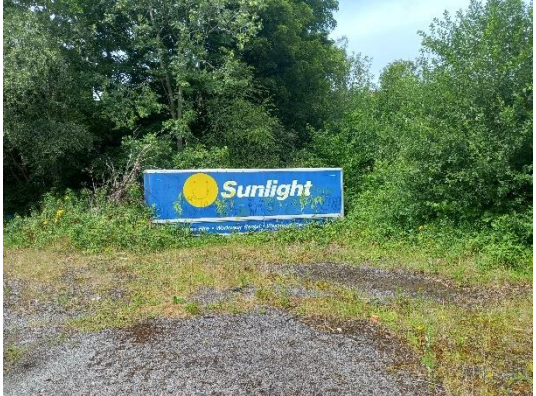
<p>Date: 10<sup>th</sup> July 2023</p>	<p>Date: 10<sup>th</sup> July 2023</p>
<p><b>Plate 7 View to the derelict container, looking NE</b></p>	<p><b>Plate 8 View for the potential ACM debris on site</b></p>

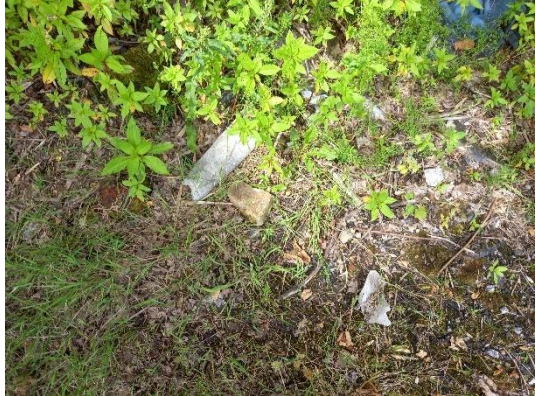
- 8.9 During the site walkover asbestos fragments were found across areas of the site.
- 8.10 Invasive plant species have been noted on the site, including Japanese Knotweed and Himalayan Balsam.

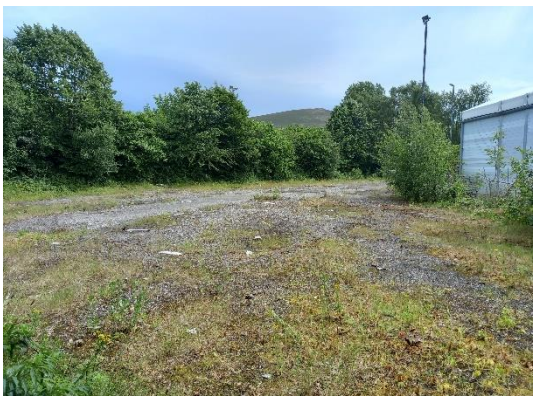
<p>Date: 10th July 2023</p>	<p>Date: 10th July 2023</p>
<p><b>Plate 9 View across the site, looking S</b></p>	<p><b>Plate 10 View for the fly tip adjacent to the north.</b></p>
