Tree Survey Report

**THE UNIT
TOR NA COILLE
BANCHORY**

October 2023

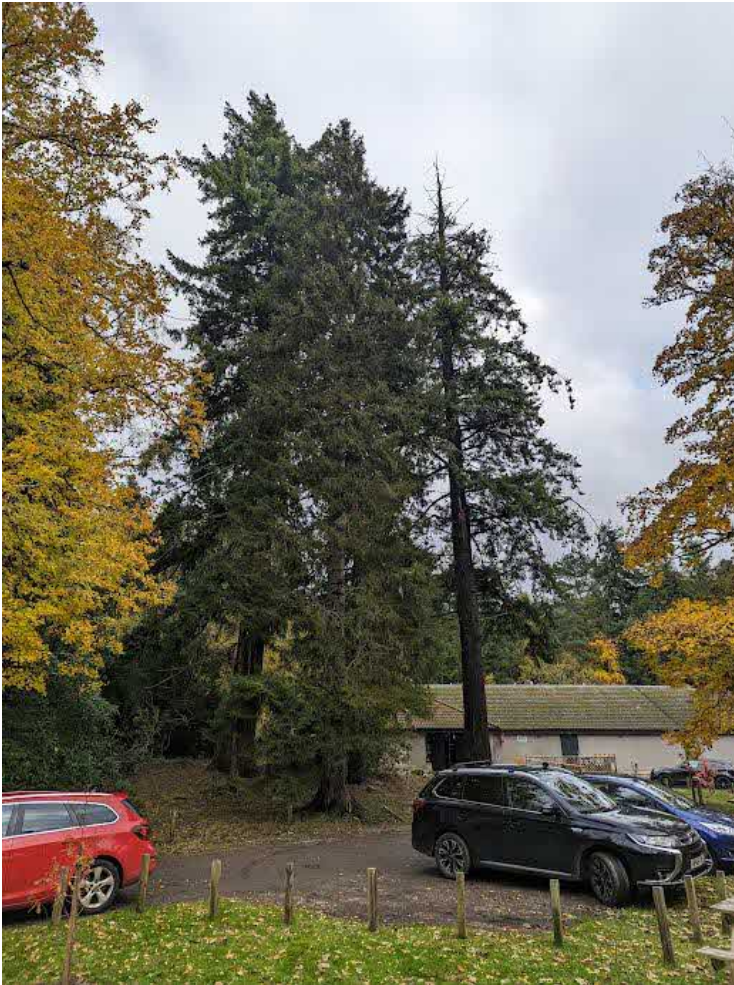
Visual inspection identified **Douglas fir 995** to be in very poor condition with a dead top and significant dieback at the tips of the lower crown. The tree is of limited life expectancy and increasingly likely to shed parts as it continues to decline.

The crowns of **Lawson cypress 996 and Douglas fir 997** display healthy vigour. Resistograph testing however identified significant internal hollowness at the base of both trees. See Appendix 3 - Resistograph Results.

Photo 1 – Douglas firs 995, 997, Lawson cypress 996 and Oriental spruce 998 in group close to The Unit. The trees are in poor condition with extensive dieback displayed by 995 and decay detected in the base of 996 and 997. 998 will be unviable following the removal of the neighbouring trees. Removal of the trees is recommended for reasons of safety.

1. **Douglas fir 995** – Due to severe dieback, irreversible decline, and close proximity to building.
2. **Lawson cypress 996** – Due to significant basal decay and exposure following removal of 995.
3. **Douglas fir 997** – Due to extensive basal decay, very large size and close proximity to building.
4. **Oriental spruce 998** - Will be left exposed and unviable following removal of its neighbours.

Removal should be undertaken as a matter of high priority and a timescale of **within 3 months** has been recommended.

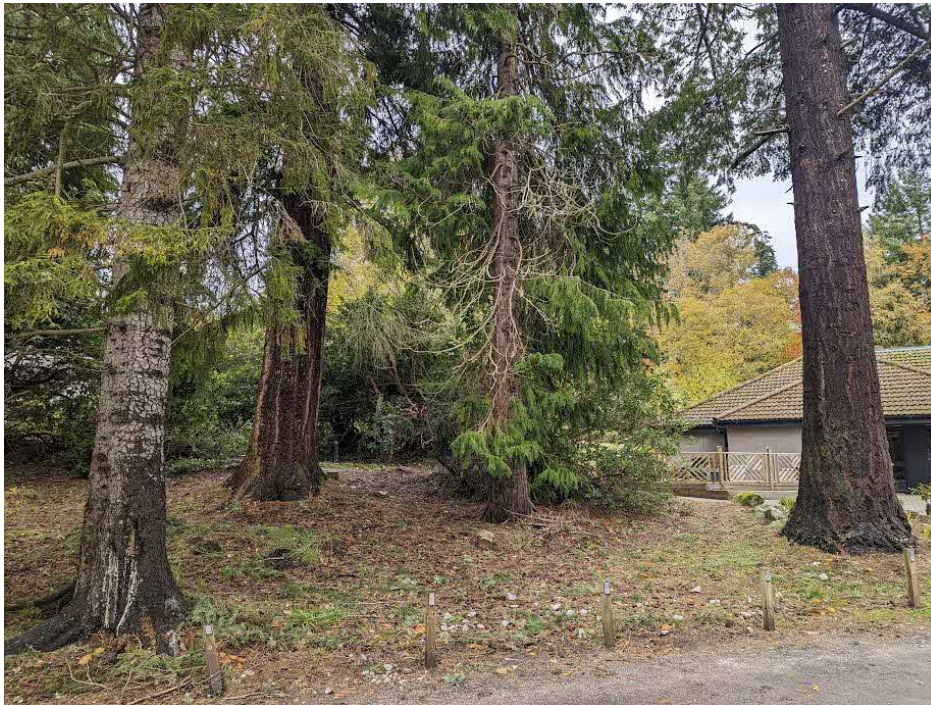
Photo 2 – Removal of trees 995 to 998 will mitigate the significant risk. Re-placement planting with Scots pine is recommended to provide red squirrel habitat.

It is recommended 4 Scots pine (*Pinus sylvestris*) be established within the gap.

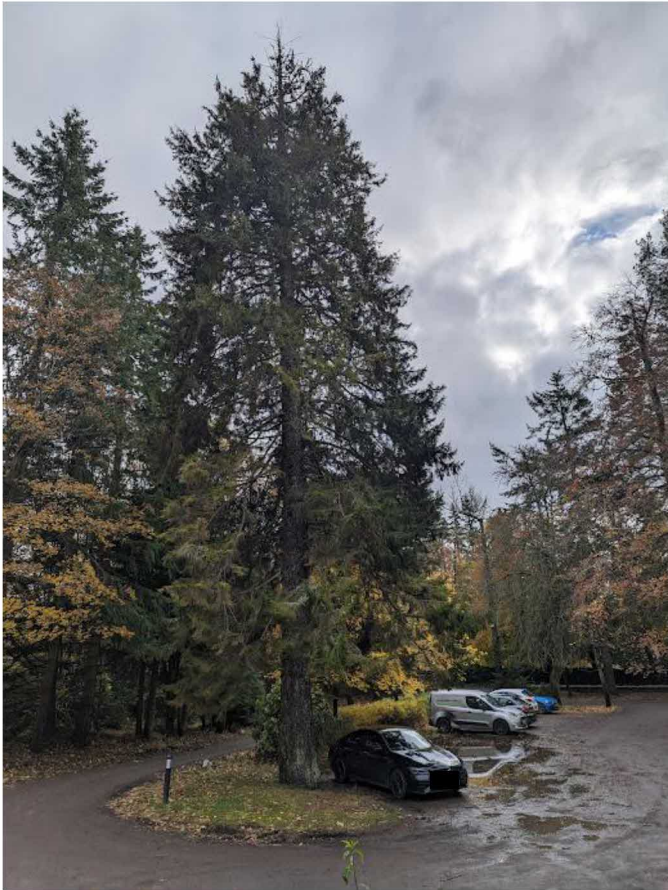
Oriental spruce 574 also displays a dead top, however the lower crown retains reasonable vigour. The roots appear to have been significantly damaged by soil compaction due to car parking around the base. The condition of the tree should be closely monitored for sign of further deterioration.

Photo 3 – Oriental spruce 574 within the car park displays a dead top. Pruning is recommended to remove the deadwood. The noticeable decline in tree health is probably due to soil compaction of rooting areas caused by car parking.

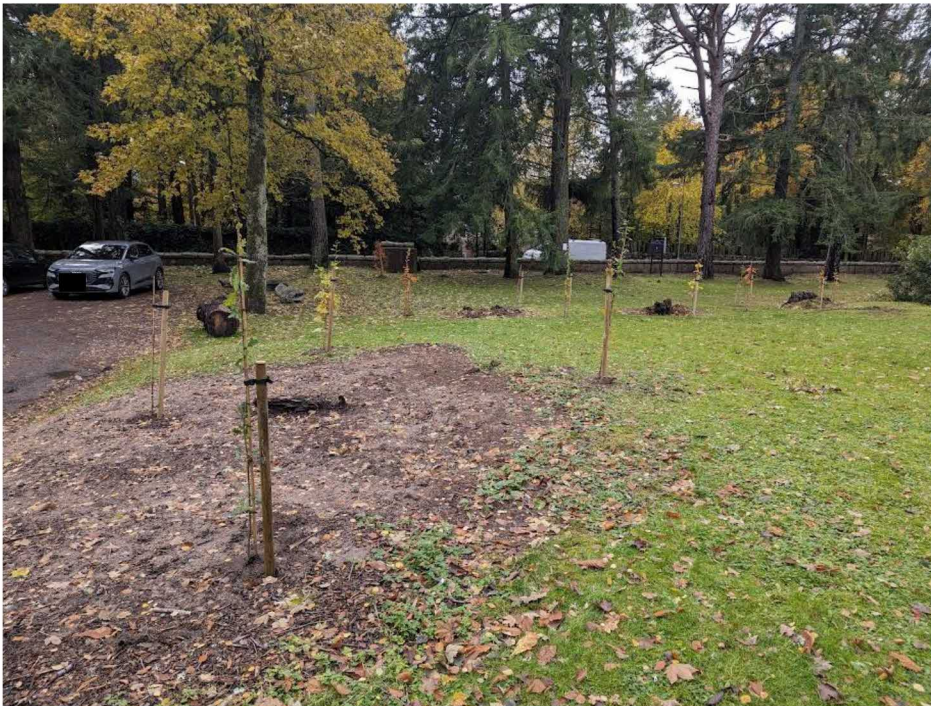
It was noted that grazing protection has not been provided and young trees are vulnerable to damage which can be caused by grazing rabbits and roe deer. Where damage appears to be an issue protection is required to ensure the young trees survive.

Photo 4 – Extensive new tree planting has recently been carried out within the property boundaries. Tree protection may be required where grazing of rabbits or roe deer is an issue. Mulching the base of newly planted trees with composted wood chips will help encourage healthy root growth and avoid the need for strimming near the base of trees.

To aid establishment newly planted trees should be mulched with a 10cm layer of well composted wood chips within a circular area 1m wide around the base of the tree. Mulch should remain clear of direct contact with the stem and should be kept weed free.

Strimming which can damage the bark of young trees should be avoided within the mulched area.
