Report

Two barns at Glebe Farm, Potter Heigham, Great Yarmouth, NR29 5LN

February 2019

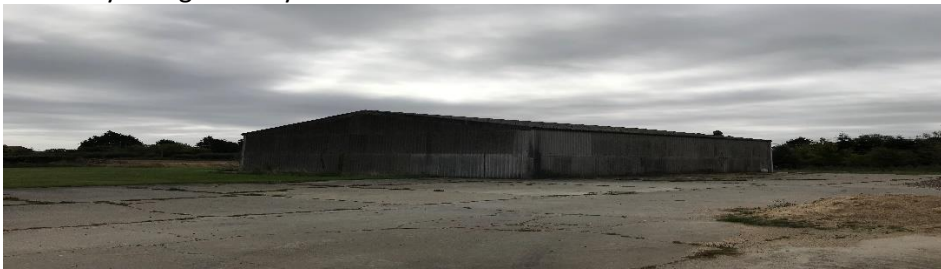
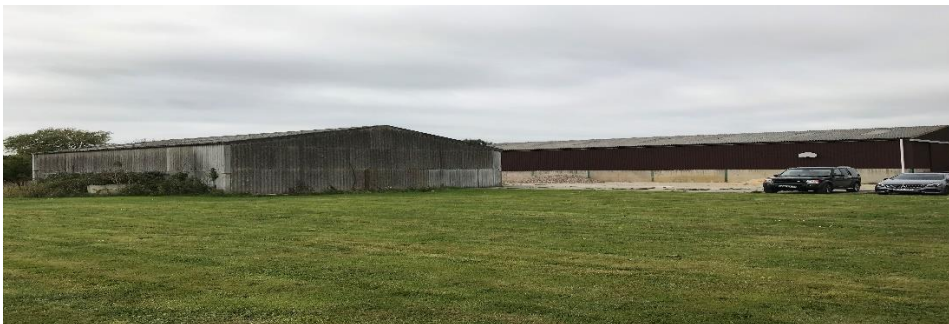
1

4.1 Generally a single storey steel framed structure circa 1960's

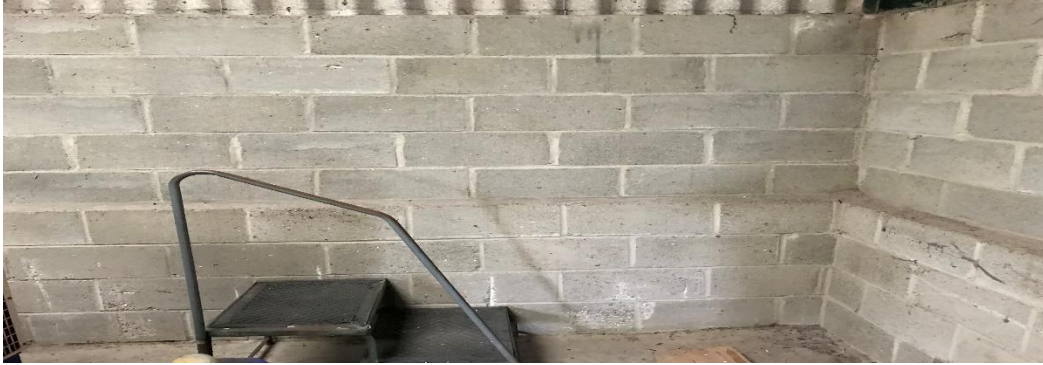
4.2 Internally an inner wall of light weight blockwork exists. The blockwork is in good condition, true alignment and structural sound.

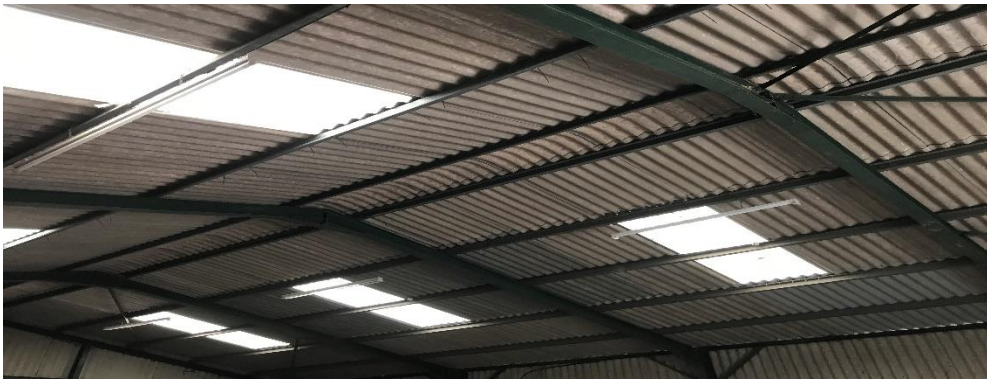
- 4.3 The main frame consists of steel portals in good condition. They are of adequate size to accommodate normal residential loads.
- 4.4 The roof covering is supported by steel purlins and wall cladding by steel sheeting rails, all in good order .
- 4.5 The roof covering and wall cladding appears to be of asbestos and should be replaced.
- 4.6 The existing steel framework is capable of carrying alternative cladding systems or walling.

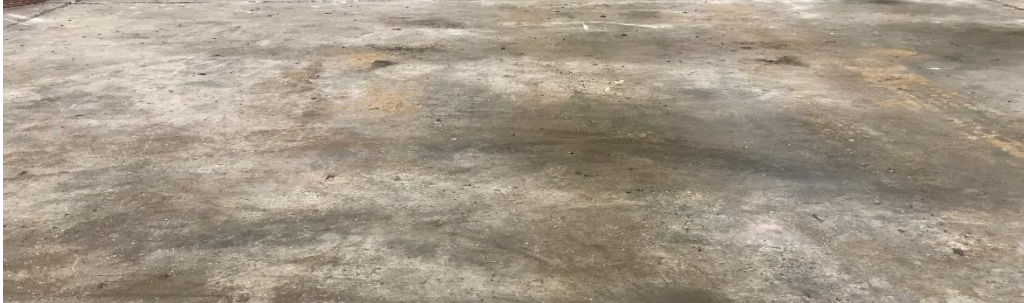
- 4.9 The floor consists of a reinforced concrete slab. The slab is true and level without any major cracks. The slab is capable of being overlaid for provision of DPM and insulation.

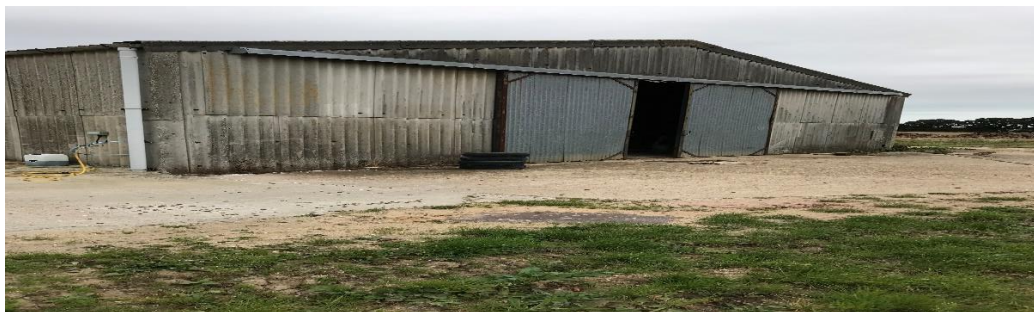
- 5 The existing structure has two opening metal doors generally in good condition these should be removed and the opening re-utilised for fenestration in any conversion works.

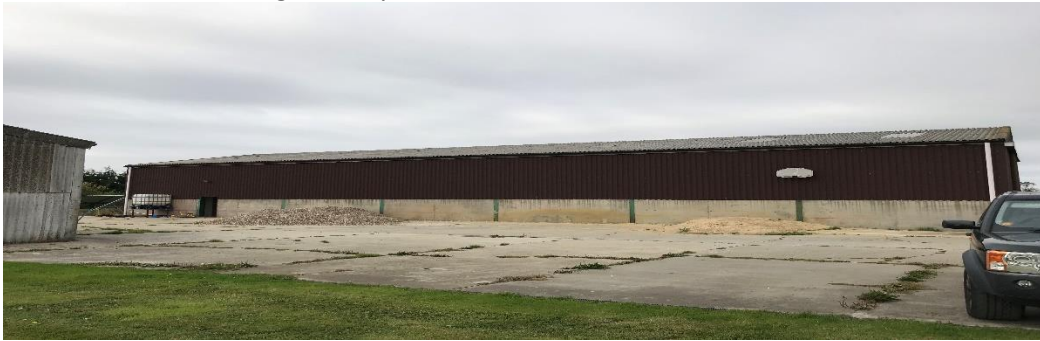
6.1 Barn B consists of a single storey steel framed metal covered structure.

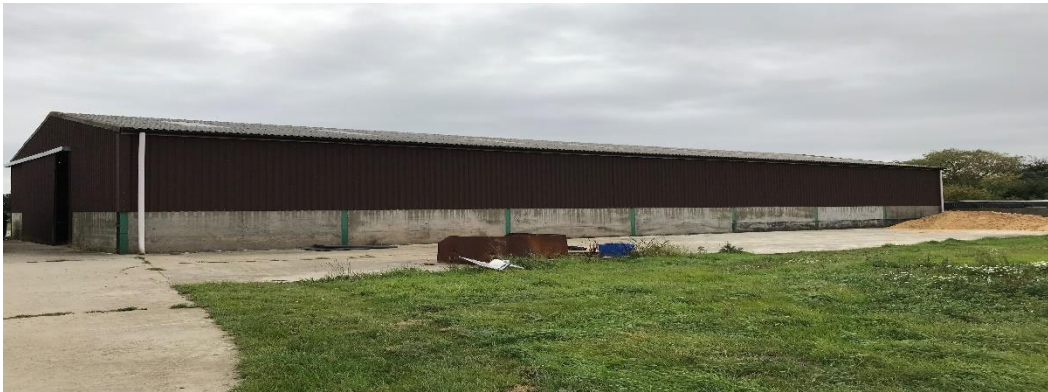
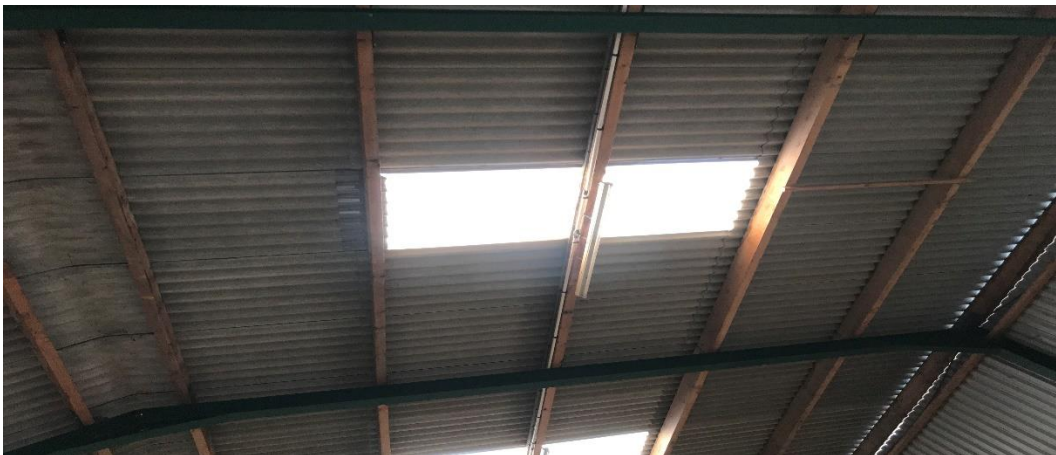
6.2 The building consists of a steel portal with steel sheeting rails with steel and timber roof structure. The timbers are in good condition and adequate to take normal residential loads associated with all commonly used roofing materials.

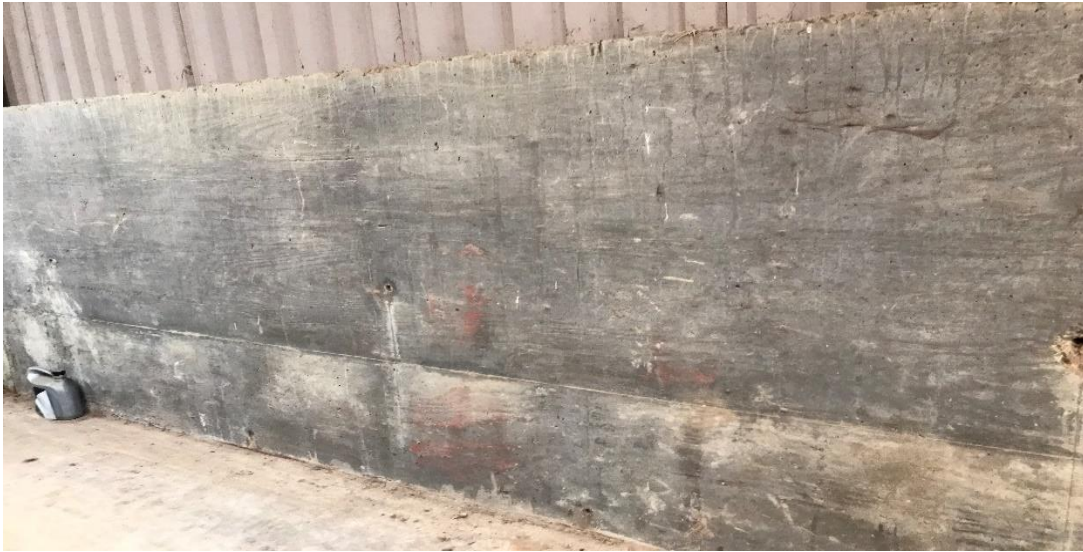
- 6.3 Internal walls to the structure consist of reinforced concrete approximately 2m in height. In good order. Some head restraint will be required depending on the final layout, of the conversion works. Lightweight blockwork can be raised off the top of this walling if required.
- 6.4 The floor structure is of substantial reinforced concrete and in good level condition. It is suitable for overlay with DPM and insulation. It is adequate to carry any internal lightweight partitions proposed.

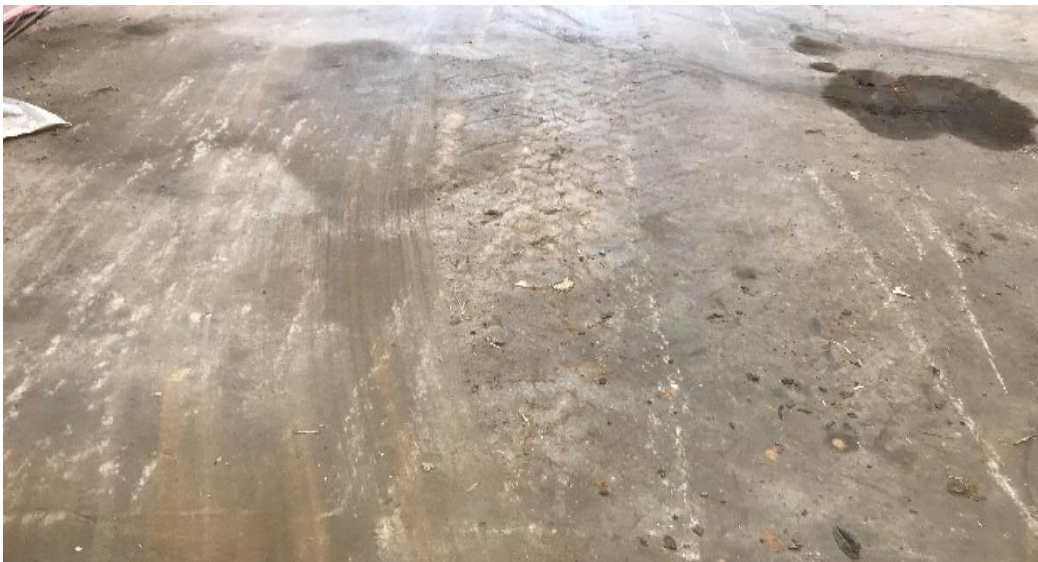
- 6.5 There is one floor pit in sound condition which will need to be dealt with once the conversion scheme is known.
