Bidborough Primary School Synthetic Sports Pitch Verification Report

PN0095-PEL-VR-01

Project No: PN0095

Date: 02.11.23

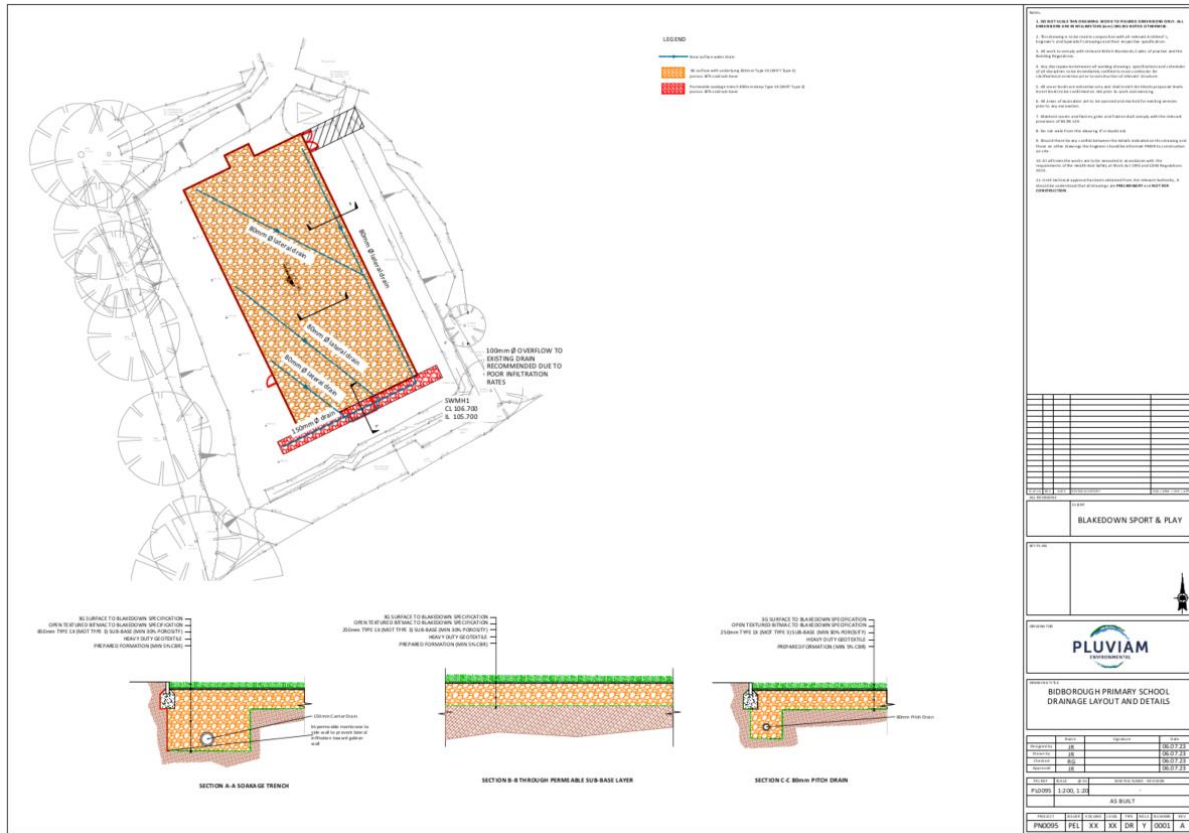
Figure 2. Snapshot of As-Built Drainage

Based on Blakedown Sport & Play’s amendments and additions, Figure 2 and Appendix A show the As-Built drainage drawing. A marked-up drawing was sent to PEL to produce the As-Built drainage drawing. The mark-up is backed up by photos from the construction, see Section 4.

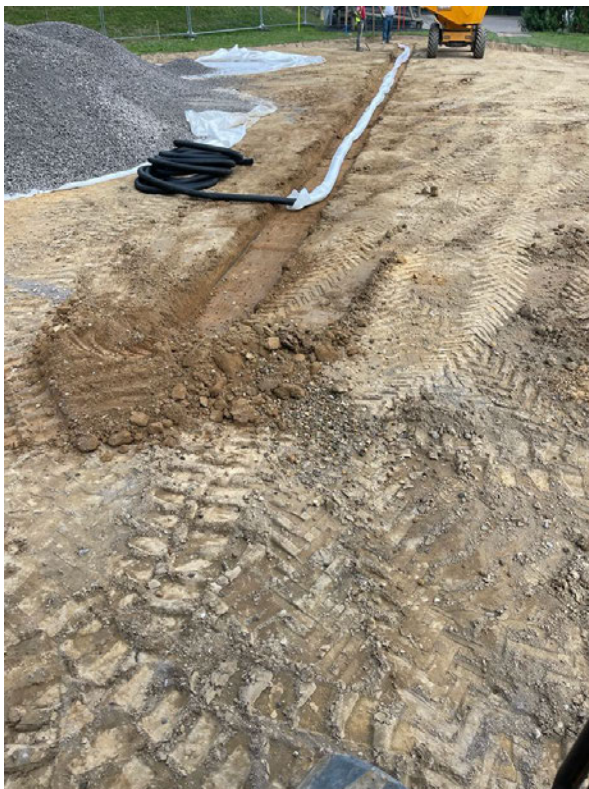
Plate 1. Formation dig and laying of sleeved pitch drain

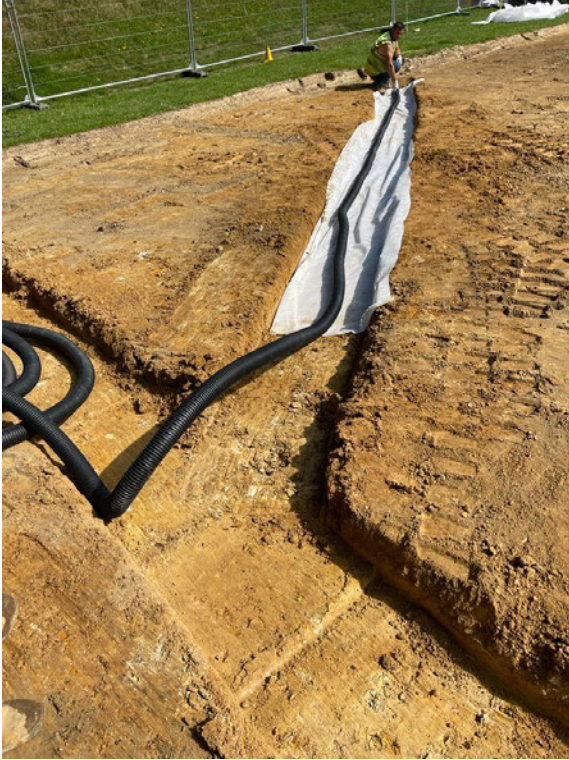
Plate 2. Pitch drainage pipework in trench

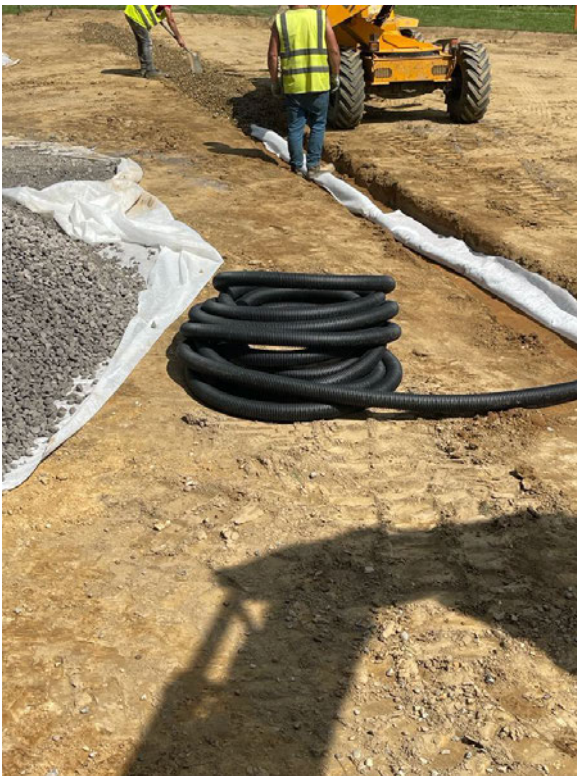
Plate 3. Pitch drainage and MOT Type 3 piled above geotextile at formation (MOT Type 3 not spread)

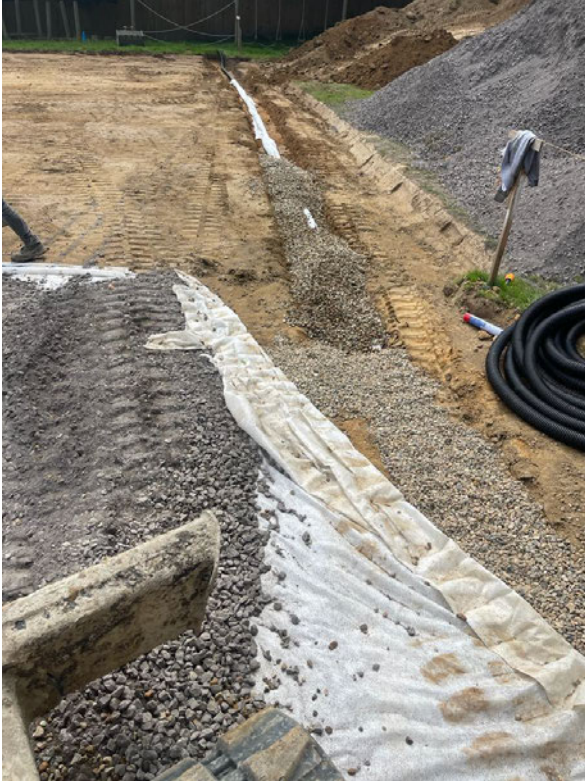
Plate 4. trench filled and geotextile at formation with MOT Type 3 being spread

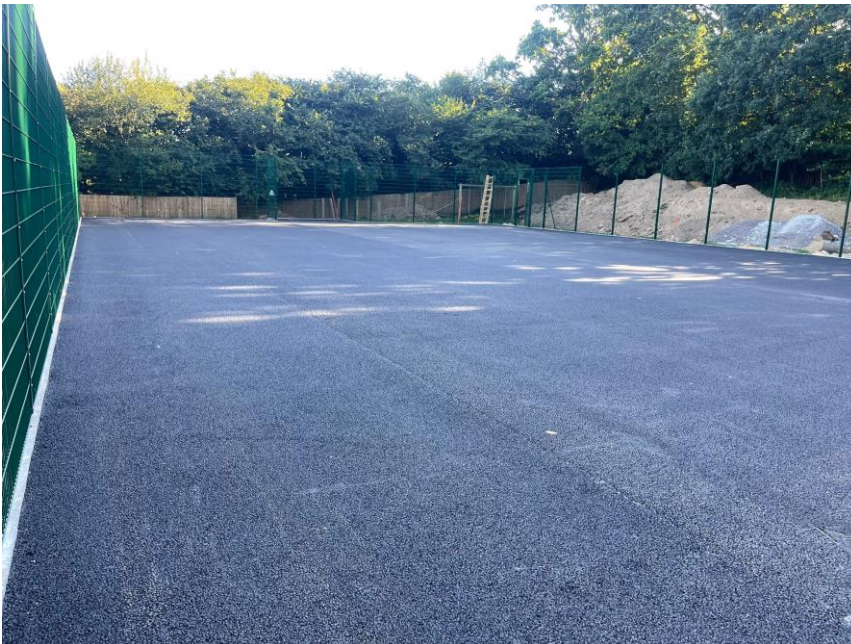
Plate 5. Permeable basecourse to Blakedown specification

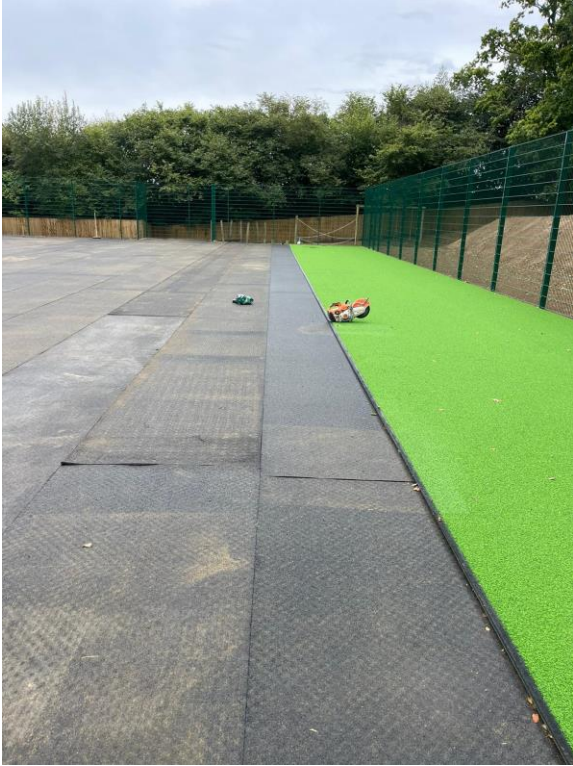
Plate 6. Shockpad installed and synthetic surface partially laid

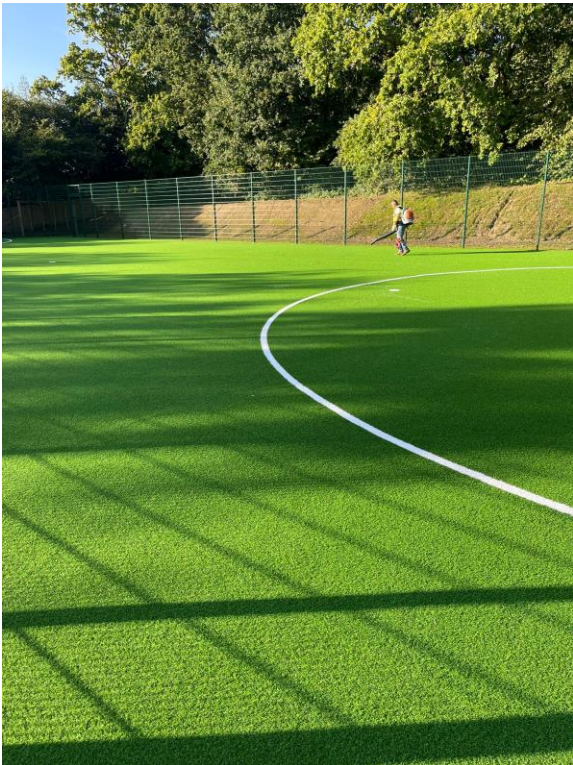
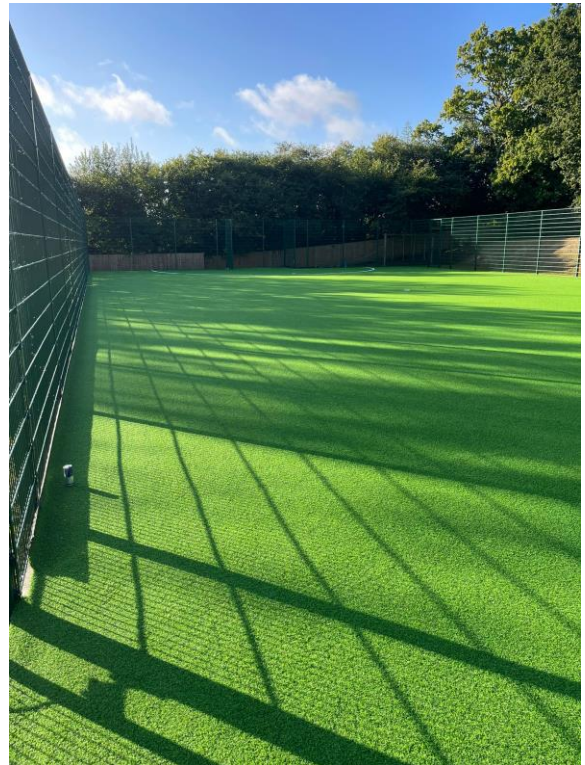
Plates 7 & 8. Finished pitch
