Subject: Survey Summary
Project: 249 West George Street
Reference: FN 002 REV3
Author: PAH

Report on Condition of Cladding on Main Elevations

249 West George Street

Project Title: 249 West George Street
Client: Carrigmay Glasgow (Jersey) Ltd
Project No: 131138

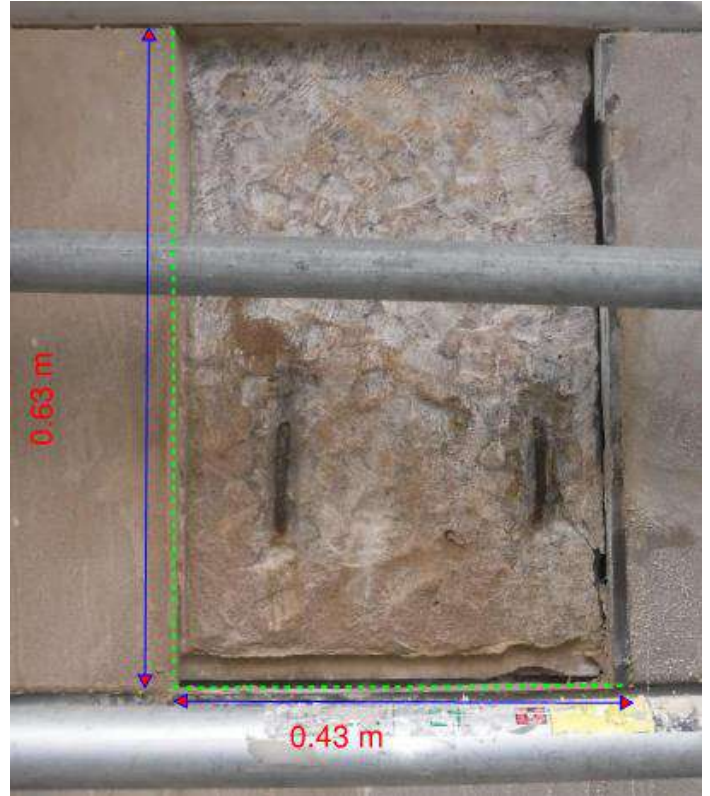
- 1) Fully bonded panels – 0.27m² of sandstone facing took about 30 min to remove during the structural investigation.

Extrapolating, to remove 1 m² of sandstone facing would therefore take approx.. 110 min.

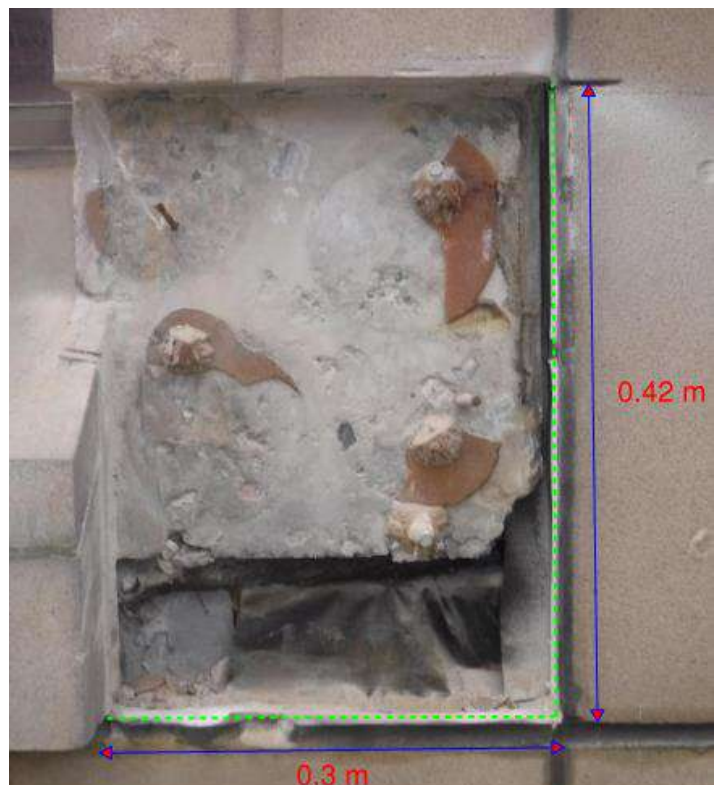
- 2) Previously Pinned Panels – 0.126 m² of sandstone facing took approx. 1 min to remove during the structural investigation.

Extrapolating, to remove 1 m² of sandstone facing would therefore take approx.. 8 min.

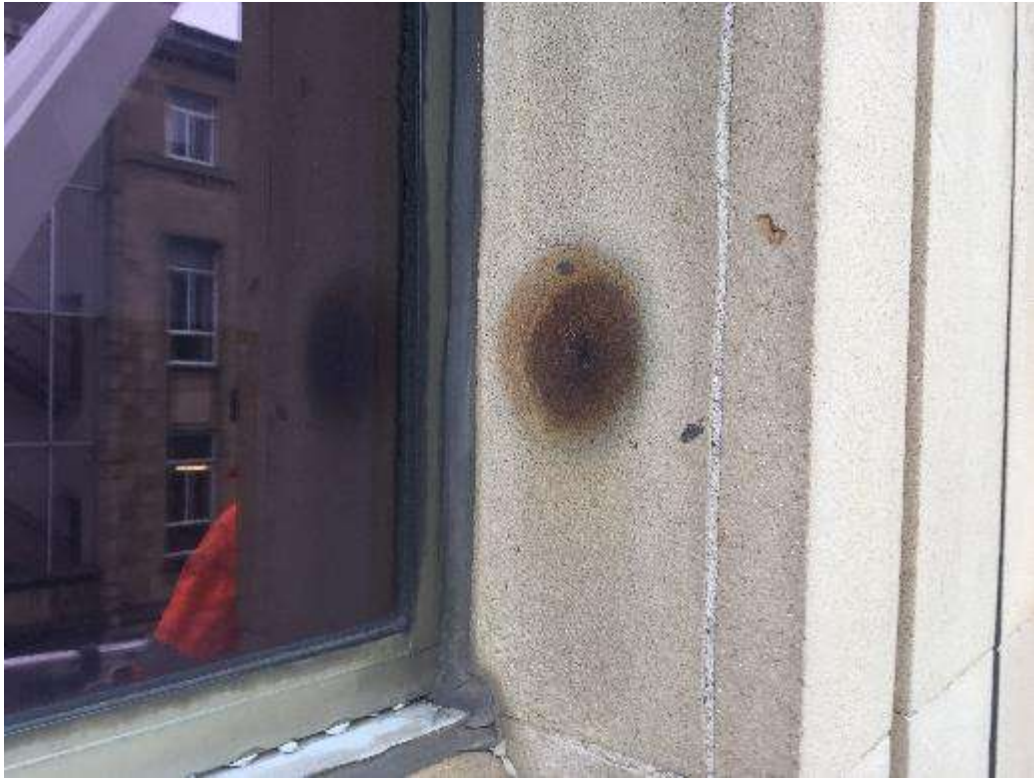
- 3.06 There is local circular discolouration of the surface of the sandstone (Photographs 1 and 2) Although there was no evidence of pinning at these locations, it is possible that a non-visible ferrous element could be corroding.
- 3.07 Panels were tapped to assess the fixity of the panel to the main load-bearing walls. Locally, where there was visible pinning, some of the panels sounded bossed (hollow). Panels with no visible pinning or remedial works were also tapped and generally appeared sound, however panel (6/6) on the Blythsewood Street elevation sounded boss, with no visible remedial pinning.

Photograph 1 Example of local discolouring

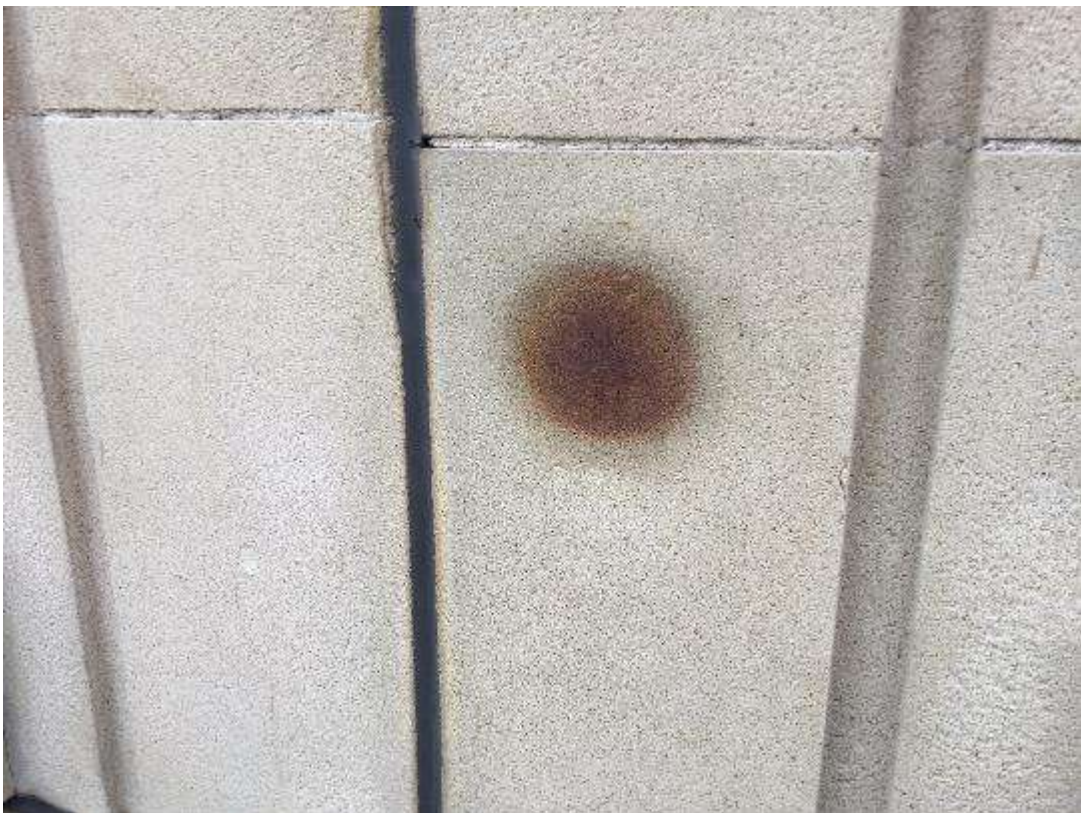
Photograph 2 Example of local discolouring

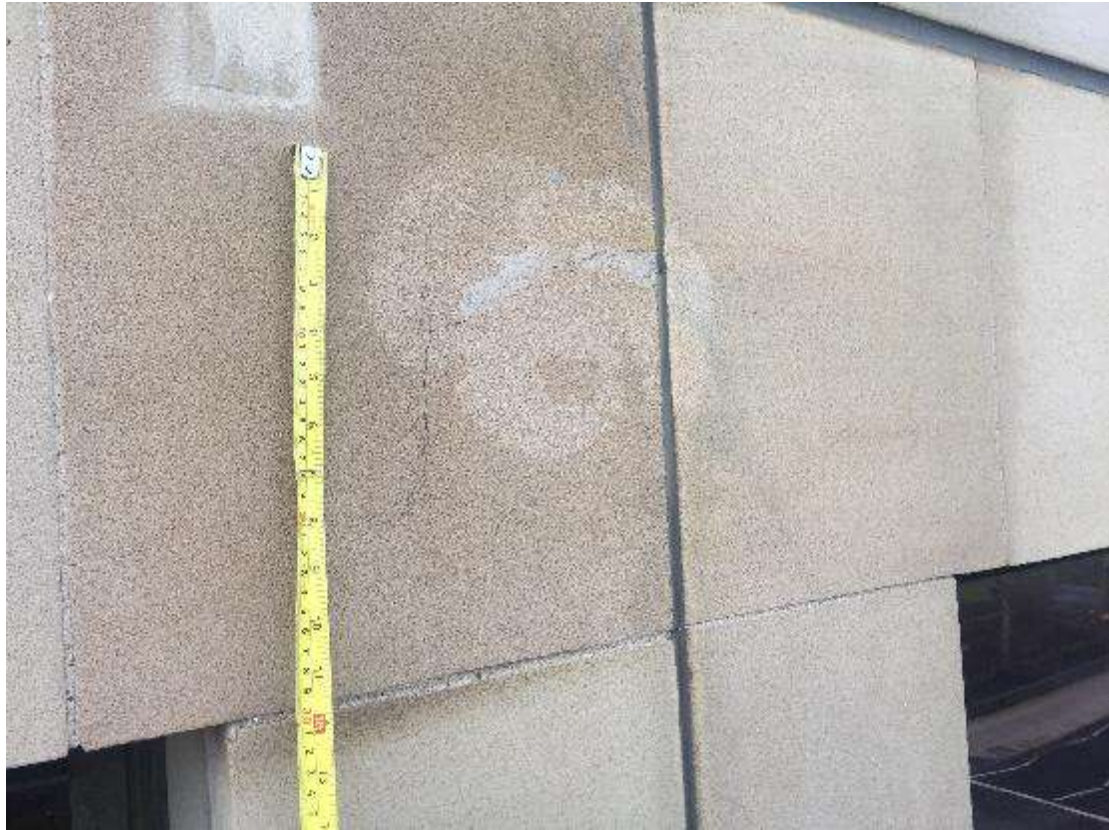
There are a number of cracks which have either occurred in the period since the last inspection or have been repair but since deteriorated (see photographs 3,4,5)
- 3.03 As per point 3.02, there are a number of additional cracks in the cills which have either subsequently formed since the last inspection and have not been repaired, or have been repaired and increased in size.
- 3.04 There is some surface weathering of the sandstone facing at high level and, above the ladder feature, at pavement level on the Blytheswood Street elevation and on generally on the window cills.

Photograph 3 - Instances of cracking worsening

- 5.01 It is apparent that there has been some further deterioration of the sandstone facing since the last inspection. In the interim, new cracks and boss panels should be pinned.
- 5.02 The sandstone faced cladding units will continue to be a maintenance liability and "inspect, repair and patch" is, in our opinion, not an appropriate approach.
- 5.03 We recommend that the existing facings are stripped off; the reinforced concrete repaired and coated; and a new rainscreen cladding system installed. This is likely to result in the replacement of existing windows and will also require consent from the Planning Authority. The structural capacity of the reinforced concrete elements will require to be checked with respect to the installation of the rainscreen overcladding

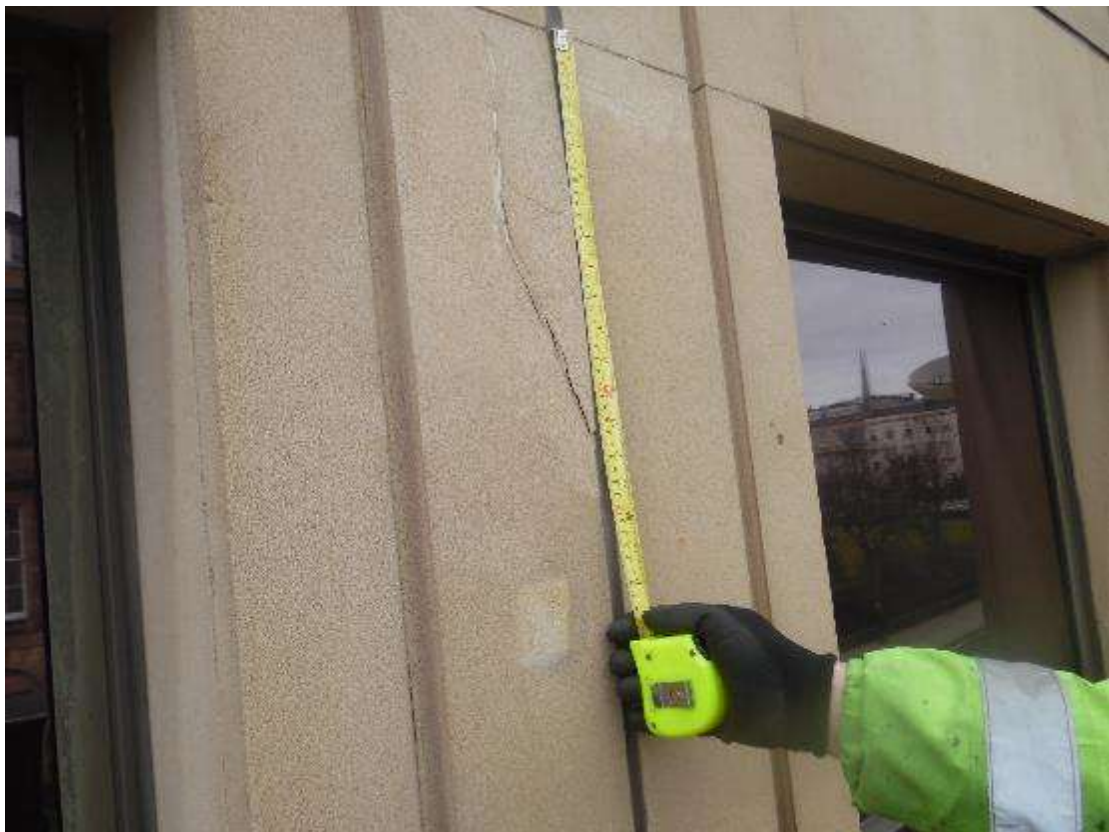
Photograph 4 Example of crack worsening

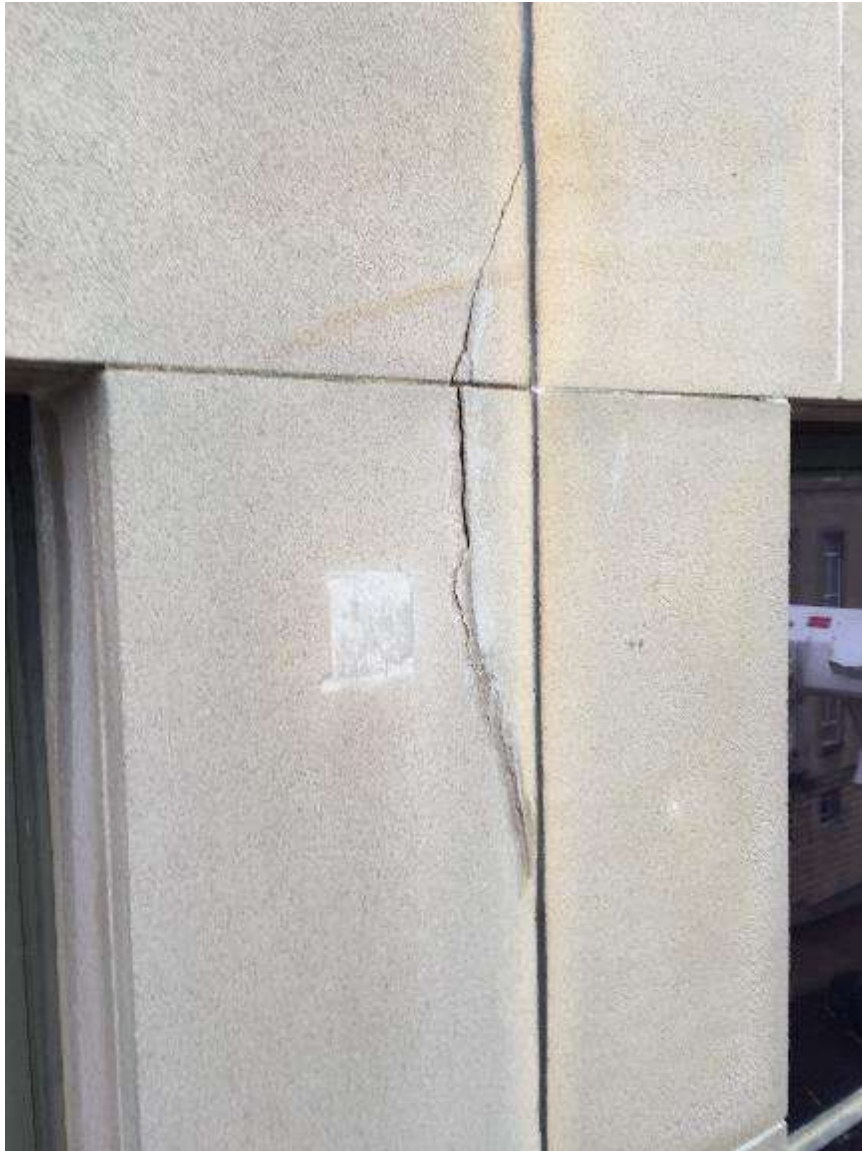
Photograph 5 New Cracking, Blytheswood elevation panel 5/7

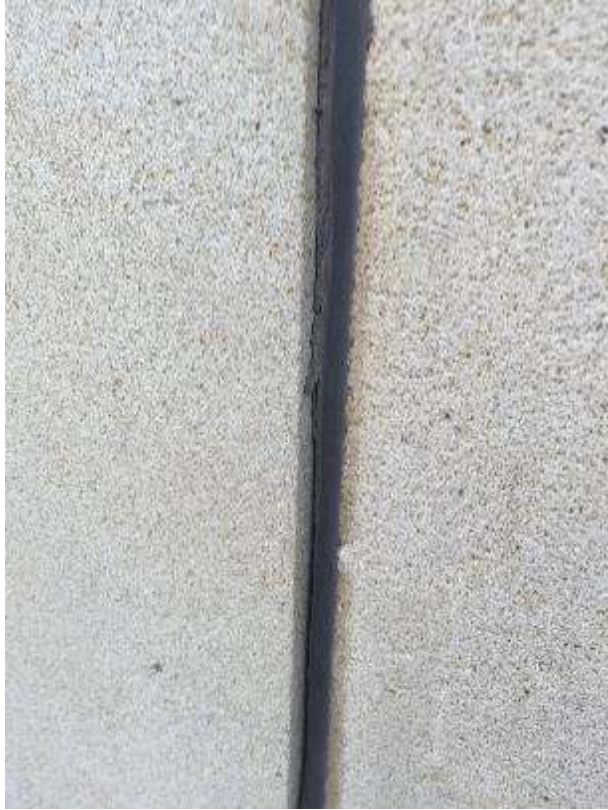
Generally speaking, at the upper levels the facing sandstone is generally weathered directly above and below the windows. (See photographs 7,8 and 9)
- 3.05 The mastic pointing to the panel joints is in reasonable condition, with only one or two areas requiring attention (see photographs 6)

Photograph 6 - Mastic Seal Broken (Panel 4/7, Blytheswood Street elevation)

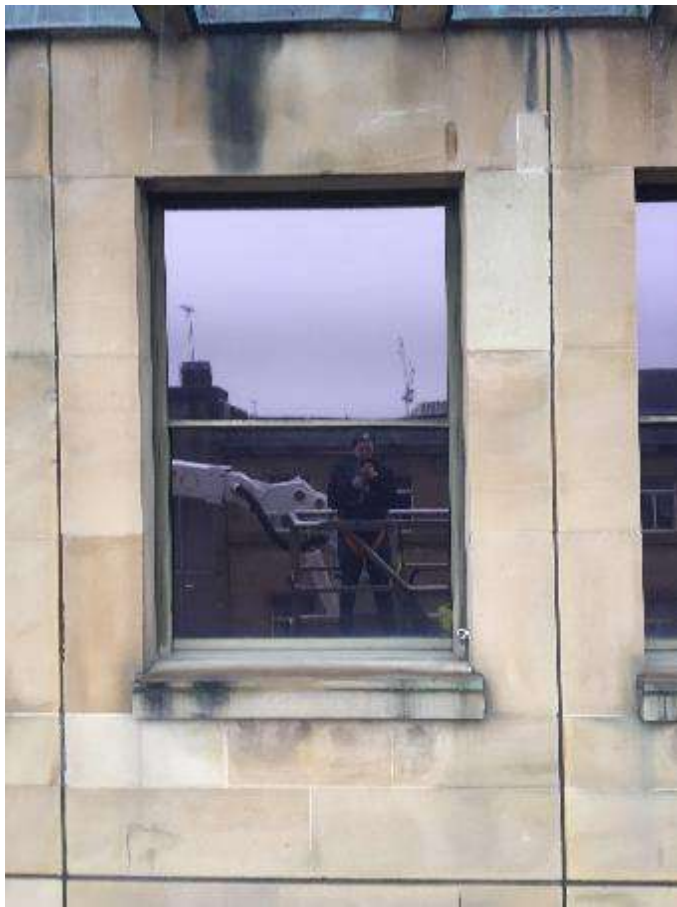
Photograph 7 - General Weathering Pattern

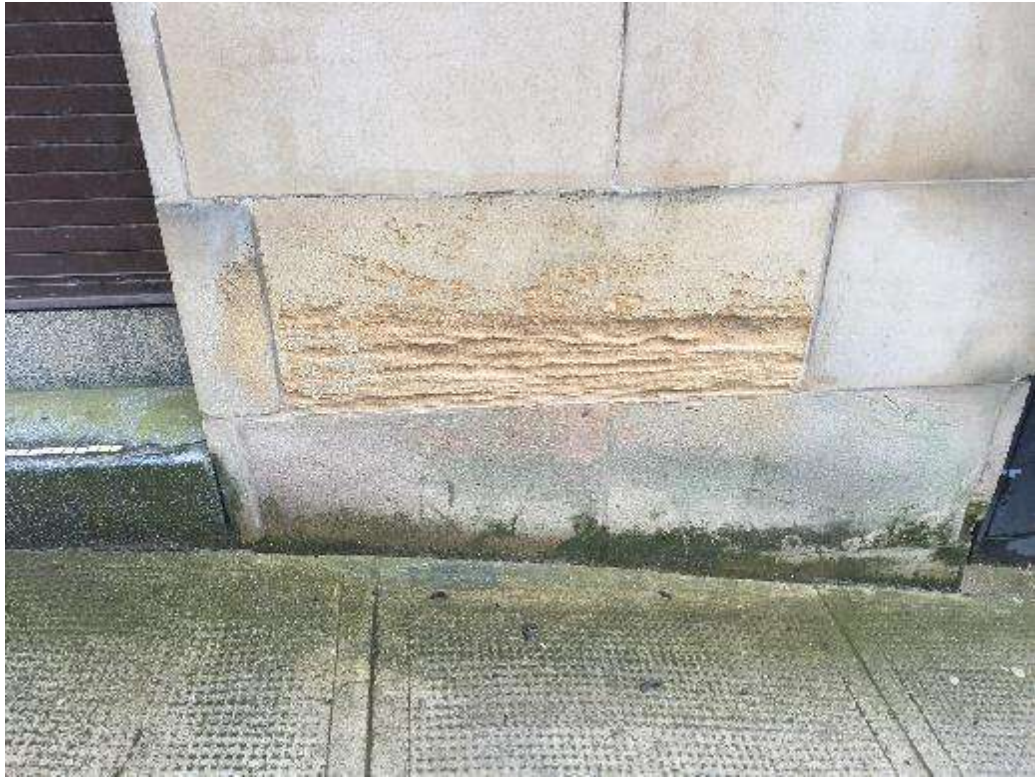
Photograph 8 - General Weathering - Ground level facing

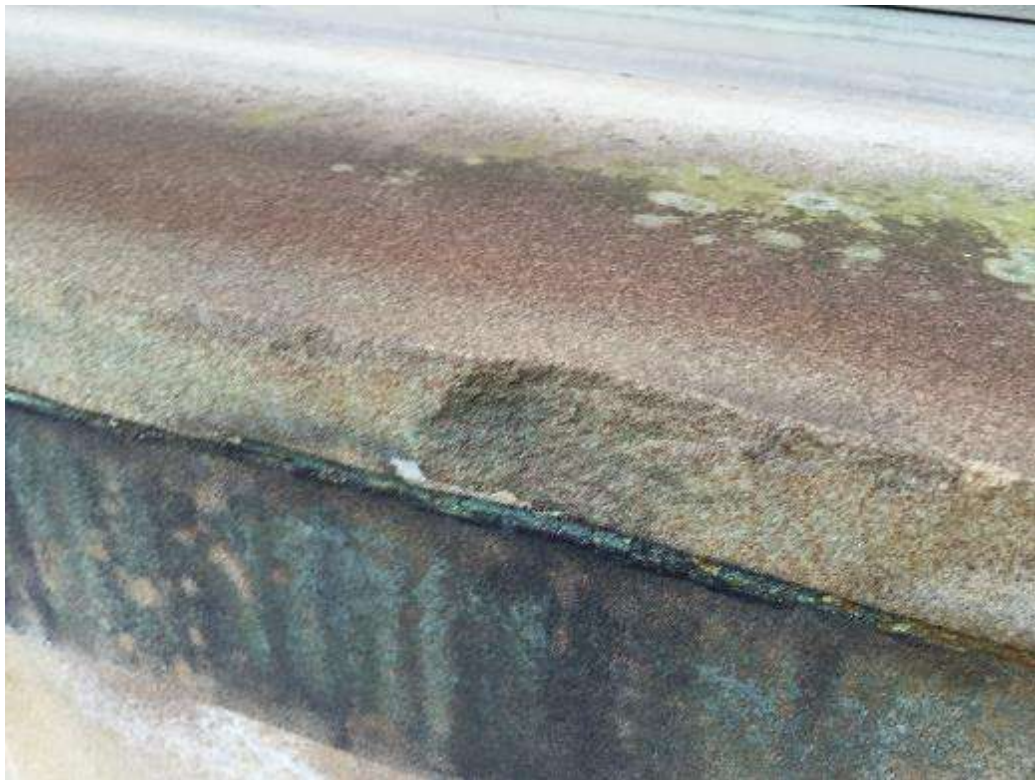
Photograph 9 Cill Weathering and spalling

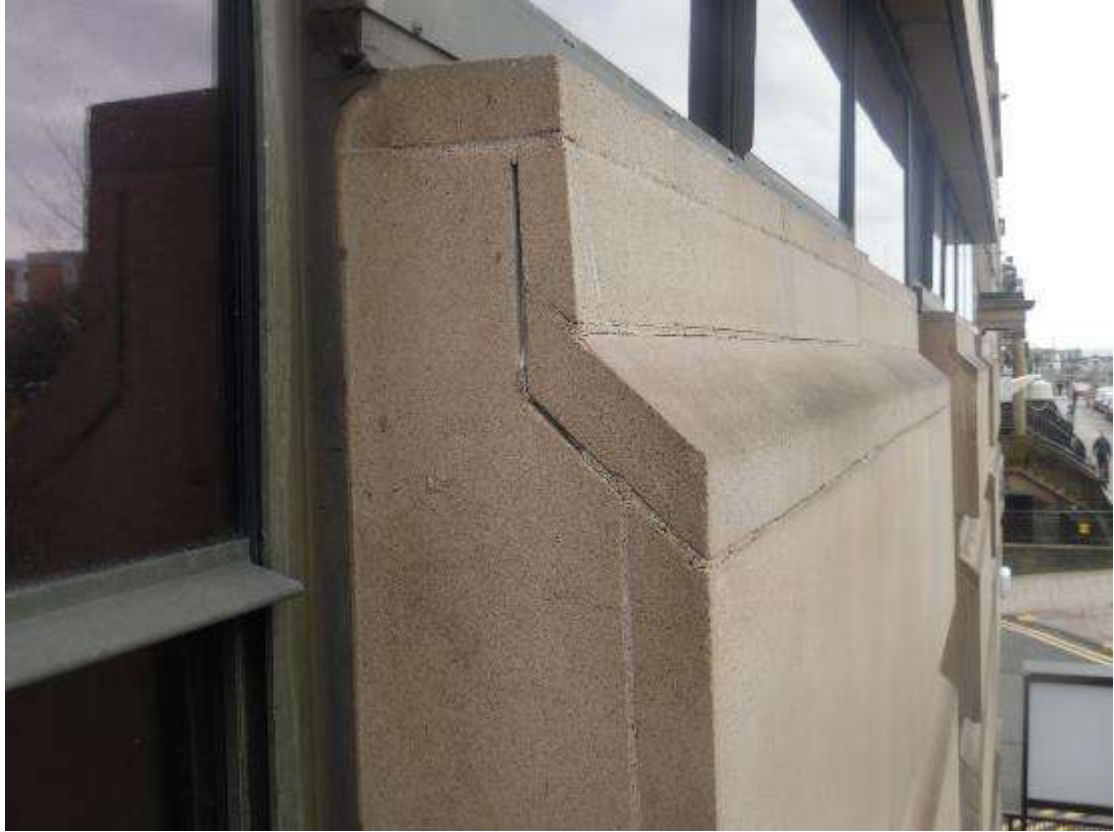
Photograph 10 Pointing on panel 3/9

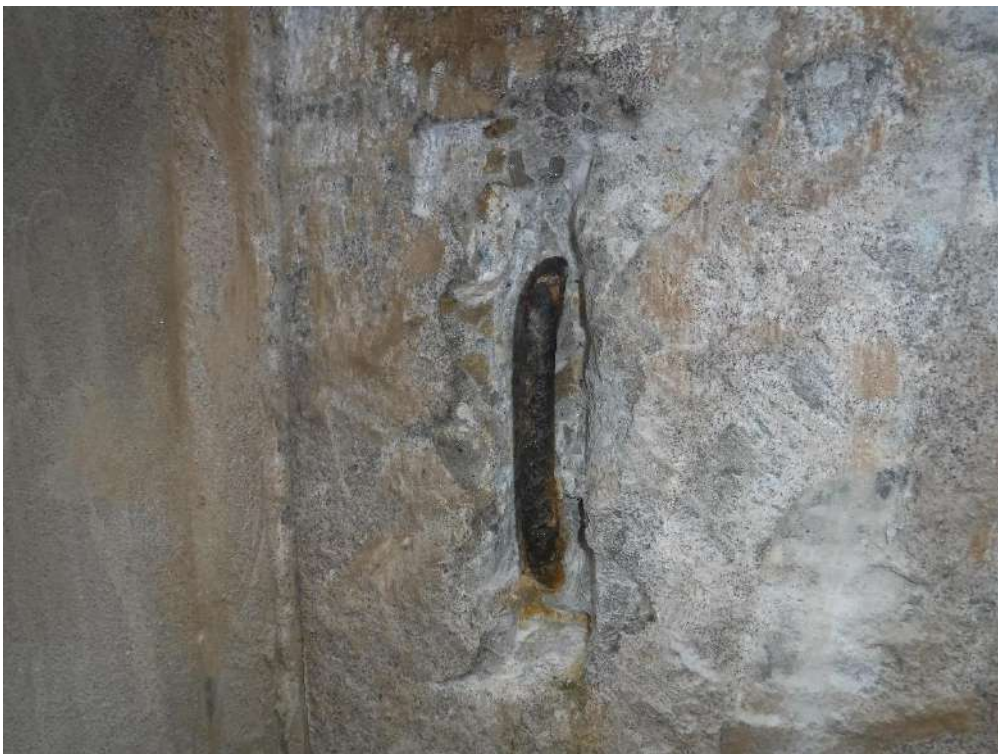
Once the sandstone had been removed a pair of corroding reinforcing bars were observed. These bars had zero concrete cover. It is considered highly likely that expansive reinforcing bar corrosion of the bars within the backing concrete has been the cause of the historical detachment problems.

Plate 4 – Showing a close up view of Bottom Panel Bar. Bottom Left Corner.

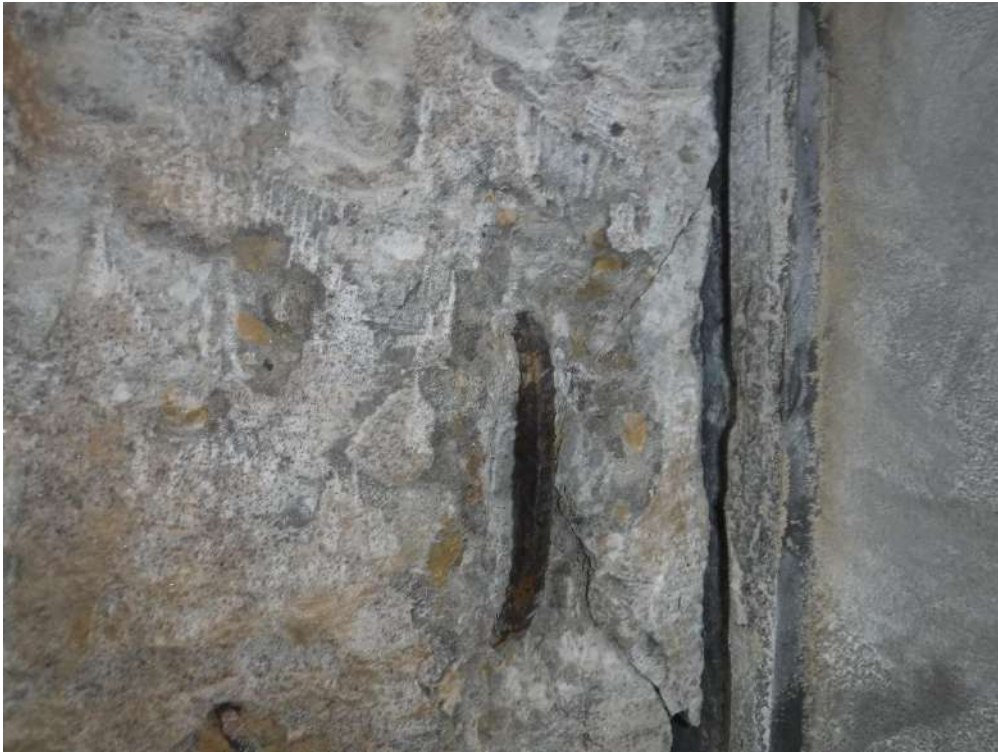
Plate 5 Showing a close up view of Bottom Panel Bar. Bottom Right Corner.

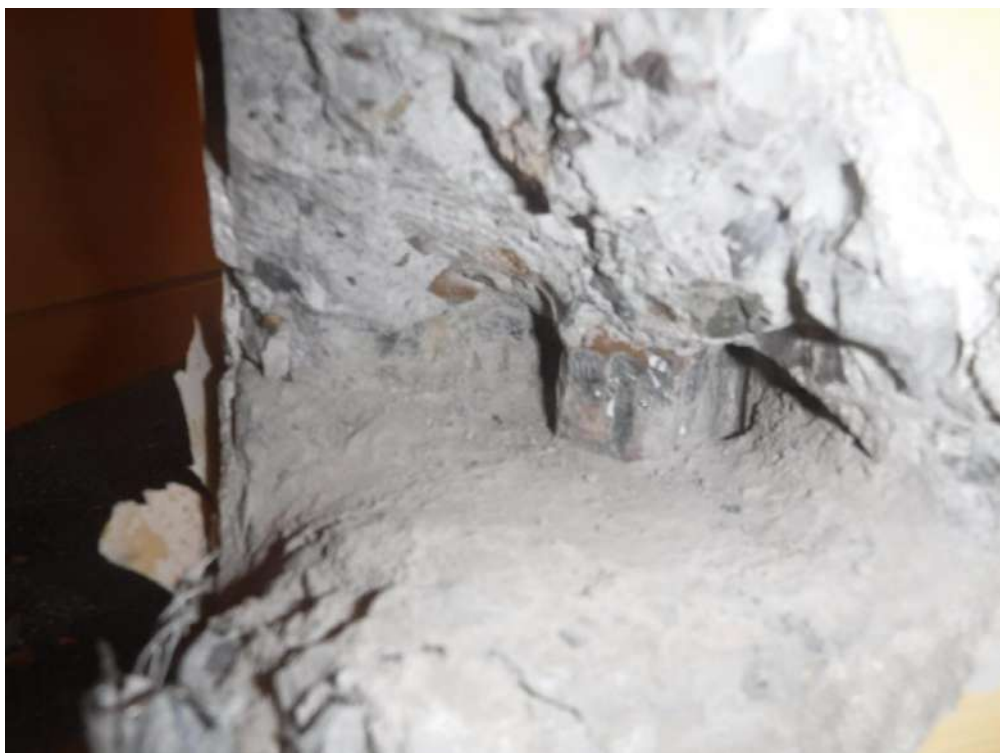
Location: Column base 1st floor (internal column)
Main (vertical) Reinforcement Exposed: 1 No. Square twisted bar, Section = 31mm
Main Reinforcement Cover = 75mm (excluding plaster)
Link Reinforcement – not exposed
Link bar spacings at 375, 260, 295 C/C
Slight surface corrosion, no loss in section

Plate 14 – Showing a close up view of breakout B/O1.
