## SMERRILL FARM CONDITION REPORT

Smerrill Farm is a cottage approx. 940 sq ft.

Built circa 1890

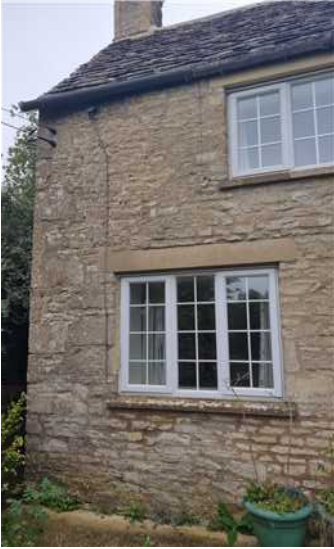
West elevation where proposed extension will abutt

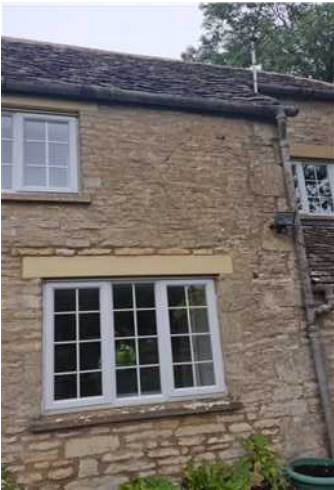
Some Broken pointing on West elevation

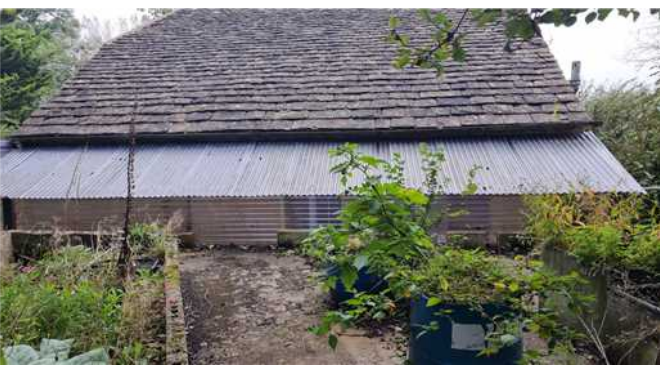
East elevation, roof only exposed. Rest covered by the plastic roof sheets

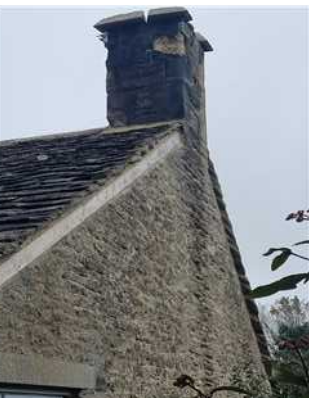
External natural stone pointed in mix of lime and cement mortars. Generally in good condition although stone heads have been replaced, some repointing and the chimney is severely decayed with broken masonry. There are a few minor cracks in the masonry.

North elevation masonry well pointed but chimney showing severe degradation

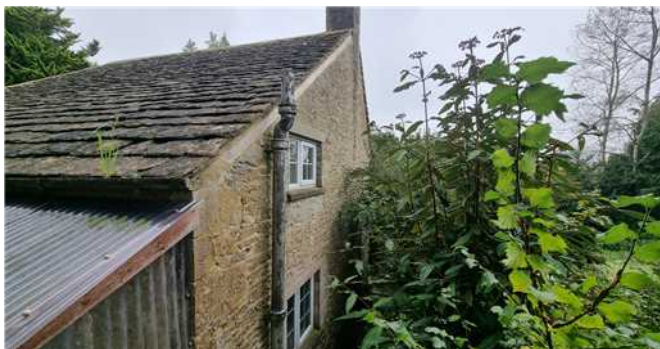
North Elevation. Pointing in good condition

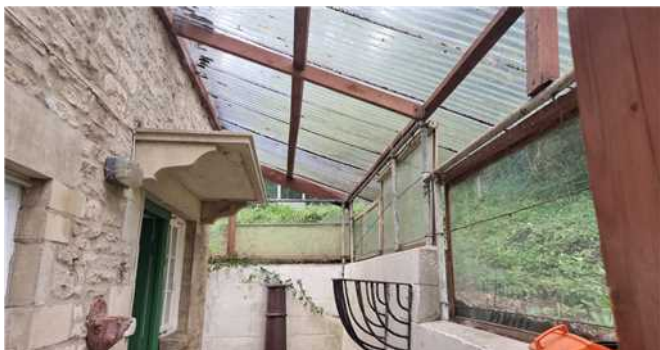
Covered area South Elevation

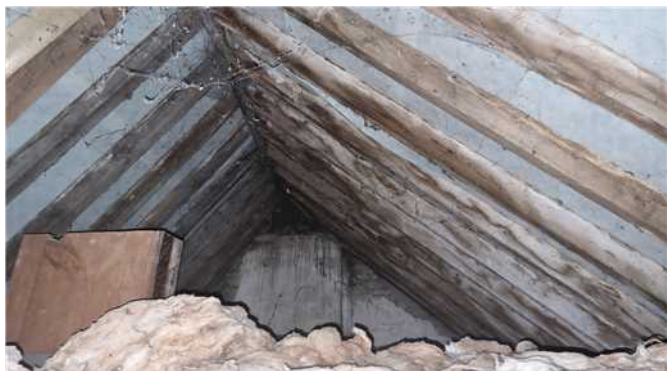
Main loft

Attached are photographs of the loft. No obvious signs of bat droppings on the insulation.

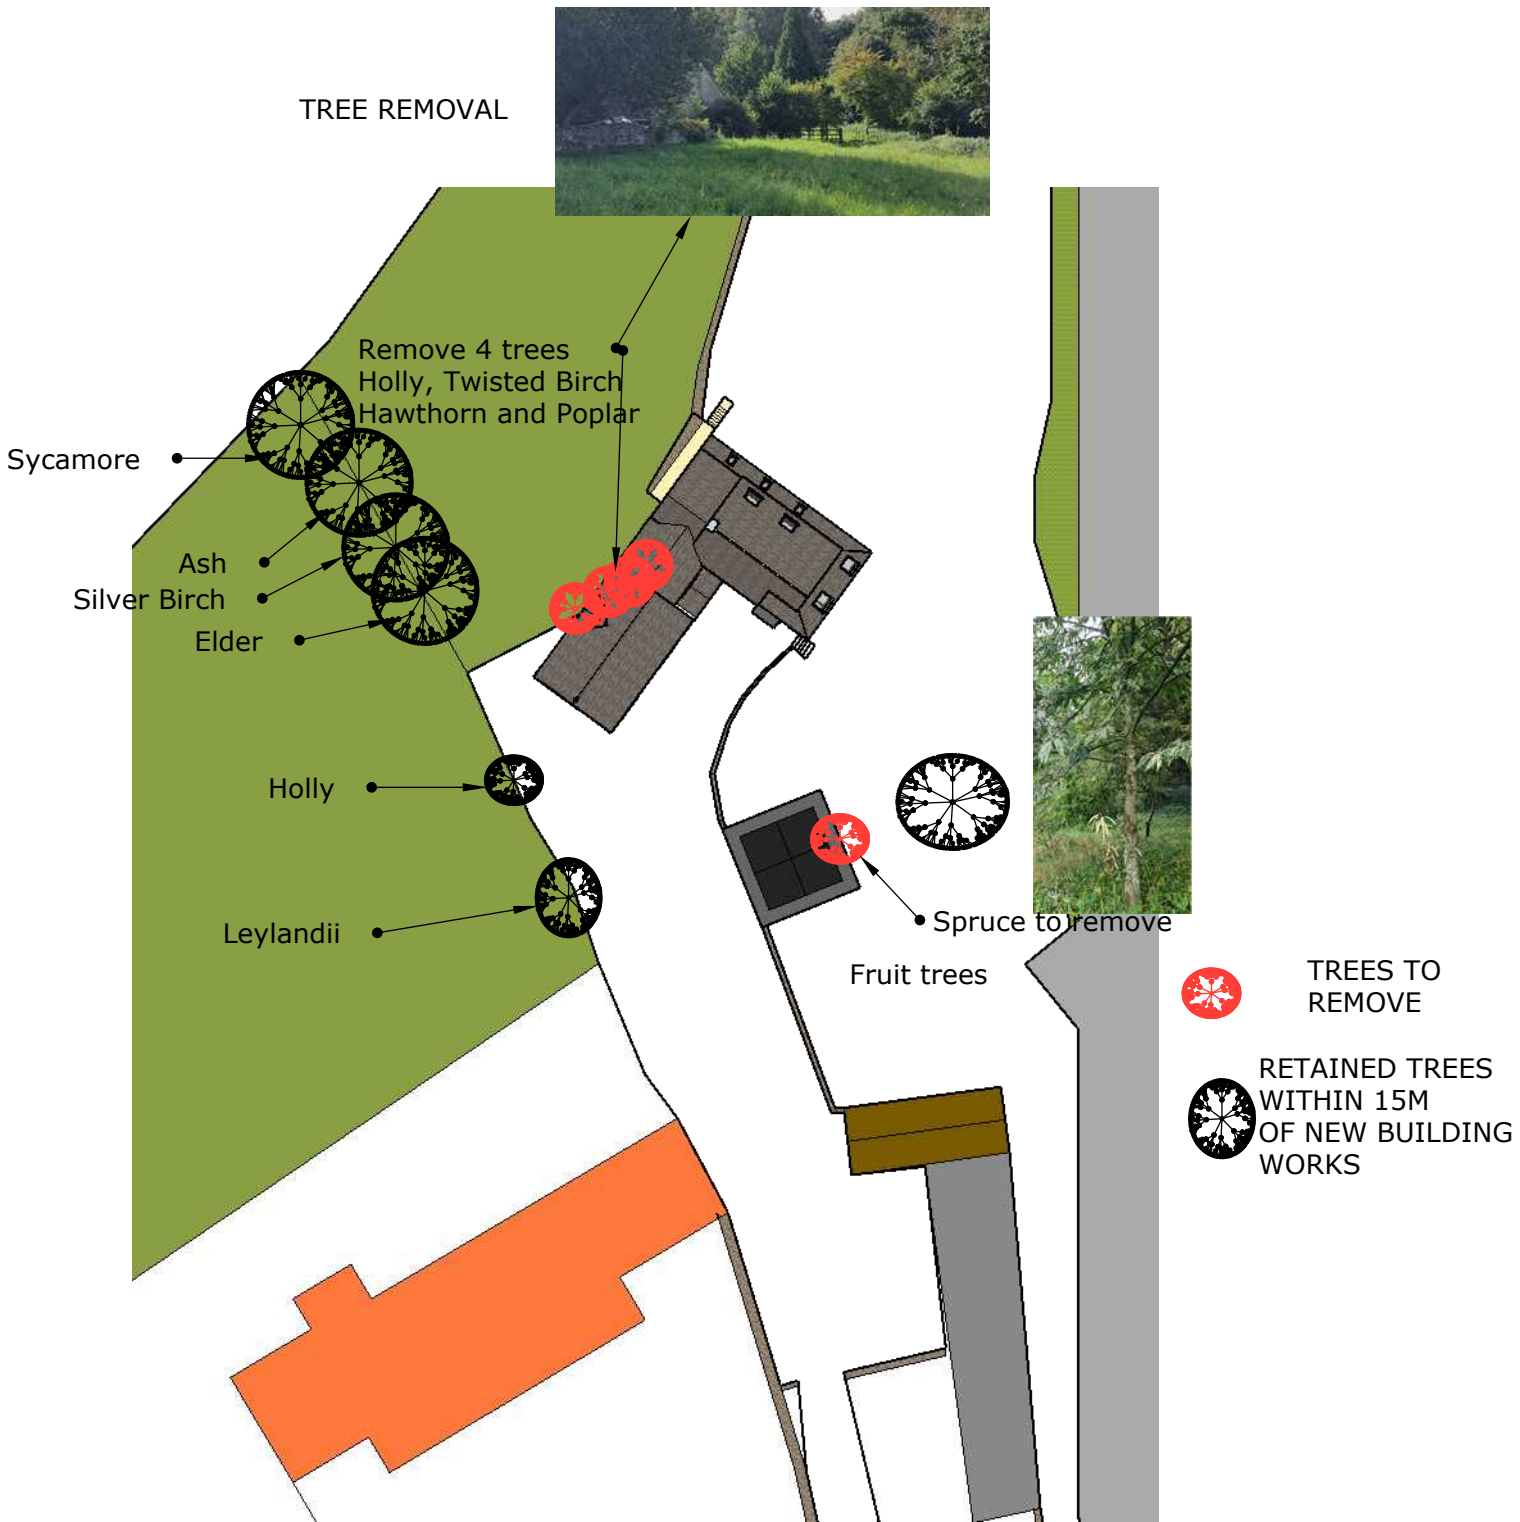
Drawing identifying trees within 15metres of extension and trees to be removed for works. All trees to be removed are young and immature
