Condition Survey of Barn off Elvington Lane York

Introduction

Tidworth Consultants were appointed to carry out a visual condition survey of the barn off Elvington Lane, York

The survey took place on Thursday 30th June 2022

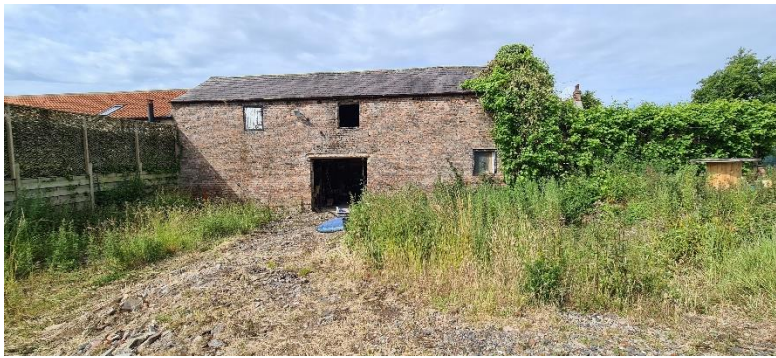
Pic 1 – Rear Elevation

The rear elevation has a large opening at ground floor level, with a steel beam exposed. There are 2 windows and 1st floor level. One is boarded up and the other is open. The window to the right has some brickwork/lintel missing from the head.

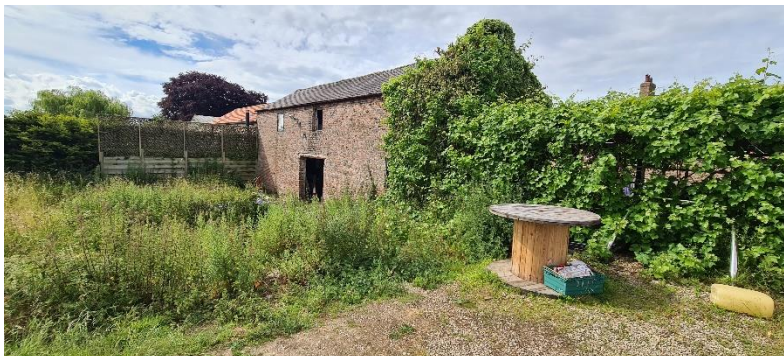
Pic 2 – Gable Elevation

As there is ivy on the gable end, inspection of the external brickwork was not able to be undertaken.

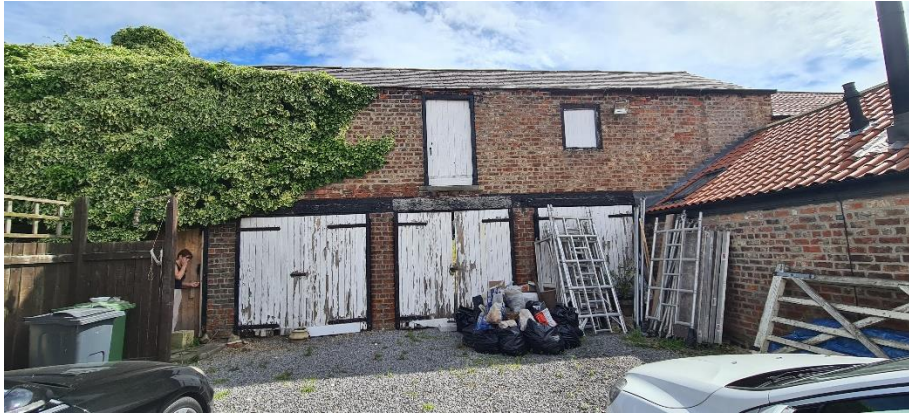
Pic 3 – Front Elevation

The front of the property has exposed brick, with the left part of the barn, and gable end, covered in Ivy.

There are 4 doors on the front elevation at ground floor level, 3 large double doors and one single door, to the left. All the doors were weathered and needed to be replaced. There are large timber beams over the large doors. The left hand beam has signs of damp and rot while the centre and right hand beams were structurally sound.

At first floor level, there is a door and window. The window opening has been boarded up.

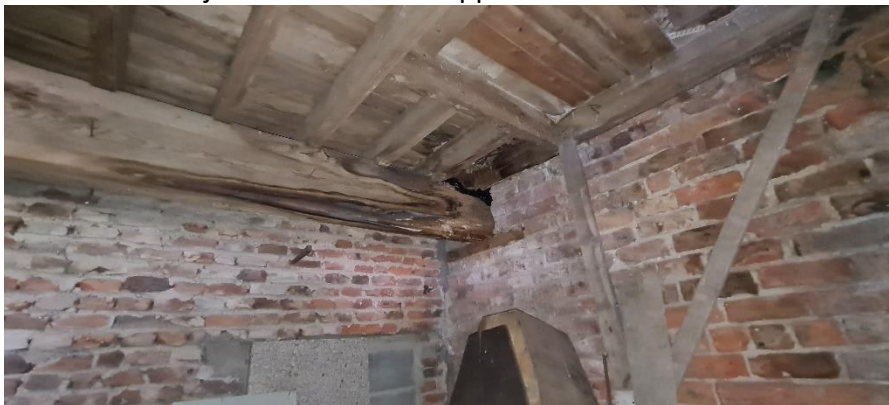
Pic 5 – 1st floor joists and timber support

The ground floor, floor was a mixture of concrete and timber. The ceiling joists (1st floor, floor joists) didn't show signs of rot or damp, with the exception of the front right hand section shown in pic 5 below of the joists and timber beam support.

There are timbers running front to back, supporting the 1st floor joists. These are in good condition, with the exception of the front right hand side, pictured in pic 5 above. These timbers are sat on brick piers which do not show any signs of being structurally unsound. Pics 6-8 below show the first floor timber supports and the piers.

The first floor, floor joists are adequate for a typical residential house loading. The timber supports that aren't affected by damp, can remain in situ, as long as not additional loads are implied. The timbers affected by damp will need to be replaced.

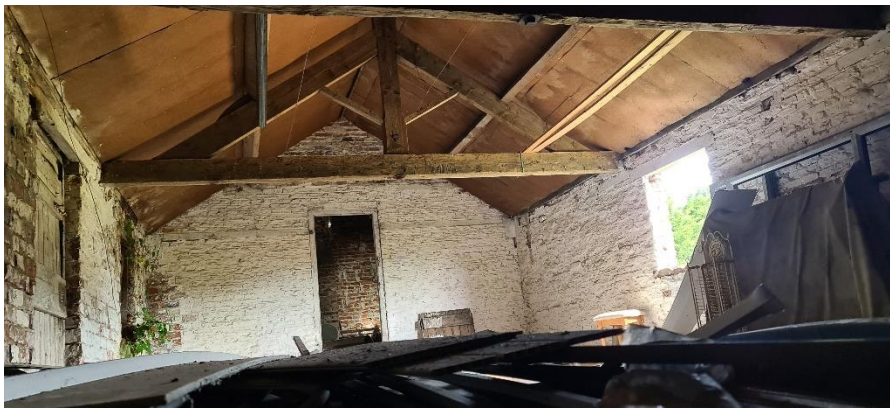
Pic 9 – External walls and trusses

There weren't any visual cracks or signs of structural issues.

A timber wall plat was visible where the roof pitch met the brickwalls This didn't show any signs of damp or rot.

The trusses didn't show any signs of damp, rot or structural instability.

The roof will need to be removed and replaced with new rafters throughout, to accommodate the new element of the proposals. It is assumed that the original trusses are to be removed.
