Subsidence Management Services

ENGINEERING REPORT

Name of Engineer: Peter Moore MCIOB Dip CII (Claims)
SMS Reference: IFS-ESU-SUB-16-0062003
Name(s) of property Owners: Mr Grant Fidler
Address of Property: 2 Elmgrove Close, Woking, Surrey, GU21 8XL
Date of Report: 05/01/2018

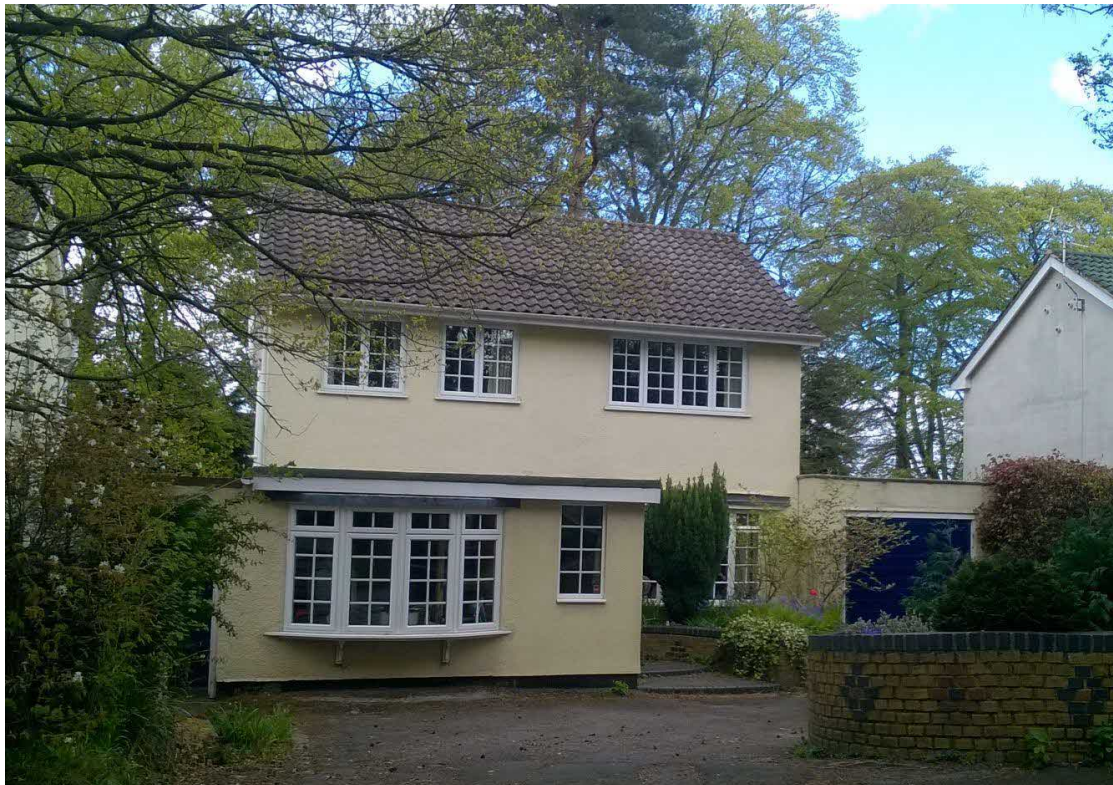
Figure 1 – The property with vegetation to rear.

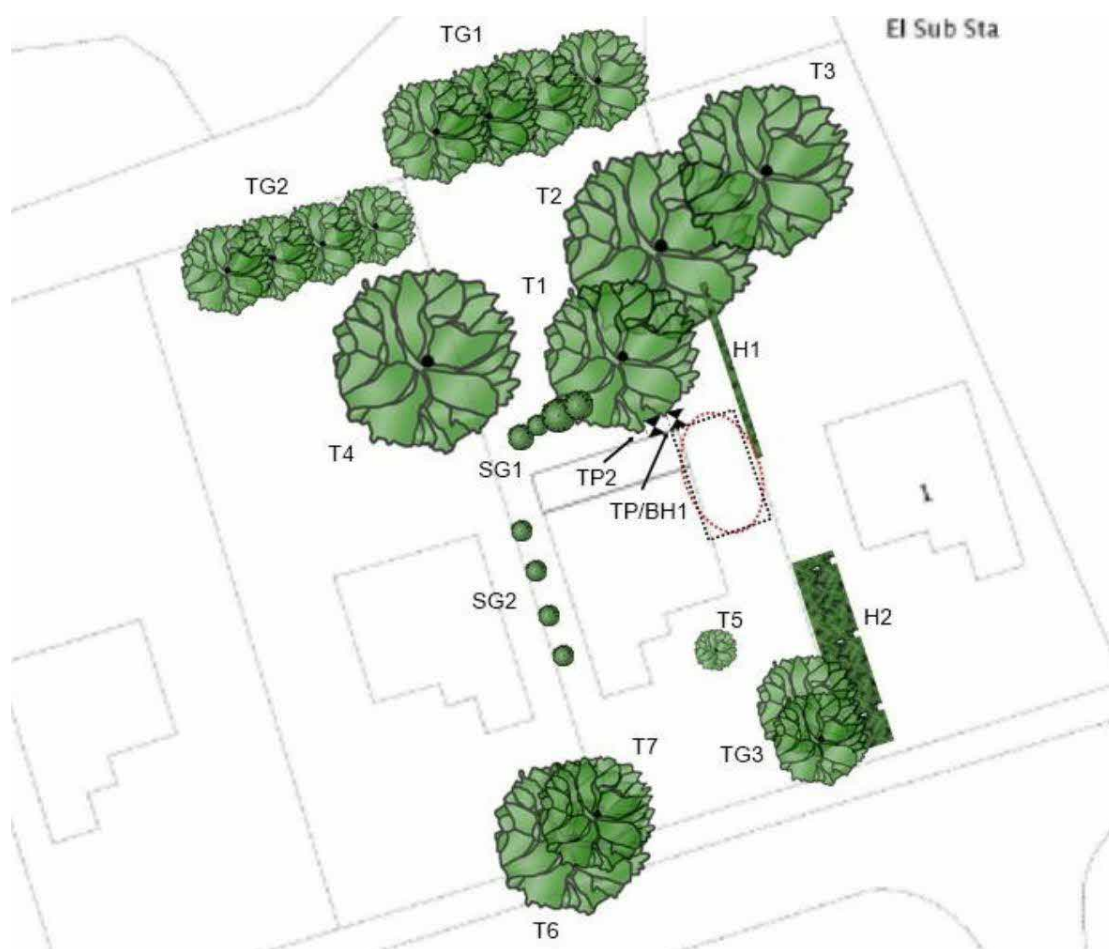
Figure 2 – Sketch taken from Environmental Services survey showing location of the principal vegetation in relation to property at the time the damage occurred.

Given its size, proximity and the presence of *Fagus* roots in the subsoil, the Beech tree (T2) is the most likely explanation for the seasonal movements recorded at the rear of the property. However, given the size and close proximity of the Pine (T1) this tree cannot be discounted as a contributory factor to the damage; despite roots from this tree not being recovered from the geotechnical investigation.

If both the Beech (T2) and the Pine (T1) are not removed, it will be necessary to underpin the property to prevent a recurrence of the damage. The only possible and effective scheme is likely to be a piled raft scheme given the depth of the roots from T2. The cost of the scheme is likely to be in the region of [REDACTED] exclusive of VAT, professional fees and ancillary costs.

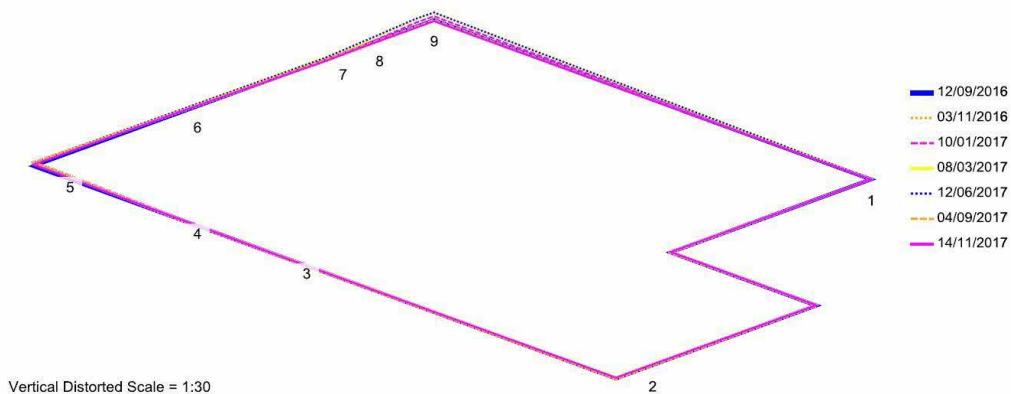
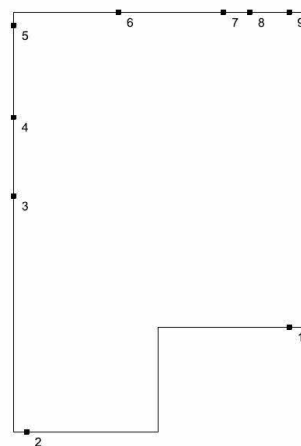
FRONT

Level monitoring was set up in September 2016. Readings have been taken at approximately 8 week intervals. The current results are up to and including the 14th of November 2017. The monitoring results, which are presented in below, show that the property is affected by seasonal downward movement at the rear right corner of the 1980s extension; particularly at point 9.

Figure 4 – Monitoring location positions

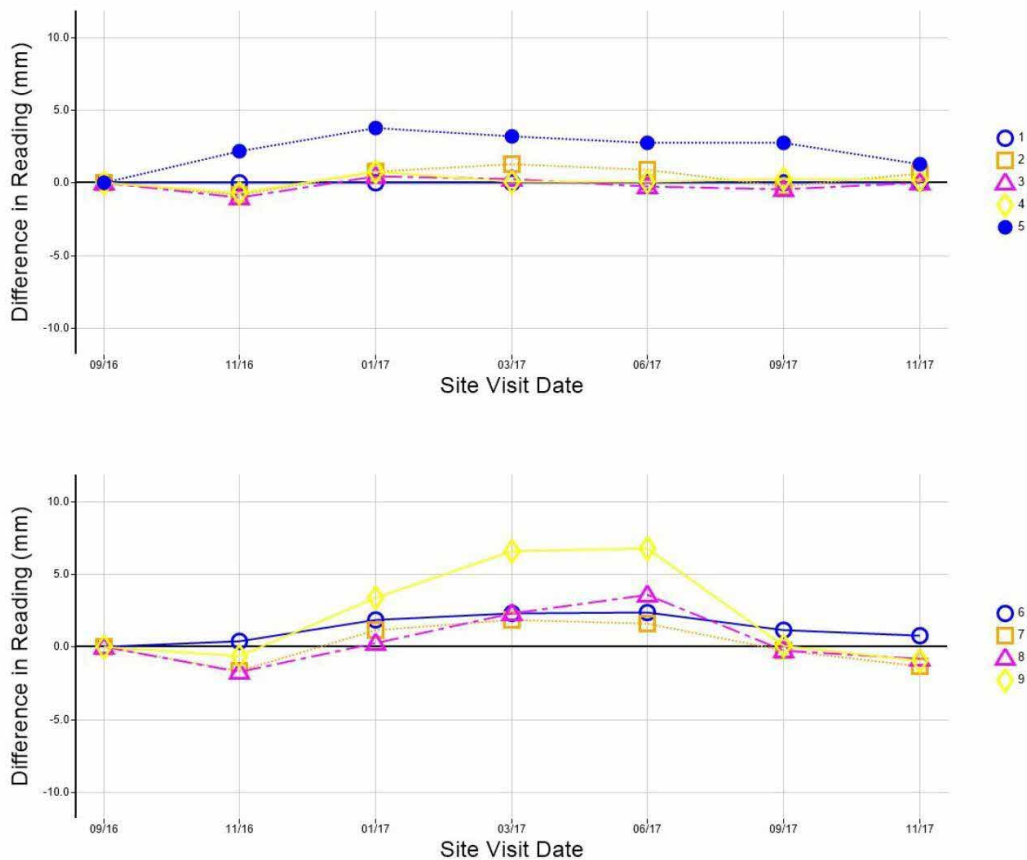
Figure 5 – Level monitoring results.

The monitoring results (*Figure 5*) clearly indicate an unacceptable scale of seasonal foundation movement of the property. Movement is most pronounced at the rear right corner of the 1980s extension at point 9 which is in close proximity to the position of the Pine (T1) and Beech (T2).

The level monitoring has confirmed that the foundations are moving seasonally and with greater movement at the rear right corner of the 1980s extension, closest to the Beech (T2) and the Pine (T1).
