Site Investigation Report

129960.2.ICC

Client	Sedgwick
Client ref	9255790
Visit date	15/07/2022
Report date	15/07/2022

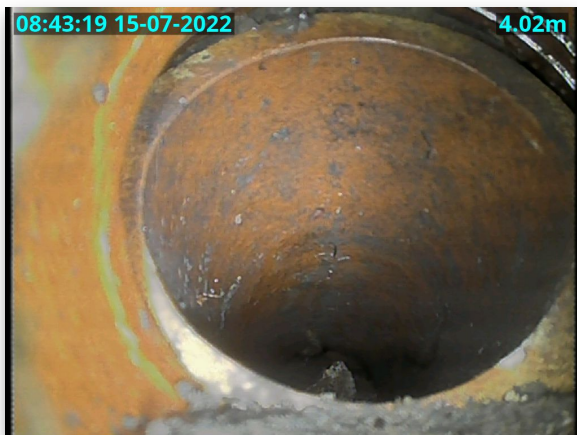
Fig 1.1: Line 2

Our survey of line 2 revealed joint displacements (see fig 1.1-1.2).

The above mentioned defects to the below ground drainage system have been caused by ground movement.

Sonde, excavate and replace 1m of 100mm pipework approximately 0.5m downstream of RWP1 at a depth no greater than 1.0m through paving slabs. We need to perform high pressure jetting of the drains before installing 4m of 100mm flexi-liner directly downstream of the excavation.
