21 Freeman Avenue
Henley
IPSWICH
IP6 0RZ

INSURANCE CLAIM

CONCERNING SUBSIDENCE DAMAGE

ENGINEERING APPRAISAL REPORT

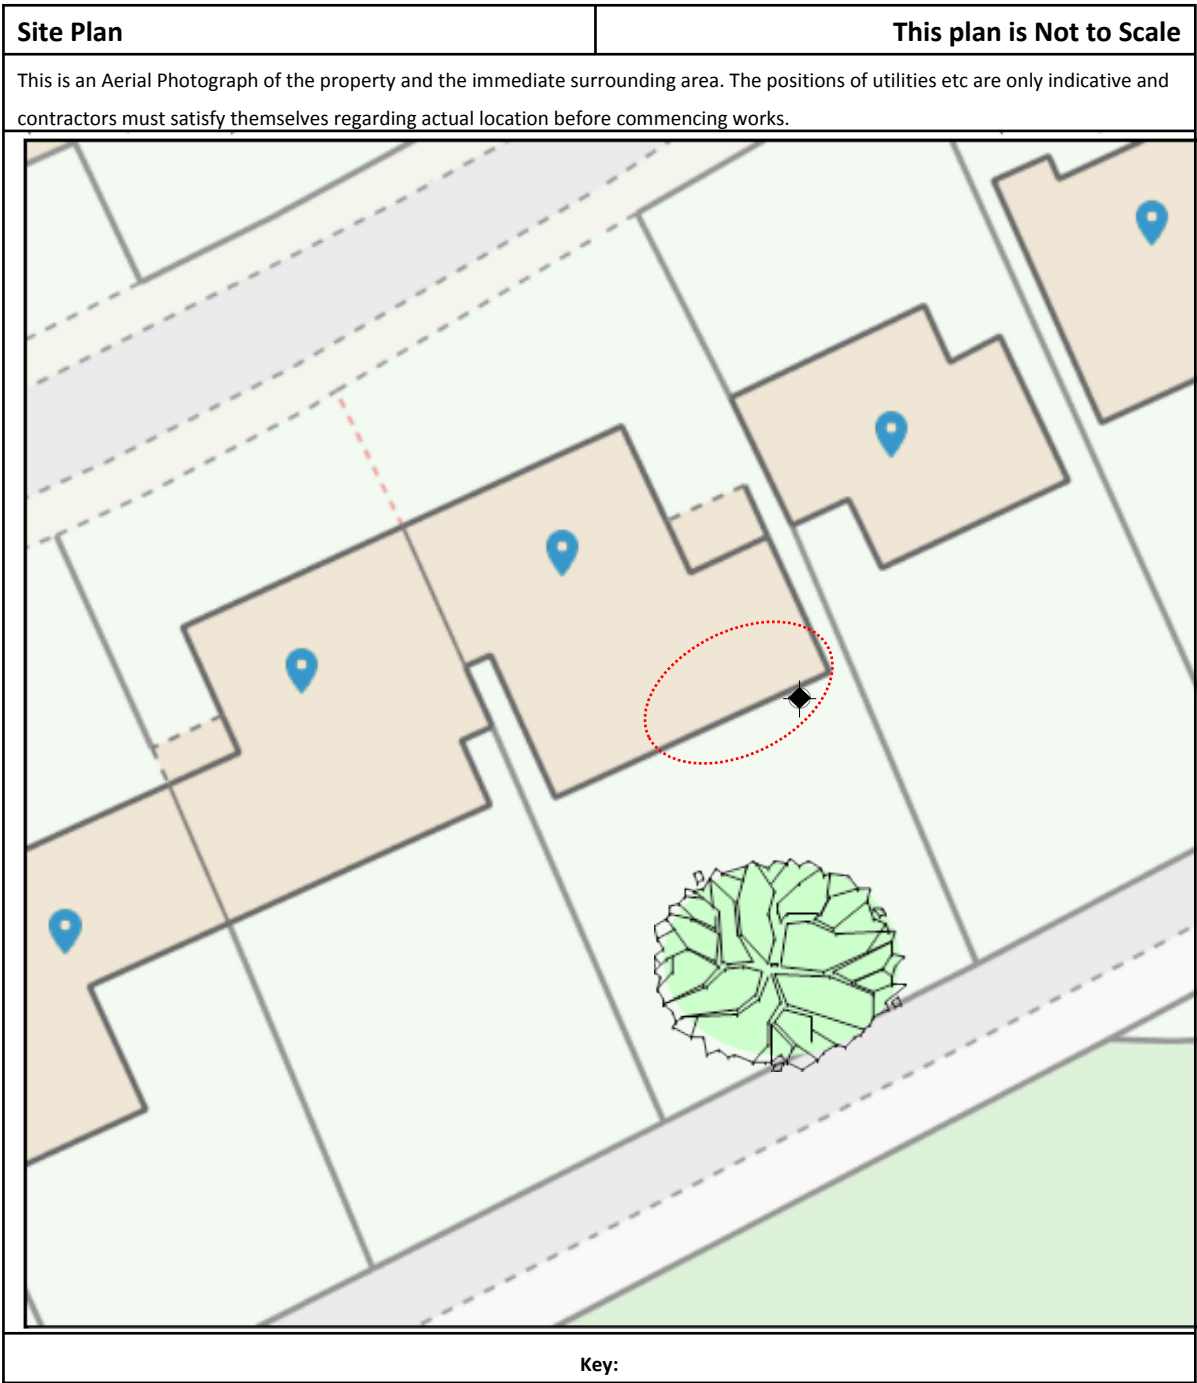
The subject property is a semi-detached bungalow, in a village location, on a plot that is level. The overall layout is recorded on our site plan:

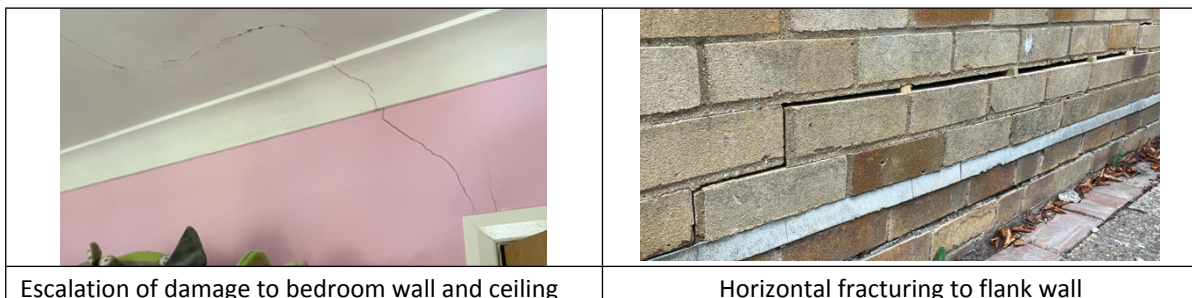
Aligned with vegetation related clay shrinkage subsidence claims the damage progressed during the summer / autumn months, as demonstrated by the level monitoring which is discussed later within the body of this report. In particular, there was an escalation in damage to the bedroom and flank wall as shown below.

In view of the escalation of damage in terms of both crack width along with additional rooms being affected we can conclude that the damage is Category 3 – Moderate. This conclusion being based on the fact that one fracture is above 5mm in width and that there are several fractures present, and this also defines the category of damage, as detailed in the extract from BRE 251 below;

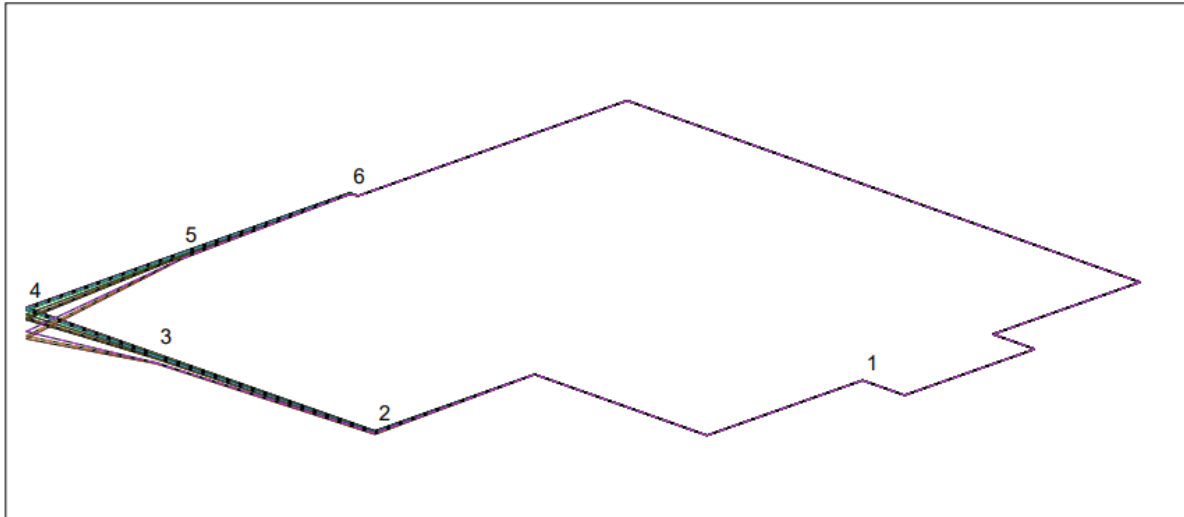
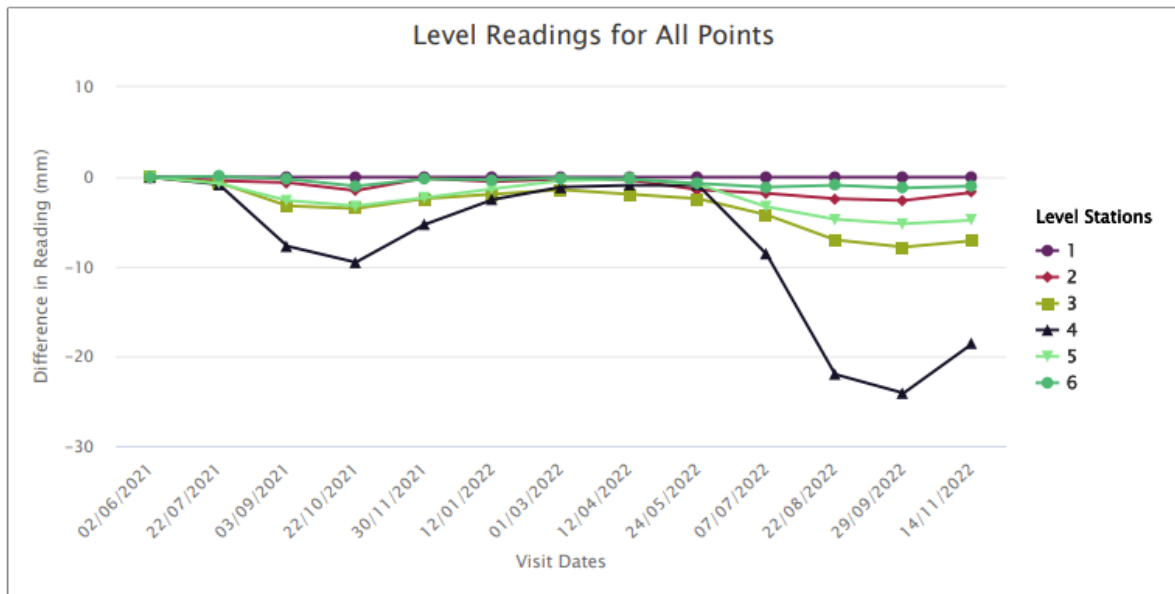
Level monitoring has been underway since June 2021. In summary, the results to date show downwards movement to the rear left-hand corner of the building over the drier summer months, and recovery (upwards movement), over the wetter winter months.

The greatest level of downward movement was recorded to station 4. Downward movement in excess of 20mm was captured on the 29th September 2022 followed by 5.5mm of recovery by 14th November 2022.

This pattern of movement is consistent with the operation of a clay shrinkage mechanism and confirms the dewatering effects of the Lime tree roots on the shrinkable clay sub-soil:
