Arboricultural method statement to install a root barrier.

October 3, 2023

POLICY HOLDER ADDRESS: 21 Freeman Avenue, Henley, Ipswich. IP6 0RZ
CLIENT REFERENCE: 9255790 / D141112170
OUR REFERENCE: 7423
PROJECT MANAGER: Spencer Caizley

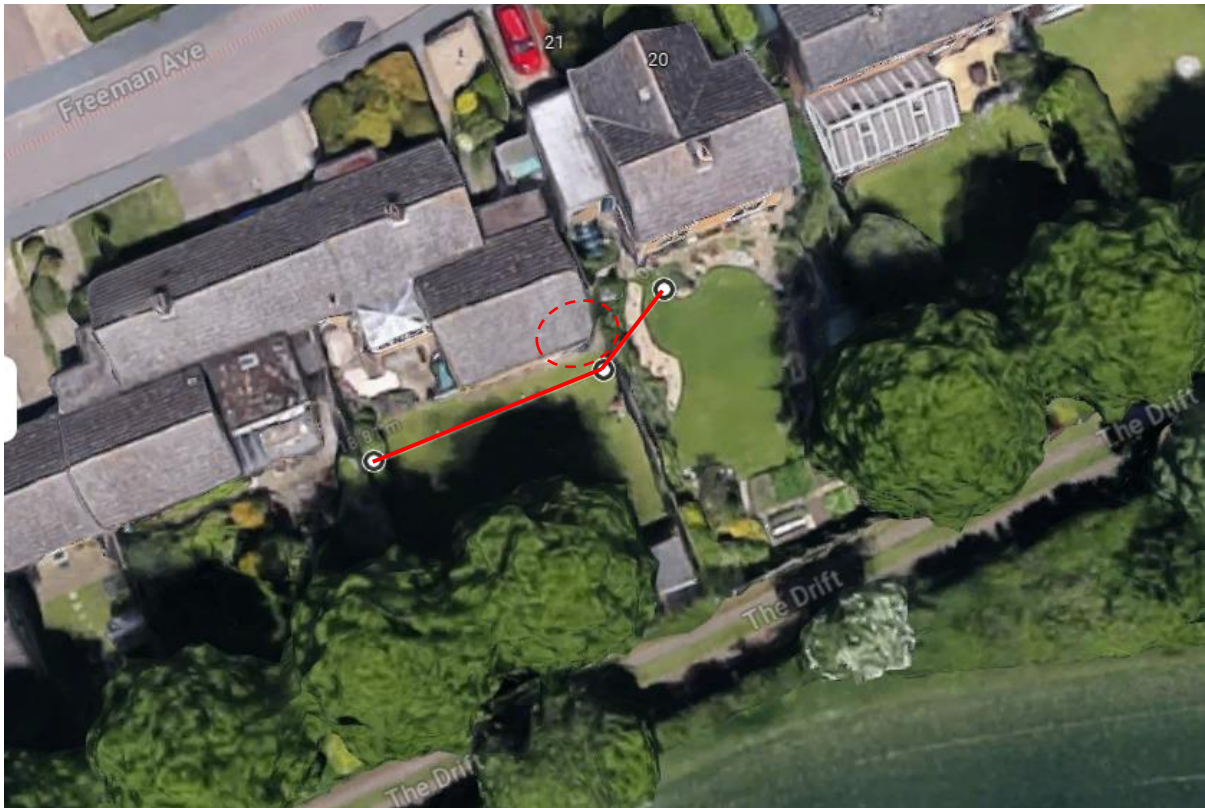
Aerial plan indicating proposed 20m length and alignment of barrier.

To be effective, we believe the barrier needs to be extended across the rear of both the risk address and the neighbouring property, number 20. The tree is large and seemingly located to the right-hand side of the risk address. If it isn't extended beyond the right-hand boundary, there is a risk it could be outgrown, and the property compromised. It is assumed for the purpose of the quote, that the neighbour will allow removal of S1 lilac which will we will grub out with the excavator as part of the works. Having reviewed the site, we believe the barrier needs to be extended into the garden of number 20 and will provide protection about the rear left hand corner, which is visually, the focus of the damage and this is confirmed with level monitoring.

It is believed that the distance between the Lime tree and bungalows is 7mm and to prevent damaging the tree, the barrier should be located as near to the properties as possible, so not to sever all the main roots of the tree. We envisage that the barrier will be around 2.0m from the bungalow and 5m from the lime tree. The barrier would be approximately 20m in length and positioned within soft landscaping. In order to carry out these works, a tree root severance application will be necessary, and this will be submitted to the local authority on authorisation. We have assumed that Sedgwick and the insured will liaise with the neighbour to obtain access and permission to install the barrier in 20 and access via the Drift should also be confirmed prior to start. We have provided the insured with our contact details if any further explanation or detail is required.

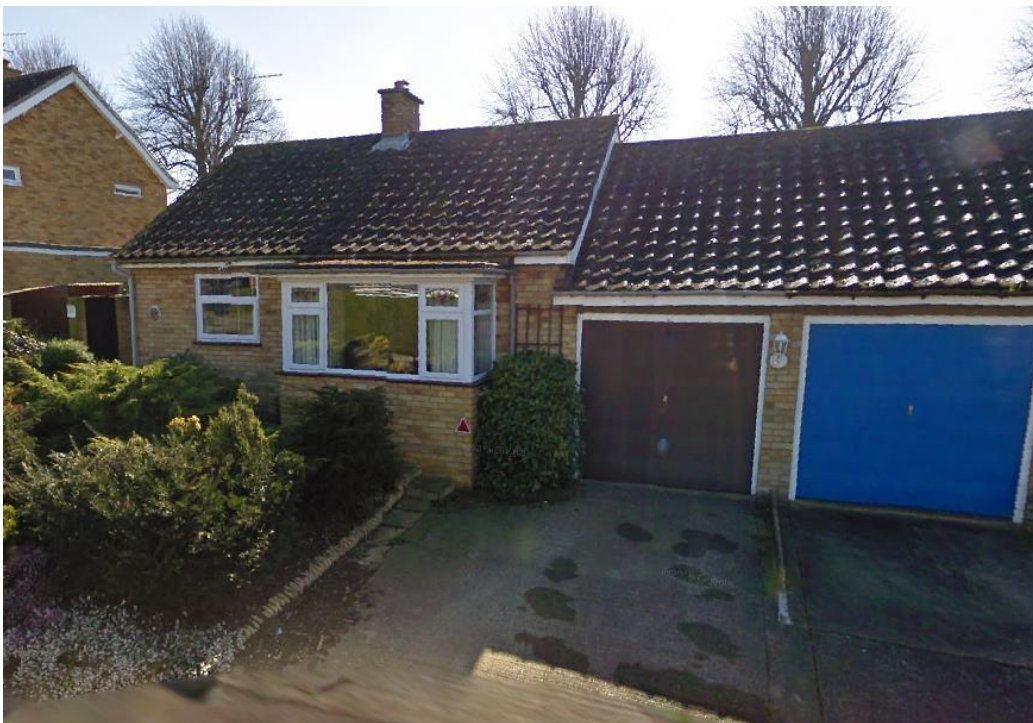
Front elevation of the property and garage, with the trees shown to the rear.

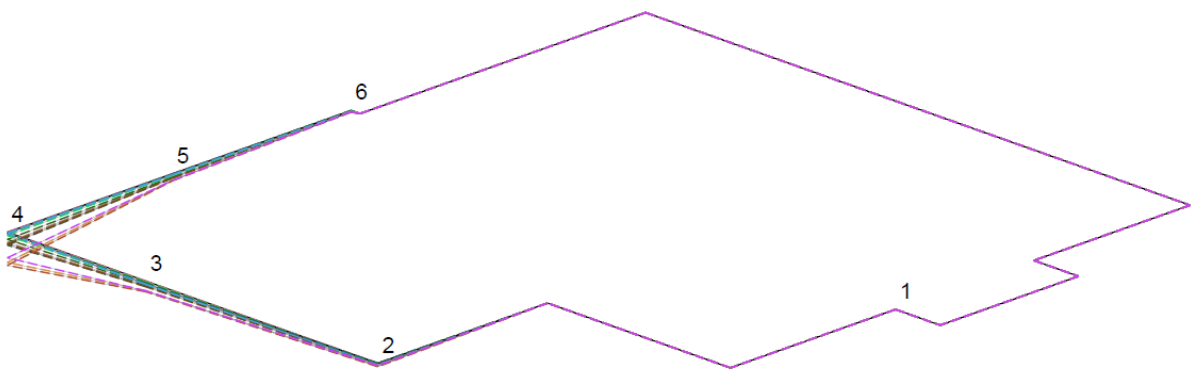
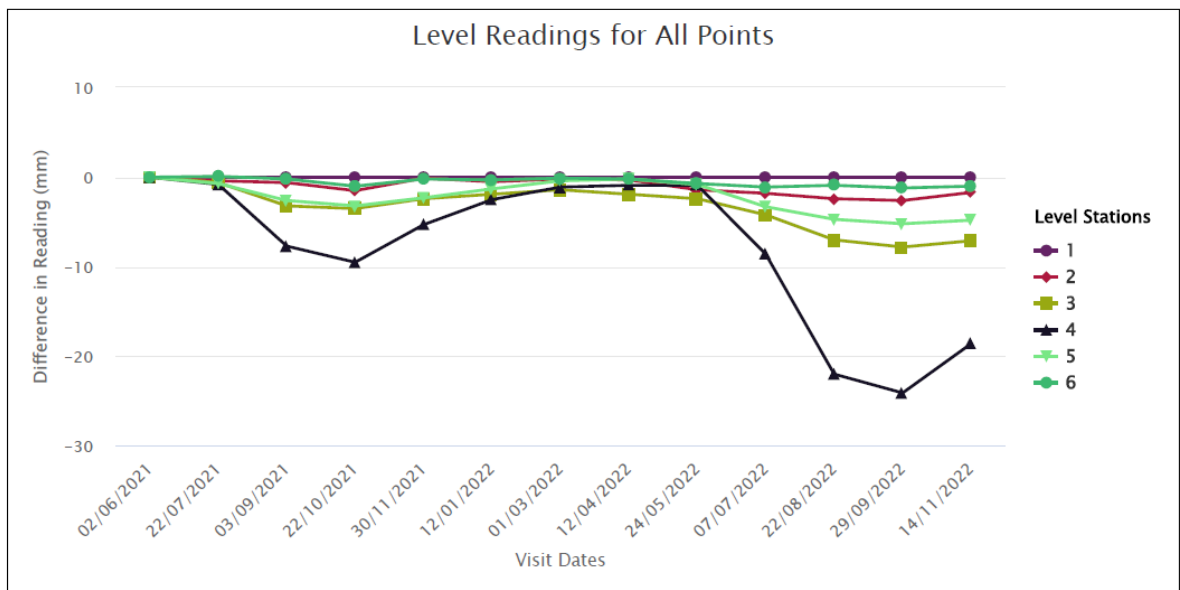
Level monitoring has been carried out across the rear and left-hand elevations. A point on the front of the property has been used as an assumed stable datum. The results confirm a cyclical pattern of downward movement during the drier, hotter summer months when the trees are in leaf and demanding moisture from the ground. Recovery and upward movement is then noted during the wetter winter months when the weather is more inclement, and the soils are able to rehydrate and swell and the trees have dropped leaf and therefore no demand of moisture is present.

The most movement is noted about the rear left hand corner where point four shows nearly 24mm of downward movement during late summer 2022 which is acknowledged as an event year where the intensity and longevity of the heatwave caused droughts and moisture deficit across the south and east of the country.

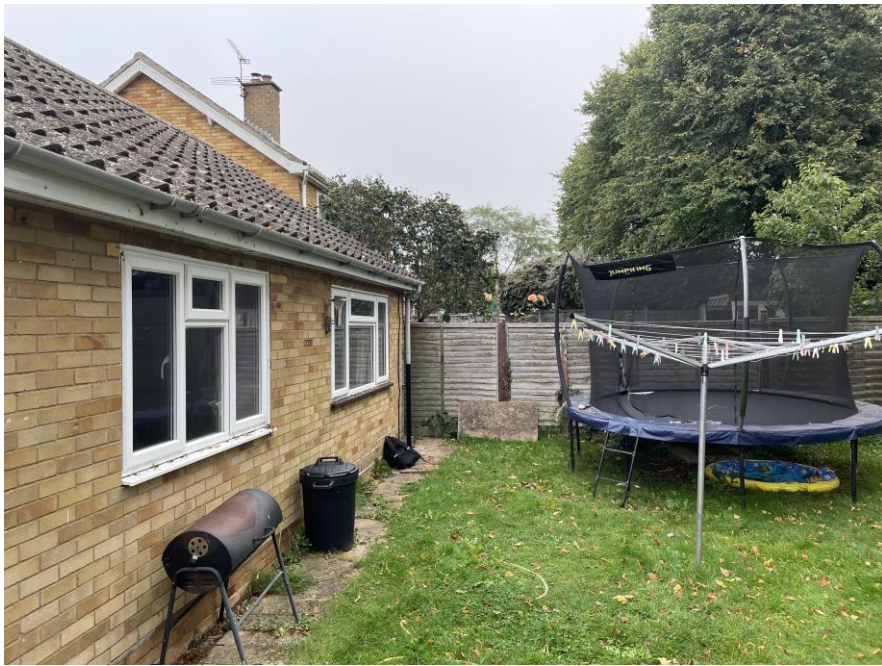
The claim concerns subsidence damage to the rear left hand corner of the building with downward movement noted about the external left-hand corner and associated stepped cracking in the bed joints. There is notable downward and outward distortion about the rear left hand corner. Internally, various cracks are documented which are felt to be related to the movement.

View of the rear of the house with the stepped cracking about the rear left hand corner.

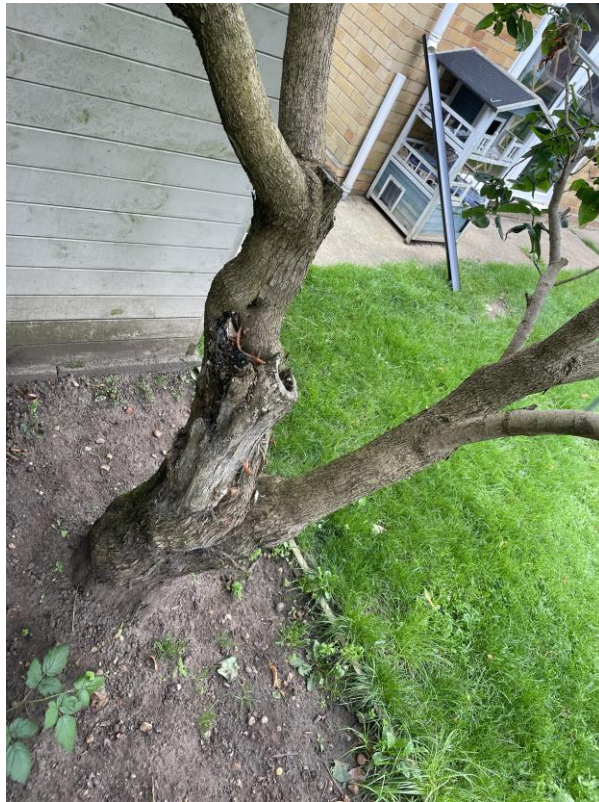
View over the fence at number 20 with the Lilac tree stump size. This is only 1.4m from the area of damage.

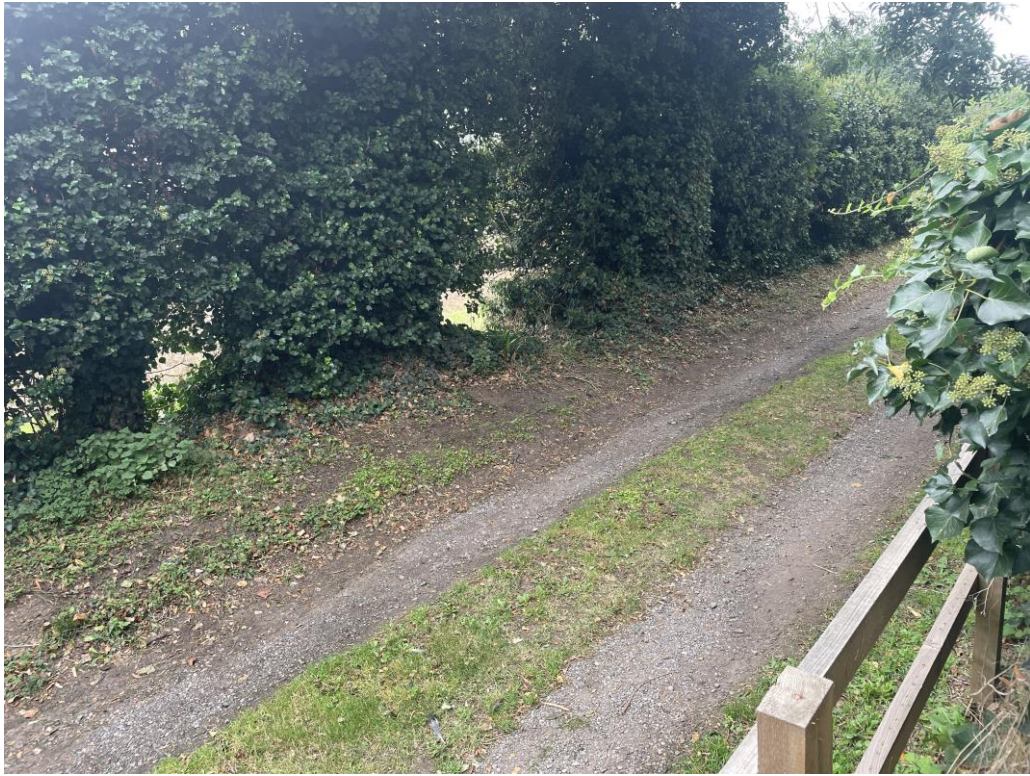
View of The Drift to the rear, which is privately owned by neighbours. This will be required for access.

Access is assumed from the rear, via The Drift which the property back on to. We have assumed that we will need to remove a fence panel in order to access the rear garden and a fence panel between the gardens of 21 and 23 for access between the two.

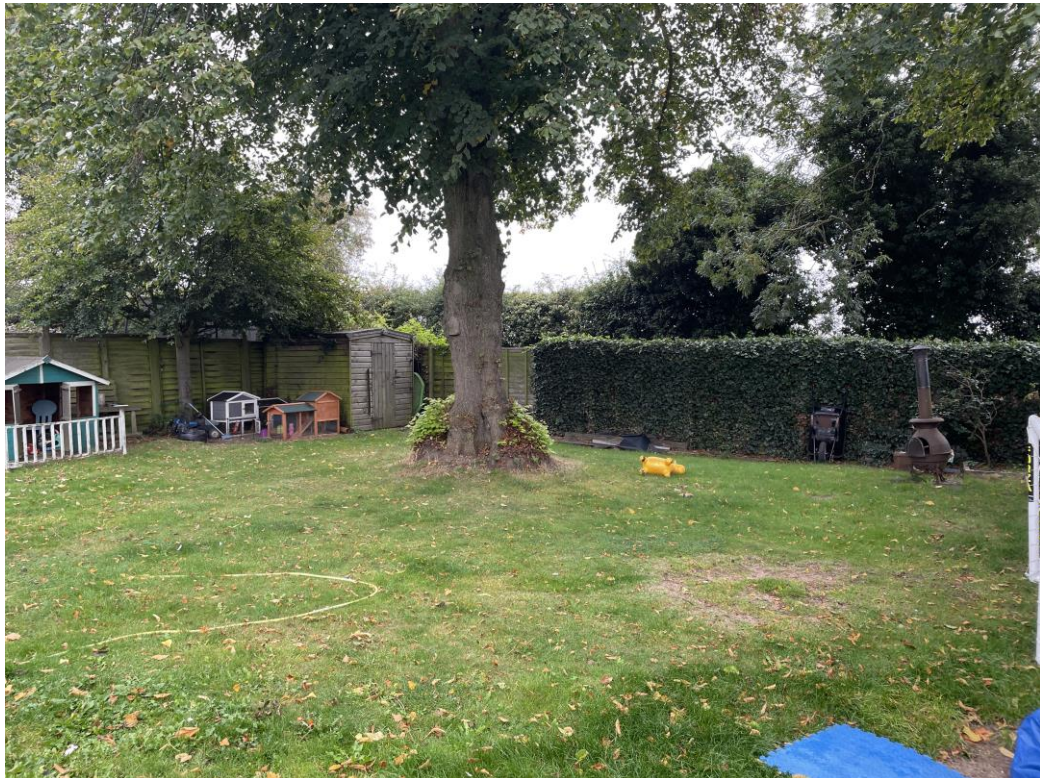
View of the insureds Lime tree with a smaller tree, T2, on the boundary fence

The arborist report from 2022 recommended the removal T1 Lime which is in the policyholder's garden but is subject to a tree preservation order. We suspect this is in part to lime tree roots being detected below the foundation in this area and it is undeniable that it will be having an influence. The barrier needs to extend into the left-hand neighbour's garden to defend against T4.
