# ARBORICULTURAL ASSESSMENT REPORT

21 Freeman Avenue, Henley, Ipswich, IP6 0RZ

**Client Ref:** 9461250  
**Insurer Ref:** D141112170

**Survey Date:** 03/03/2022

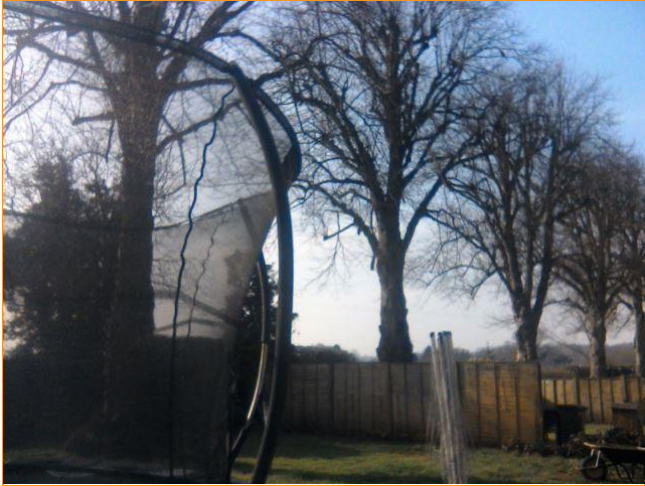
T1 - Lime on left

Tree No:	Species	Works Required
T1	Lime	Fell and treat stump with eco plugs (broadleaved).

Babergh and Mid Suffolk Council has confirmed that the implicated Lime vegetation is subject to a Tree Preservation Order. There are no Conservation Area controls.

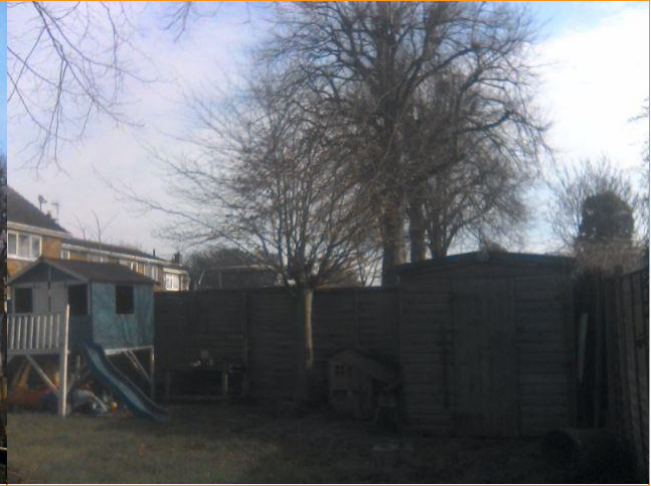
T2 - Beech mid view

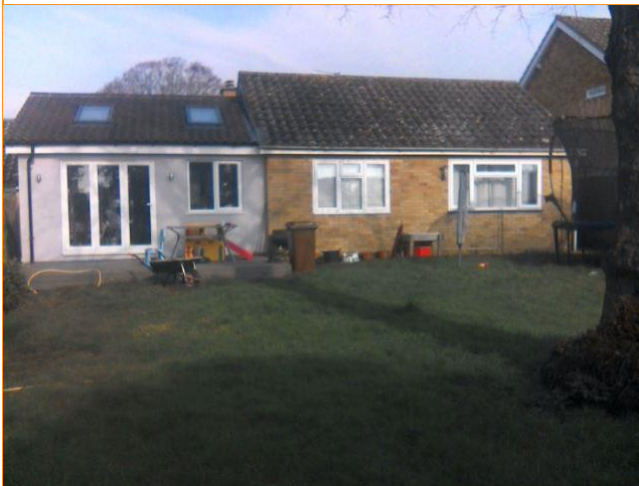
Property rear elevation

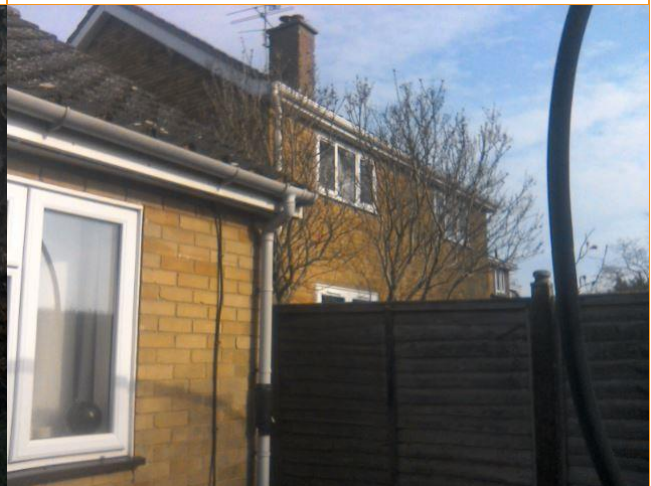
S1 - Lilac mid view

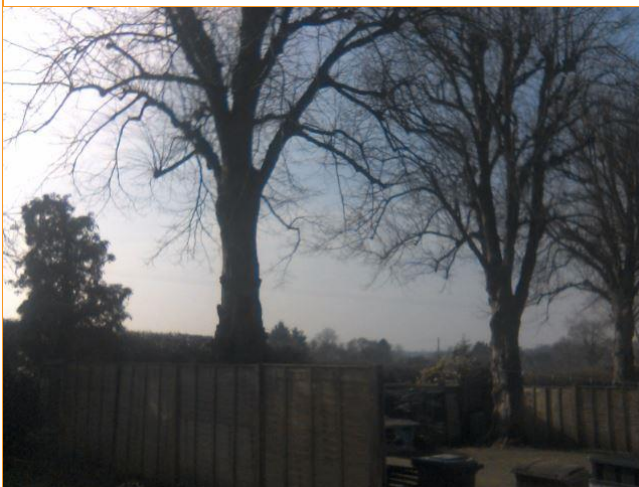
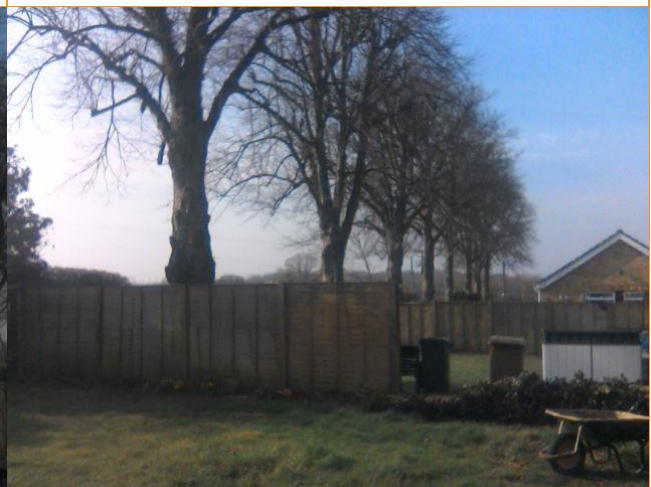
T3 - Lime

T3 - Lime & distant view

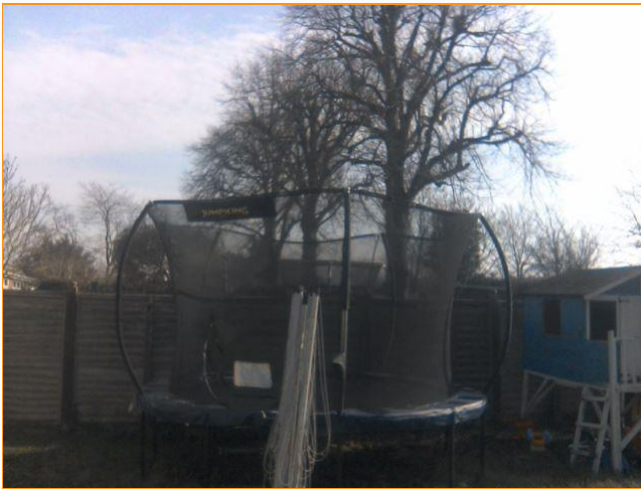
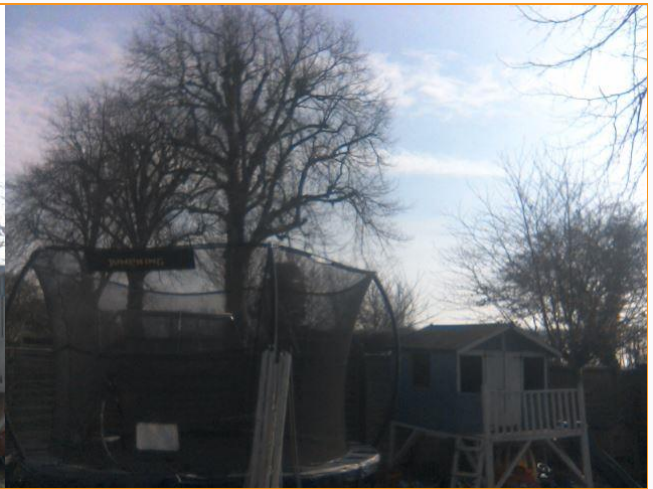
Tree No	Common Name	Age Class	Condition	Height (m)	Crown Spread (m)	Stem diam. (mm)	Dist to bldg. (m)	Roots Implicated	Pruning history	Recommendation	Tree work constraints	Notes	Owner address	Owner
T4	Lime	Semi-Mature	Good	15	12	700*	16.5	N	Subject to past reduction management (within last 3 years).	keep pruned			20 Freeman Avenue Henley Ipswich IP6 0RZ	P3P

T4 - Lime and distant view

T4 - Lime & distant view
