Arboricultural Report: TPO/CA Tree Works Application

Date: 06.11.23

Job no: 23039

Address: Ackworth Grove, Pontefract Road, Ackworth, Pontefract, WF7 7EE.

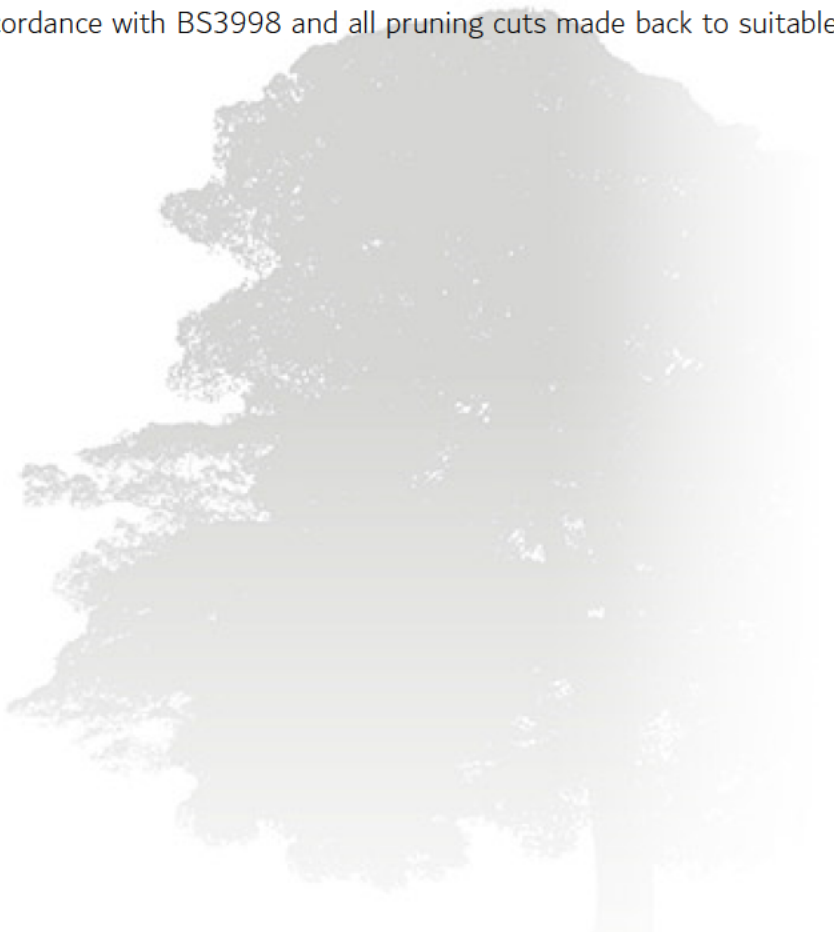
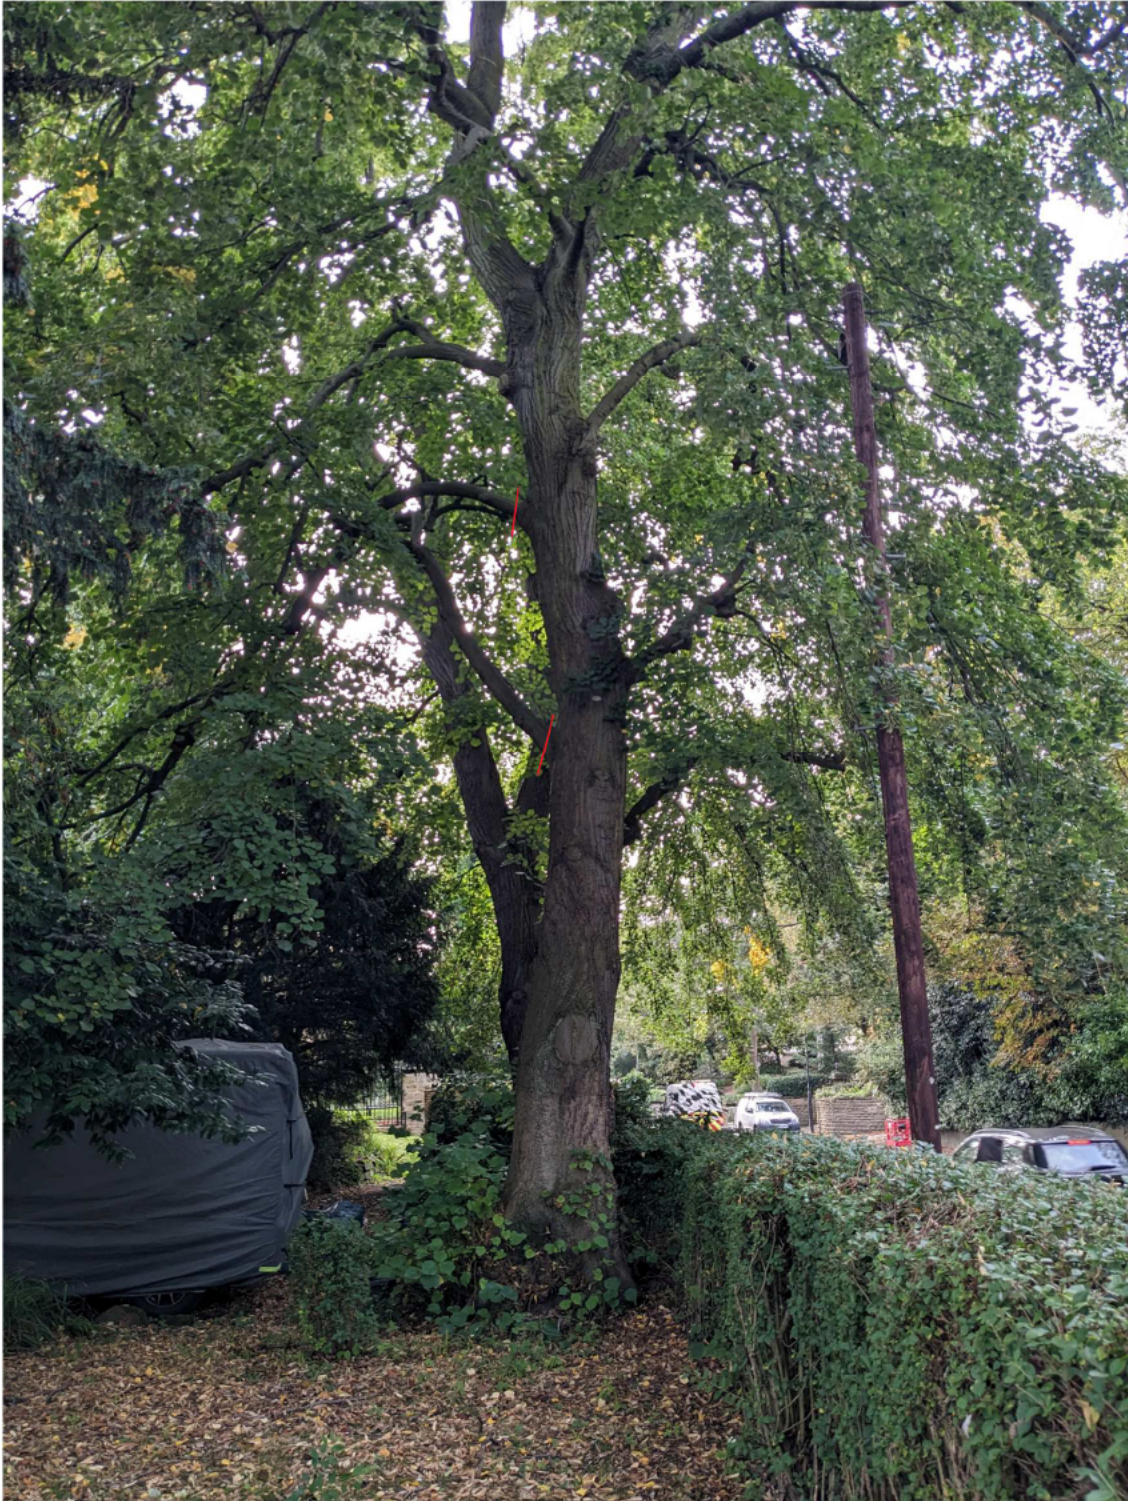
T1: Silver Pendent Lime (*Tilia tomentosa* 'Petiolaris')

Observations: The canopy conflicts with adjacent telecoms cables. There are rubbing branches noted in the lower crown. The lowest branch has a poor attachment point, which poses a risk of failure over the car parking space. Some epicormic growth at the base of the stem.

Figure 2 T1 showing branches to be removed as part of minor crown-lifting works over car parking area A268 can be seen behind the site boundary

branches to create 2m of clearance from the telecoms cables.

2. Crown lift by removing the lowest two branches which overhang the parking space.
3. All above works to be conducted in accordance with BS3998 and all pruning cuts made back to suitable growth points.

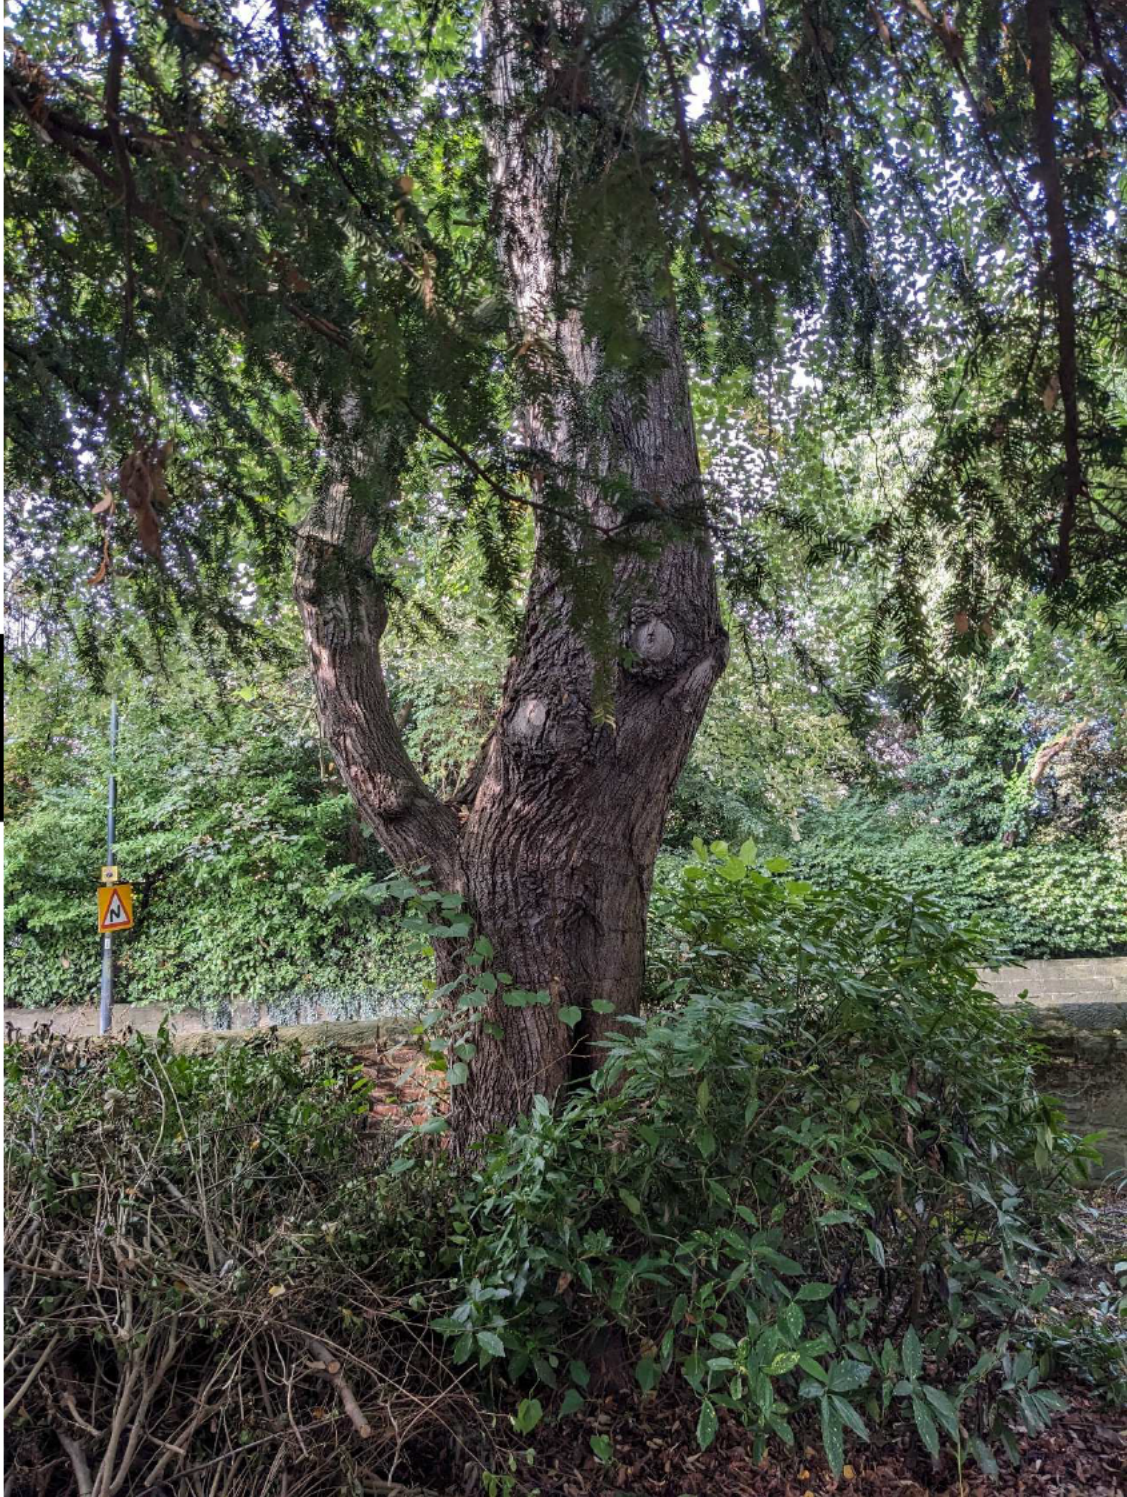
T2: Silver Pendent Lime (*Tilia tomentosa* 'Petiolaris')

Observations: The main stem is bifurcated at approximately 2.5m. There is a branch tear wound noted in the upper-mid canopy on the South-West side. Minor deadwood noted in the crown.

Figure 3 T2 shown adjacent to boundary, with A628 behind

[REDACTED] a height of 3m, to provide clearance over the car parking area.

[REDACTED] deadwood.

3. All above works to be conducted in accordance with BS3998 and all pruning cuts made back to suitable growth points.

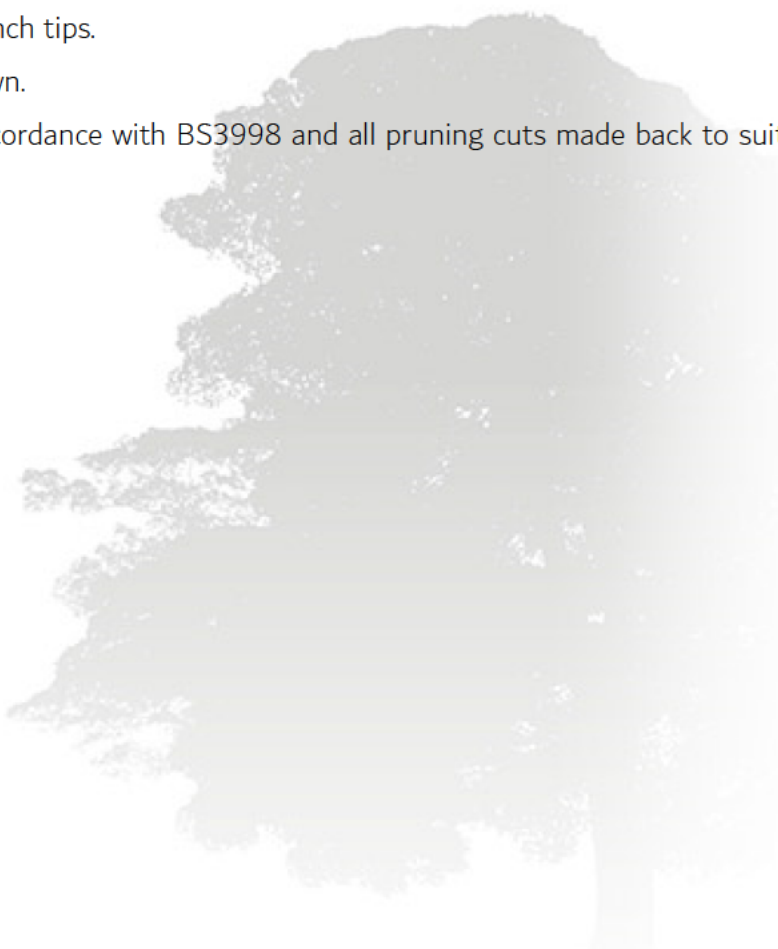
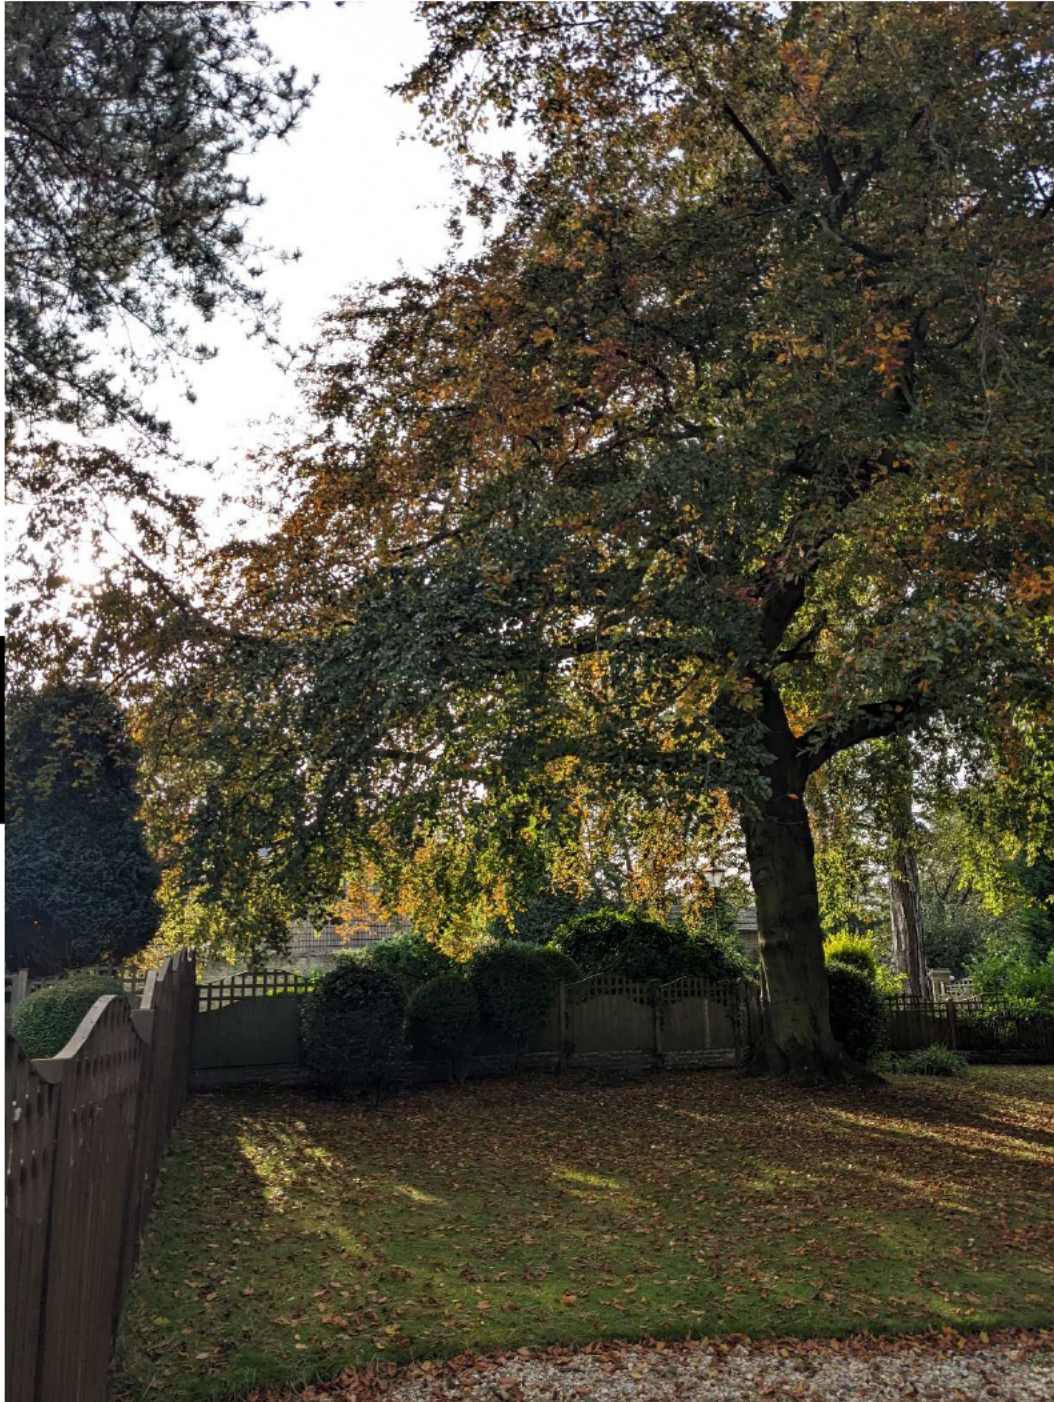
T3: Copper Beech (*Fagus sylvatica* 'Atropurpurea')

Observations: A large specimen with a wide spreading crown and low hanging crown. There are burrs on the stem and occluded pruning wounds noted throughout from previously crown lifting and crown reduction works. Also noted are multiple crossing and rubbing branches within the crown, as well as a minor broken branch in the lower

Figure 4 T3 with wide spreading crown, overhanging the lawned area

1. Crown lift to a height of 4m.
2. Reduce crown laterally by 3m from branch tips.
3. Remove broken branch from lower crown.
4. All above works to be conducted in accordance with BS3998 and all pruning cuts made back to suitable growth points.

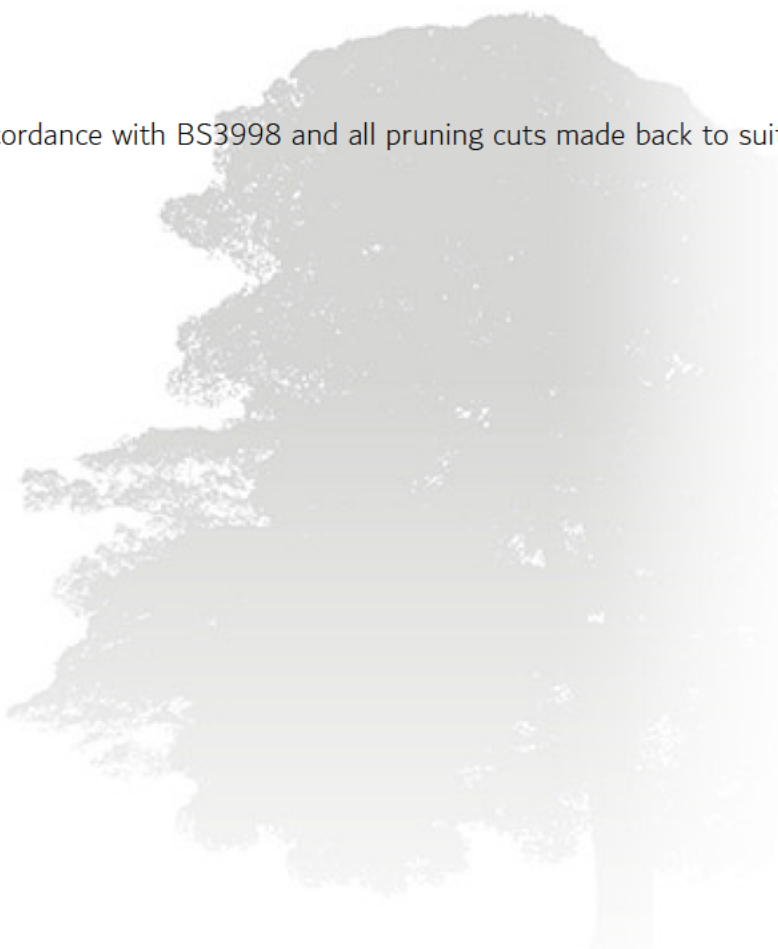
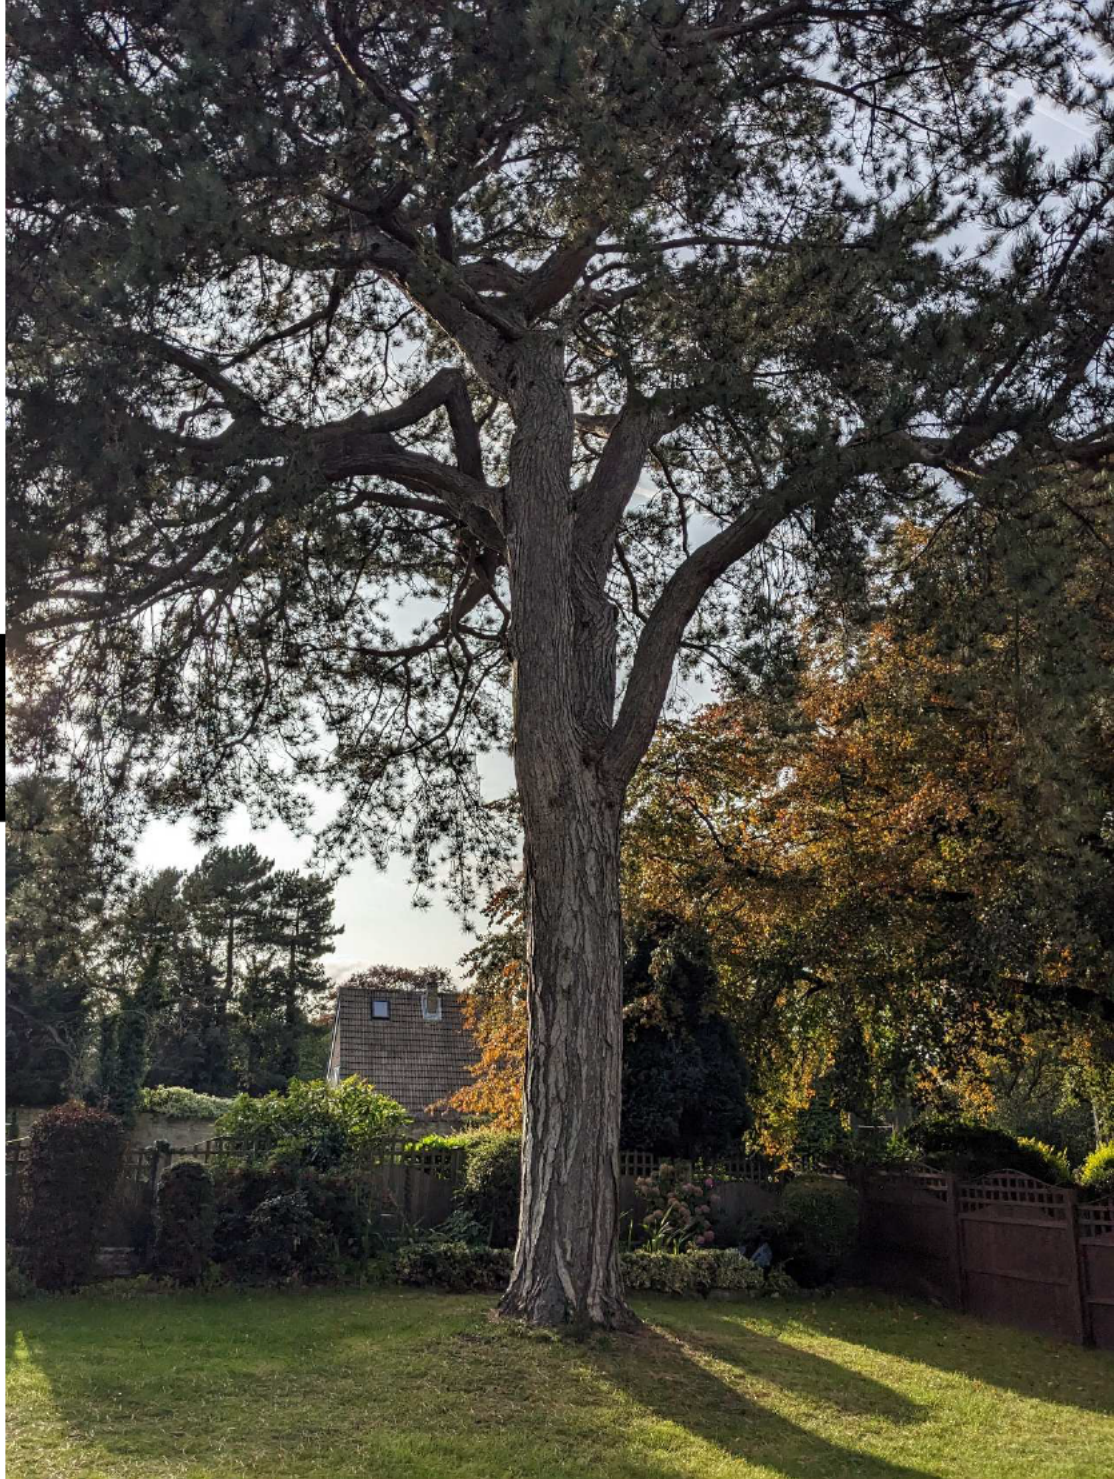
T4: Corsican Pine (*Pinus nigra*)

Observations: A large specimen with a wide spreading crown and large lateral branches reaching towards the adjacent dwelling. There are occasional crossing and rubbing branches within the crown, as well as some minor deadwood noted.

Figure 5 T4 is situated in lawn area

[REDACTED] ches reaching towards the dwelling by 3m.

2. Lateral Crown reduction by 2m from branch tips.
3. Crown lift to a height of 5m.
4. Remove deadwood.
5. All above works to be conducted in accordance with BS3998 and all pruning cuts made back to suitable growth points.
