LAND INVESTIGATION SURVEY
OF
1 CANADA COTTAGES, STORTFORD ROAD, GREAT DUNMOW, ESSEX, CM6 1SH

CLIENT: CINDY HOWELLS
1 CANADA COTTAGES, STORTFORD ROAD, GREAT DUNMOW, ESSEX, CM6 1SH

UPRN NO: N/A
PROJECT NO: J828691
DATE: November 2022

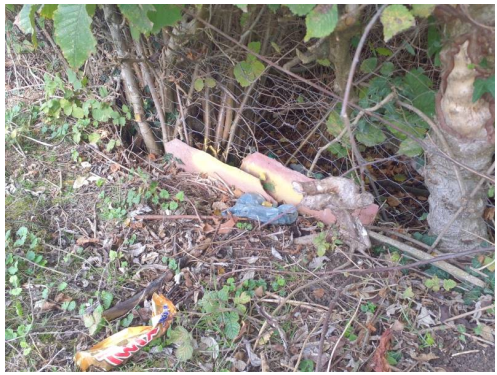
BUILDING NAME:	
FLOOR/LOCATION:	External Rear Garden Plot
DESCRIPTION:	Red cement roof slate to RHS boundy fenceline
RECOMMENDATIONS: Remove under controlled conditions	
EXTENT:	>50m ² or >50m pipe run
SAMPLE REF:	UV000247
RESULT:	Chrysotile

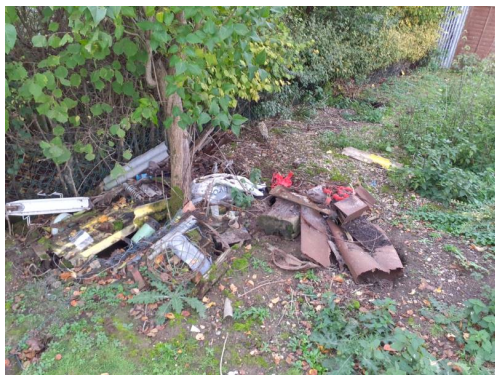
BUILDING NAME:	
FLOOR/LOCATION:	External Rear Garden Plot
DESCRIPTION:	Corrugated cement roof sheets to/below soil
RECOMMENDATIONS: Remove under controlled conditions	
EXTENT:	<10m ² or <10m pipe run
SAMPLE REF:	UV000248
RESULT:	Chrysotile

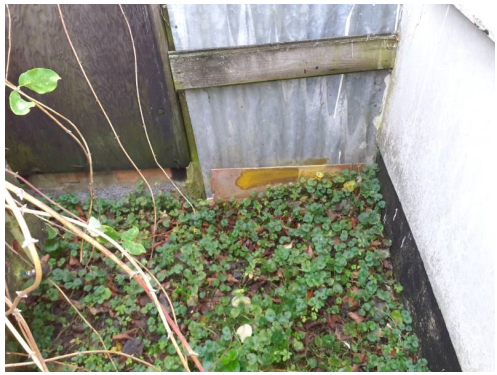
BUILDING NAME:	
FLOOR/LOCATION:	External Rear Garden Plot
DESCRIPTION:	Red cement roof sheet to rear of garage
RECOMMENDATIONS: Remove under controlled conditions	
EXTENT:	<10m ² or <10m pipe run
SAMPLE REF:	SPST UV000247
RESULT:	Chrysotile

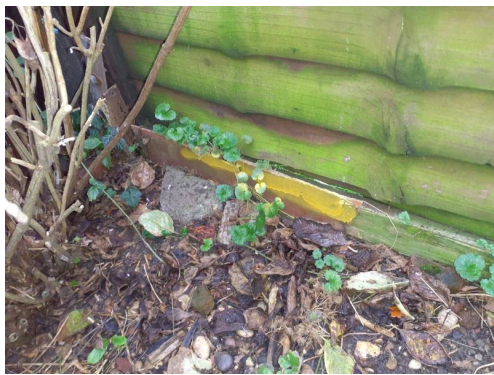
BUILDING NAME:	.
FLOOR/LOCATION:	External Rear Garden Plot
DESCRIPTION:	Cement roof sheet to LHS boundary fenceline
RECOMMENDATIONS:	Remove under controlled conditions
EXTENT:	<10m ² or <10m pipe run
SAMPLE REF:	SPST UV000247
RESULT:	Chrysotile
