GROUND ASSESSMENT & INFILTRATION TEST REPORT

**BRAEMAR LODGE HOTEL
6 GLENSHEE ROAD
BRAEMAR
ABERDEENSHIRE
AB35 5YQ**

3362/23

09 May 2023

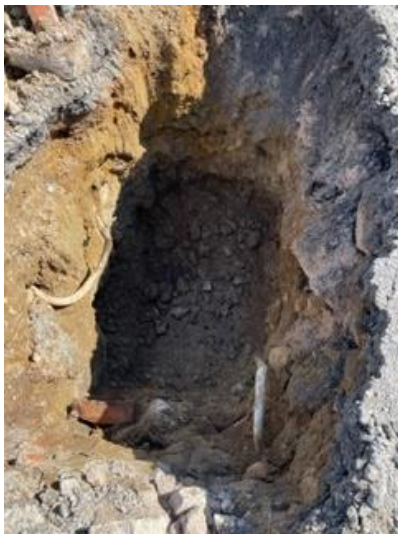
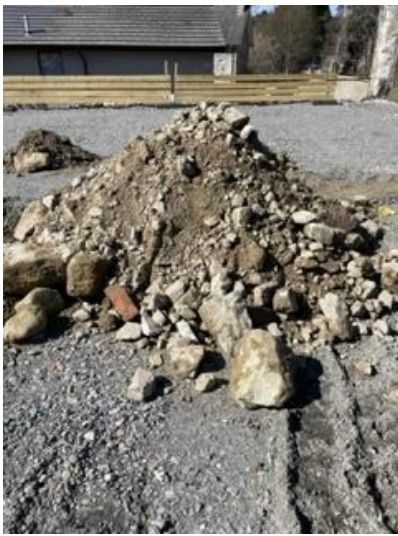
Excavation Method		Dimensions		Ground Level (mOD)		Site		Trial Pit Number	
Tracked excavator with 0.70m bucket		1.00 x 2.00				Braemar Lodge, Braemar		TP1	
		Location		Dates		Client		Job Number	
				18/04/2023		Braigh Mharr Ltd		3362/23	
						Engineer		Sheet	
						HGA		1/1	
Depth (m)	Sample / Tests	Water Depth (m)	Field Records	Level (mOD)	Depth (m) (Thickness)	Description	Legend	Water	
					(0.12)	MADE GROUND - grey gravel hardcore			
					0.12	MADE GROUND - building rubble			
					(0.38)				
					0.50	MADE GROUND - reworked sandy gravelly material ...lead pipes at 0.50m			
					(0.40)				
					0.90	Medium dense grey and orange silty fine SAND			
					(0.70)				
			Infiltration test zone 1.60-1.80m		1.60	Weak grey highly weathered well fractured ROCK (seen as angular gravels and cobbles)			
			No groundwater ingress		(0.20)				
					1.80	Complete at 1.80m

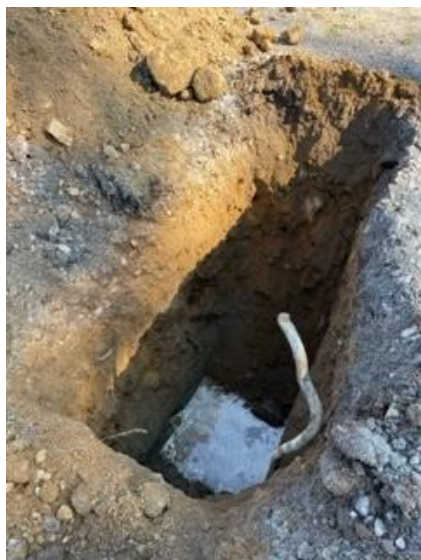
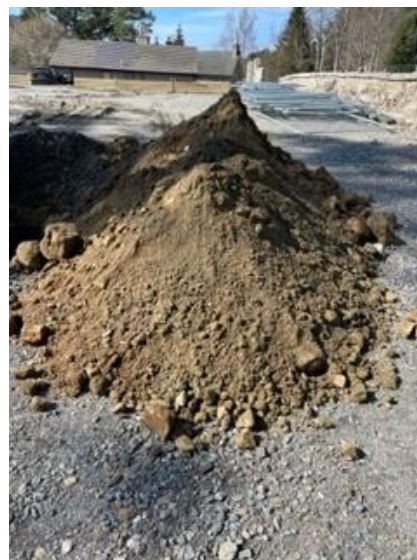
Excavation Method		Dimensions		Ground Level (mOD)		Client		Trial Pit Number	
Tracked excavator with 0.70m bucket		0.80 x 1.80				Braemar Lodge, Braemar		TP3	
		Location		Dates		Engineer		Job Number	
				18/04/2023		HGA		3362/23	
Depth (m)	Sample / Tests	Water Depth (m)	Field Records	Level (mOD)	Depth (m) (Thickness)	Description		Legend	Water
					0.25	MADE GROUND - grey gravel hardcore			
					0.25	Original TOPSOIL			
					0.75				
					1.00	Medium dense dark grey and orange silty fine SAND			
					0.60	...becoming gravelly below 1.40m			
					1.60	Dense grey sandy angular GRAVELS and cobbles completely to highly weathered rock			
					0.40				
					2.00	Complete at 2.00m			
			Infiltration test zone 1.80-2.00m No groundwater ingress
