**Tree Survey and
Arboricultural Impact Assessment**

Eldwick Primary School, Bingley

Report Reference: CE-ES-2450-RP01-Final Tree Survey and AIA

3 October 2023

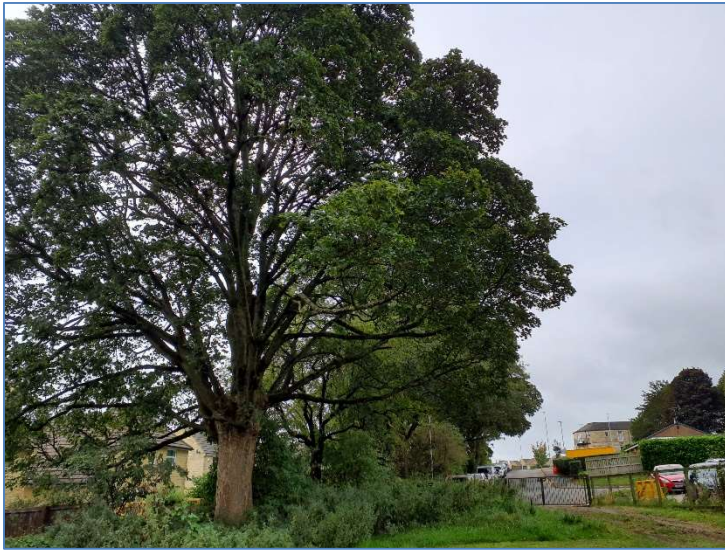
- 4.1.5 **Sycamore T1** is a large broad spreading tree located on the southern boundary and is next to an existing access from the access driveway into the sports pitch area. There is clear evidence of vehicular access into this area some, part of which is within the root protection of the tree. The tree is considered to be in good condition and has high crown clearance. This tree has been rated category A status.

Photo 1 (left): Sycamore TI, with the existing access point at the right hand edge of the photograph.

- 6.5.1 To enable access to implement the development there is a requirement to access a small proportion of the RPA of **T1**. Access requires the use of construction vehicles and MEWPs to facilitate safe access. All of this has the potential to lead to ground compaction unless suitable ground protection methods are adopted.
- 6.5.2 To prevent ground compaction from the use of vehicles there will be a requirement to install temporary ground protection mats within the root protection areas outside the protective fencing.
- 6.5.3 Temporary ground protection would need to be of a type suitable to facilitate temporary vehicle access within the rooting areas without leading to ground compaction or contamination. This would need to

8.1.3 There will be a requirement to access the installation site via an existing access point that is partly within the RPA of one tree and ground protection for this will need to be installed prior to installation.

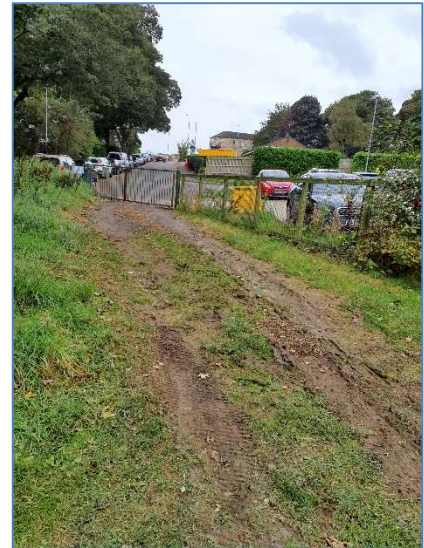
Photo 2 (below): A closer view of the existing access and the current evidence of usage, partly within the RPA.

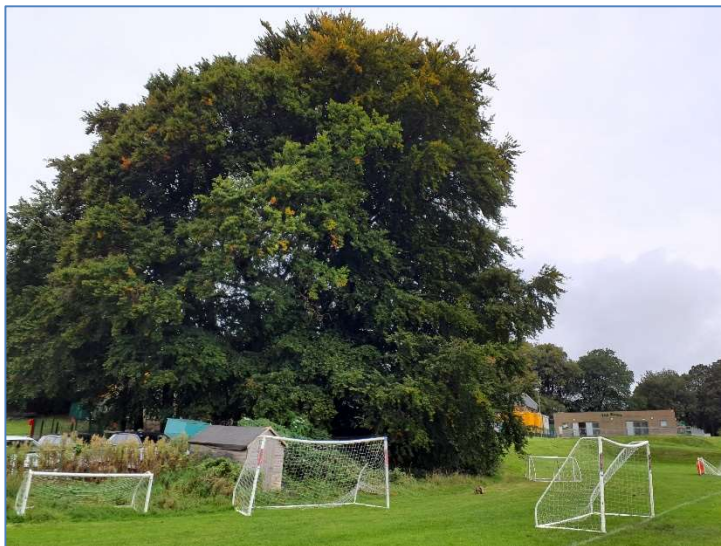
- 4.1.6 **Group G3** is located immediately west of the sports pitch, in a fenced area near to a school car parking area. This consists of a number of close growing mature trees of significant prominence. One particularly large Beech tree within this group is approximately 3m from the boundary with the sports pitch. This is probably the most dominant tree in this group and the root protection area and canopy spread constraints are derived from this tree. This group has been rated category A status.

Photo 3 (above): Group G3 immediately west of sports pitch showing prominence.

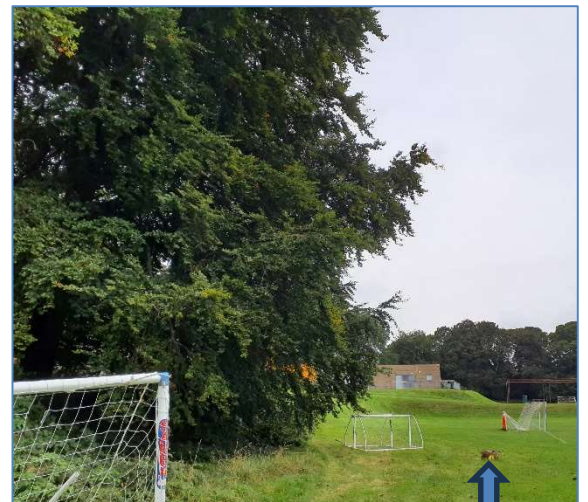
- 6.3.1 Whilst being located close to group **G3** there is no encroachment into the RPA of the trees or underneath the tree canopies. The sloping ground towards the trees will also help prevent any desire to encroach into that area.
- 6.3.2 It is noted that the likely access into the sports pitch area will be through the existing access gateway in the southwest corner of the site. This will result in the passage of vehicles within a small part of the root protection area of **T1**. There is currently evidence of the passage of vehicles in this area, so the impact is considered very low, however the area is still vulnerable to further ground compaction from heavy vehicles, of the type that is likely to be used to transport the classroom buildings.
- 6.3.3 To avoid significant ground compact temporary ground protection will be required in the area shown on the TPP **Appendix T4**.

Photo 4 (right): Outer edge of G3 with measured extent of RPA from largest Beech (15m radius) indicated with survey bag.

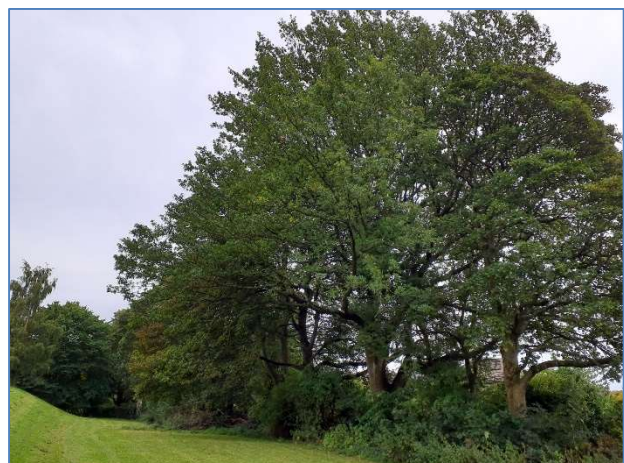
- 4.1.7 **Group G4** is along the southern boundary and the trees are a significant mature screen whilst being located on ground that slopes downwards to the east and is much lower than the plateau of the sports pitch. Owing to the limited life expectancy of the mature Hawthorn trees within this group the group has been downgraded to category B status.

Photo 5 (bottom right): Group G4 located on the southern boundary on ground significantly lower than the sports pitch area
