Appendix TFT Photographs

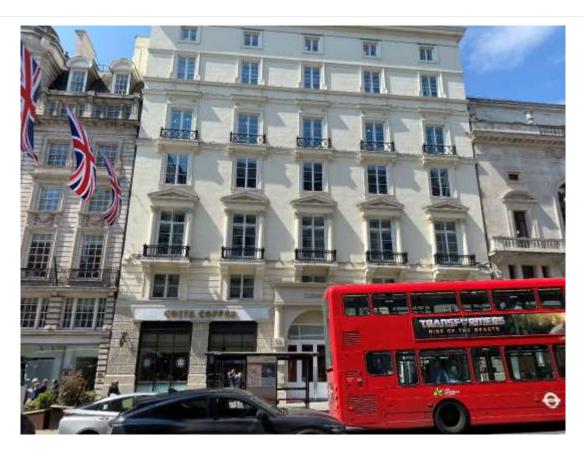
Photo 1: General View front elevation.

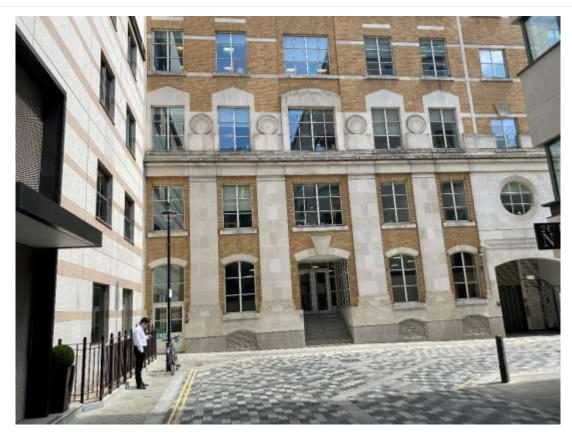
Photo 2: Rear elevation.

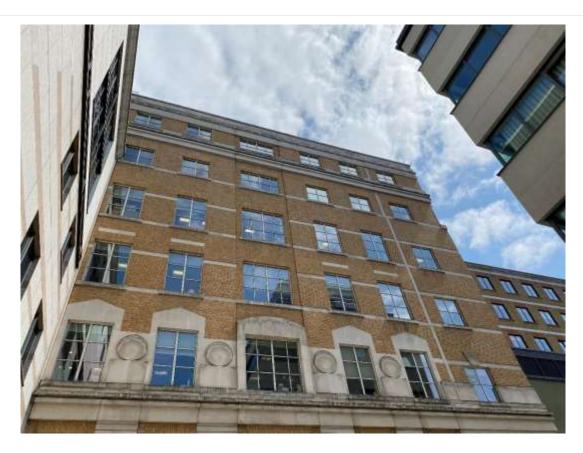
Photo 3: Rear elevation high level.

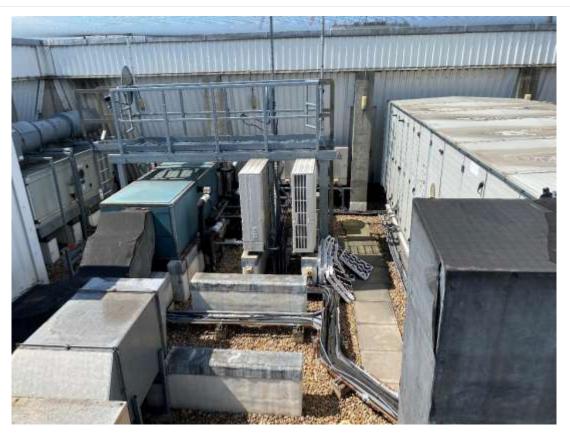
Photo 4: Roof level plant area.

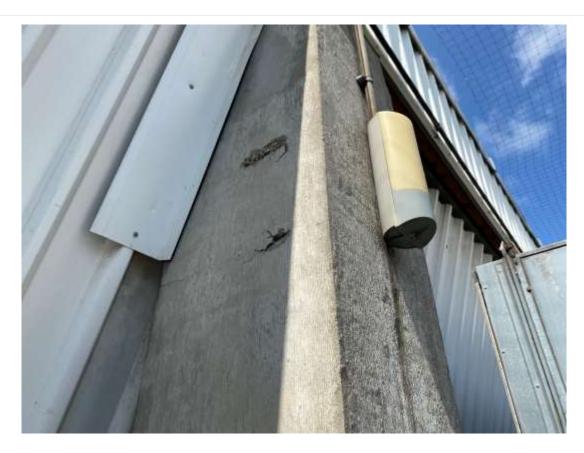
Photo 5: Spalling to concrete frame.

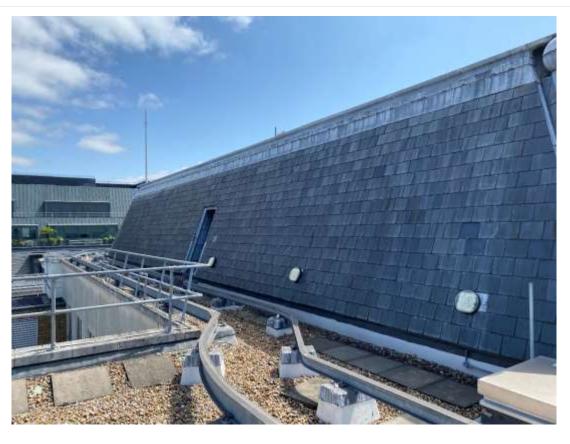
Photo 6: General roof area.

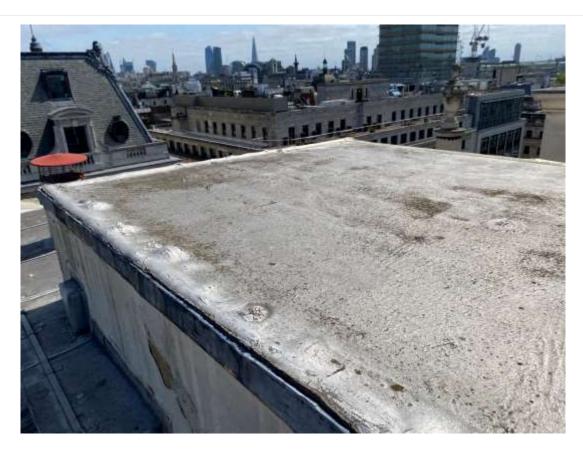
Photo 7: Asphalt covering to flat roof area.

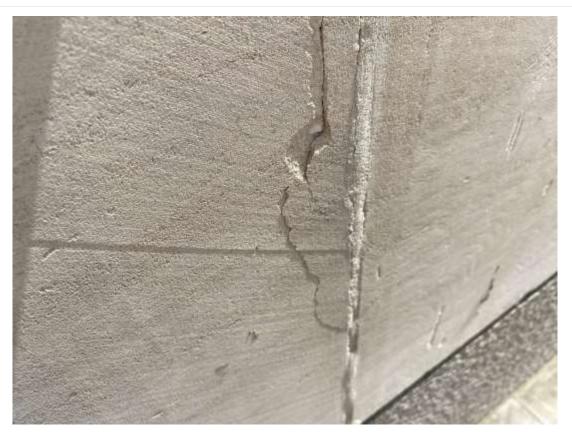
Photo 8: Spalling stone to the read elevation.

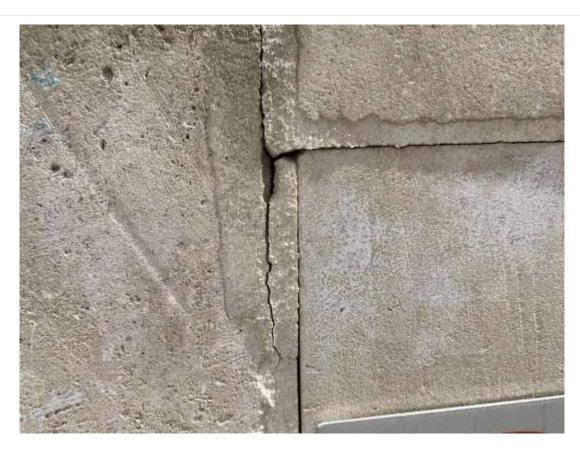
Photo 9: Loose / Cracked pointing to stone.

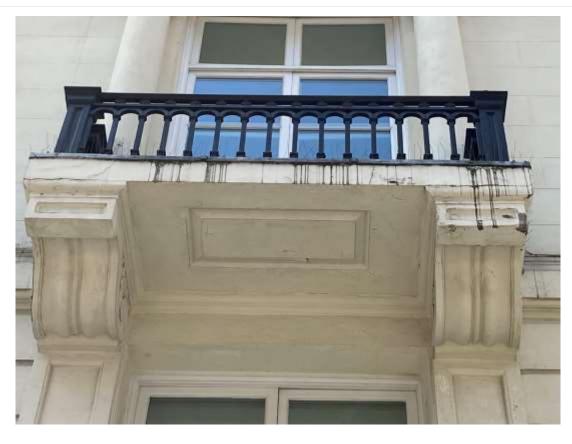
Photo 10: Splits / cracks to decoration to front elevation. Paint runs visible.

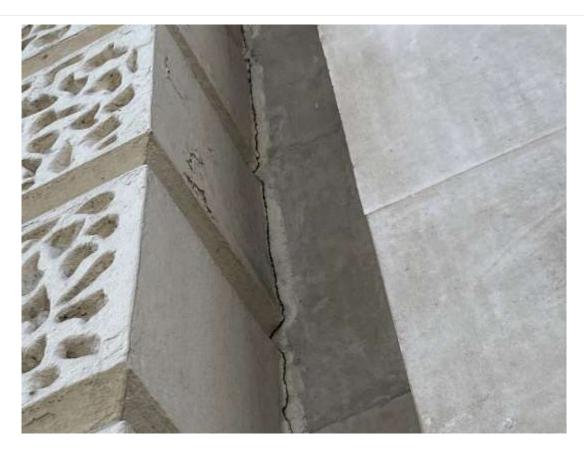
Photo 11: Crack to joint between 15 Regent Street and adjacent property.

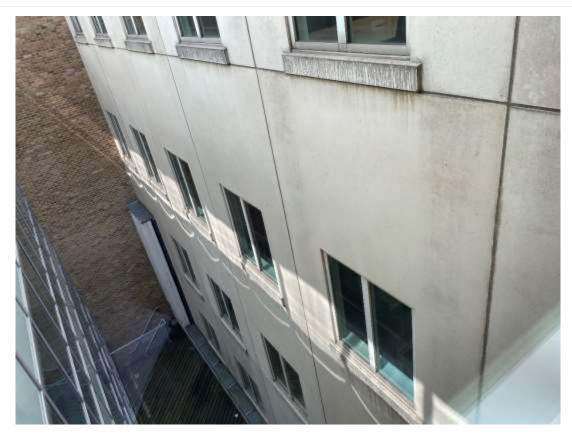
Photo 12: Flank elevation
