CLIENT		The Crown Estate	
PROJECT		15 Regent Street London SW1Y 4LR	
DRAWING TITLE		Proposed Elevation - A	
DRAWING No.		230546-E-B-DL-E-01	
PROJECT No.		230546	DATE 17-10-2023
SCALE 1:100	SIZE A1	REVISION 2	DRAWN JB
		PROPOSED

CLIENT		The Crown Estate	
PROJECT		15 Regent Street London SW1Y 4LR	
DRAWING TITLE		Proposed Elevation - B	
DRAWING No.		230546-E-1-DL-E-02	
PROJECT No.		230546	DATE 17-10-2023
SCALE 1:100	SIZE A1	REVISION 2	DRAWN JB
PROPOSED		REV 1

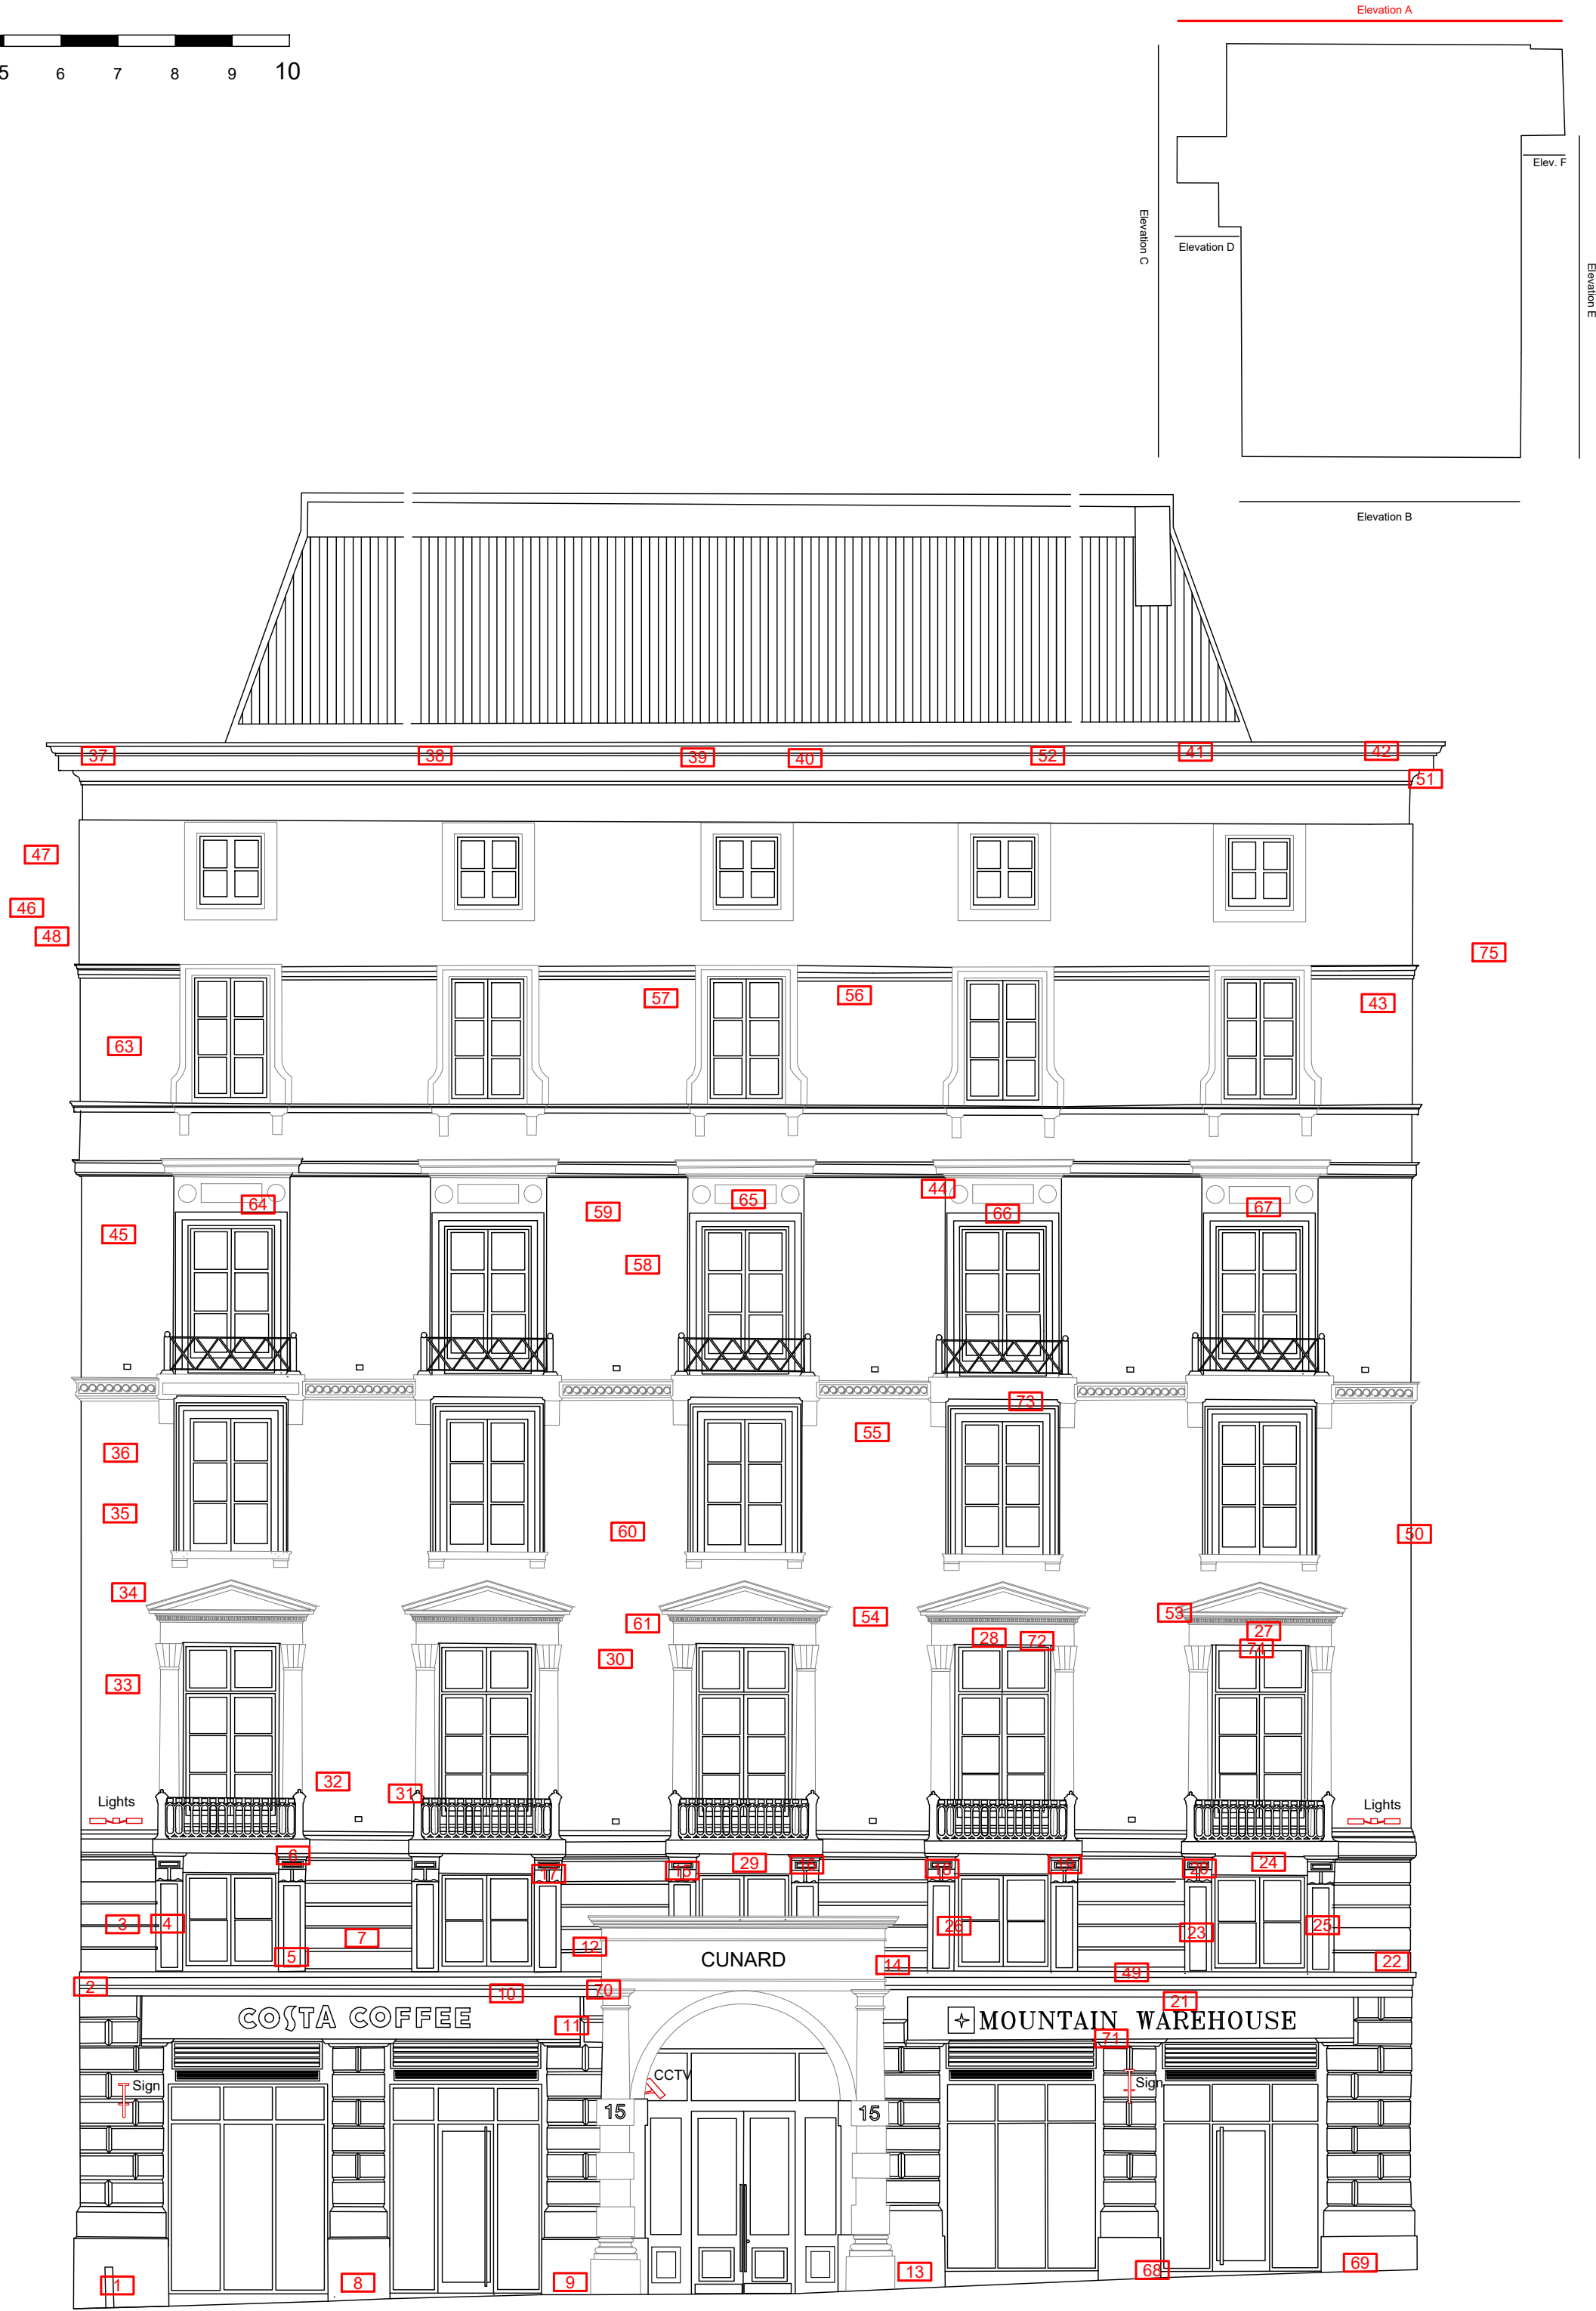
Elevation A

Scope of Repair Works		
Repair Type	Description of works	Photo Reference(s)
A Nothing required	No action at present. (Hairline cracks, previous repairs, or small spalls deemed too small to repair – subject to close access inspection on rear elevations) Locations recorded for future monitoring.	43, 45, 50, 53-58, 61, 62, 64 - 67,
G & H Repointing to open/reopened cracks	Wash and rake out any existing repointing repairs or other debris. Repoint joint to a minimum depth of 50mm using 3:1 sharp sand: NHL 2 hydraulic lime mortar.	1-3, 6, 8-11, 15-22, 24, 35, 37-42, 44, 48, 49, 51, 52, 59, 63, 68-74
P Repairs to lintels/cills potentially damaged by corrosion of embedded metal	Tap test area around cracks to determine extent of loose material. Remove loose material and determine if cracking extends into main lintel structure. If no, carry out Repair Type N. If yes, locally break out existing concrete to fully expose the corroded surface of existing rebars or beams (indicative extents shown on details below). Refer to engineer if corrosion found is excessive and has resulted in significant steel section loss. Clean back exposed steel surfaces by hand or with a needle gun to Grade ST2 as far as reasonably possible. Paint exposed steel and concrete surfaces with 'Ronafix' repair system (or similar approved) cement primer. Re-form concrete encasement to original profile using Ronacrete 'Ronafix' repair system (or similar approved) mortar, applied in strict accordance with the manufacturers' recommendations. Re-render surface if applicable, as per Repair Type N	4-5, 13, 23-29, 47

N Cracked render to wall panels or lintels	Tap test area of render around crack. If no loose material, rake out crack and repair with a colour-match mortar. If there is loose material, remove back to base substrate and check if the cracking extends into the substrate. If yes, allow for stainless steel pinning of substrate cracks (see Repair Type K), or in the case of lintels, consider the need for Repair Type Q if cracks indicate likely internal corrosion. Apply new render to affected area to match existing (1:1:6 cement : lime : sand mix – colour matched). If whole panel to be replaced, consider using NHL lime : sand mix render only	
W Corroded embedded fixings (no visible masonry) or abandoned fixing holes	Tap test area around fixings to determine if there is any loose material. If no loose masonry, remove any ferrous fixings/sockets and then plug all fixing holes with 3:1 sharpsand: NHL2 hydraulic lime mortar.	7, 12, 30-34, 36, 60
